3112 3rd Ave South Heritage Preservation Site Plan

Prepared by Jennifer Tschida
Minneapolis Department of Health
On behalf of
Reina S Benavides Guaman

December 12, 2013

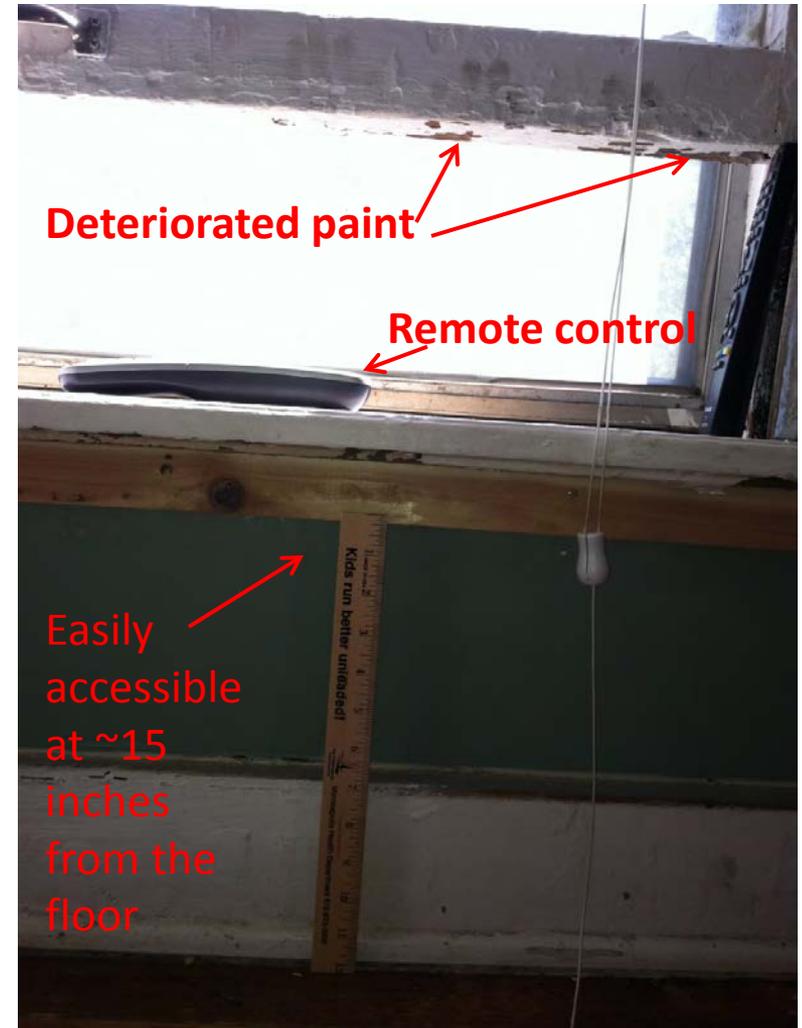
In this home the windows are exceptionally accessible to the children as they are close to the floors. This photo also shows a remote control on the sill which is likely contaminated with lead dust. Children, pregnant women and their fetus' are at risk of lead poisoning just by touching the contaminated remote control.

On September 26, 2012, this window sill contained 45,000 ug/ft² of lead dust which is **180 times the level considered safe for window sills**. The floor directly below the window contained 5,200 ug/ft² of lead dust which is **130 times the level considered safe for floors**.

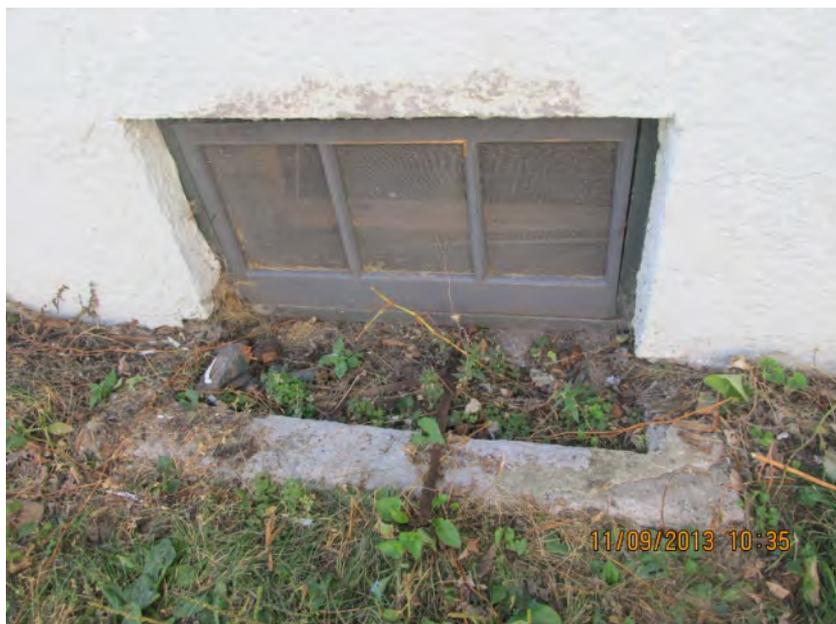
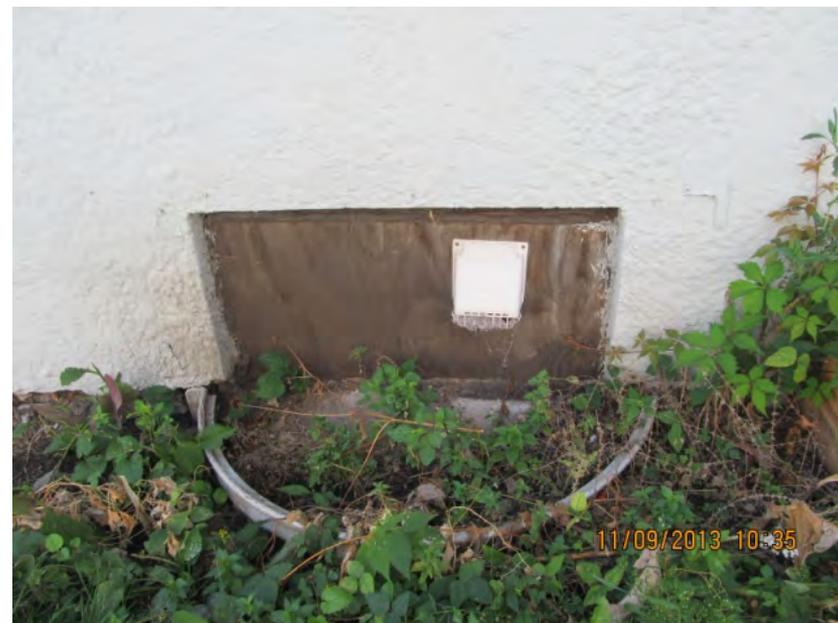
North Side Cellar Windows

These are the cellar windows on the north side. Note that there is no consistency in “historic-ness” of these windows.

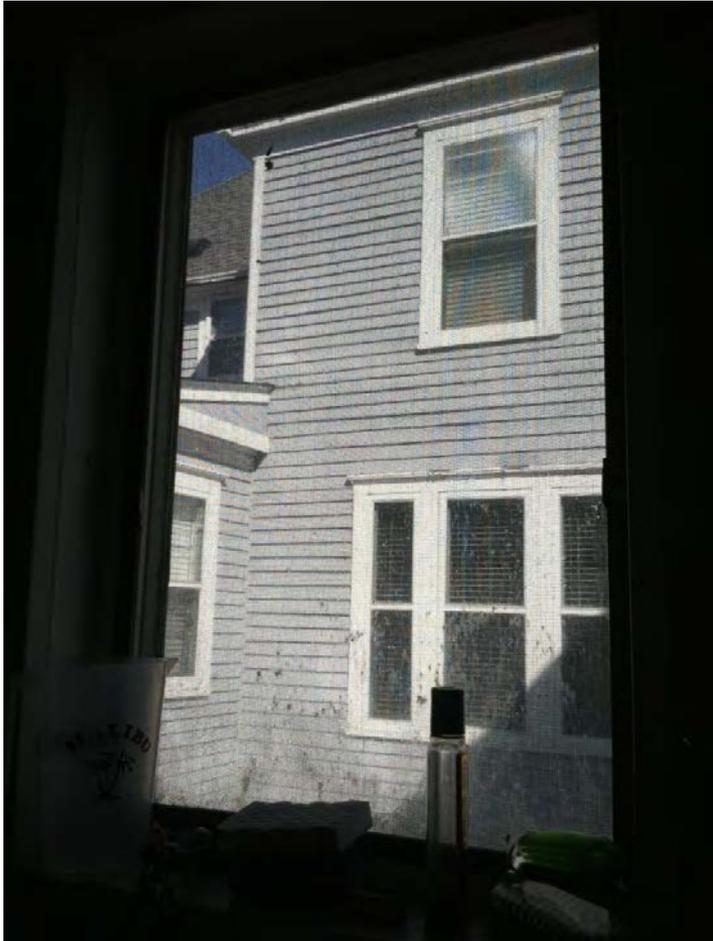
Lower bath casement window

There are four non-historic windows in this home all on the north side of the home.

- 1 vinyl casement in the bedroom closet
- 1 vinyl casement window in the lower bath
- 1 vinyl double hung window in the upper bath
- 1 swing window in the upper kitchen containing lead paint

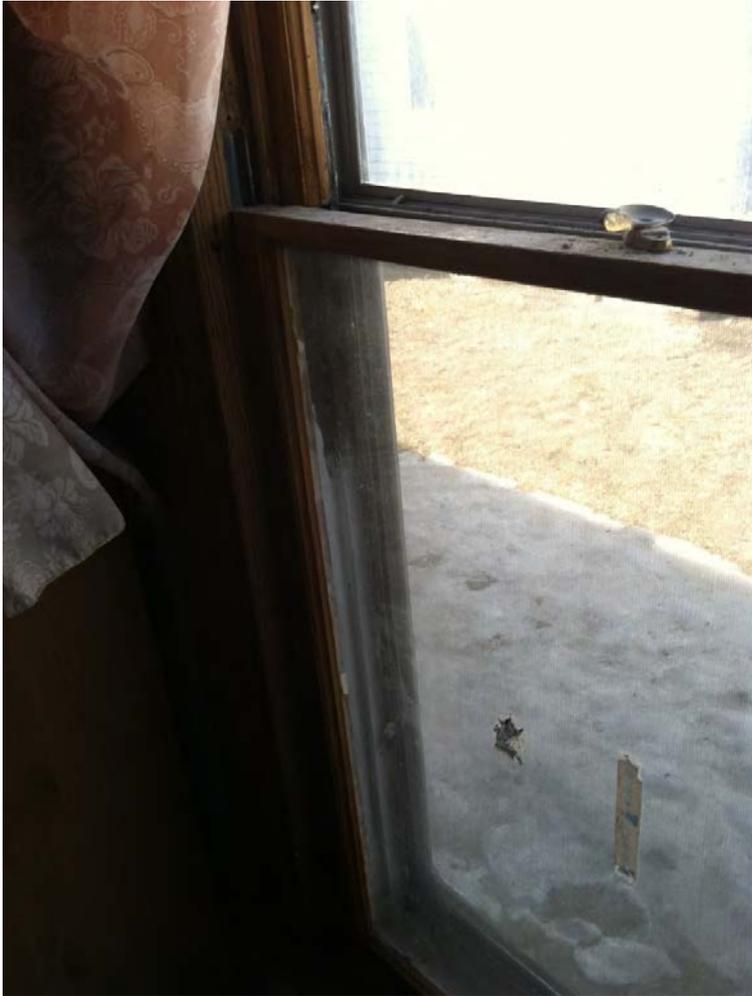
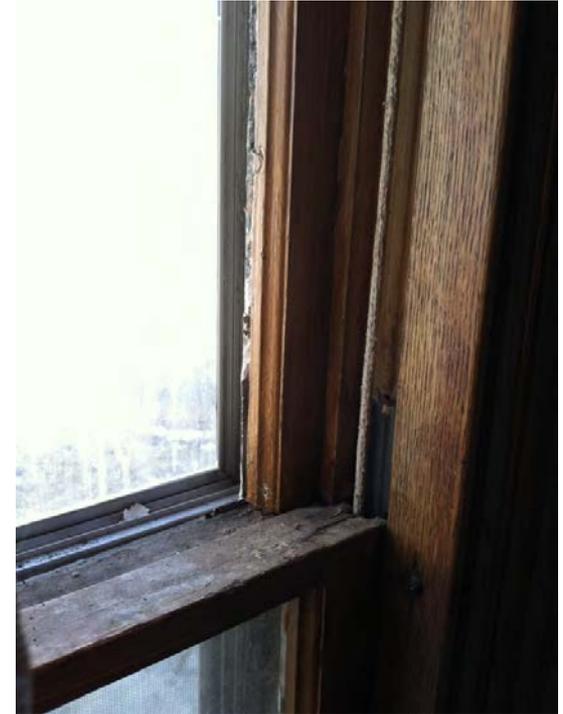
Lower Living Room deterioration

There are two original windows in the living room.
Window 1- Immobile window. We are not requesting any modifications.

Window 2- This window has broken sash cords, is missing the ropes and pulleys are broken. There is missing glass on upper sash and the lower sash contains Plexiglass which is falling out. The exterior sash is rotted, it has a warped meeting rail. There is a non-historic metal storm.

Insp/XRF	Floor	Room	Side	Component	Substrate	Condition	Color	DI	Results	PbC
FO/23480	1st	Living Room 6	B	Window Stop	Wood	Poor	Brown	2.09	POS	4.9

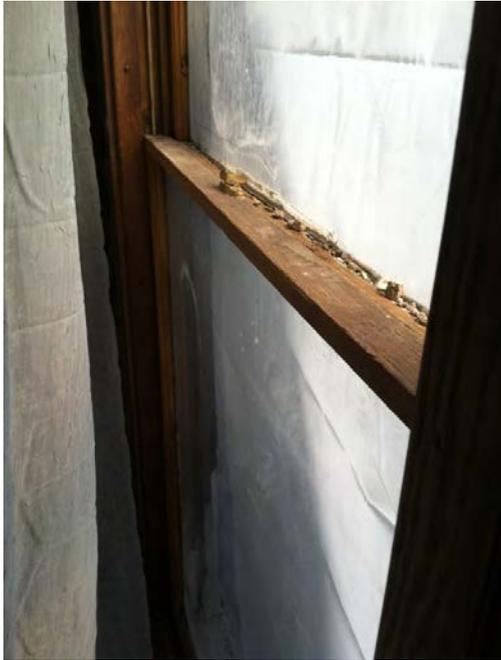
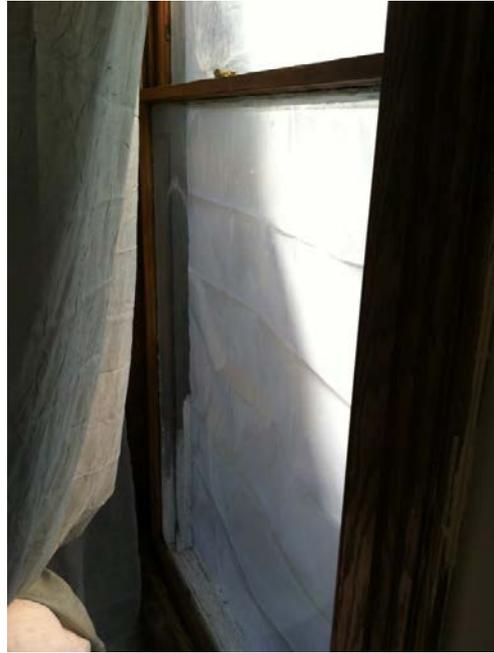
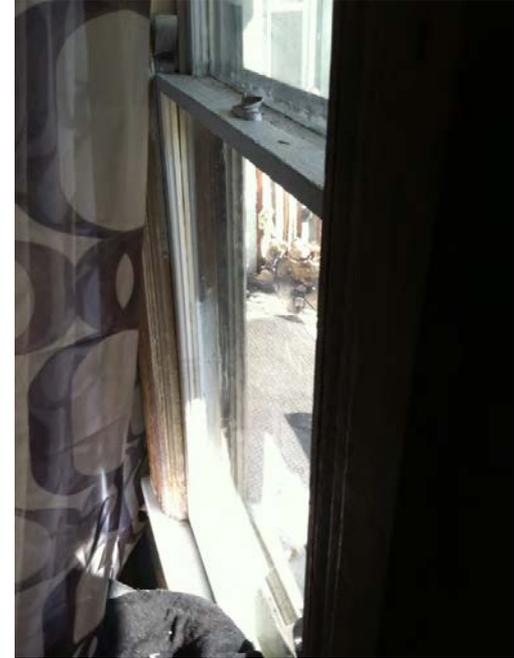
Dining Room Deterioration

The Dining Room consists of three original double hung windows with non historic metal storms

Window 1-Missing glass, meeting rail rot on both upper and lower portions of lower sash, easy access for child as it is low to ground 18 inches.

Window 2-Missing storm, missing mutins, mutins were 5/8 inch wide with a depth of 1 3/8, rotting upper and lower meeting rail on lower sash.

Insp/XRF	Floor	Room	Side	Component	Substrate	Condition	Color	DI	Results	PbC
FO/23480	1st	Dining Room 7	B-1	Window Stop	Wood	Poor	Brown	1.84	POS	2.7
FO/23480	1st	Dining Room 7	B-1	Window Stop	Wood	Poor	Brown	2.04	POS	2.8
FO/23480	1st	Dining Room 7	B-2	Window Stop	Wood	Poor	Gray	2.44	POS	4.7
FO/23480	1st	Dining Room 7	B-3	Window Sash	Wood	Intact	Natural	1.96	POS	2.5
FO/23480	1st	Dining Room 7	B-3	Window Sash	Wood	Poor	Natural	1.93	POS	1.6
FO/23480	1st	Dining Room 7	B-3	Window Sash	Wood	Poor	Natural	2.37	POS	1.8

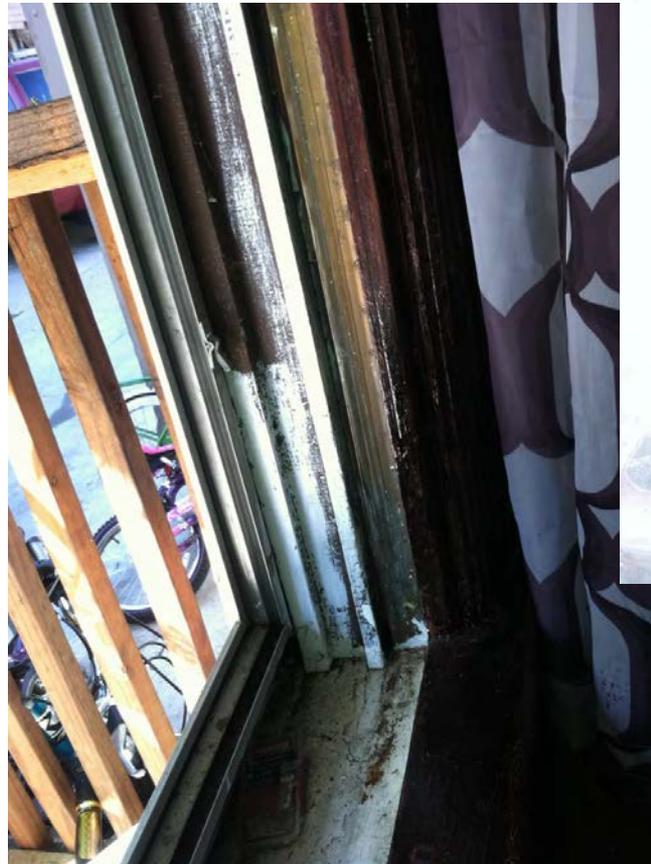
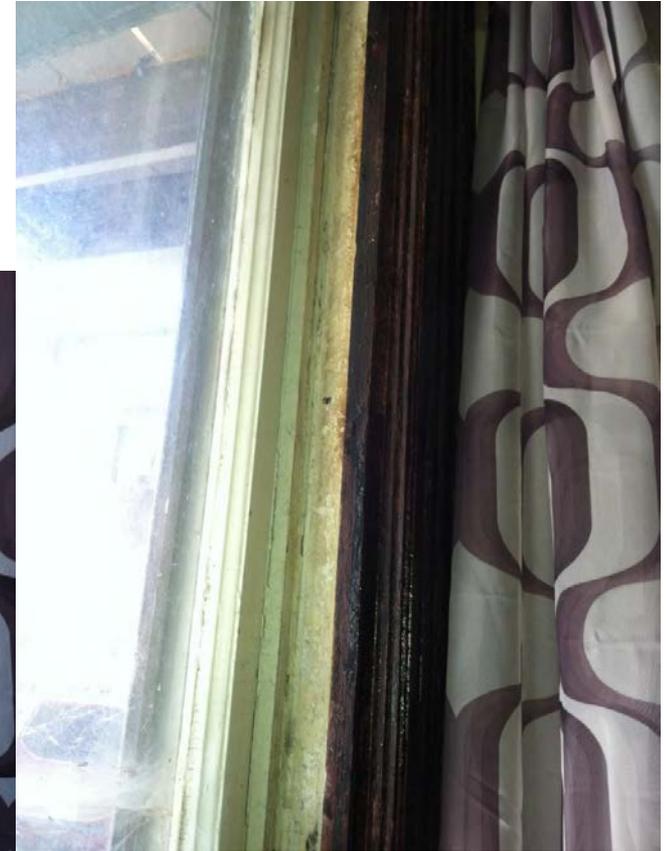
Kitchen Deterioration

The Kitchen consists of one original double hung window with a metal non-historic storm.

The window has missing sash cords. Sash rot on upper and lower meeting rail and on lower sash. Rotting on right track (stop). Easily accessible by a child as the window is 18 inches from the floor.

Insp/XRF	Floor	Room	Side	Component	Substrate	Condition	Color	DI	Results	PbC
FO/23480	1st	Kitchen 8	B	Window Sash	Wood	Poor	White	8.51	POS	1.9
FO/23480	1st	Kitchen 8	B	Window Stop	Wood	Poor	Brown	1.76	POS	2.6
FO/23480	1st	Kitchen 8	B	Window Well	Wood	Poor	Brown	2.58	POS	14.5

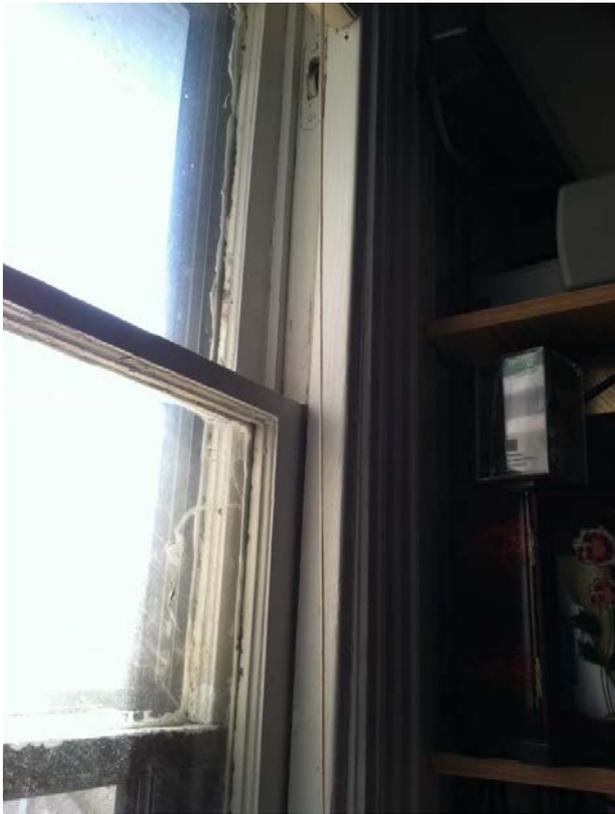
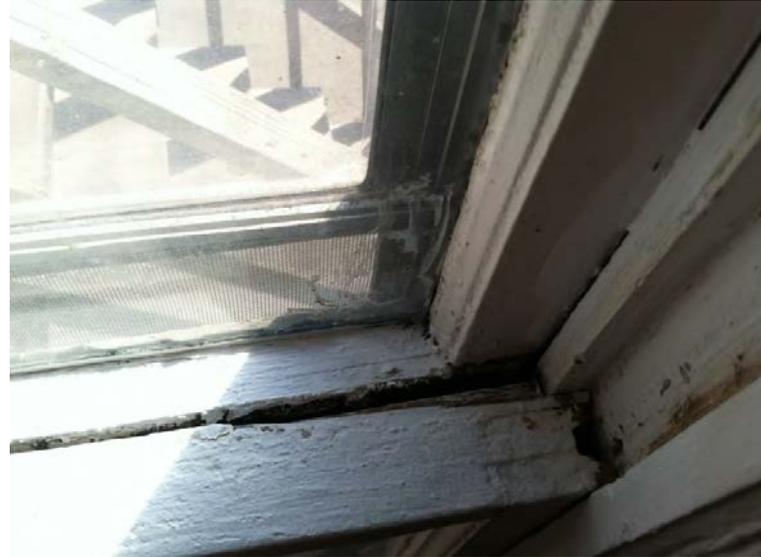
West Bedroom deterioration

The west bedroom contains four windows, two of which are the original double hung windows with metal non-historic storms and are south facing. There are two north facing non-historic windows which are newer casement windows which we are not recommending modifications or replacement.

Window 1- Missing sash cords, broken sash

Insp/XRF	Floor	Room	Side	Component	Substrate	Condition	Color	DI	Results	PbC
FO/23480	1st	W Bedroom 9	B-1	Window Casing	Wood	Poor	White	4.65	POS	10.5
FO/23480	1st	W Bedroom 9	B-1	Window Sill	Wood	Poor	White	7.44	POS	8.3
FO/23480	1st	W Bedroom 9	B-1	Window Sash	Wood	Poor	White	10	POS	14.2
FO/23480	1st	W Bedroom 9	B-1	Window Stop	Wood	Poor	Gray	2.07	POS	2.9
FO/23480	1st	W Bedroom 9	B-2	Window Casing	Wood	Poor	White	6.51	POS	5.5
FO/23480	1st	W Bedroom 9	B-2	Window Sill	Wood	Poor	White	4.46	POS	2.5
FO/23480	1st	W Bedroom 9	B-2	Window Sash	Wood	Poor	White	3.35	POS	8.3

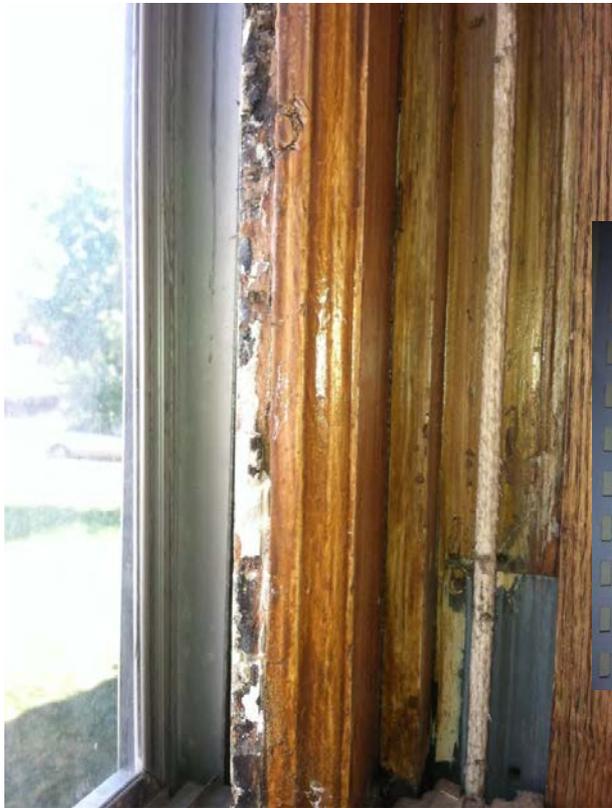
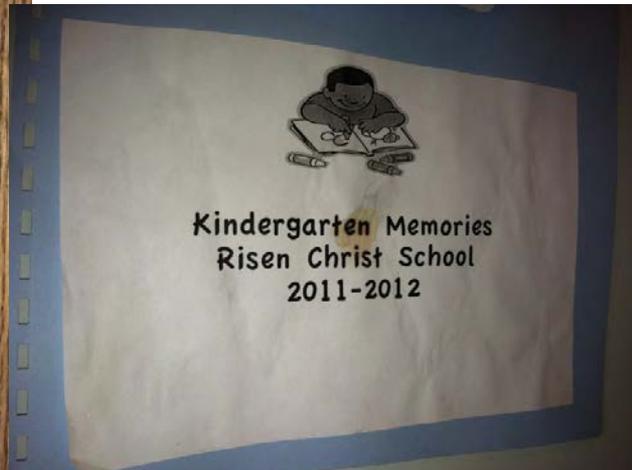
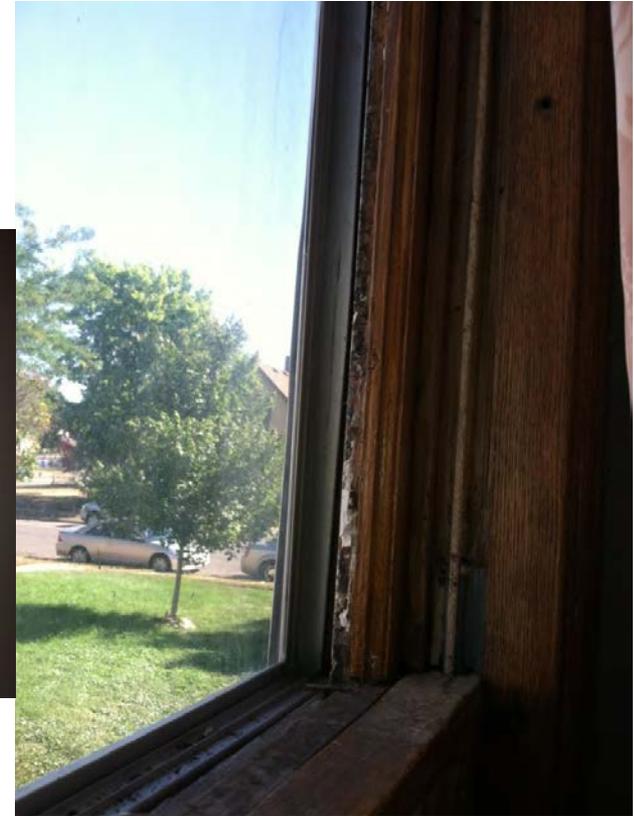
Child's Bedroom deterioration

There is one original double hung window in the child's bedroom with a metal non-historic storm. The window is missing glass on upper sash, the sash cords are broken, the lower sash dropped down, and the upper and lower meeting rails on lower sash are rotting.

Insp/XRF	Floor	Room	Side	Component	Substrate	Condition	Color	DI	Results	PbC
FO/23480	1st	Child's Bedroom 12	D	Window Stop	Wood	Poor	Brown	2.54	POS	12.4
FO/23480	1st	Child's Bedroom 12	D	Window Sash	Wood	Poor	Natural	3.29	POS	1.8

Date of testing	Component	Lead Content	Comments
September 11, 2013	Window well	10,500	Result ten months after lead cleaning. The lead levels in the dust found in the window well are 26 times the level considered safe for a child.
	Sill	252	Result ten months after lead cleaning. The lead levels found in the dust on the window sill is over the safe level.

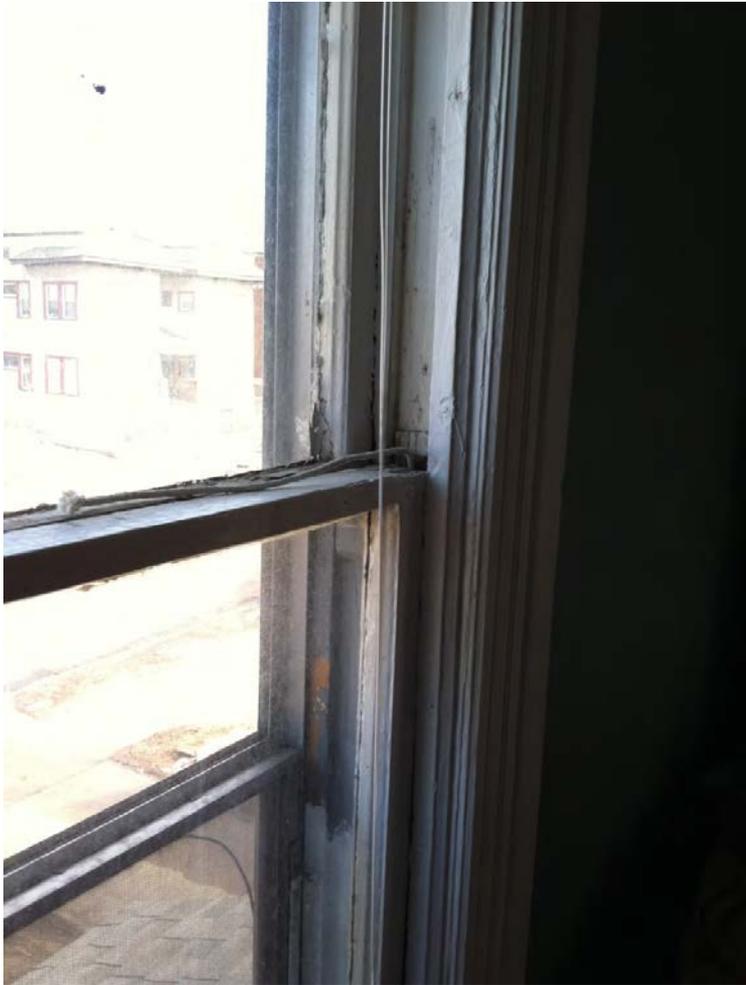
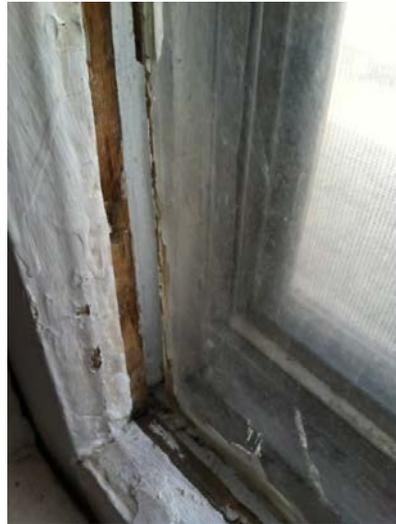
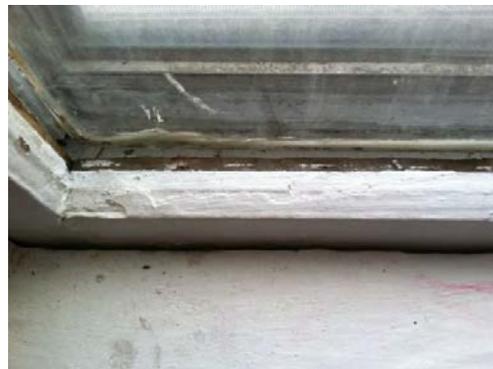
East Bedroom deterioration

There are two original double hung windows in the East Bedroom which contain non-historic metal storms.

The window on the street side has a rotted sash, missing sash cords, missing muntins, and the stool is tilted toward outside.

The south side window is 14 inches from floor with easy access by a child. The window is missing the profile, glass and sash cords.

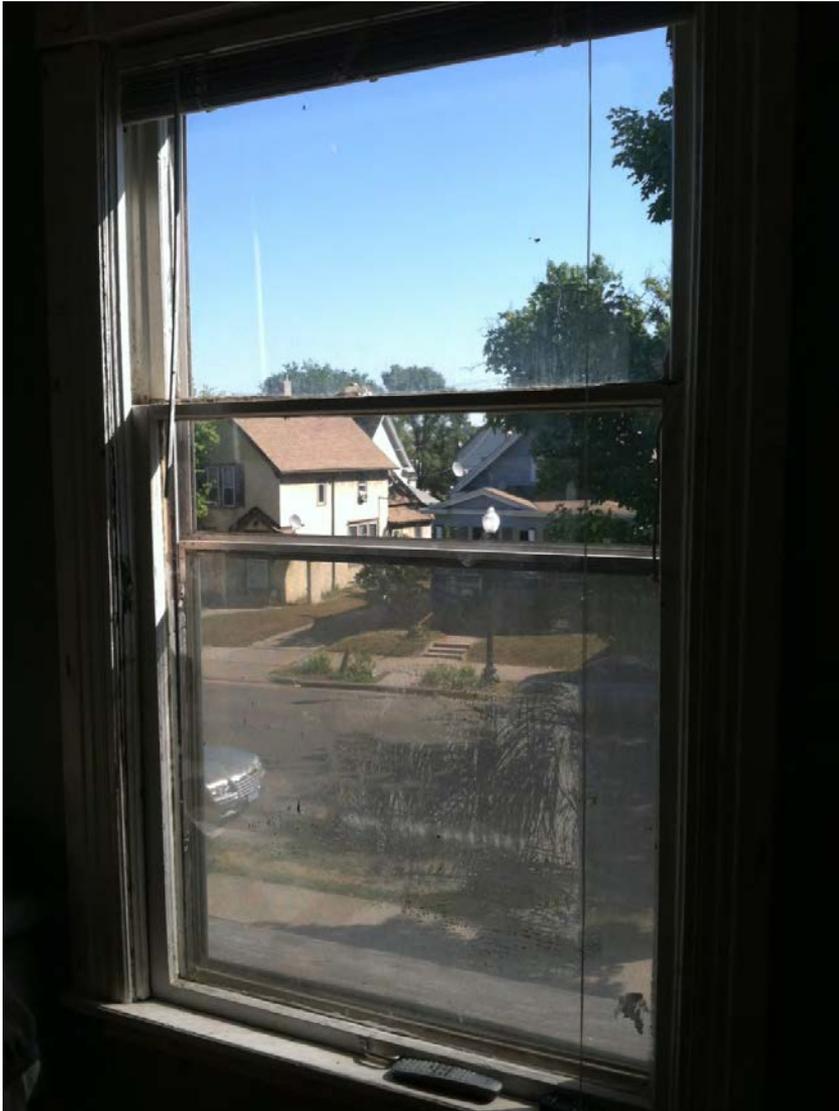
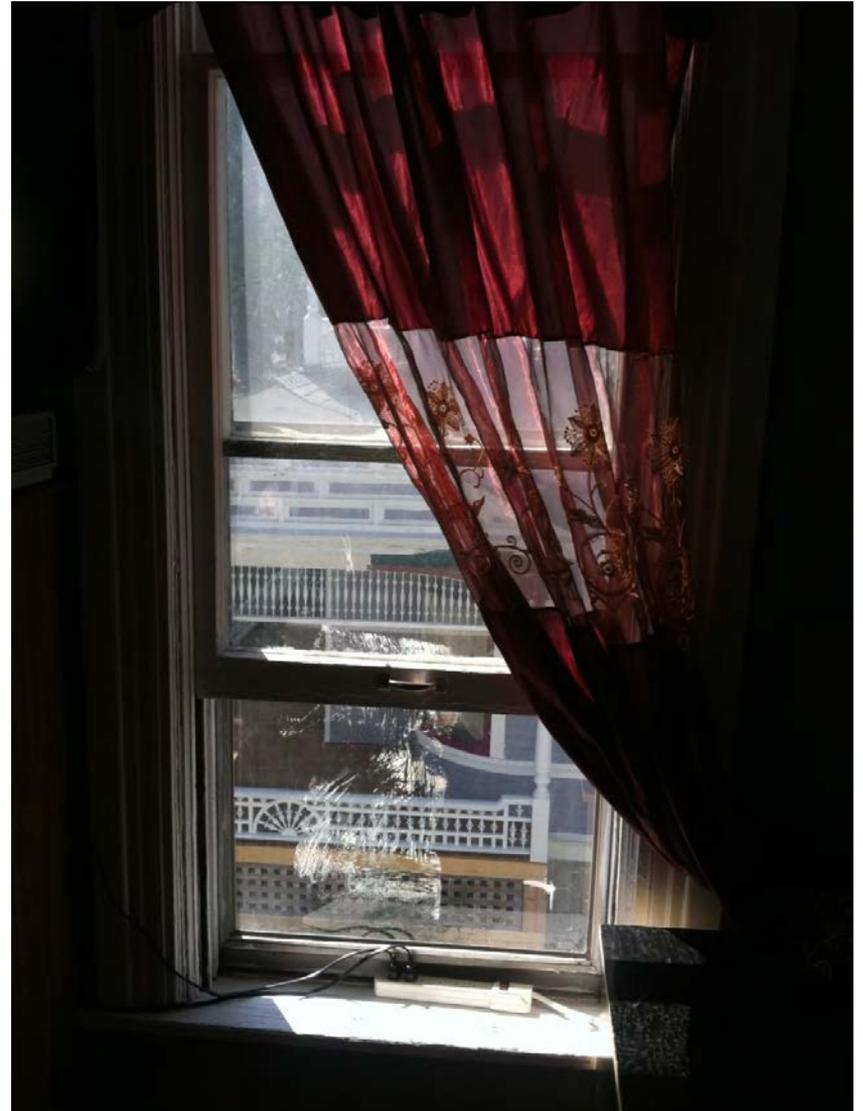
East Bedroom deterioration

Insp/XRF	Floor	Room	Side	Component	Substrate	Condition	Color	DI	Results	PbC
FO/23480	2nd	E Bedroom 15	B	Window Casing	Wood	Poor	White	10	POS	6.1
FO/23480	2nd	E Bedroom 15	B	Window Sill	Wood	Poor	White	3.11	POS	6.3
FO/23480	2nd	E Bedroom 15	B	Window Sash	Wood	Poor	White	10	POS	5.6
FO/23480	2nd	E Bedroom 15	A	Window Casing	Wood	Poor	White	6.85	POS	7.9
FO/23480	2nd	E Bedroom 15	A	Window Sill	Wood	Poor	White	3.32	POS	1.8
FO/23480	2nd	E Bedroom 15	A	Window Stop	Wood	Poor	White	2.13	POS	11
FO/23480	2nd	E Bedroom 15	A	Window Well	Wood	Poor	White	2.06	POS	2.5

Date of test	Component tested	Lead Content	Comments
September 26, 2012	Floor	5,200	The dust levels at initial inspection. Lead content is 130 times the standard considered safe.
	Window Sill	45,000	The dust levels at initial inspection. The lead levels are 180 times the standard considered safe.
November 9, 2012	Floor	5.4	The dust levels after a professional lead cleaning.
	Window Well	78.2	The dust levels after a professional lead cleaning.
September 11, 2013	Window Well	3,000	The lead levels ten months after the lead cleaning. The hazard has returned as the lead levels are 7.5 times the standards considered safe.
	Window Well	2,740	The lead levels ten months after the lead cleaning. The hazard has returned as the lead levels are 7 times the standards considered safe.

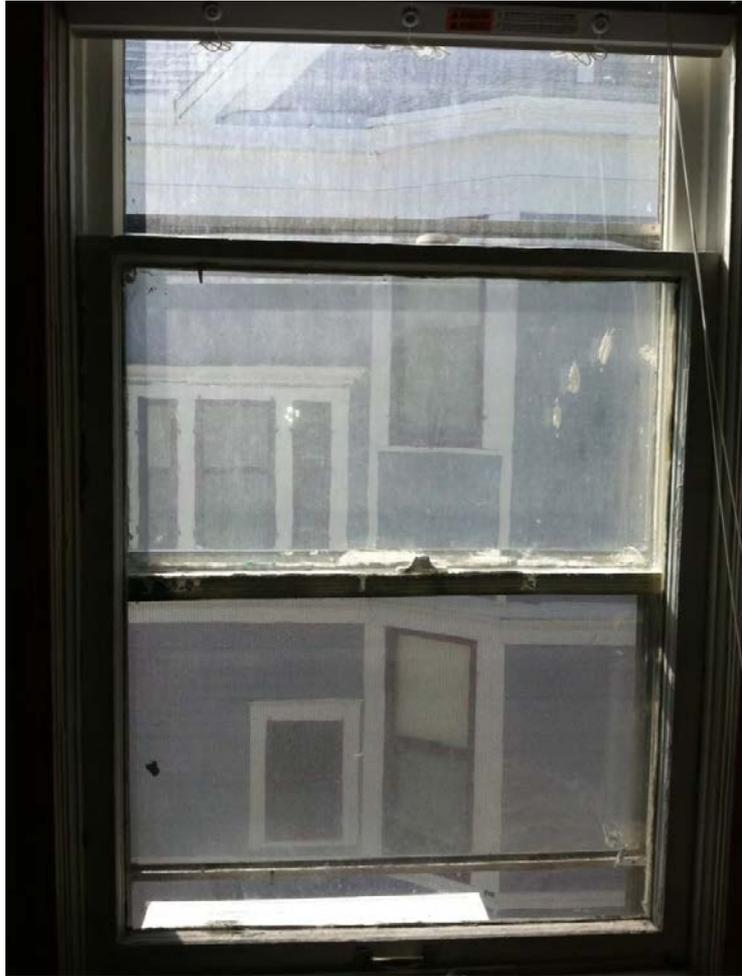
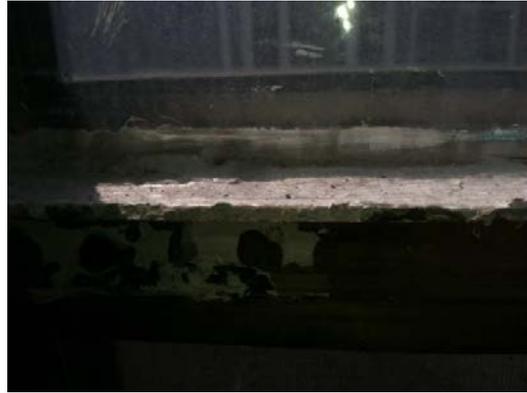
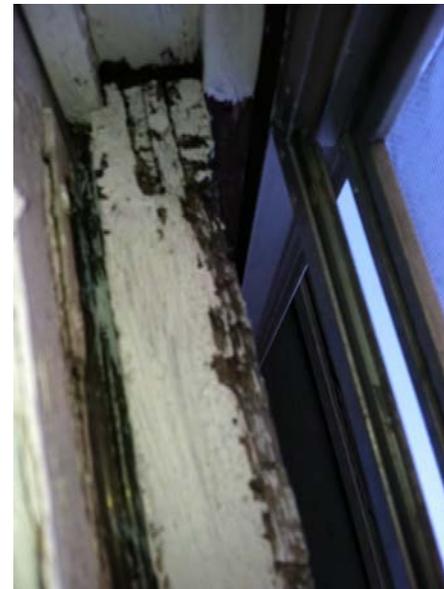
Upper Living Room Deterioration

The upper living room contains two original double hung windows with non-historic metal sashes. Window 1 is missing sash cords has a cracked upper meeting rail on lower sash, and a rotted lower meeting rail on lower sash. Window 2 has a rotted sash, missing glass (plexie glass replaced), paint on sash cord, the profile is rotted and a rotted exterior sash.

Insp/XRF	Floor	Room	Side	Component	Substrate	Condition	Color	DI	Results	PbC
FO/23480	2nd	Living Room 16	B	Window Casing	Wood	Poor	Pink	10	POS	5.1
FO/23480	2nd	Living Room 16	B	Window Casing	Wood	Poor	Pink	10	POS	5.3
FO/23480	2nd	Living Room 16	B	Window Sill	Wood	Poor	Pink	9.86	POS	6.9
FO/23480	2nd	Living Room 16	B	Window Sash	Wood	Poor	Pink	10	POS	6.8
FO/23480	2nd	Living Room 16	B	Window Stop	Wood	Poor	Pink	2.16	POS	3.8
FO/23480	2nd	Living Room 16	C	Window Casing	Wood	Poor	Pink	10	POS	7.5
FO/23480	2nd	Living Room 16	C	Window Stop	Wood	Poor	Brown	1.66	POS	1.8
FO/23480	2nd	Living Room 16	C	Window Sash	Wood	Poor	White	10	POS	4.1

Date of test	Component tested	Lead Content (ug/sq ft)	Comments
September 11, 20313	Window Well	42,800	Result ten months after lead cleaning. The window well contains lead dust that is 107 times the level that is considered safe for children.

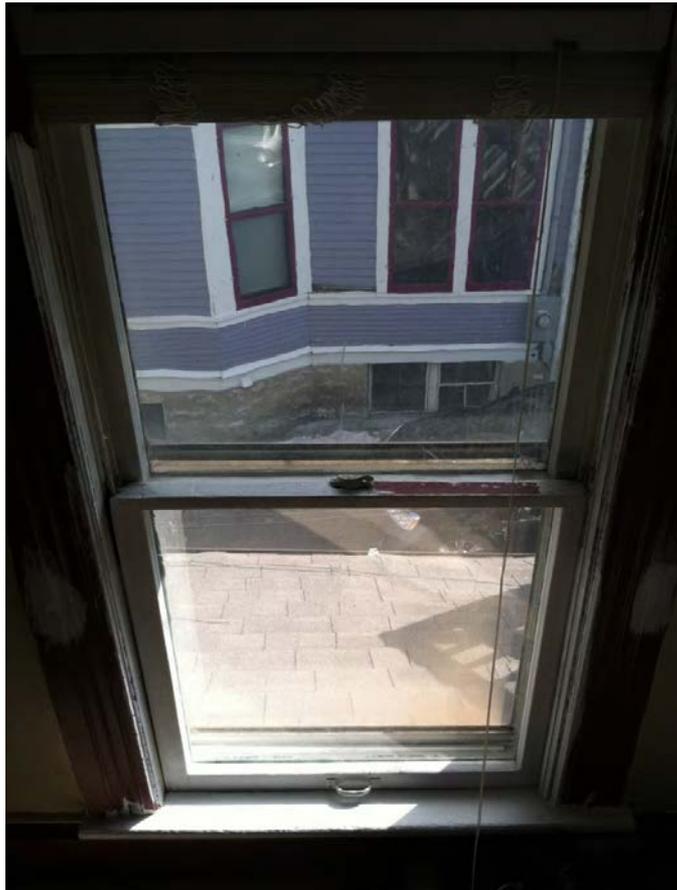
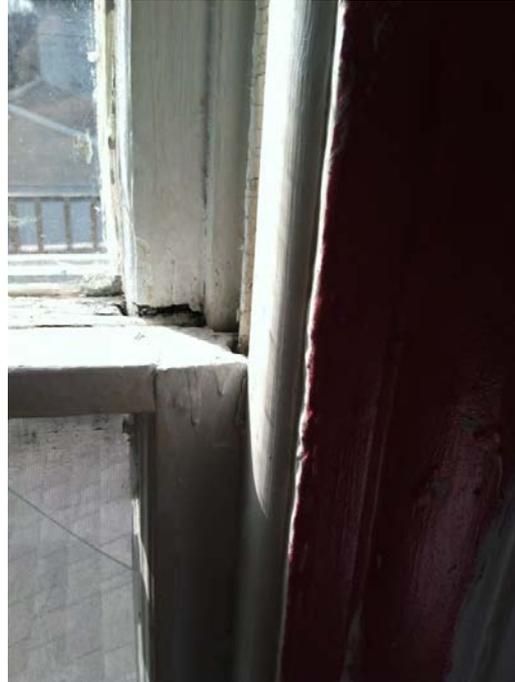
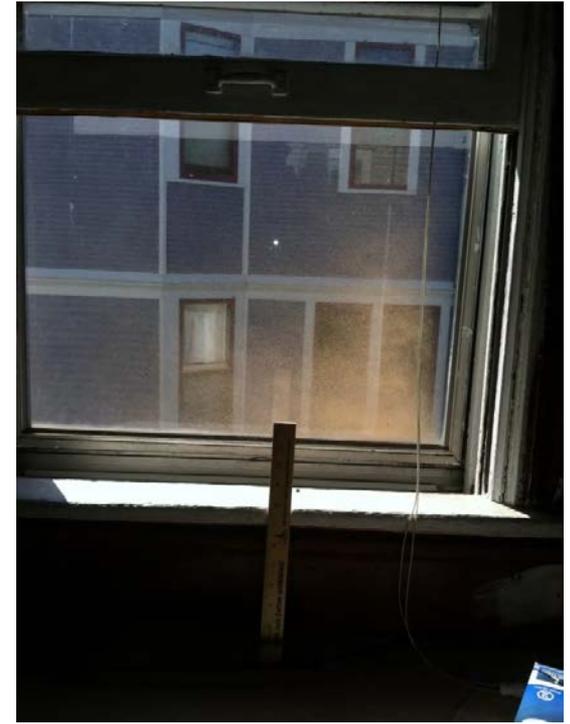
Upper Kitchen deterioration

The Upper Kitchen has one original double hung window which contains a non-historic metal storm. The second window is a non-historic swing window. The double hung window's lower sash is rotting and missing the profile. This window is a significant lead and fall hazard for young children as it is 8 inches from the floor.

Insp/XRF	Floor	Room	Side	Component	Substrate	Condition	Color	DI	Results	PbC
FO/23480	2nd	Kitchen 17	D	Window Sash	Wood	Poor	Red	10	POS	4.6
FO/23480	2nd	Kitchen 17	D	Window Sash	Wood	Poor	Red	10	POS	4.4
FO/23480	2nd	Kitchen 17	D	Window Sash	Wood	Poor	Red	10	POS	2
FO/23480	2nd	Kitchen 17	B	Window Casing	Wood	Poor	Red	10	POS	4.9
FO/23480	2nd	Kitchen 17	B	Window Sill	Wood	Poor	Red	10	POS	5.6
FO/23480	2nd	Kitchen 17	B	Window Sash	Wood	Poor	White	10	POS	4.8
FO/23480	2nd	Kitchen 17	B	Window Stop	Wood	Poor	White	4.79	POS	5.5

Date of Test	Component tested	Lead Content (ug/sq ft)	Comments
September 11, 2013	Window Well	632	Result ten months after lead cleaning. The lead dust content in window well is considered hazardous to children. Window well is 8 inches from floor with easy access for children.

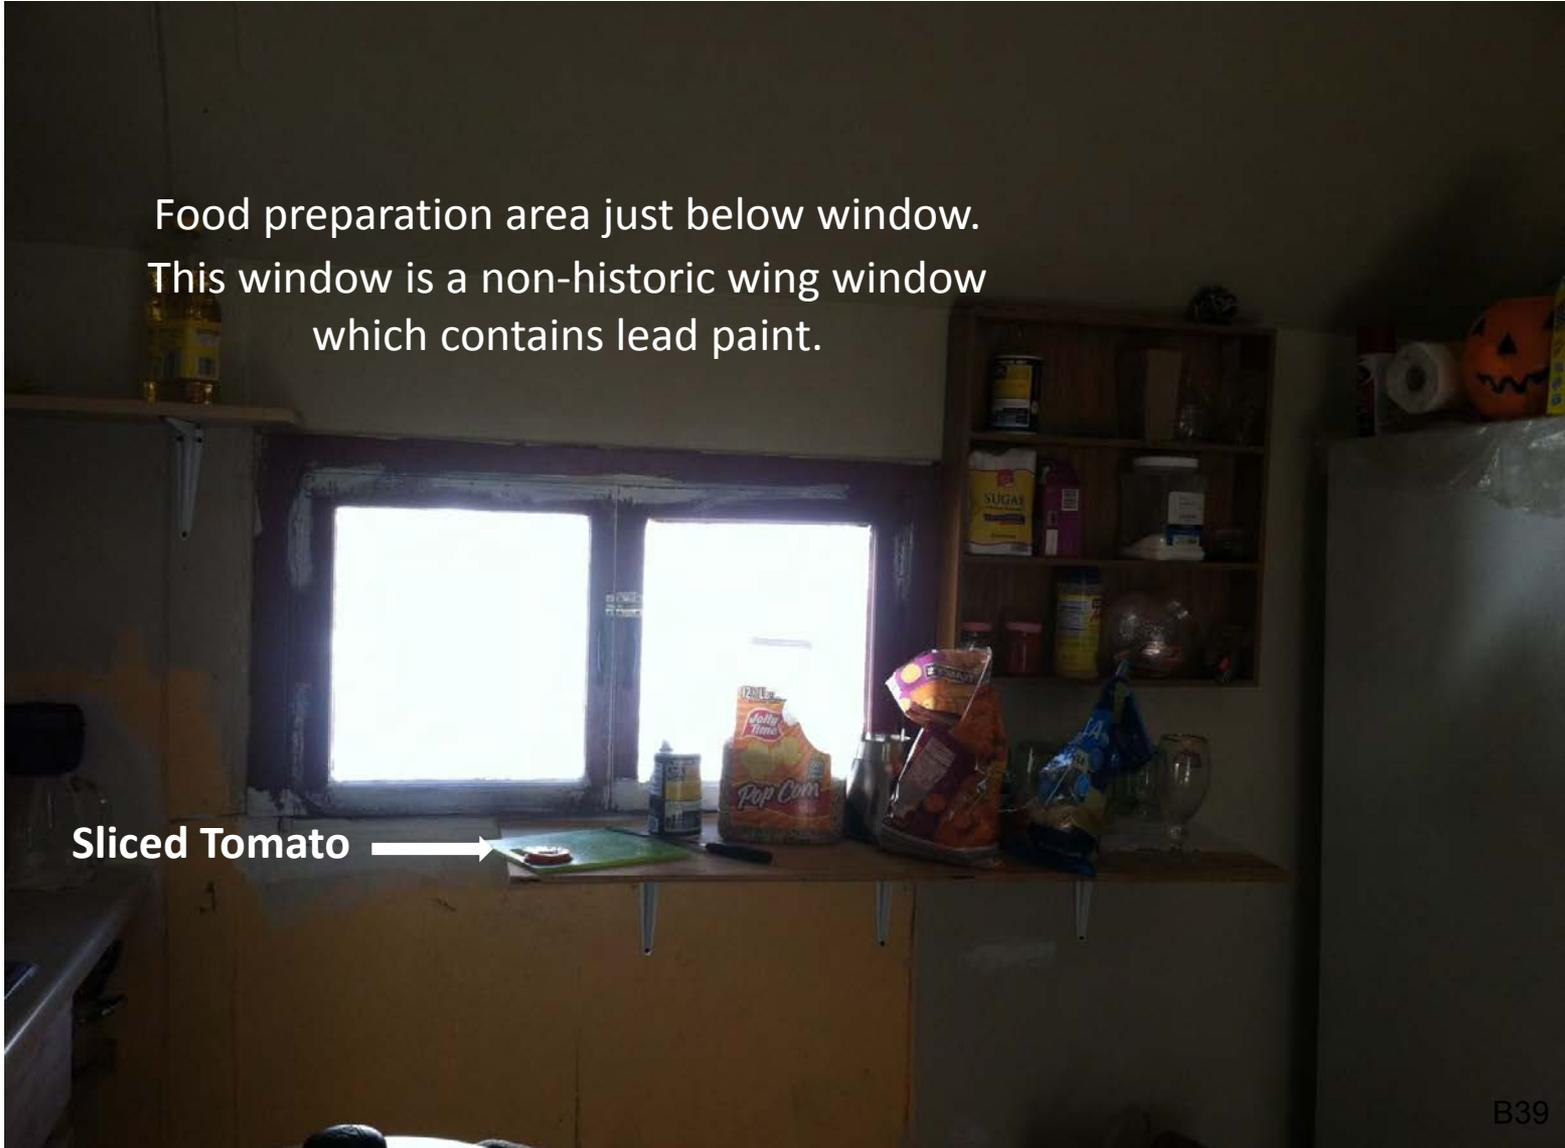
Upper Kitchen

Food preparation area just below window.
This window is a non-historic wing window
which contains lead paint.

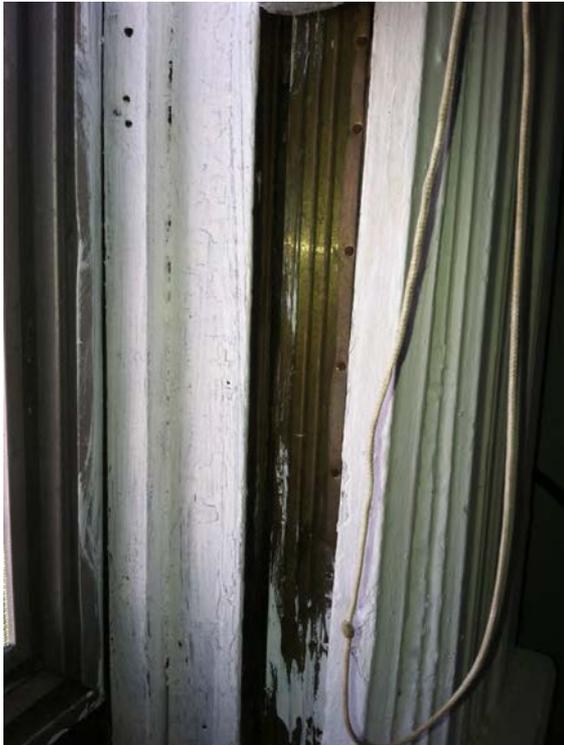
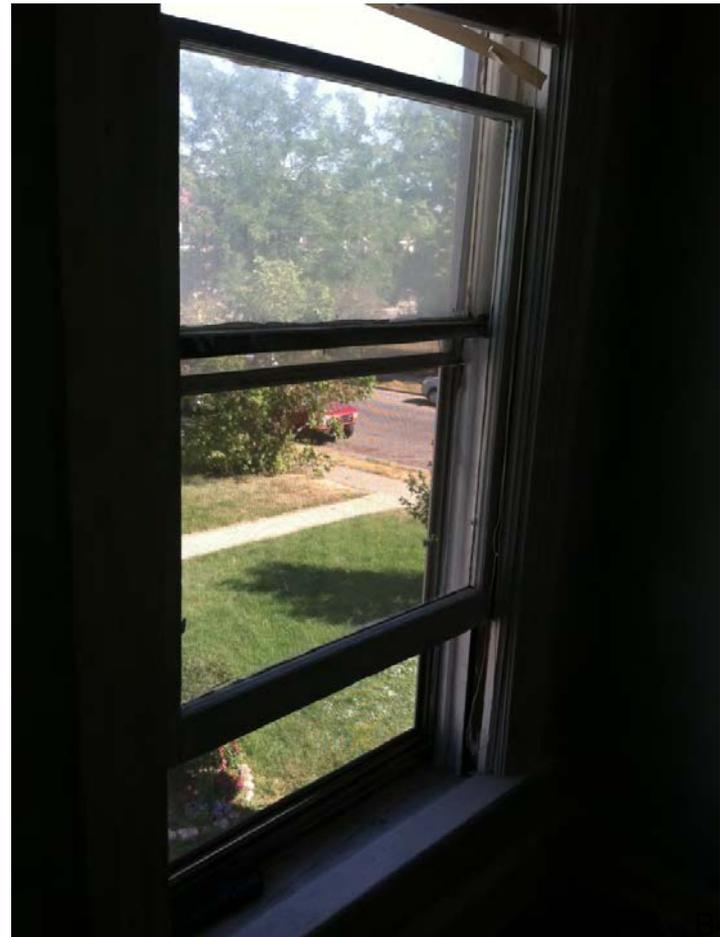
NW Bedroom deterioration

The NW bed has one original window with a non-historic metal storm. The meeting rail on upper sash is separated, the lower sash is rotted, it's missing sash cords and missing glass on lower sash (plexie glass).

Insp/XRF	Floor	Room	Side	Component	Substrate	Condition	Color	DI	Results	PbC
FO/23480	2nd	NW Bedroom 18	D	Window Stop	Wood	Poor	Brown	1.98	POS	1.6
FO/23480	2nd	NW Bedroom 18	D	Window Stop	Wood	Poor	Brown	1.99	POS	3.5

Date of lead test	Component tested	Lead Content (ug/sq ft)	Comments
September 11, 2013	Window Well	6050	Result ten months after lead cleaning. The lead levels in the dust found in the window well are 15 times the level considered safe for a child.

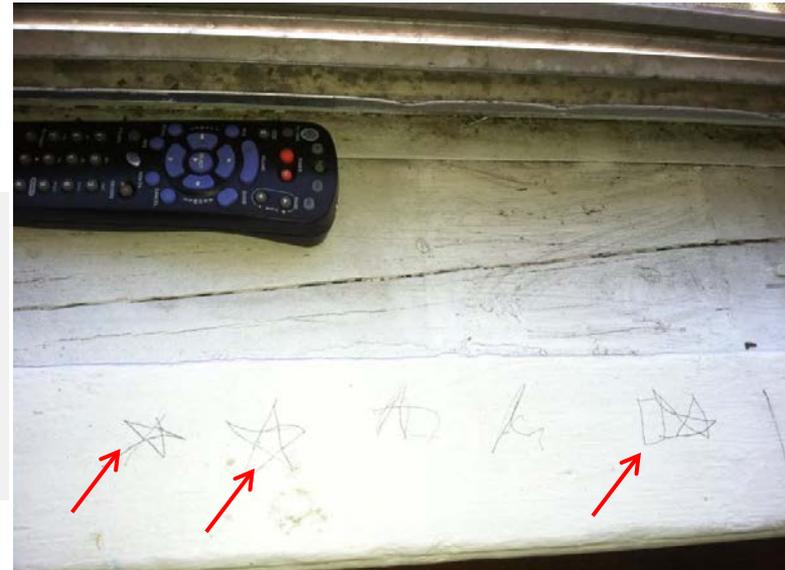
NW Bedroom 18

This window is easily accessible to a child. Note the drawing on the sill and remote control in well.

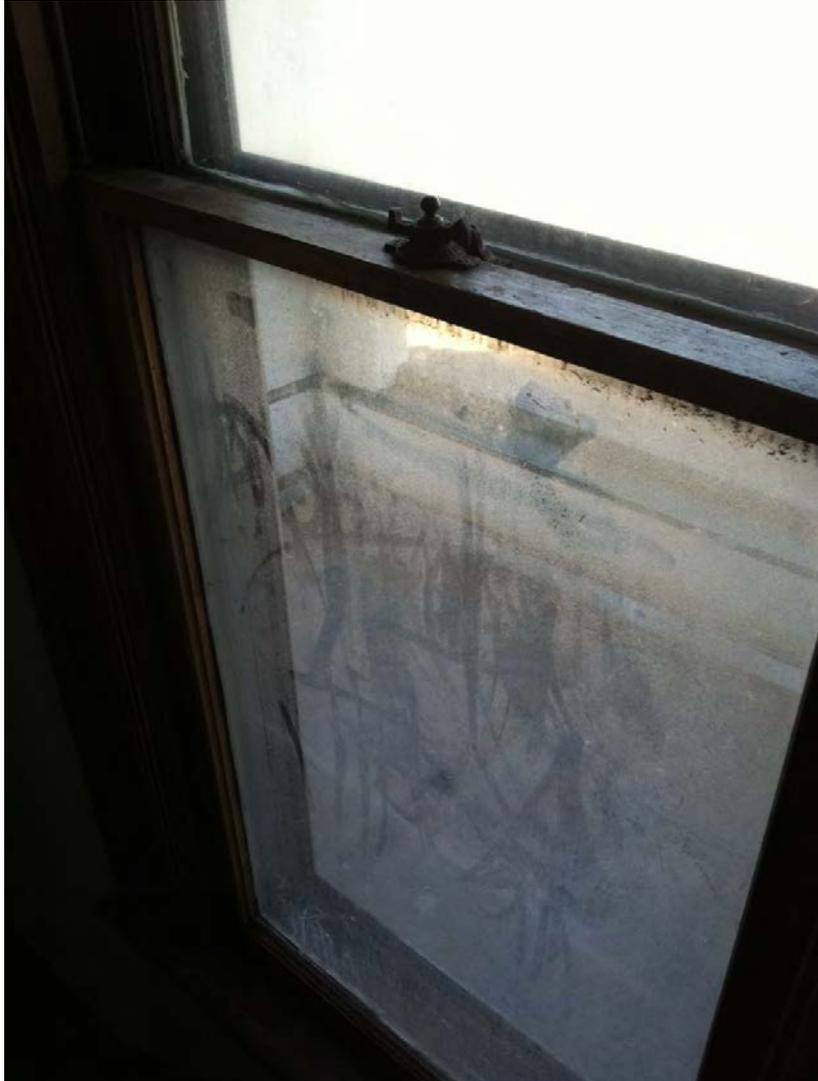
Hallway Deterioration

There are two original windows in the hallway which contain a non-historic metal storm.

Window 1- Window on stairway is missing mutins on both upper and lower sash. The lower sash contains plexie glass, the right corner of the lower sash is rotting. This window contains a historic lock.

Window 2- The upper sash, lower meeting rail, and the lower sash meeting rail are all rotting. Both lower corners are chipped. Loose lower sash. Brass weather stripping is bent and won't lock. This window contains a historical lock.

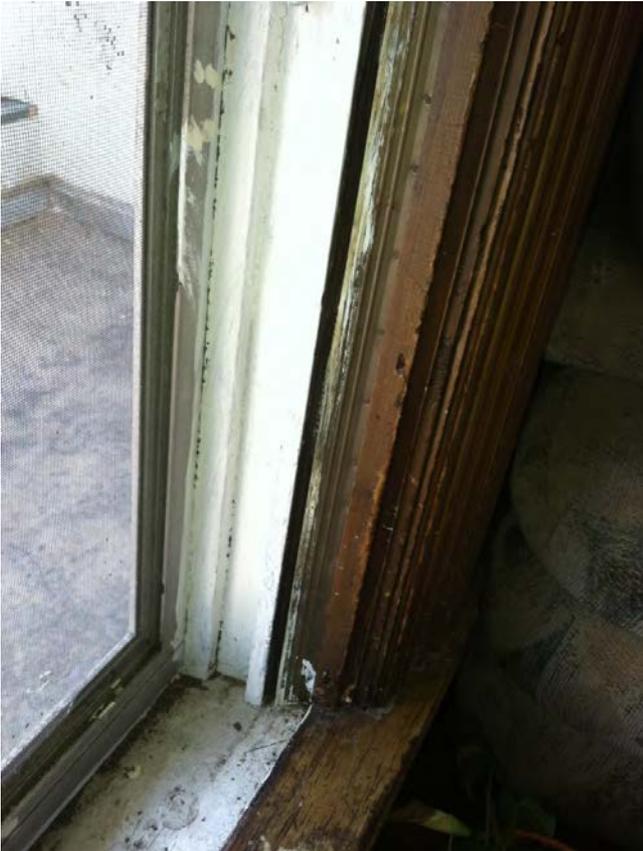
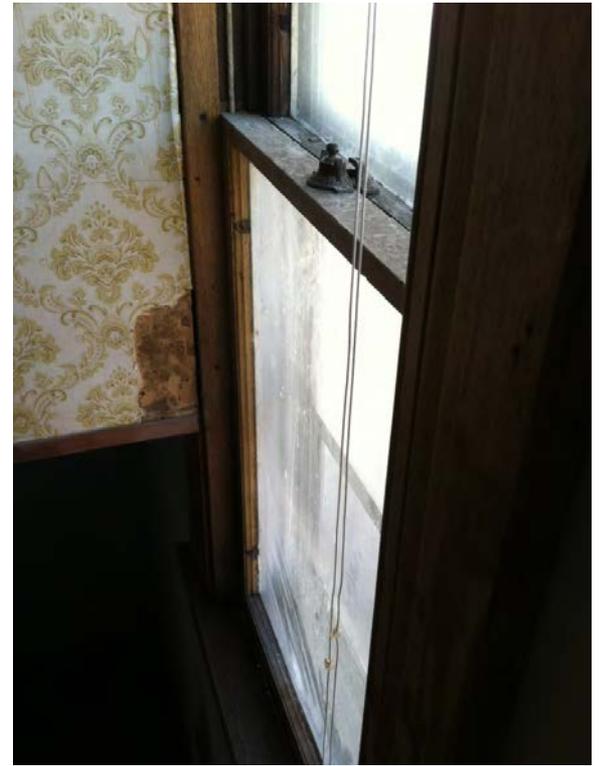
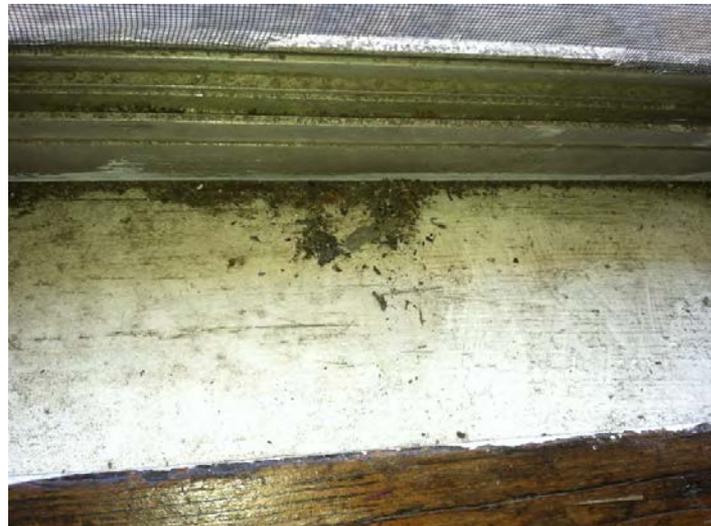
Hallway Deterioration

Insp/XRF	Floor	Room	Side	Component	Substrate	Condition	Color	DI	Results	PbC
FO/23480	1.5	Hall/Stairs 13	D	Window Stop	Wood	Poor	Brown	1.84	POS	2.6
FO/23480	1.5	Hall/Stairs 13	D	Window Sash	Wood	Poor	Natural	2.36	POS	1.8
FO/23480	1.5	Hall/Stairs 13	A	Window Stop	Wood	Poor	Brown	1.69	POS	13
FO/23480	1st	Hall/Stairs 13	A	Window Sash	Wood	Intact	Natural	2.55	POS	1.8
AR/222	2nd	Hall-2 20	D	Window Sash	Wood	Intact	Natural	1.83	POS	1.5
AR/222	2nd	Hall-2 20	D	Window Stop	Wood	Poor	Brown	2.04	POS	13.5
AR/222	2nd	Hall-2 20	D	Window Well	Wood	Poor	Brown	2.25	POS	14.5
AR/222	2nd	Hall-2 20	A	Window Well	Wood	Poor	Brown	1.47	POS	2.8
AR/222	2nd	Hall-2 20	A	Window Stop	Wood	Poor	Brown	1.9	POS	9.4

Date of lead test	Component Tested	Lead Content (ug/sq ft)	Comments
September 11, 2013	Window Well	55800	Result ten months after lead cleaning. The lead dust content found in the window well 139 times the level which is considered safe for children.
	Window Sill	375	Result ten months after lead cleaning. The lead dust content found on the window sill considered hazardous for children.
