3112 3rd Ave South Heritage Preservation Site Plan

Prepared by Jennifer Tschida
Minneapolis Department of Health
On behalf of
Reina S Benavides Guaman

December 12, 2013

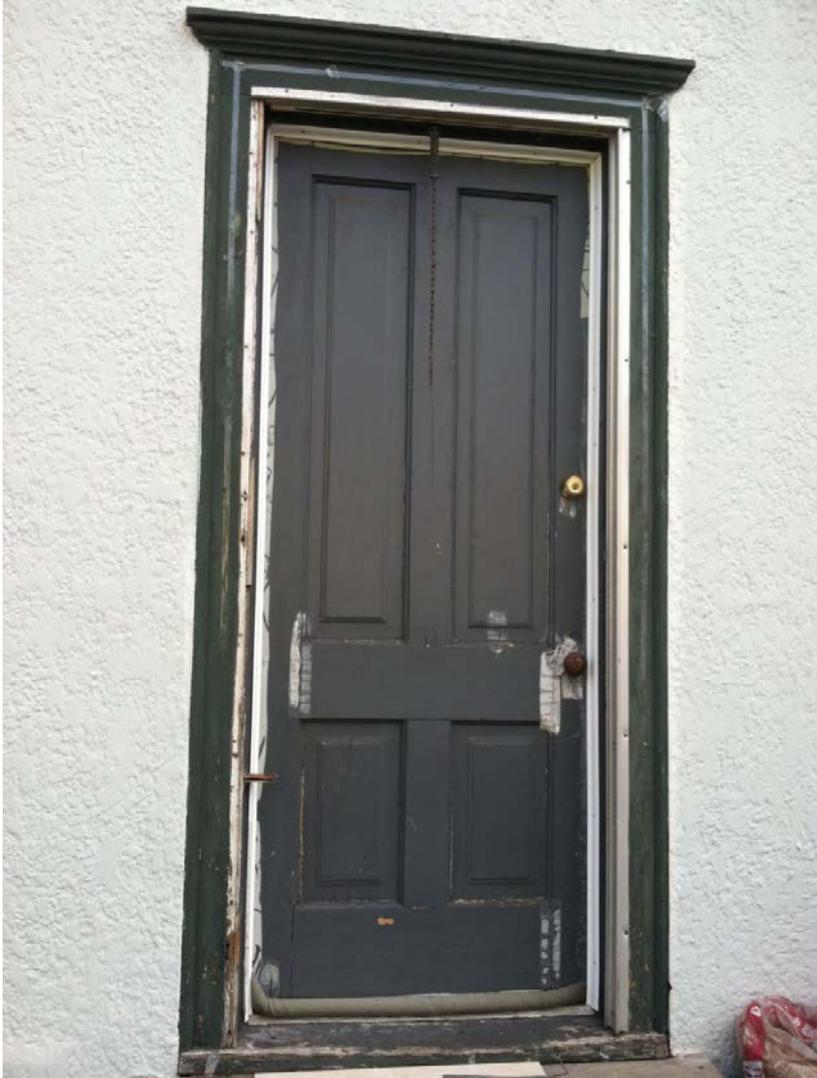
Exterior alley side door

This door is an original door painted with lead paint. The bottom has been cut to accommodate a remodeled floor on the interior and therefore has 1-2 inch gap between the door and floor allowing excessive cold into the bedroom of the owners where a newborn baby sleeps.

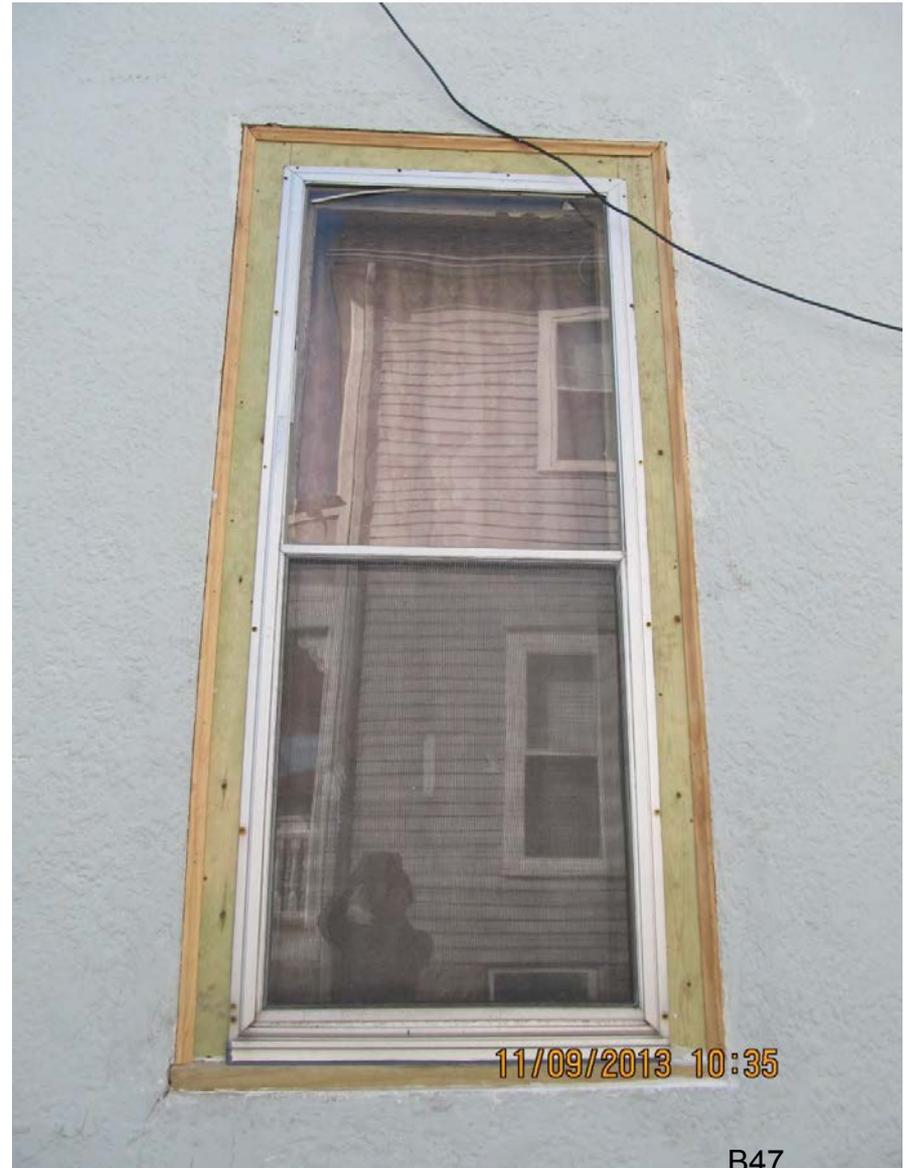
Existing non-historical metal storm

The home has non-historical
metal storm windows such as
this one throughout.
