**UPPER MISSISSIPPI MASTER PLAN  
STABILIZATION, RESTORATION AND  
ENHANCEMENT RECOMMENDATIONS**

**NORTH & NORTHEAST MINNEAPOLIS,  
MINNESOTA**

**Minneapolis Parks and Recreation Board  
Minneapolis, Minnesota**

August 2, 1999

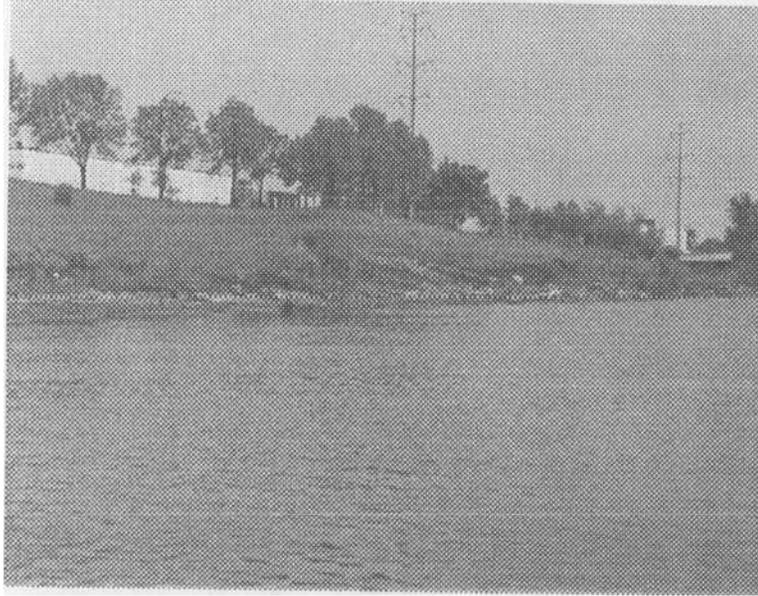
Maintained grass area with trees on top

Brushmattress

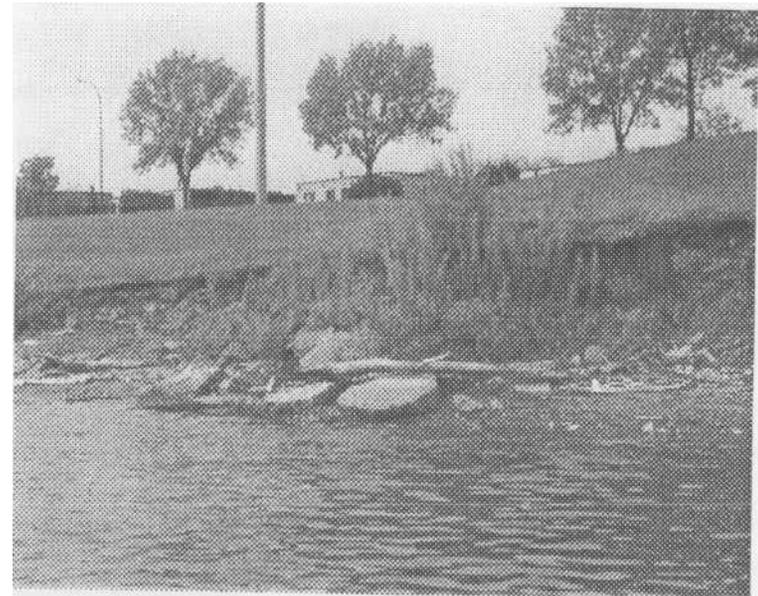
Toe erosion with vegetation along shore

Live Fascine

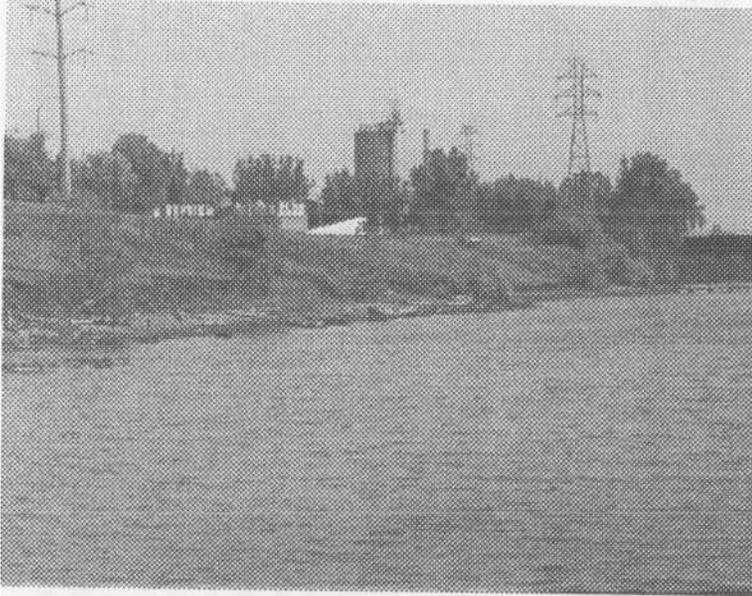
Open bank condition

Joint Planting

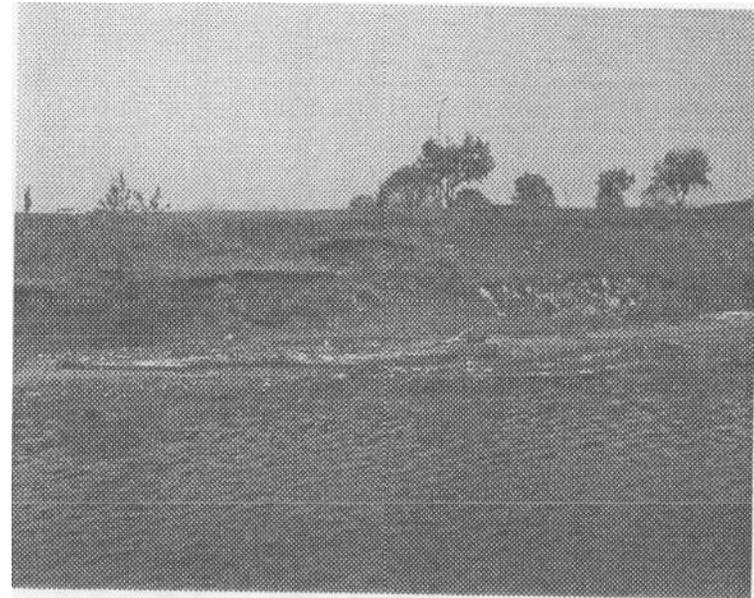
Large shallow failures, little vegetation

Live Fascine

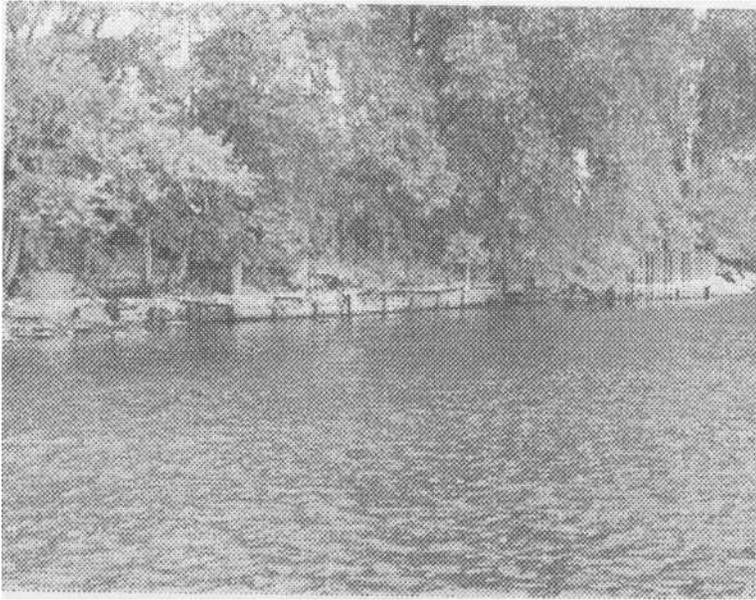
Low failing wall with vegetation

Vegetated Geogrid

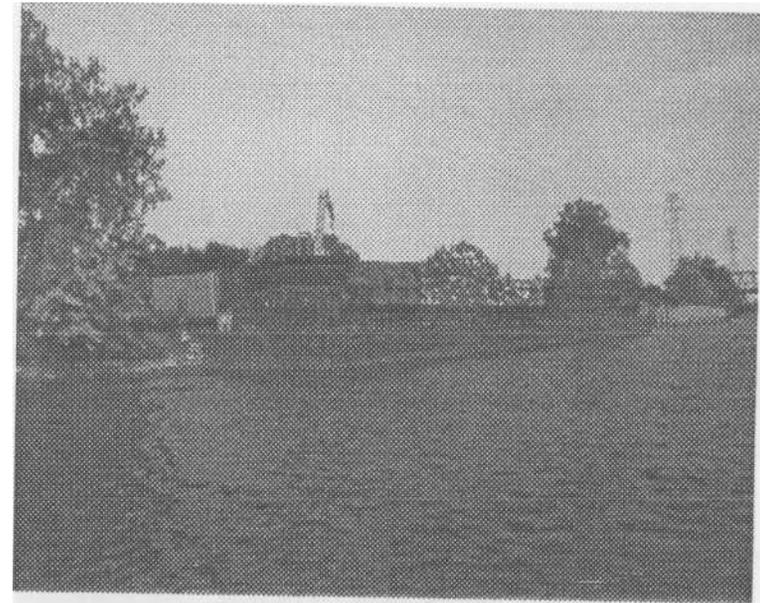
Sheet pile edge and barge area

Live Fascine

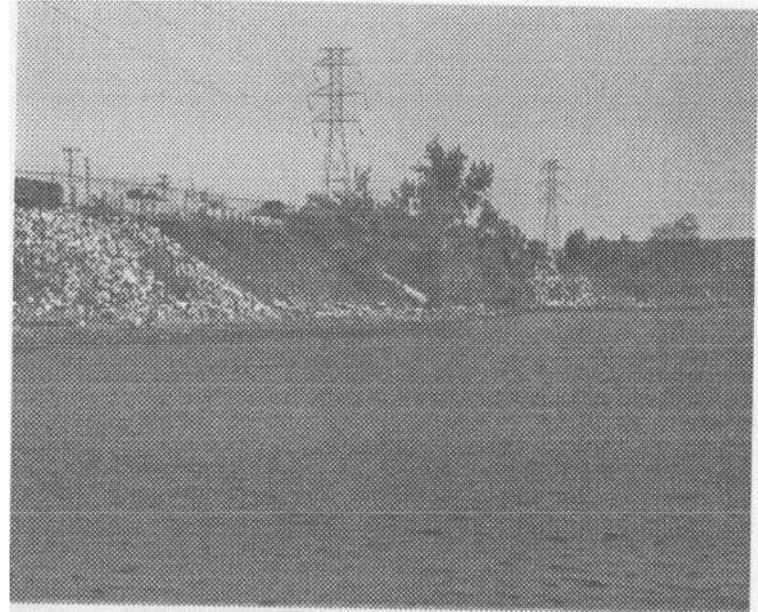
Open rock armor area

Vegetated Geogrid

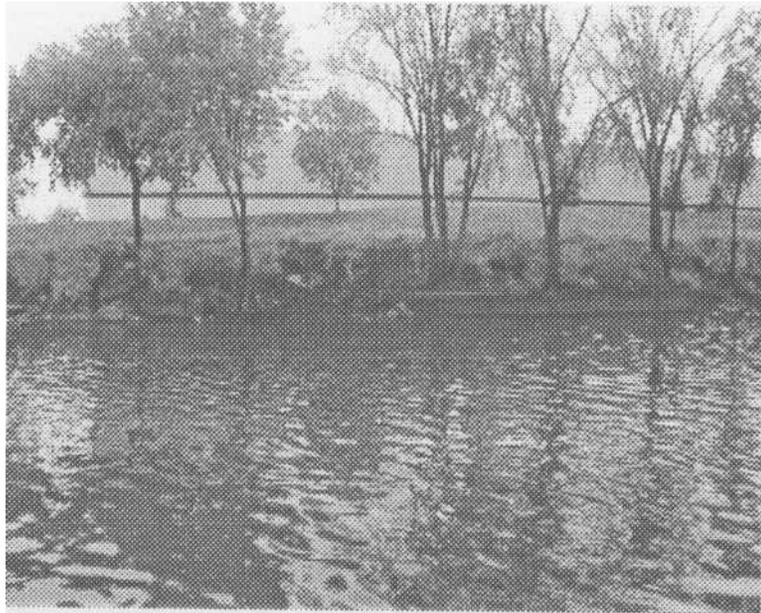
Low concrete wall, rubble, eroding bank

Vegetated Geogrid

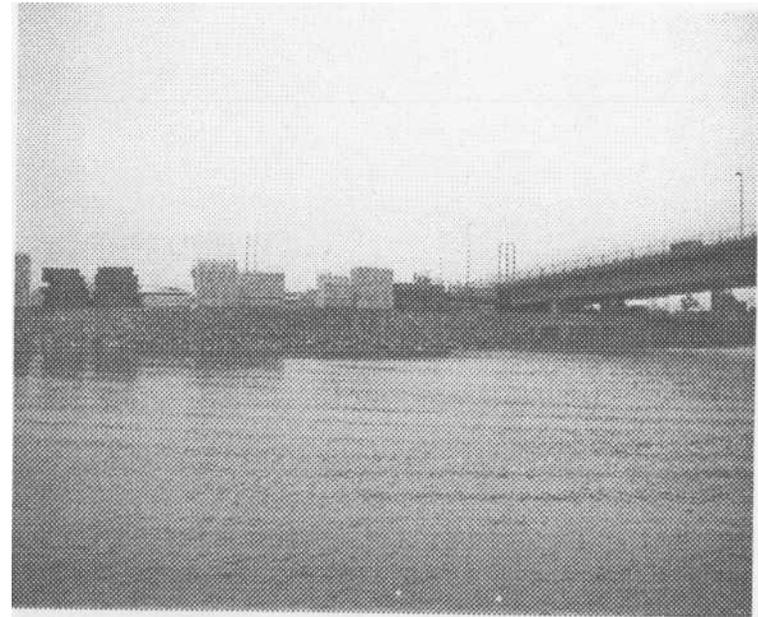
Riprap bank upstream of Plymouth Ave.

Joint Planting

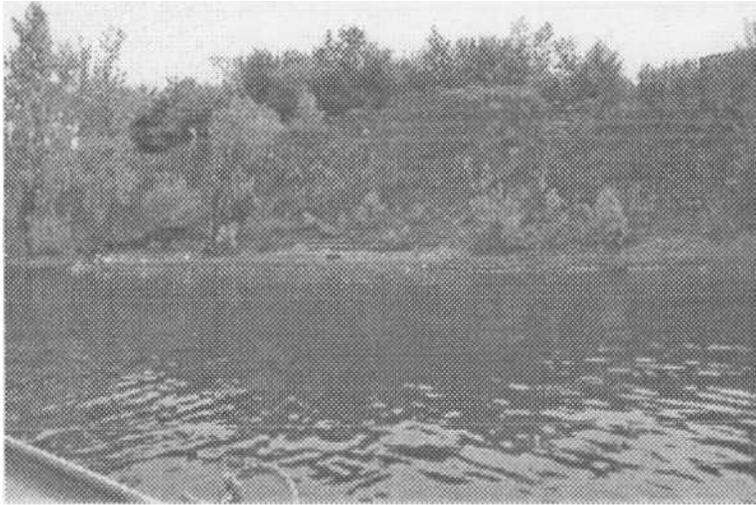
Very high and steep sloughing slopes

Live Fascitie

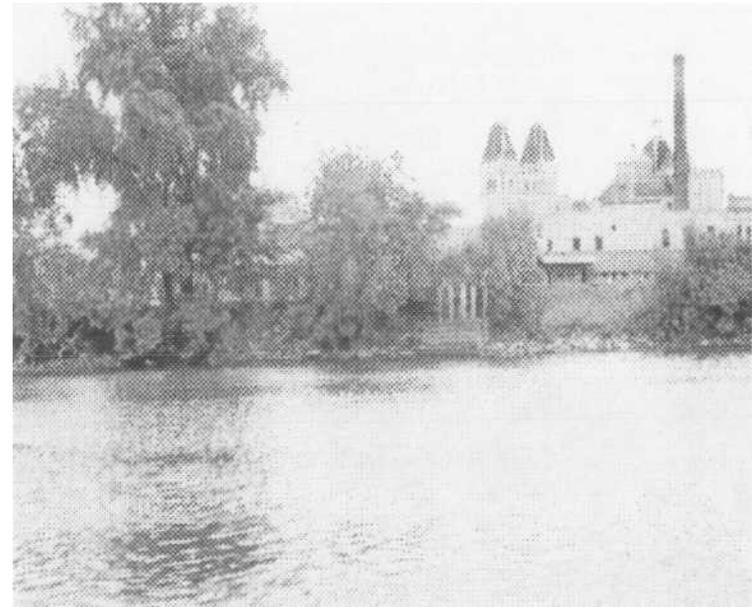
Concrete rubble batik

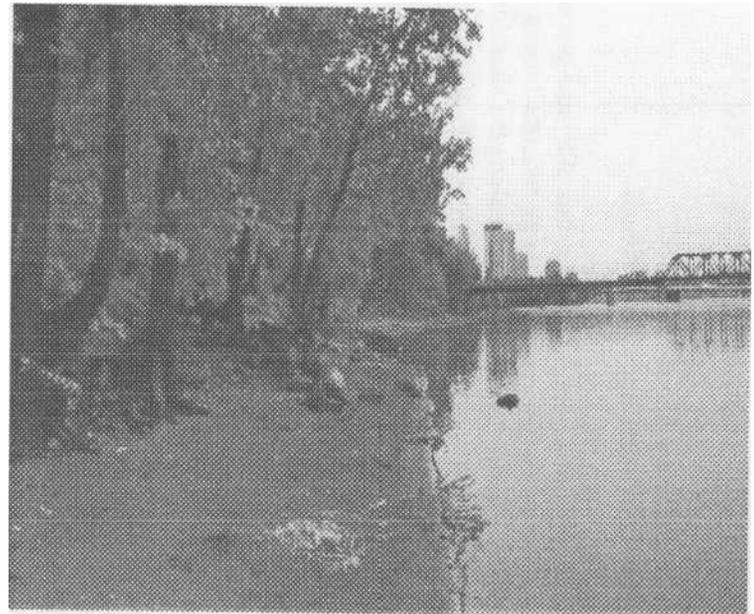
Old growth poplars appear to be dying

Vegetated Geogrid

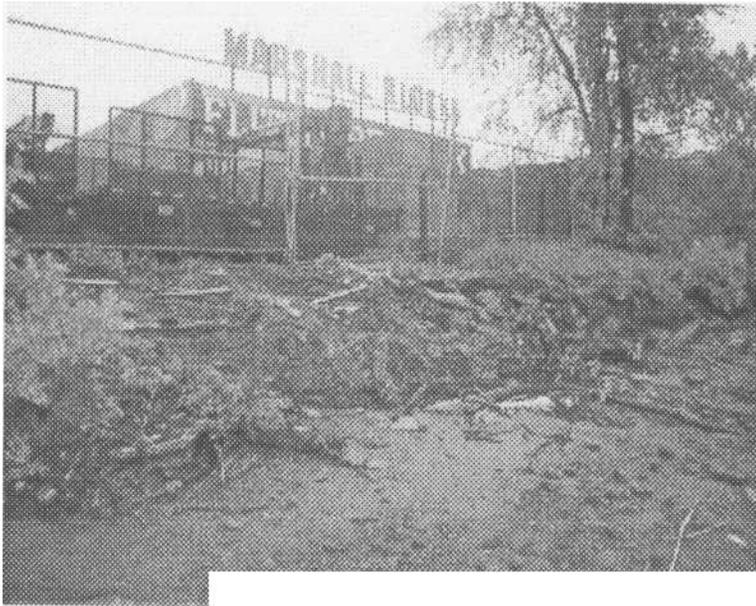
Toe erosion, construction fill and overwash

Vegetated Geogrid

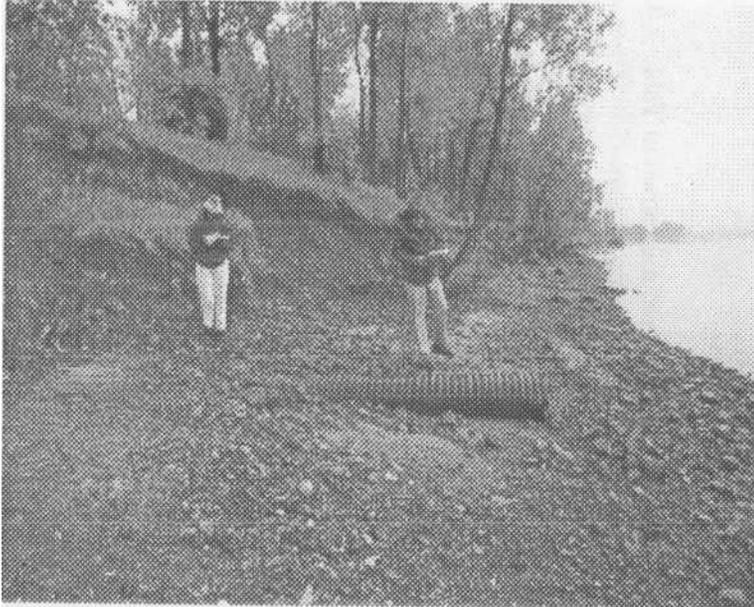
Toe erosion and bank recession

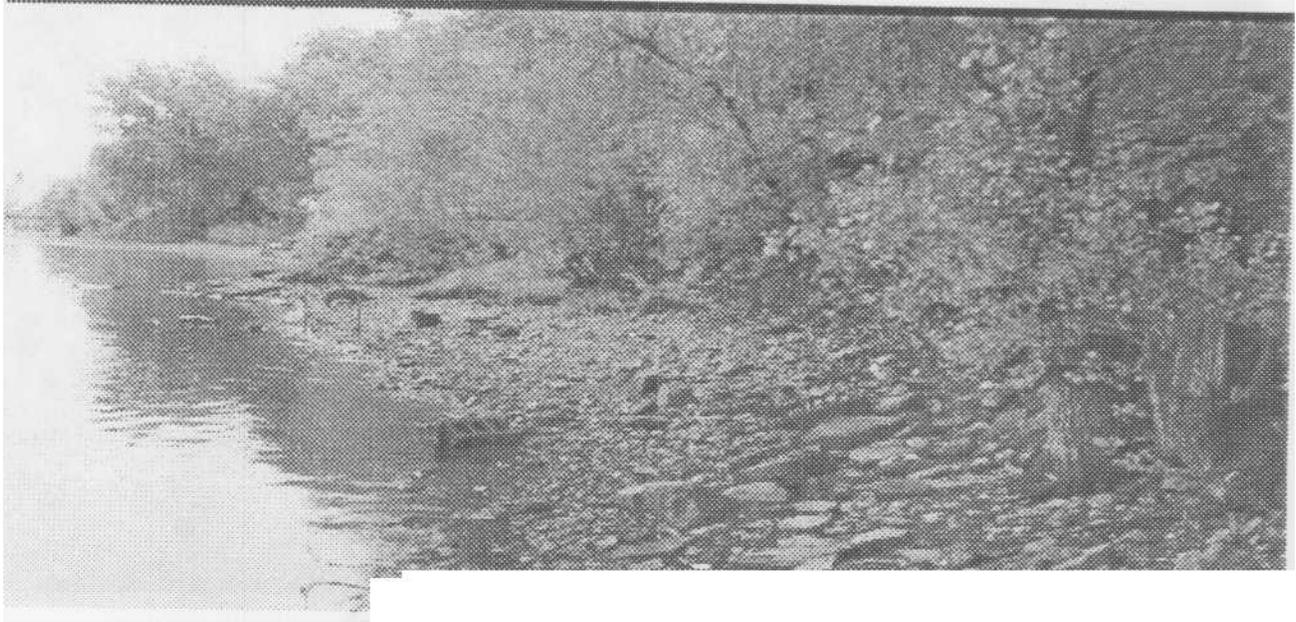
Photograph 11 Construction debris along the shoreline with vegetation above

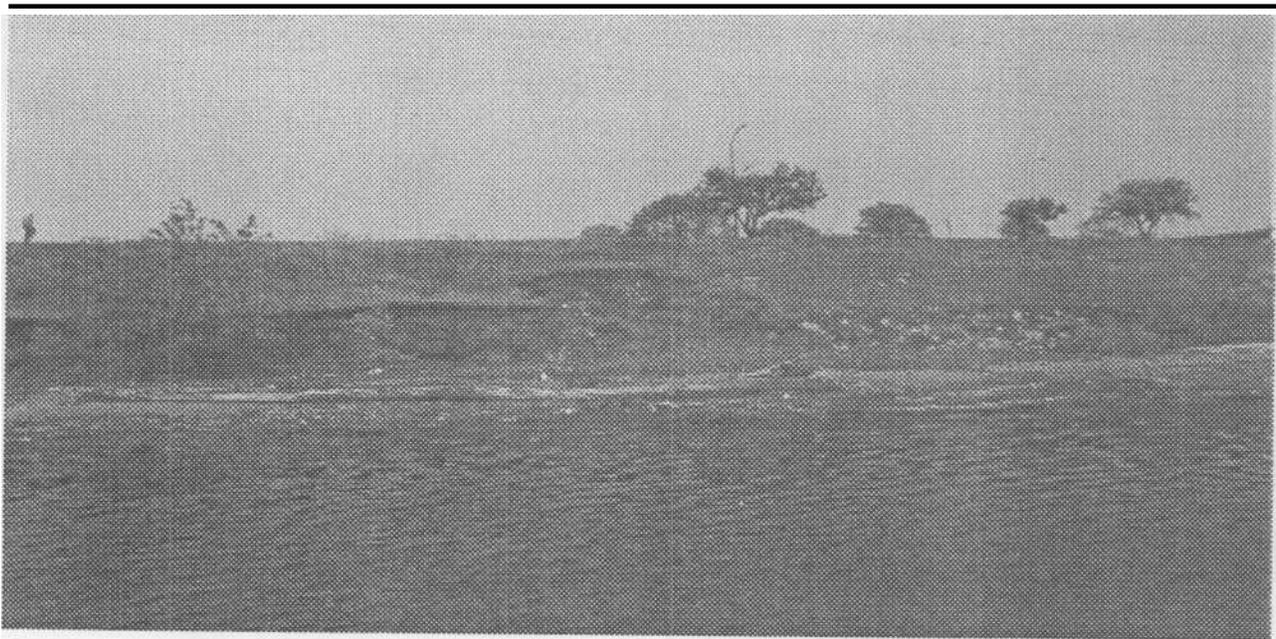
Photograph 12 Large shallow failures on bank with very little vegetation

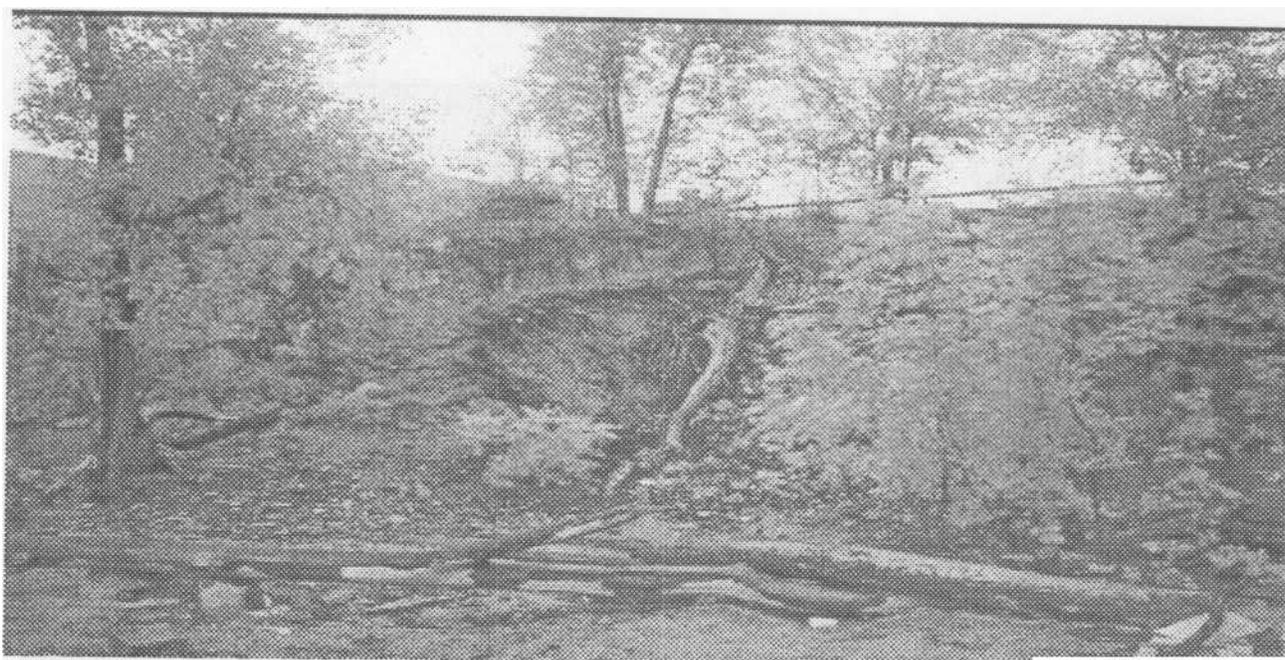
Photograph 14 Surface sloughs, gully and sparse vegetation on a steep bank

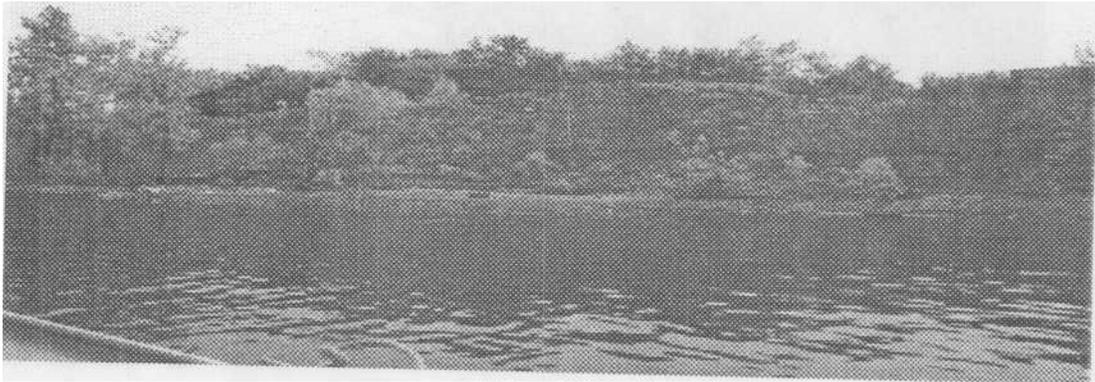
Photograph 15 Very high, sloughing steep slopes

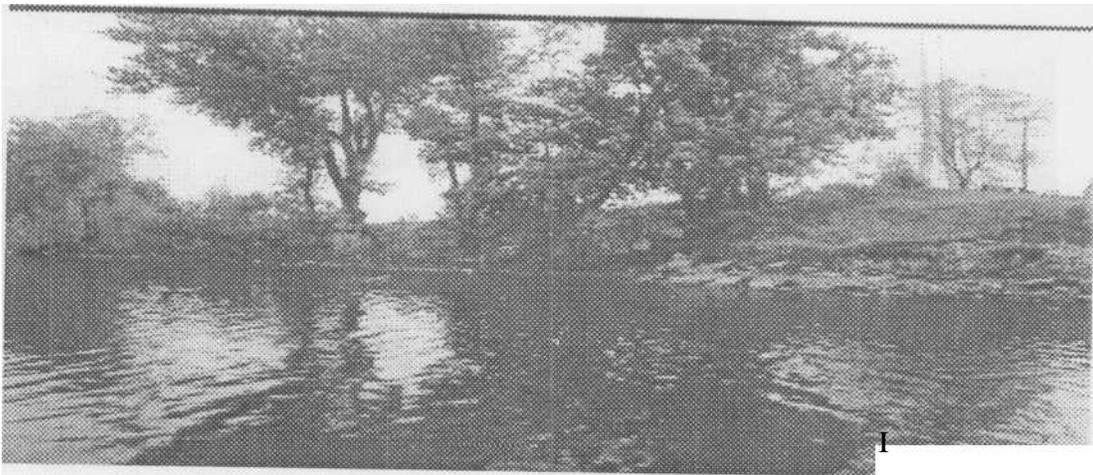
Photograph 16 Toe erosion in old construction fill bank

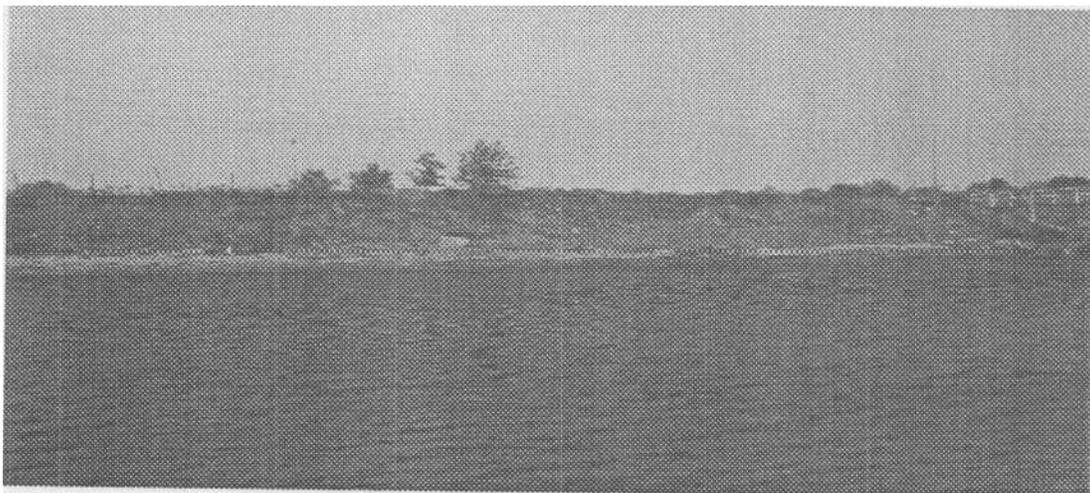
Photograph 17 Eroding open slope face

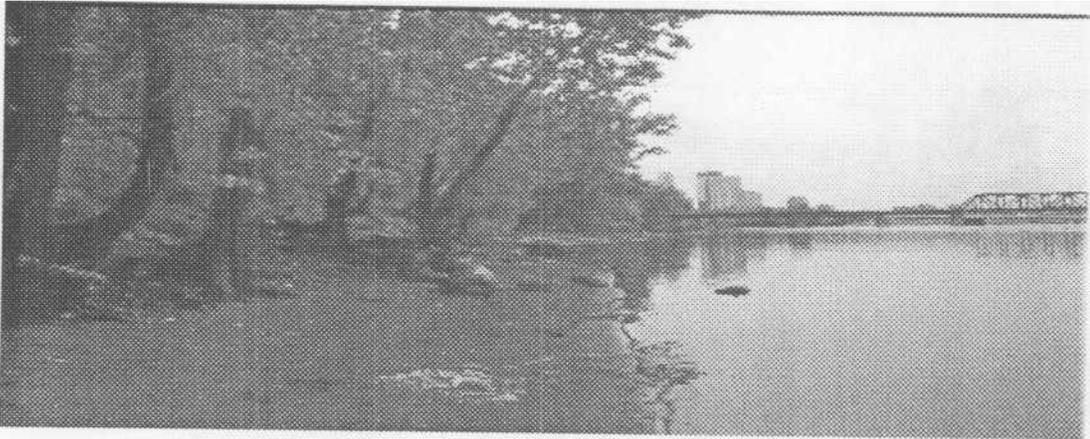
Photograph 18 Old growth poplars appear to be dying

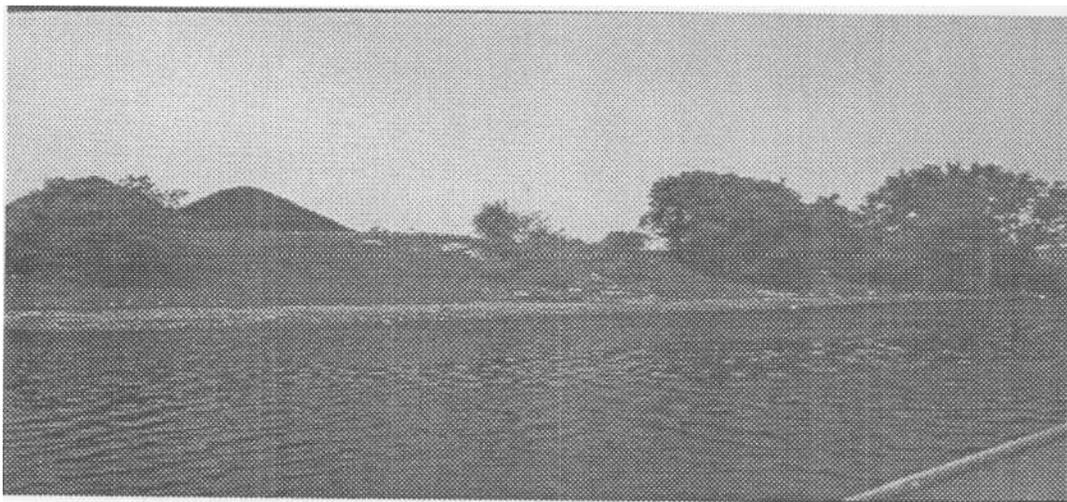
Photograph 20 Sparsely vegetated shoreline slope
