Framework for the Treatment of Character Defining Features
for the Reactivation of the Hollywood Theater

Proposed by CPED-Planning, Preservation & Design
March 10, 2009

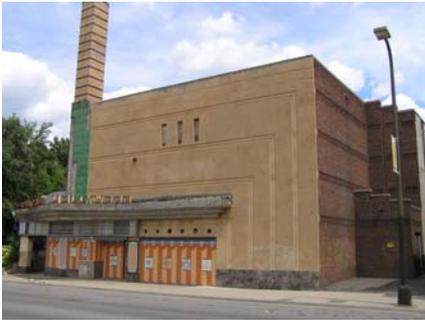
Materials

The front façade is wrapped in Kasota stone with a granite base. The sides and rear are common brick with brick details in toward the front of the sides of the structure. The stone around the chimney is reinforced with steel banding, which is not original.

Guidance Rehabilitate

The materials shall be rehabilitated and repaired as needed. New or enlarged openings in the front façade shall be prohibited.

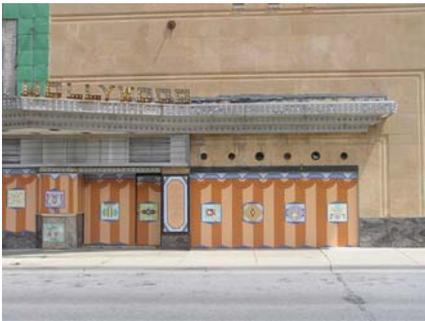
Ticket Booth

The ticket booth is a character defining feature of the Hollywood as it depicts the significance of the structure as a theater. The original materials for the ticket booth appear to be missing. It is currently plywood and other structural materials.

Guidance Reconstruct

The ticket booth shall be reconstructed.

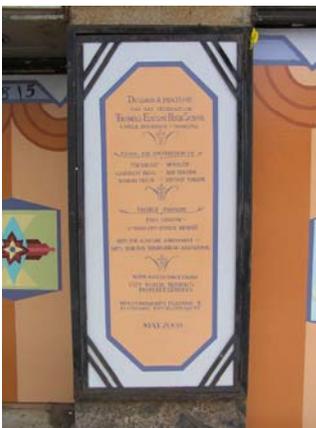
Poster Cases

This original feature is mostly intact; however the glass is missing. Much like the ticket booth, the poster cases are a design feature that depicts the significance of the structure as a theater.

Guidance Rehabilitate

The poster cases are historically significant and shall be rehabilitated and new glass shall be installed.

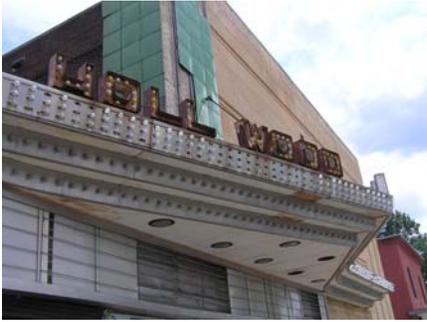
Marquee, Canopy, & Sign

The current canopy, sign and marquee are not original; however they were designed by Liebenberg and Kaplan, the original architects, and installed in 1948. While they are not original they are historically significant features that warrant preservation and shall be rehabilitated.

Guidance Rehabilitate

While they are not original they are historically significant features that warrant preservation and shall be rehabilitated.

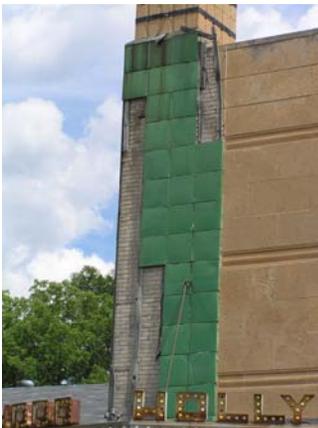
Green Tile

The green tile system was added in 1948 when the original sign and marquee were removed. The green tile above the canopy has been removed to protect the structure from damage caused by falling tile due to the failure of the system used to fasten the tile to the building.

Guidance Rehabilitate/Reconstruct

The green tile may not be original, but it is historically significant and warrants preservation. Green tile system shall be reinstalled with rehabilitated tile or replacement tile.

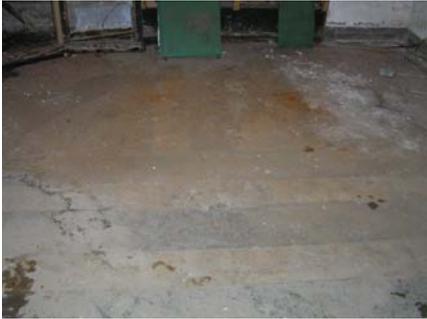
Terrazzo Floor

The multicolored terrazzo floor inlaid in grey, yellow, black and pink is covered in dust and dirt.

Guidance Rehabilitate

All efforts shall be made to rehabilitate the floor. It may be covered up if proven necessary, that it is reversible, and that it won't damage the floor. See below for further guidance.

If a proposed rehabilitation requires the leveling of the outer lobby floor to activate the space, a sensitive and reversible leveling of the floor may be considered if the following criteria can be demonstrated. First, the proposed leveling will not result in the damage or destruction of the floor and adjacent original features and can be reversed without causing damage to the floor. Second, financial information, such as a pro forma, demonstrate that this space must be utilized to make the rehabilitation and activation of the theater viable. Furthermore, it is demonstrated that utilization of this space must require the floor to be leveled.

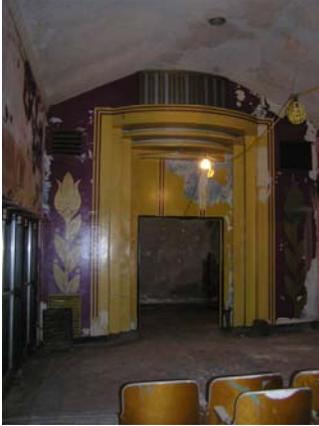
Volume of Space

The entrance vestibule and main lobby have a unique feeling which is created by the height of the ceiling and the scale of the features contained in these spaces.

Guidance Maintain

This volume of space is important to convey in future reuse of the structure. The volume of space shall be maintained and dropped ceilings shall be avoided.

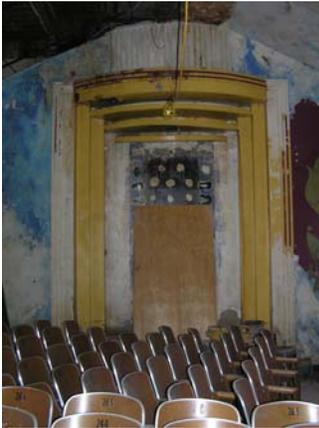
Alcove Feature

Symmetrically designed architectural alcove features flank the north and south walls of the main lobby. The northern feature contains the entrance to the main lobby from the entrance vestibule. The south feature contained an engraved mirror and water fountain; both of which are gone.

Guidance Maintain

The features do not have to be reconstructed to original levels including the mirror and fountain details. The features shall not be enclosed and shall be maintained and repaired as necessary. The plaster fluting above the feature shall also be maintained and repaired as necessary. The features can be painted as desired

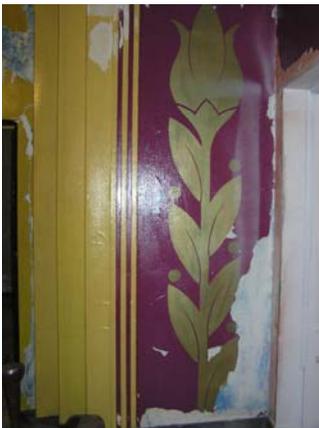
Tulip Detail

Flanking the north and south wall alcove features are stenciled tulip details. Analysis of the pictorial evidence suggests that the current tulip is not the same as the original tulip.

Guidance Removal Allowed

These features could be are not required to be preserved or maintained.

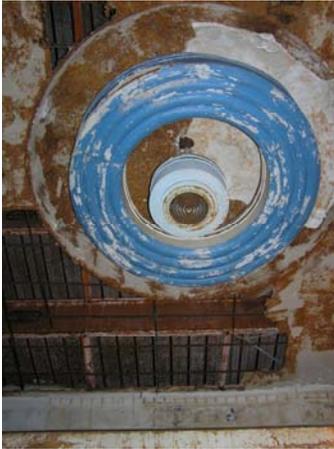
Circular Ceiling Light in Entrance Vestibule

An elaborate circular light feature sits above the entrance vestibule. The feature, shown below in the original drawings by the architect, consists of a circular feature with indirect light that shines onto a concaved plaster ceiling. In the center of the circle a light fixture provides direct light. The portions of this feature are intact.

Guidance Rehabilitate

The design of the light is important as it is indicative of the streamline moderne design of the Hollywood Theater. Efforts shall be made to rehabilitate the fixture and plaster.

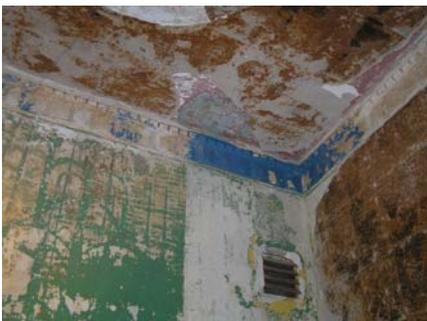
Crown Molding in Entrance Vestibule

The moldings in the entrance vestibule are missing in some locations and severely deteriorated in others.

Guidance Removal allowed with Mitigation

The molding can remain its current state or be removed. If the molding is removed, profile and pattern drawings of the molding shall be done to mitigate the loss.

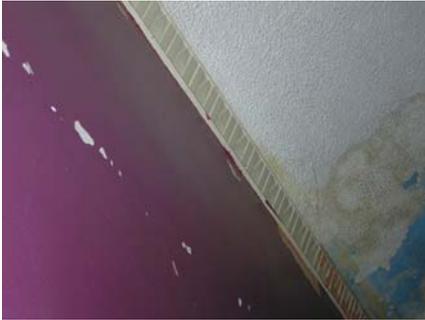
Crown Molding in Main Lobby

The crown molding is original and appears intact.

Guidance Rehabilitate

Moldings shall be rehabilitated

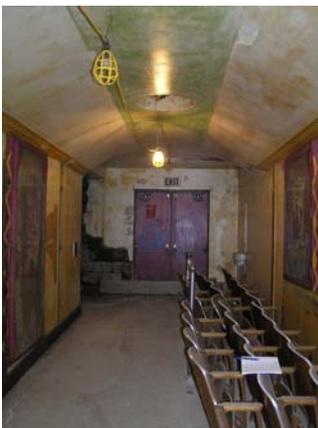
Volume of Space

The volume of space is intact. The feeling created by the lower vaulted ceilings in the inner lobby is more intimate than other areas of the theater which contain larger volumes of space

Guidance Maintain

The feeling created by the vaulted ceilings is important to convey in future reuse of the structure. The volume of space should be maintained and dropped ceilings shall be avoided.

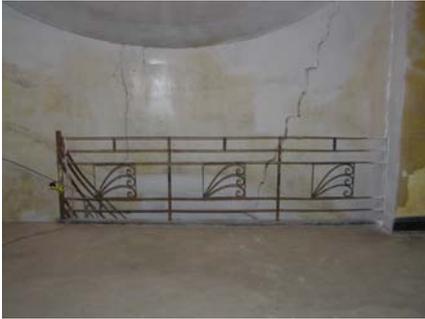
Railing

The railing is one of the most prominent features of the inner lobby. The railing is intact.

Guidance Rehabilitate

The railing shall not be enclosed or obscured; it shall be maintained and rehabilitated as necessary

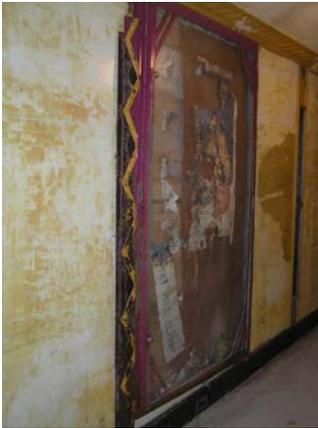
Poster Cases

The poster cases are characteristic of the zig-zag art deco design themes that influenced the streamline moderne style of the theater.

Guidance Rehabilitate

The features appear to be original and shall not be removed or enclosed. The features shall be repaired and incorporated into the reuse of the structure.

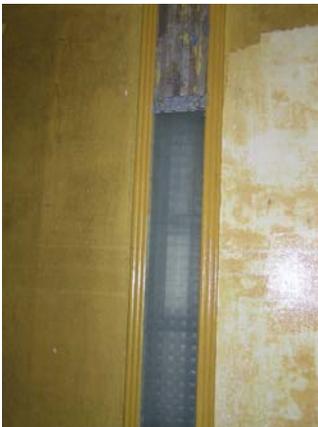
Linear Light Features

The light features are characteristic of the original design aesthetic of the Hollywood. The metal on the top and bottom of the feature needs repair and cleaning. The glass may not be original- the original plans from 1935 called for glass rods.

Guidance Rehabilitate

Features shall be rehabilitated and incorporated into the reuse of the space

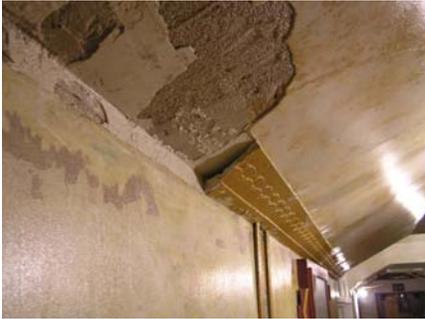
Crown Moldings

Much like the poster cases and light features the crown moldings are characteristic of the art deco design themes. The moldings remain fairly intact with the exception of a few locations.

Guidance *Rehabilitate - Reconstruct*

Missing features shall be reconstructed and existing moldings rehabilitated.

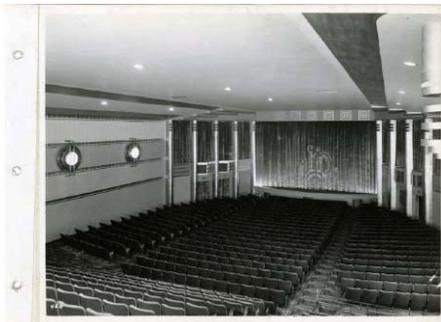
Volume of Space

The volume of the auditorium is intact. The plaster of the roof was removed during remediation and roof replacement- this slightly changes the feeling of the volume of the space.

Guidance *Maintain- Convey volume with sensitive subdivision*

The subdivision of the space can be done, however, the sense of space associated with the volume of the space and theater activity shall be conveyed in the subdivision. See below for details.

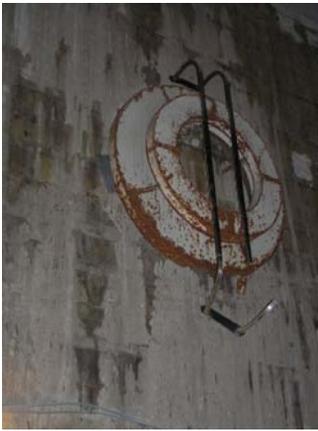
Porthole Lights

The porthole lights are important feature that exemplify the streamline moderne design of the Hollywood. The metal frames of the porthole lights are intact. The condition of some of the metal is deteriorated due to moisture exposure. The finish materials are missing.

Guidance Maintain

The existing features shall be stabilized to prevent further deterioration and the frames repaired. The features do not have to be reconstructed to their original finish.

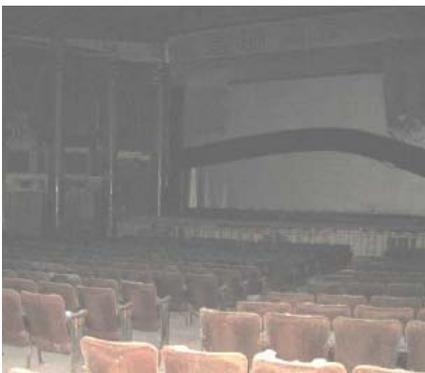
Stage

The original proscenium appears to be intact, but in serious disrepair. A plywood addition has been made to the stage and the pillars surrounding the stage appear to be intact

Guidance Maintain - Removal Allowed with Mitigation

The removal of the proscenium will be allowed with proper mitigation and documentation. The addition to the stage can be removed. The configuration of the stage shall be maintained. A reconfiguration of the stage may be considered to allow for an entertainment reuse of the Hollywood.

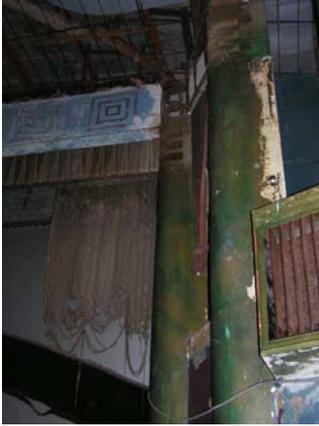
Pillars

The ten pillars that flank the stage are important in conveying the nautical themes of the streamline moderne design that Hollywood is significant for.

Guidance Maintain

The pillars do not have to be restored to their original finish, but they shall be maintained and shall not be enclosed or covered up. The leveling of the floor shall be done in a way that is sensitive to the pillars.

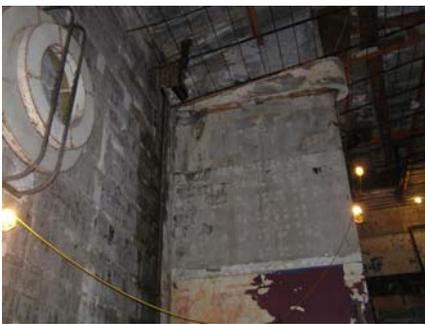
Rear-wall Cornices

Two wall cornices flank either side either side of the balcony wall. As is evident in the historical photographs these cornices had horizontally banded metal mounted below which was used for decorative lighting. What remain of these features are the plaster cornices.

Guidance Maintain

These plaster cornices shall be maintained.

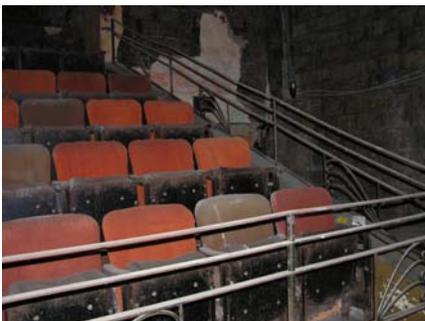
Balcony Railing

A decorative metal railing separates the balcony from the auditorium. The design of the railing is the same as the railing in the inner lobby stairway.

Guidance Rehabilitate

The balcony railing shall be rehabilitated as needed. The railing shall be rehabilitated. The installation of walls to separate the balcony from the auditorium space shall be inset from the balcony railing.

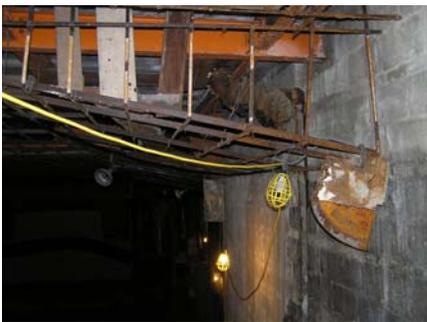
Balcony Light Fixtures

Located in the rear of the balcony these two light fixtures appear to have been mounted into the corner of the dropped ceiling and the outside wall.

Guidance Removal Allowed

These fixtures can be removed with proper mitigation steps.

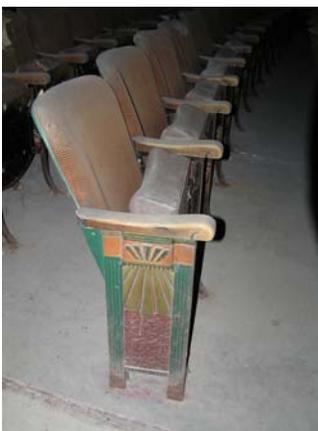
Seats

The seats appear to be original and have survived the water intrusion and years of deferred maintenance. The metal end panels appear to be intact and in good condition. Some seats have been removed leaving metal framing.

Guidance Removal Allowed with Mitigation

The removal of the seats is allowed with mitigation measures that include drawings of a typical seat, photographs of configuration, and the salvage and storage of the decorative metal end panels.
