Report  
for the  
2009 Structural Review

1001 West Broadway  
Avenue Building

BCG Project Number R739-09-1

## 2009 Structural Review of the 1001 West Broadway Avenue Building

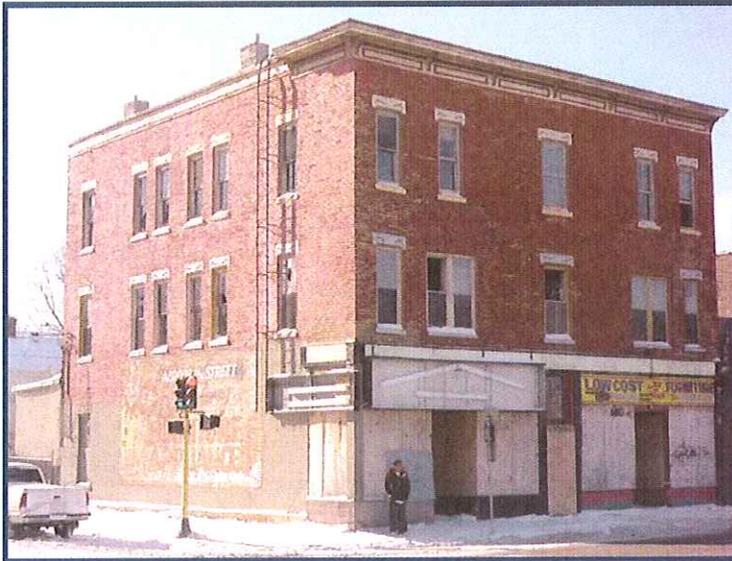
**Image 1**

An overall view of the north and east elevations of the building. The brick veneer cladding and wood cornice is visible, as well as the two store fronts. Also visible is the east wall of the middle addition at the south of the building. A bus stop is present on Broadway in front of the east storefront.

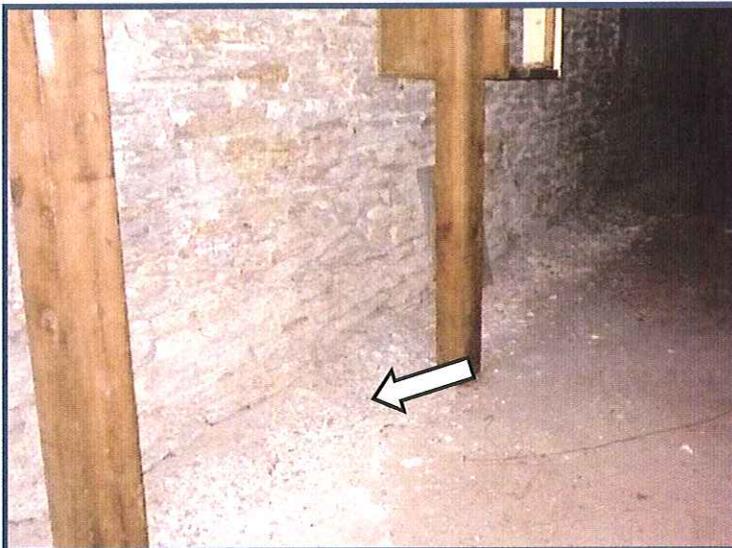
**Image 2**

The foundation at the west half of the basement was viewable from the interior. It consisted of mortared limestone. The mortar at the lowest about 3' was deteriorated and had fallen out of the joints at the west half of the basement to a depth of a few inches. (See image 2.)

The mortar has generally deteriorated at the lower few feet of the foundation wall. However, this type of foundation wall could be 2' to 3' thick which allows for significant systemic deterioration without resulting in structural instability.

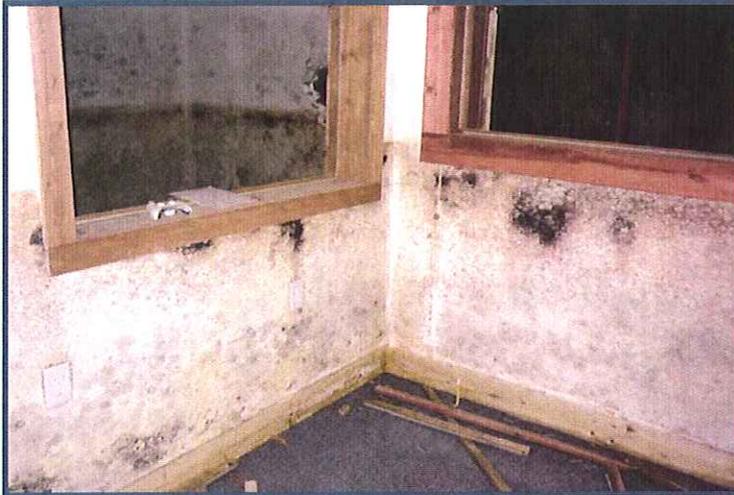
**Image 3**

Most of the foundation wall at the east half of the basement was concealed by deteriorated finishes. However, there were a few voids in the foundation exterior visible at the exterior from the Dupont Avenue sidewalk that extended about a foot into the wall and downward. Staining on the wall finishes indicated the basement had been previously flooded to a depth of about 3'. (See image 3.)

Damage to interior finishes, probably resulting from flooding.

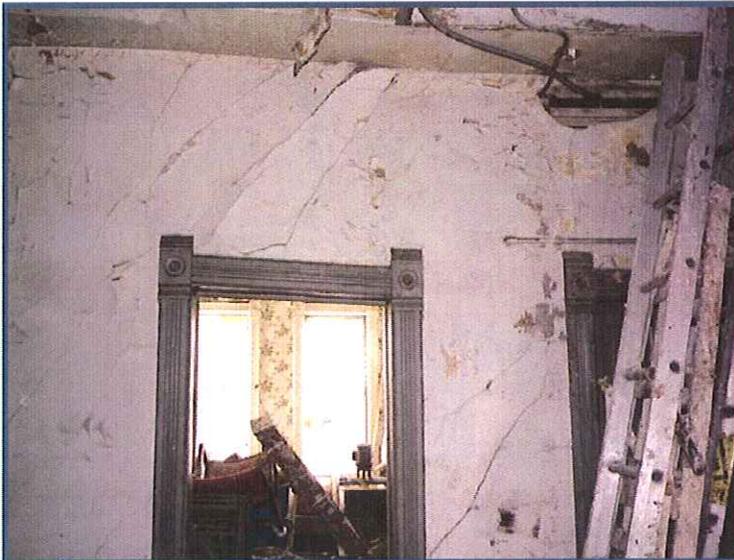
**Image 4**

Many of the interior wall and ceiling finishes displayed significant moisture damage, and large areas of wall and ceiling plaster had fallen, permitting observation of wall studs and floor joists. Where interior finishes remained there was significant diagonal cracking, indicating building movement. Movement and settling appeared to be greatest at the southwest quarter of the building. (See image 4.) Moisture damage was the most prevalent at the third floor than compared to the second, and uncommon at the first floor.

Significant diagonal cracking of the interior plaster was observed indicating settlement or shifting of the building. Additional, several door frames were observed to be out-of-square. The amount of cracking and differential settlement was greater at the southwest of the building.

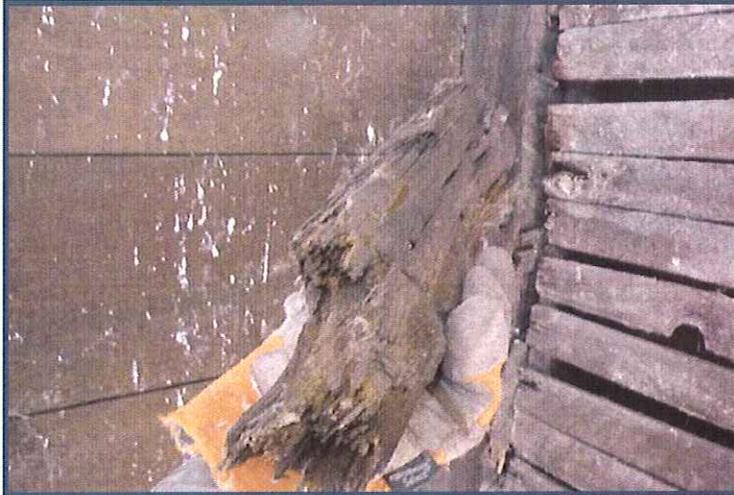
**Image 5**

Some wood wall studs were observed to be decayed. Close investigation was performed at the southeast corner where significant deterioration was observed at a few corner studs. (See image 5.)

The debris in the image is a piece of wood stud removed by hand from the southeast corner of the 3<sup>rd</sup> floor. Only isolated areas of interior finish were absent which means there may be more areas where primary structural components (such as studs and joists) have deteriorated, but are concealed.

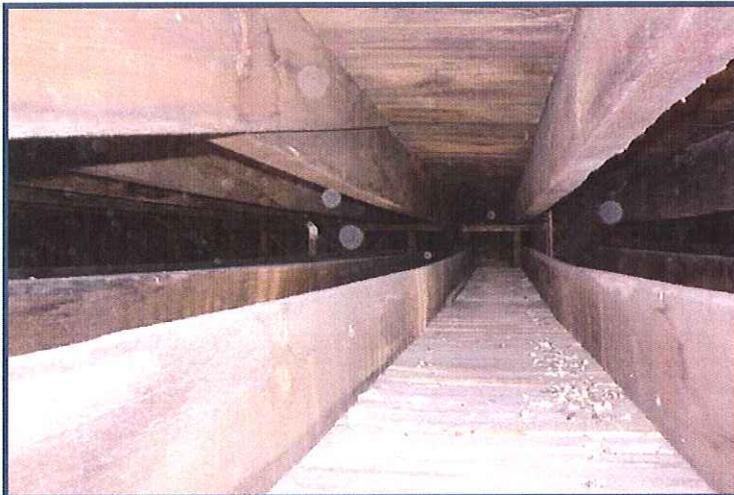
**Image 6**

The roof construction was viewable at one location where the ceiling finish had fallen. (See image 6.) The roof structure was independent of the 3<sup>rd</sup> floor ceiling, each consisted of rough-sawn 2x8s spanning half the width of the building. Significant creep (permanent deflection over time) was present at the ceiling joists and slight bowing was observed at the roof joists. The roof sheathing appeared to be tongue-in-groove wood boards. Moisture staining was observed at the underside of the roof sheathing, and on most of the roof and ceiling joists. However, no joists seemed to be soft or decayed where accessible.

This interior view of the roof and ceiling was taken by climbing onto a pile of debris. There were signs of past moisture intrusion, but the weather was below freezing and no liquid moisture was observed. Additionally, no joists appeared to be failed.

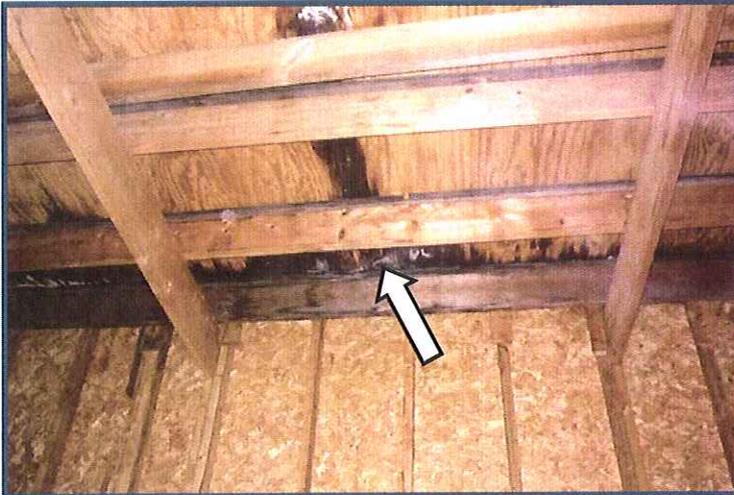
**Image 7**

The middle addition was of more recent wood construction, probably about 10 to 20 years in age. Significant moisture deterioration was observed at the underside of the roof at a few locations resulting in isolated rot of the sheathing and part of the joists. (See image 7.)

There was significant isolated decay of the wood at the underside of the roof at the middle addition. The weather was below freezing and no liquid moisture was observed.

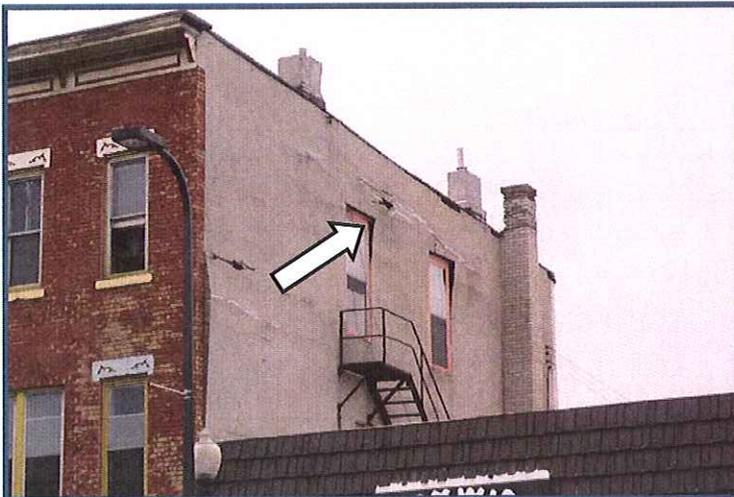
**Image 8**

Generally, the stucco facade at the west wall appeared to be unstable posing an immediate potential safety hazard. The facade on the west face had pulled several inches away from the building at many locations. (See image 8.)

The stucco on the west face was generally peeling off the building.

Deteriorated clapboard siding was behind the stucco. The total weight of this 2 story stucco facade at this elevation is estimated to be about 3 to 4 tons.

- A. The stucco at the west face (see image 8) is generally unstable and should be removed to eliminate a potential safety hazard to the sidewalk on Broadway in front of the 1005 West Broadway Avenue building. Loose stucco also poses a potential hazard to the roof of the adjacent 1005 building.
- B. Similar loose stucco is likely present on the south elevation.
- C. The stucco should be removed and legally disposed of on the west and south walls.
- D. We assumed the underlying wood siding is deteriorated, and would need to be temporarily protected with building paper and battens. Alternatively, the wood siding could be covered with vinyl or metal siding.

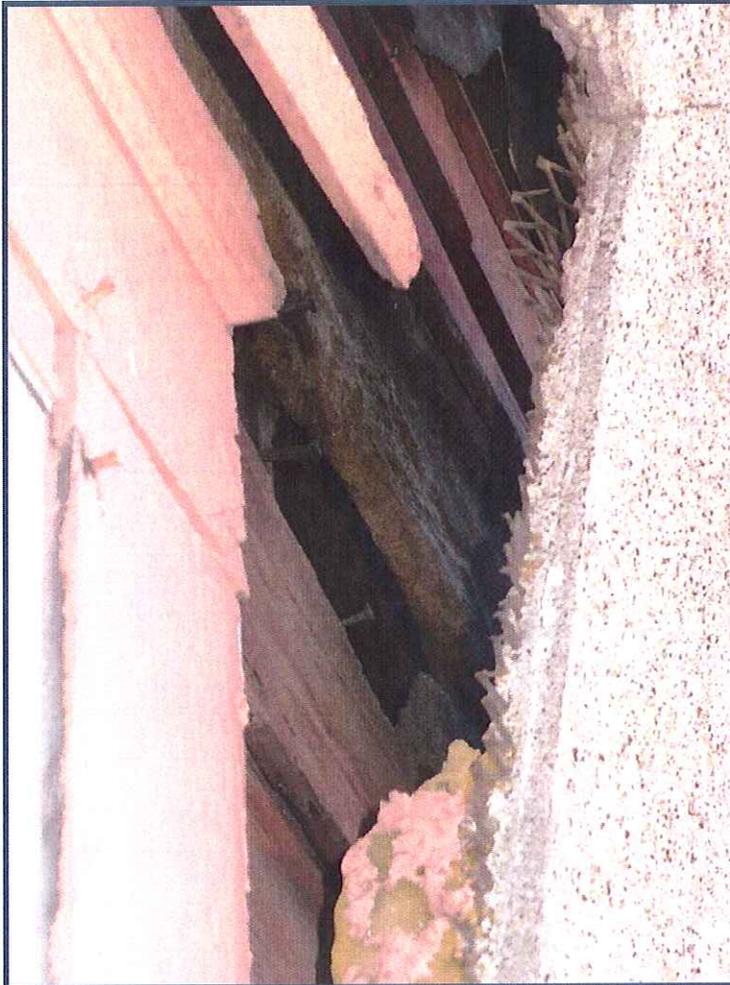
**Image 9**

The stucco veneer at the west and south elevations had been installed over wood clapboard siding, and was generally dislocated away from the wall. Where the siding was accessible it was observed to be significantly distressed. (See image 9.) One layer of building paper was observed behind the stucco, and one layer of building paper was observed behind the clapboard. No obvious anchorage of the metal lath was observed.

Close-up of upper right corner of north window at third floor of west wall.

No restraint was observed to restrain the stucco on the face of the building. The gap between the stucco and the building face was several inches in some areas. The exposed lath displayed surface corrosion.

The clapboard siding behind the stucco was observed to be deteriorated with voids. A single layer of building paper was observed behind the clapboard siding.

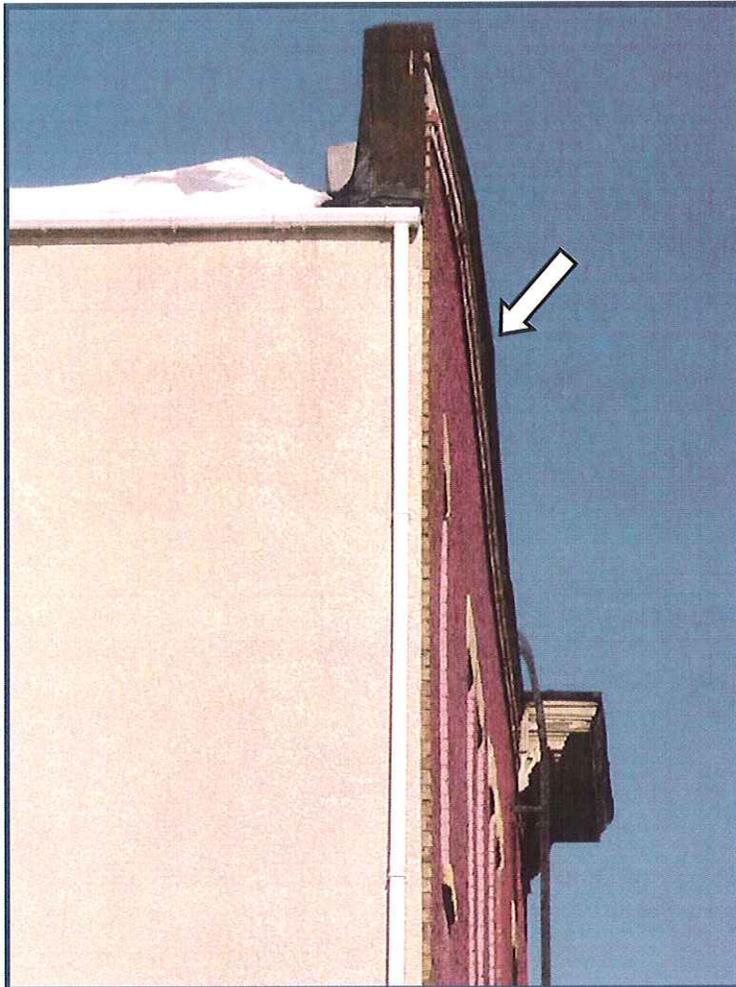
Image 10

The east wall parapet appeared to bow outward several inches and displayed a slight outward rotation at the top. Additionally, there was brick and mortar cracking in the brick parapet. (See image 10.)

- A. The brick parapet along the east wall (see image 10) appeared to be dislocated, and bowed outwards.
- B. Isolated large areas of distressed brick veneer were also observed below the parapet.

The parapet along Dupont displayed outward bowing. The roof was not accessible, so the cause of this bowing, and the severity and significance is undetermined. However, this bowing can be assumed to be significant.

- C. As part of the repair, further investigation should be performed to verify the significance of the outward bowing and loose brick. An aerial lift can be used for access, and the condition of the backup wood wall studs and lateral wall ties should be verified.

- D. Assuming the backup wall construction and wall ties are in adequate condition, the brick veneer should be temporarily stabilized by:
  1. Adding additional lateral wall ties on the east elevation brick veneer.

2. Installing steel fence netting, anchored by the additional lateral wall ties, to restrain any loose brick or mortar.
  3. At the roof parapet, installing additional EPDM flashing as necessary to temporarily tie-in to the existing roof membrane.

- E. Alternately, brick masonry could be temporarily removed and the brick salvaged and stored for reuse. Temporary protection would be needed to protect the exposed wood backup. Removal of the brick without replacing the brick would be very noticeable on the street side of this building. The parapet should be braced or removed to eliminate a hazard to the adjacent sidewalk and street.

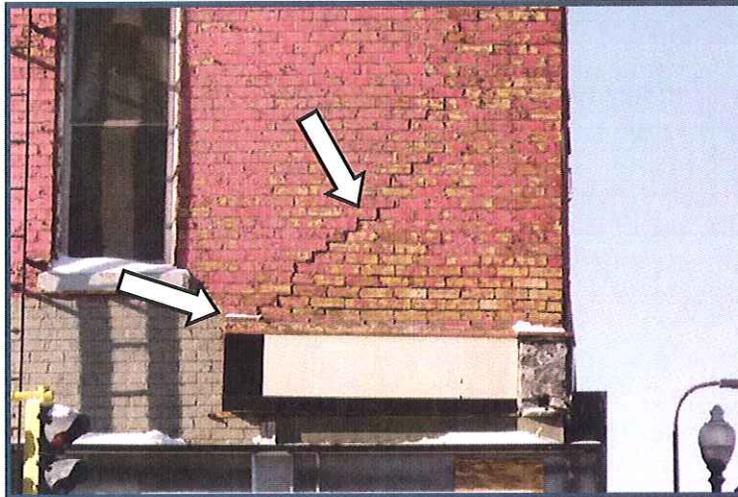
Image 11

One area of the brick facade above the east face of the east store front was reviewed up close using a ladder. (See image 11.) There was a step crack displaying about  $\frac{1}{4}$ " of movement at this location. The brick below the step crack were loose. The mortar below and to the right of the step crack was generally deteriorated to a typical depth of about  $1\frac{1}{2}$ ".

The area of brick to the right and below the crack is very deteriorated with soft mortar, large mortar voids, and loose brick.

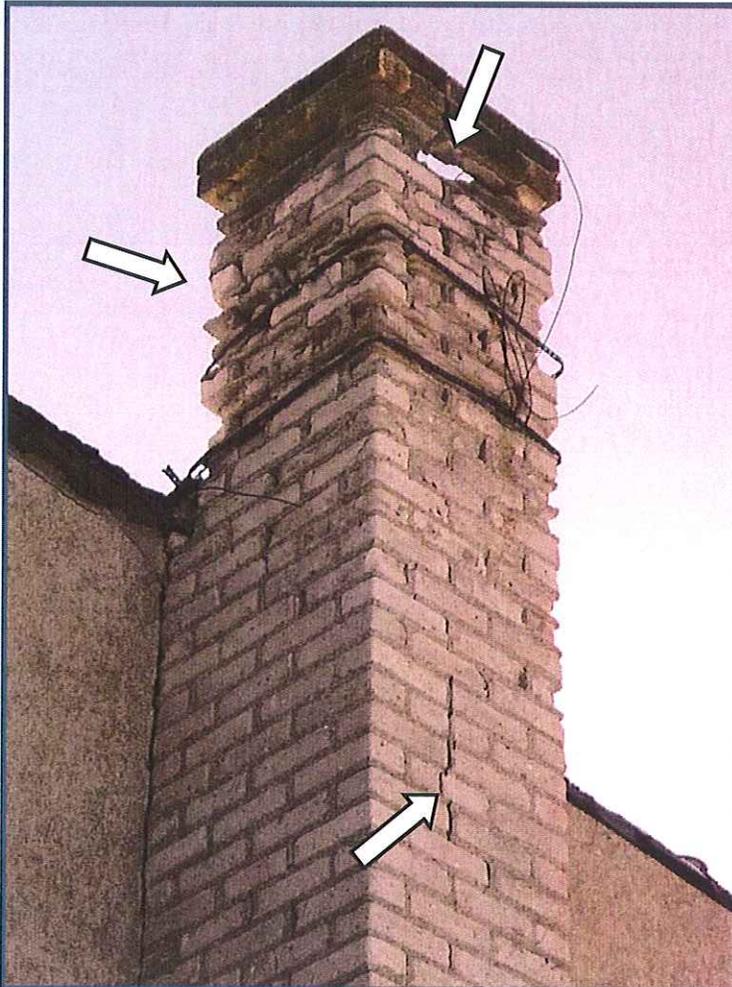
Image 12

The chimney at the west face of the building appears to be on the 1005 West Broadway Avenue property. However, this chimney is also attached to the west face of the building. The top few feet have significantly deteriorated with large voids, and the lower part displayed significant cracking and mortar deterioration.

The chimney attached to the west face of the building appears to belong to the 1005 W. Broadway Ave. property. The top few feet of this chimney is significantly deteriorated including missing brick, crumbling and cracking mortar.

The top few feet of this chimney appears to be wrapped with strapping which may be an ad hoc stabilization measure, or may have been for an antenna which is no longer present, or other purpose.

- A. The top few feet of the west chimney brick (see image 12) should be removed to eliminate a potential hazard to the adjacent 1005 building and its occupants.
- B. The brick should be salvaged and stored on-site for future use when the building is renovated.
- C. A sheet metal cap should be installed over the shortened chimney.
- D. This repair has assumed the chimney is no longer used for heating. If the chimney is used for heating, more extensive repairs or installation of a metal flue would be required.
