STRUCTURAL SURVEY OF THE BUILDING AT 1101 BROADWAY AVENUE MINNEAPOLIS, MINNESOTA

RE: Structural Survey of the Building at
1101 Broadway Avenue
Minneapolis, Minnesota
MCDA Contract No. C-21595, Release 01
BCG Project No. R111-05-1

**STRUCTURAL SURVEY OF THE BUILDING AT
1101 BROADWAY AVENUE
Minneapolis, Minnesota
BCG Project No. R111-05-1
September 23, 2005**

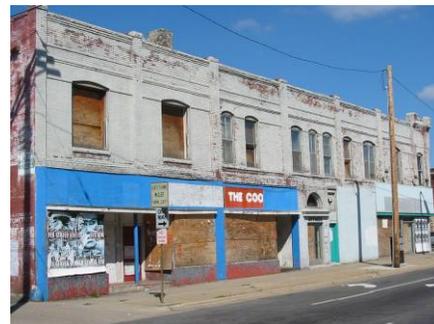
East elevation of the 1101 Building

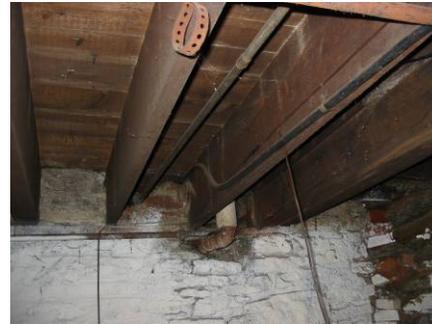
Typical wood framing supporting the first floor, and end bearing on the stone masonry basement walls

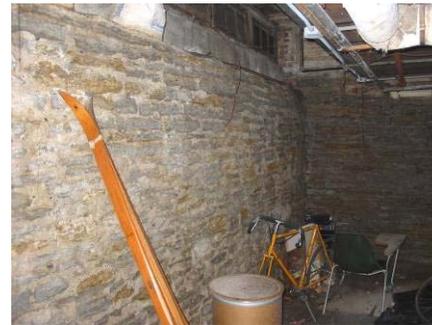
Typical stone foundation wall

- A. Spot-repairing existing rubble stone masonry walls.
- B. Providing a new basement wall waterproofing membrane on the interior side of all walls.
- C. Providing new interior drain tile and sump.

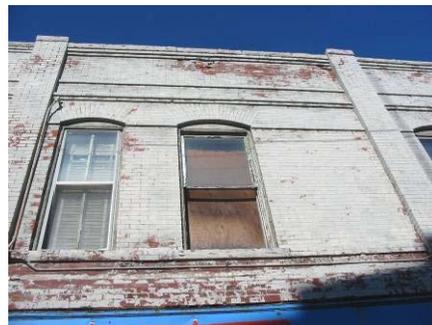
Second floor brick masonry on the east elevation

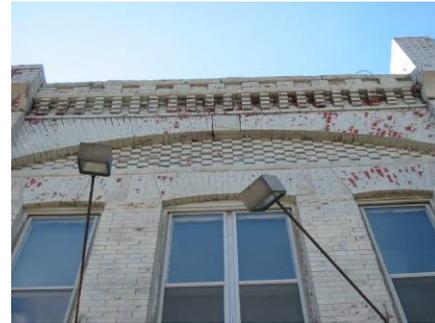
Typical brick masonry on the front (north) elevation.

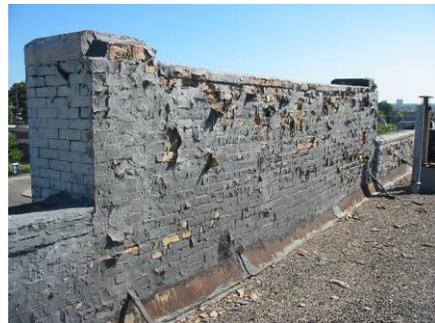
Deteriorated brick at the north wall parapet

1. At the 1st floor cornice on the east elevation.
 2. Above the 2nd floor bay window on the north elevation.
 3. Rebuilding portions of the roof parapet, resetting cap stones, and providing new through-wall flashing.

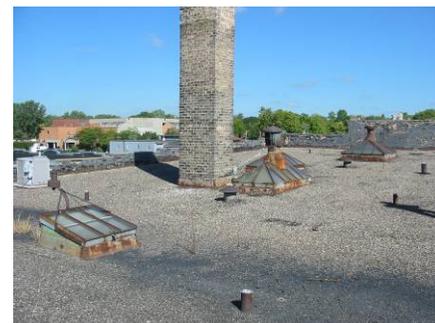
Roof view showing chimney, skylights, and typical roof membrane condition

Item	Condition Noted
Roofs	<p>The roof system was in poor condition. We noted:</p> <ul style="list-style-type: none">• The roof membrane is a built-up roof in very poor condition. Numerous leaks have occurred, likely for several years, into the second floor below as evidence by peeling paint and deteriorated plaster ceilings.• The roof flashing extends up onto the brick masonry parapet walls. The backside of the parapet walls were mopped with asphalt and this coating is brittle and debonding from the brick.• There are four skylights on the roof, generally steel framed peaked roof structures with wire-reinforced glass. The skylights are likely original or several decades old.• The original roof system likely sloped from the front of the building to the rear and had an exterior gutter system at the rear of the building. An interior drain was installed when the south building additional was installed. One drain and one scupper were present at the east side of the building. An additional drain and scupper are likely required to provide additional drainage capabilities.

- A. Removing the existing roof membrane and insulation.
- B. Replacing decayed roof boards as necessary.
- C. Providing new insulation and vapor retarder.
- D. Providing additional roof drains in the flatter-sloped addition towards the south.
- E. Providing a new built-up roof membrane.
- F. Replacing the existing skylights with new skylights.

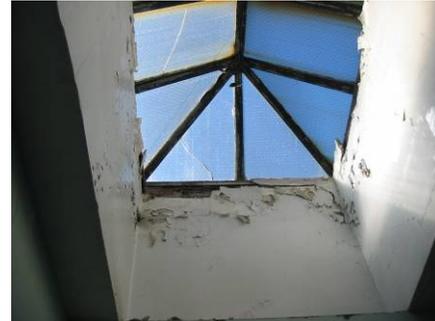
Typical skylight viewed from 2nd floor

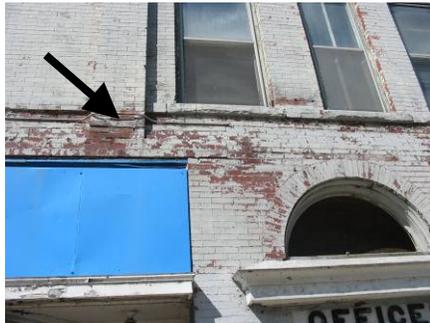
Brick masonry bulging at the 2nd floor line needs to be rebuilt

1. Exterior brick and stone masonry repairs
 - A. Tuckpointing 100% of the exterior masonry walls.
 - B. Rebuilding bulging or shifted wall areas. These areas include:

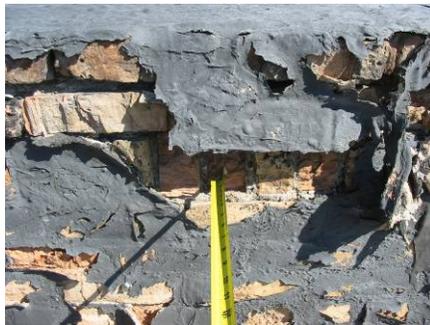
Typical brick masonry distress at roof parapet

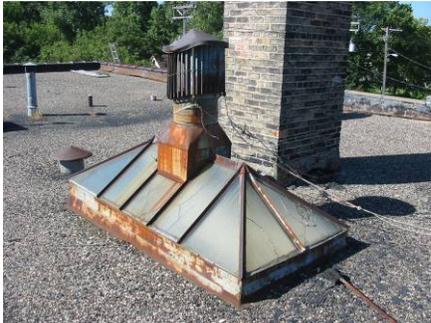
Existing skylights should be replaced

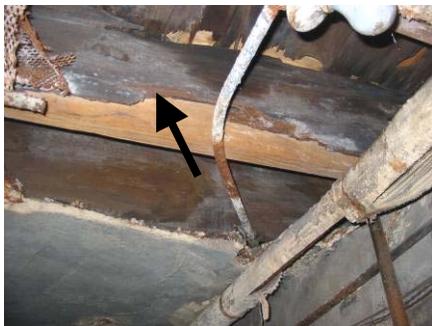
Decayed joist with sister repair joist adjacent to it

- A. Replacing decayed, cracked, or broken wood floor joists and floor boards as necessary.
