Warehouse District Heritage Street Plan

Existing Conditions

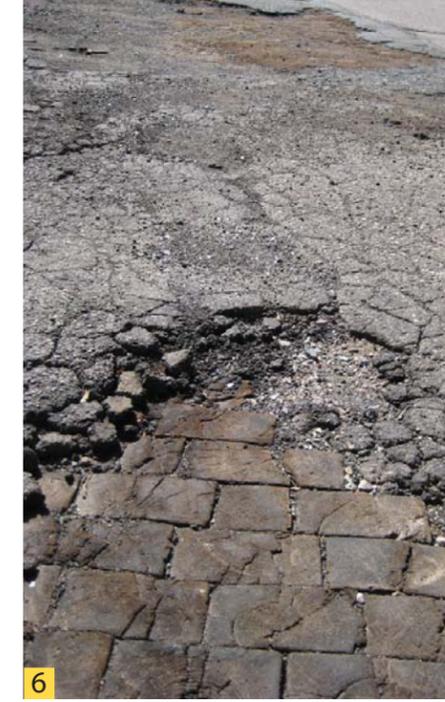
5 Existing areas of wood block pavers

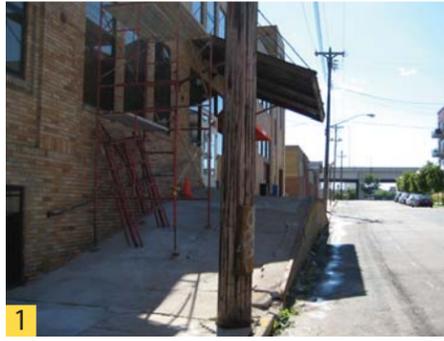
Existing ramp in poor condition and not ADA accessible

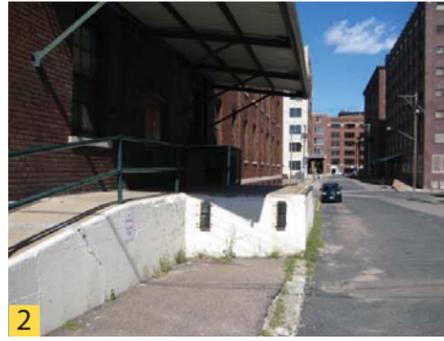
Existing loading dock in poor condition

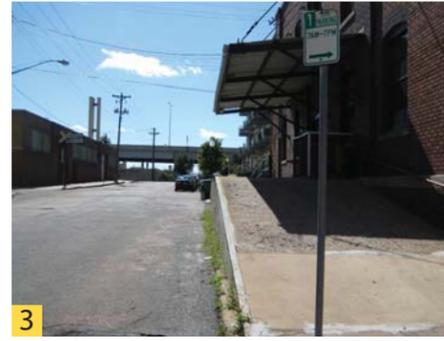
Existing loading dock and ramp in poor condition and not ADA accessible

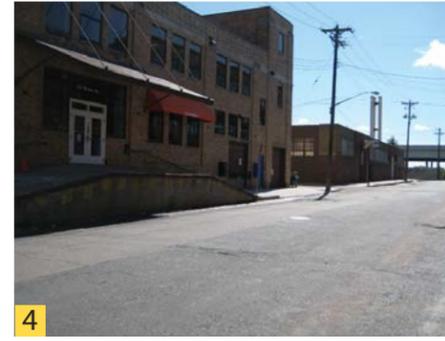
Existing ramp in poor condition and not ADA accessible

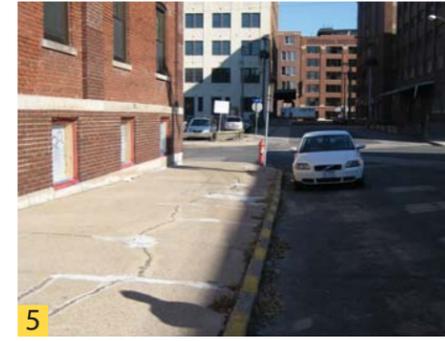
Sidewalk in poor condition

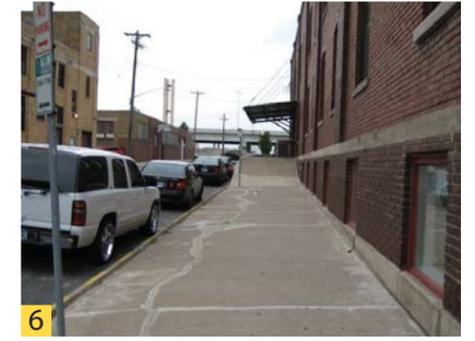
Sidewalk in poor condition

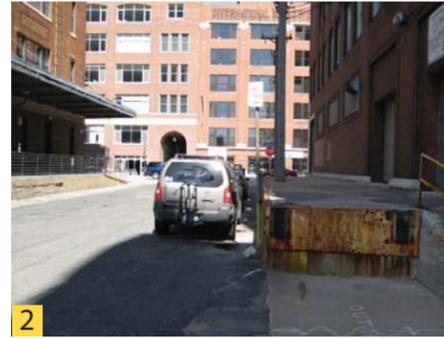
1 Existing ramp in poor condition and not ADA accessible

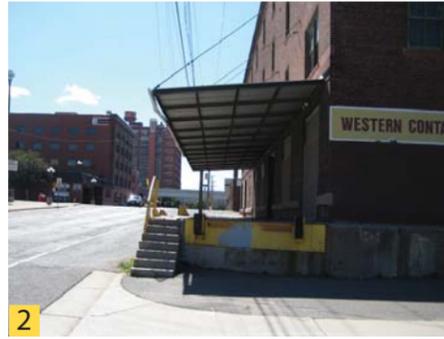
1 Sidewalk in poor condition. Pedestrians prefer to walk on streets vs. loading dock

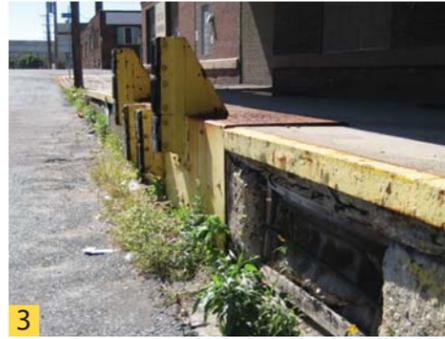
2 Loading dock appears private property so perceived no access

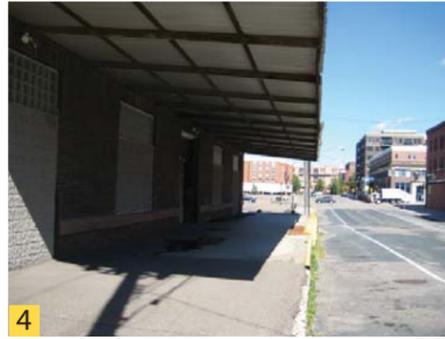
3 Edge of dock in fair to poor condition. Metal infrastructure in fair condition

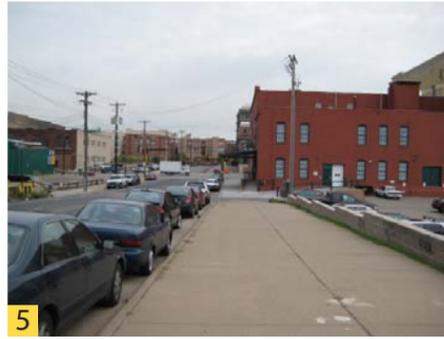
4 Concrete surface of loading dock in fair condition

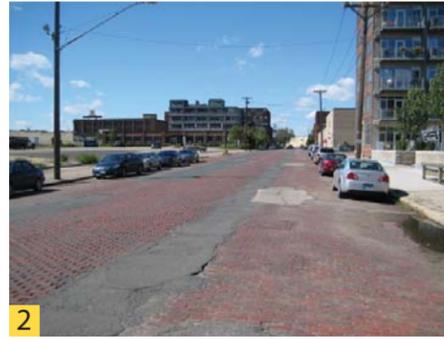
1 Excessive areas of road patching. Pavers settling causes water to collect in certain areas. Variety of different materials has been used in patching

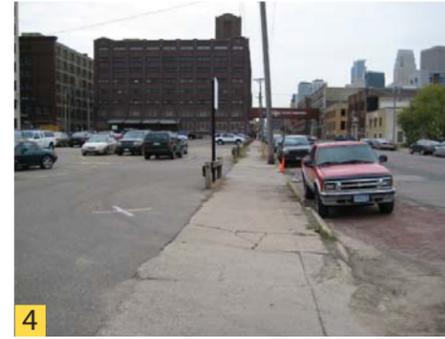
3 Most sidewalks in poor condition throughout this section of 3rd Street N

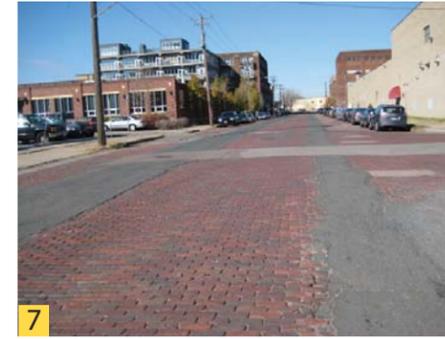
6 Sidewalks and infrastructure in poor condition

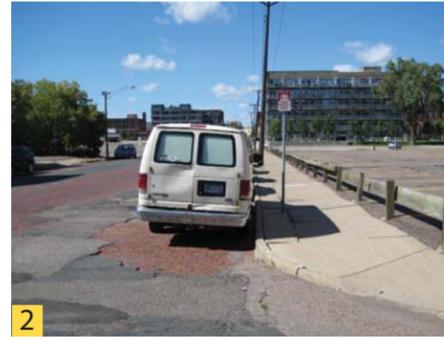
1 Excessive areas of pavement patching

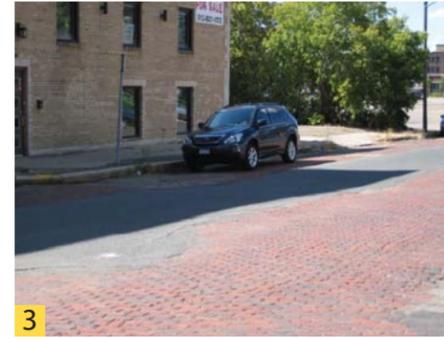
2 Narrow sidewalks in poor condition are typical through this section or road

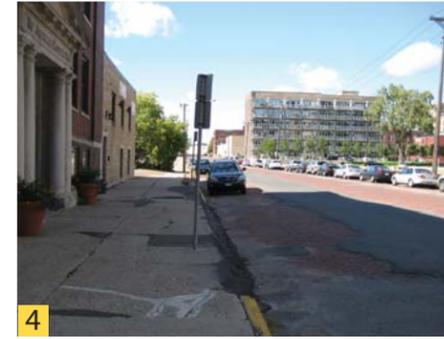
3 Extensive areas of pavement patching occur near intersection at 7th Avenue

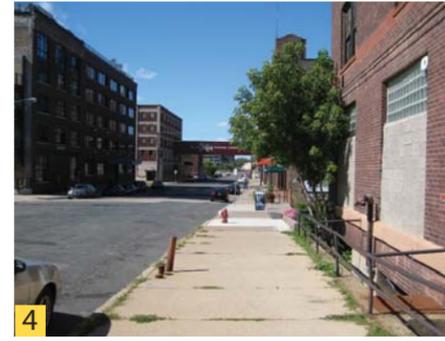
4 Sidewalks in fair to poor condition

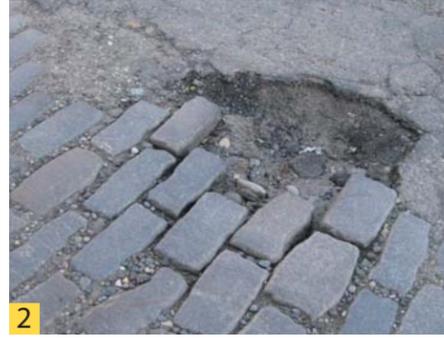
2 Missing granite cobbles

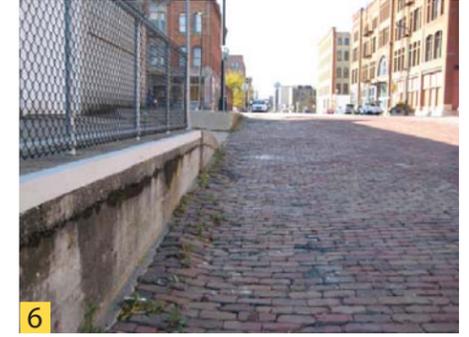
6 View towards 1st Street N along loading dock. Some pavers have heaved along the edge of the loading dock area

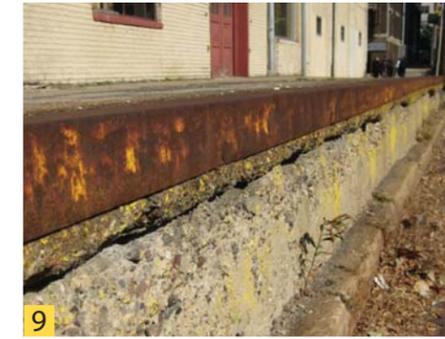
9 Concrete is deteriorating at edge of dock
