# Warehouse District Heritage Street Plan

Prepared for City of Minneapolis Community Planning  
& Economic Development (CPED)  
September 13, 2011

## APPENDIX 3 Additional Analysis

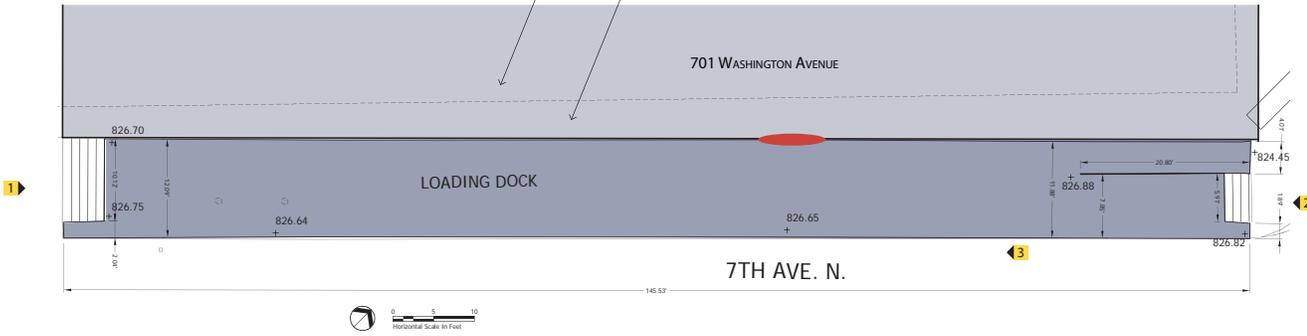
Surface of loading dock in good shape.

Loading dock has ADA compliant ramp off of Washington Avenue and stairway access at both ends of the dock. There are also existing callings along the entire edge of the dock.

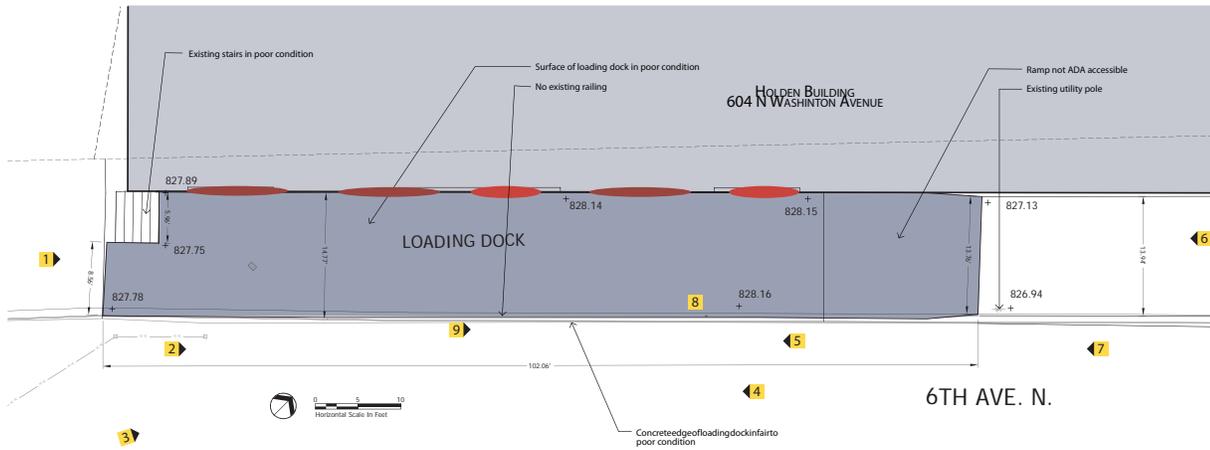
6th Avenue Loading Dock Existing Conditions  
WAREHOUSE DISTRICT HERITAGE STREET PLAN

1 Existing stairs at loading dock in poor condition

2 No clearly defined pedestrian/ADA accessible route

3 Concrete along the face of the loading dock is in poor condition

4 If vertical dimension is greater than 30 inches, railings may be required to meet current building codes

5 Concrete on top of loading dock is in poor condition

6 Loading dock ramp is not ADA accessible

7 No clearly defined pedestrian access around existing loading dock

8 Remnant utility pole

9 Concrete is deteriorating at edge of dock
