CPED STAFF REPORT

HPC Agenda Item #1
 March 24, 2015
 BZH-28577

Property Location: 2540 3rd Avenue South
Project Name: MCAD Residence Hall
Prepared By: [Lisa Steiner](#), City Planner, (612) 673-3950
Applicant: Minneapolis College of Art & Design
Project Contact: Jeffrey Mandyck, Cuningham Group
Ward: 10
Neighborhood: Whittier
Request: To allow exterior alterations to a noncontributing building.
Required Applications:

**Phase 1 Report
Existing Conditions Assessment and
Exterior Cladding and Window Replacement Strategies**

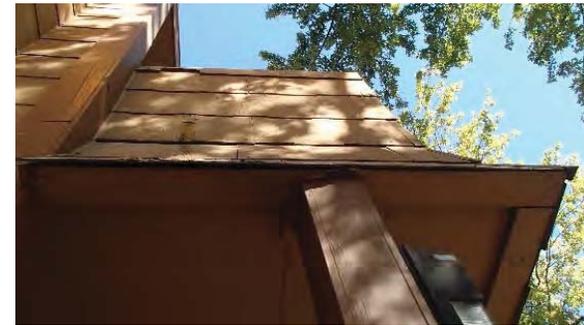
Canopy scupper and outflow damage

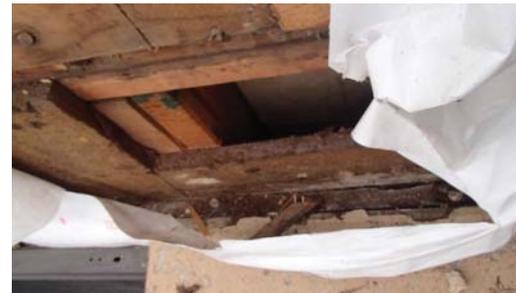
West wall looking down to brick ledge and backup fiber sheathing, metal flashing not present

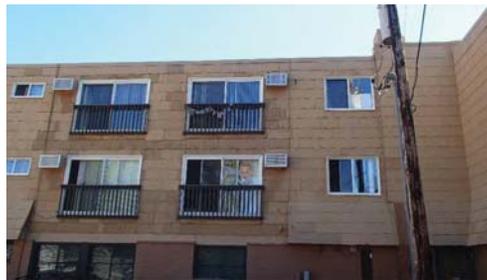
West wall patio doors, windows and through wall air conditioners
Multiple repairs are visible surrounding patio doors.

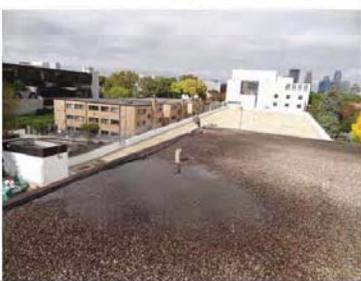
Inventory / Photo Info	Photo
<p>Photo #1 Roof overview of the existing asphalt and gravel built-up roof system.</p>

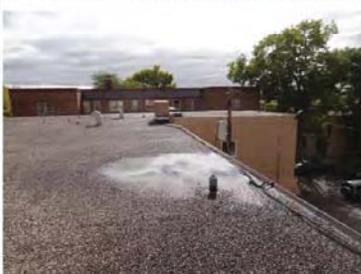
<p>Photo #2 Observe signs of ponding water due to inefficiency of the drainage system.</p>

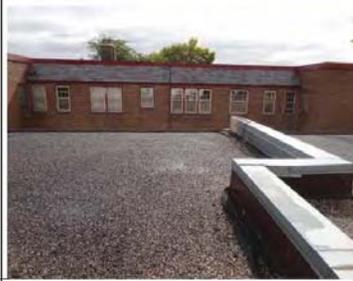
Inventory / Photo Info	Photo
<p>Photo #3 Firewall between the main roof and the southwest roof section.</p>

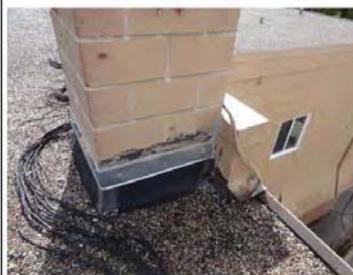
<p>Photo #4 Flashing base of the existing chimney system.</p>

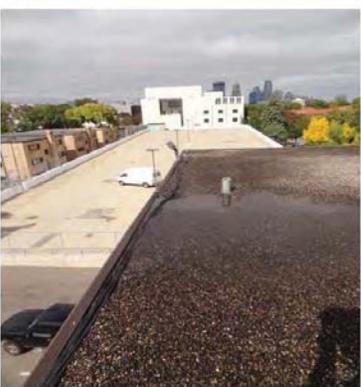
Inventory / Photo Info	Photo
<p>Photo #5 Perimeter overview. The perimeter will need to be raised approximately 6" to accommodate tapered insulation and roof crickets.</p>

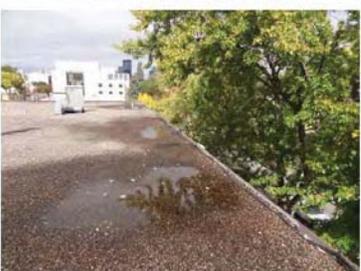
<p>Photo #6 Overview of the east side of the perimeter. Ponding water exists due to the lack of roof crickets directing moisture to the existing scupper and downspout.</p>

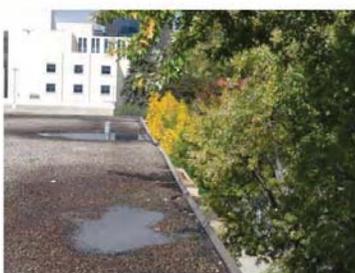
Inventory / Photo Info	Photo
<p>Photo #7 Additional overview of the east perimeter and two areas of ponding.</p>

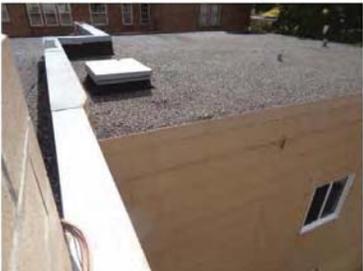
Inventory / Photo Info	Photo
<p>Photo #8 Southwest roof section overview.</p>

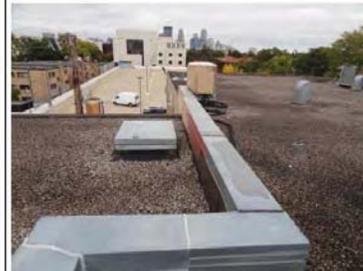
Inventory / Photo Info	Photo
<p>Photo #10 Additional overview of the existing firewall between the two roof sections.</p>

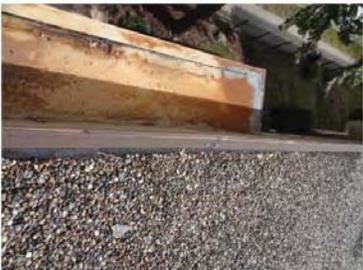
<p>Photo #13 Looking down at the metal over the window system. If this is removed this metal does not need to be replaced. If it is not removed, this area will need to be waterproofed and tied into the building with new metal that is tapered to the outside edge.</p>

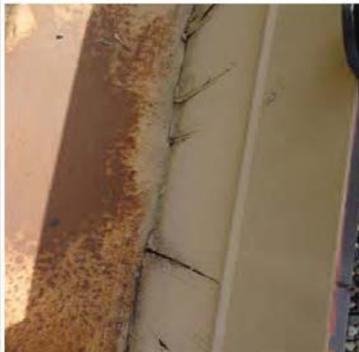
Inventory / Photo Info	Photo
<p>Photo #14 Additional overview of the metal covering the large picture window.</p>

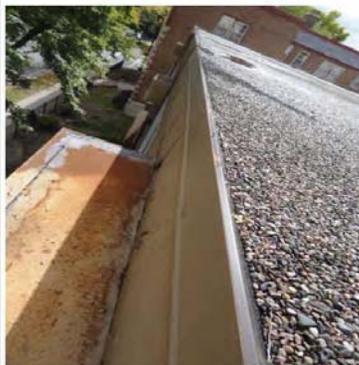
<p>Photo #15 Additional overview of the metal covering the large picture window.</p>

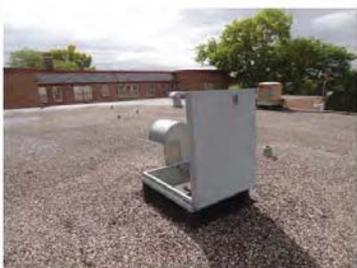
Inventory / Photo Info	Photo
<p>Photo #16 Existing roof hatch. At the outside edge of the roof hatch a vent restricts the access to the roof. This vent will either need to be moved or turned to allow better access.</p>

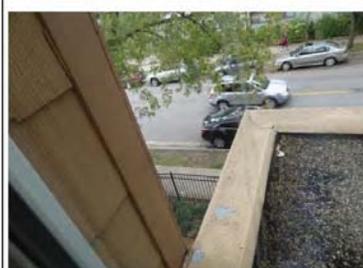
Inventory / Photo Info	Photo
<p>Photo #17 Shooting from the inside window at the roof over the canopy.</p>

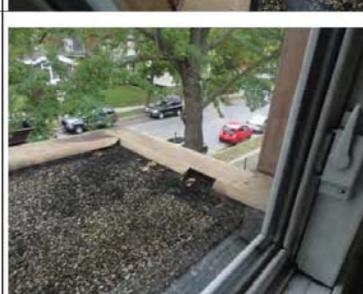
<p>Photo #18 Shooting from the inside window at the roof over the canopy. This roof system will need to be tapered to the outside edge, new wood at the roof perimeter, and a possible tie-in problem to the wall system which will need to be reviewed upon removal of the siding.</p>

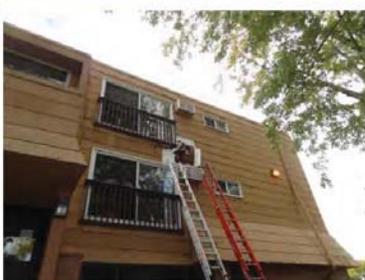
Inventory / Photo Info	Photo
<p>Photo #19 Examination of the siding and substructure at the front of the building.</p>

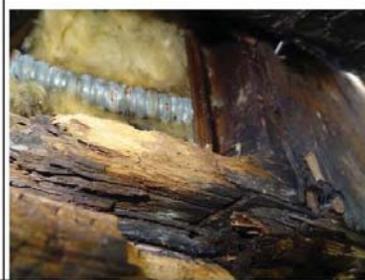
Inventory / Photo Info	Photo
<p>Photo #20 Rotting wood below the railing.</p>

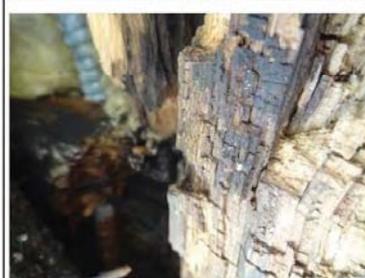
<p>Photo #21 Rotting wood below the railing.</p>

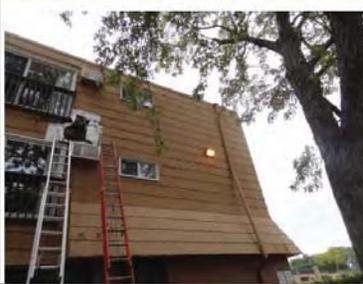
Inventory / Photo Info	Photo
<p>Photo #22 Based on how the railing was installed, after the roof deck was removed it is not unusual to find rotting wood. These areas will need to be exposed in order to add a solid substrate.</p>

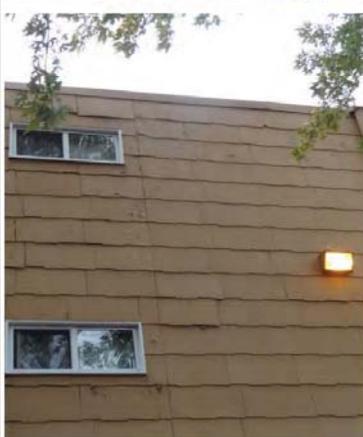
<p>Photo #23 Siding overview.</p>

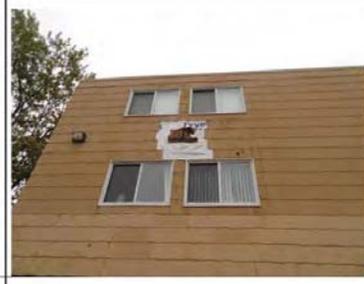
Inventory / Photo Info	Photo
<p>Photo #24 Wall inspection, north elevation, east side.</p>

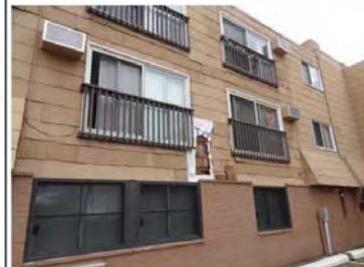
<p>Photo #25 Existing wood within the siding inspection on the west side appears to have no rotting and has not been affected by moisture.</p>

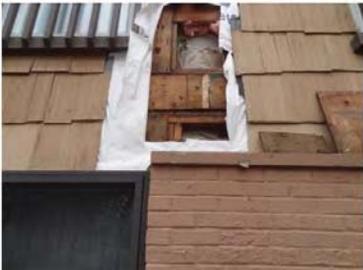
Inventory / Photo Info	Photo
<p>Photo #26 During insulation of the siding system a thru-wall flashing will be needed over the brick ledge.</p>

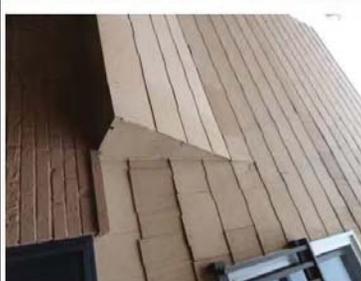
<p>Photo #28 Mansard siding to be removed eliminating this drainage problem. A flash system will be installed.</p>

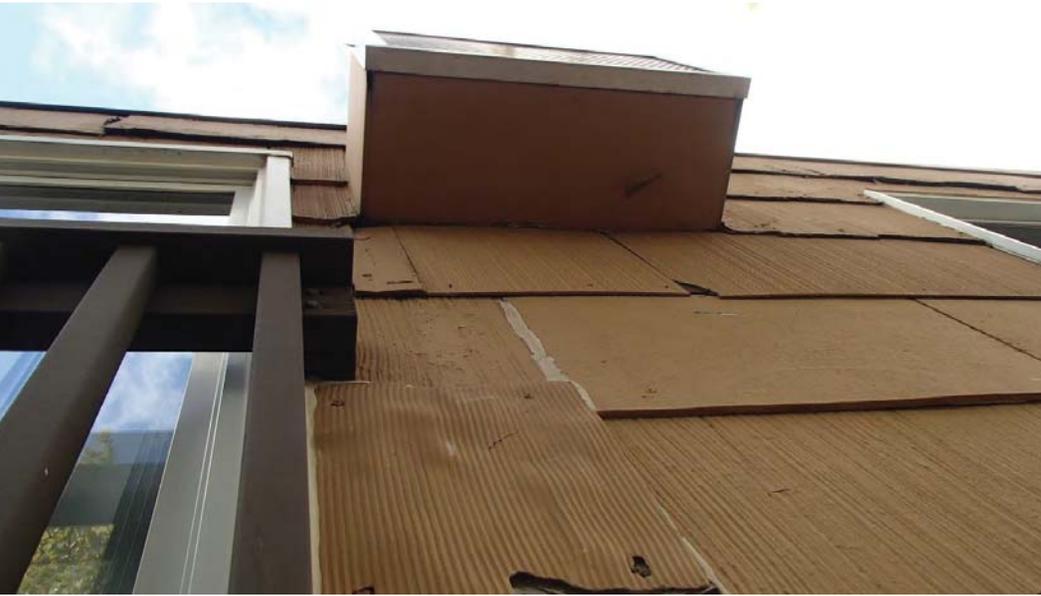
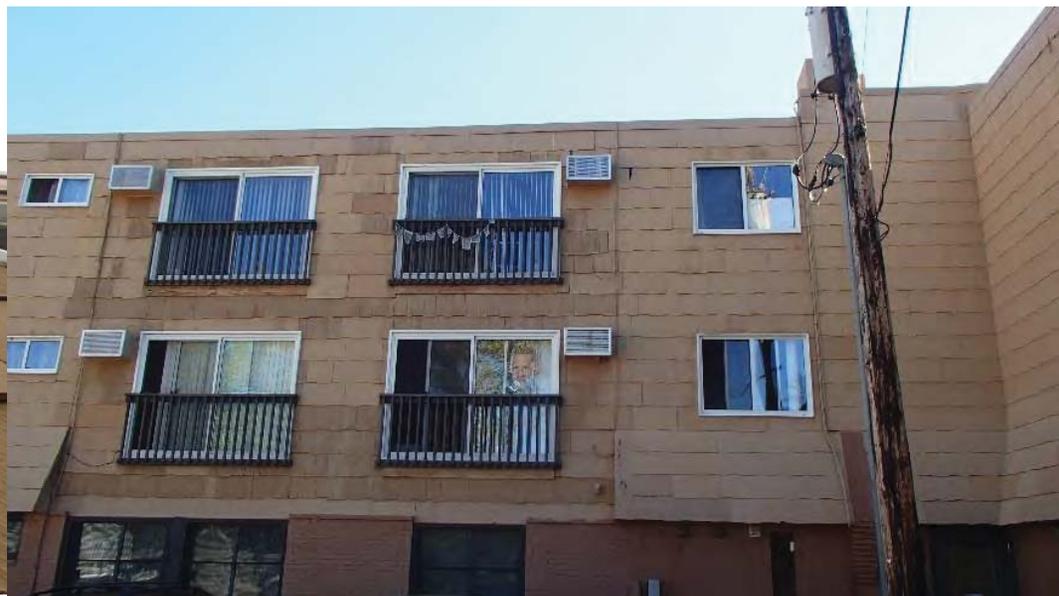
Exhibit 3.2

Degraded Asbestos Shingles

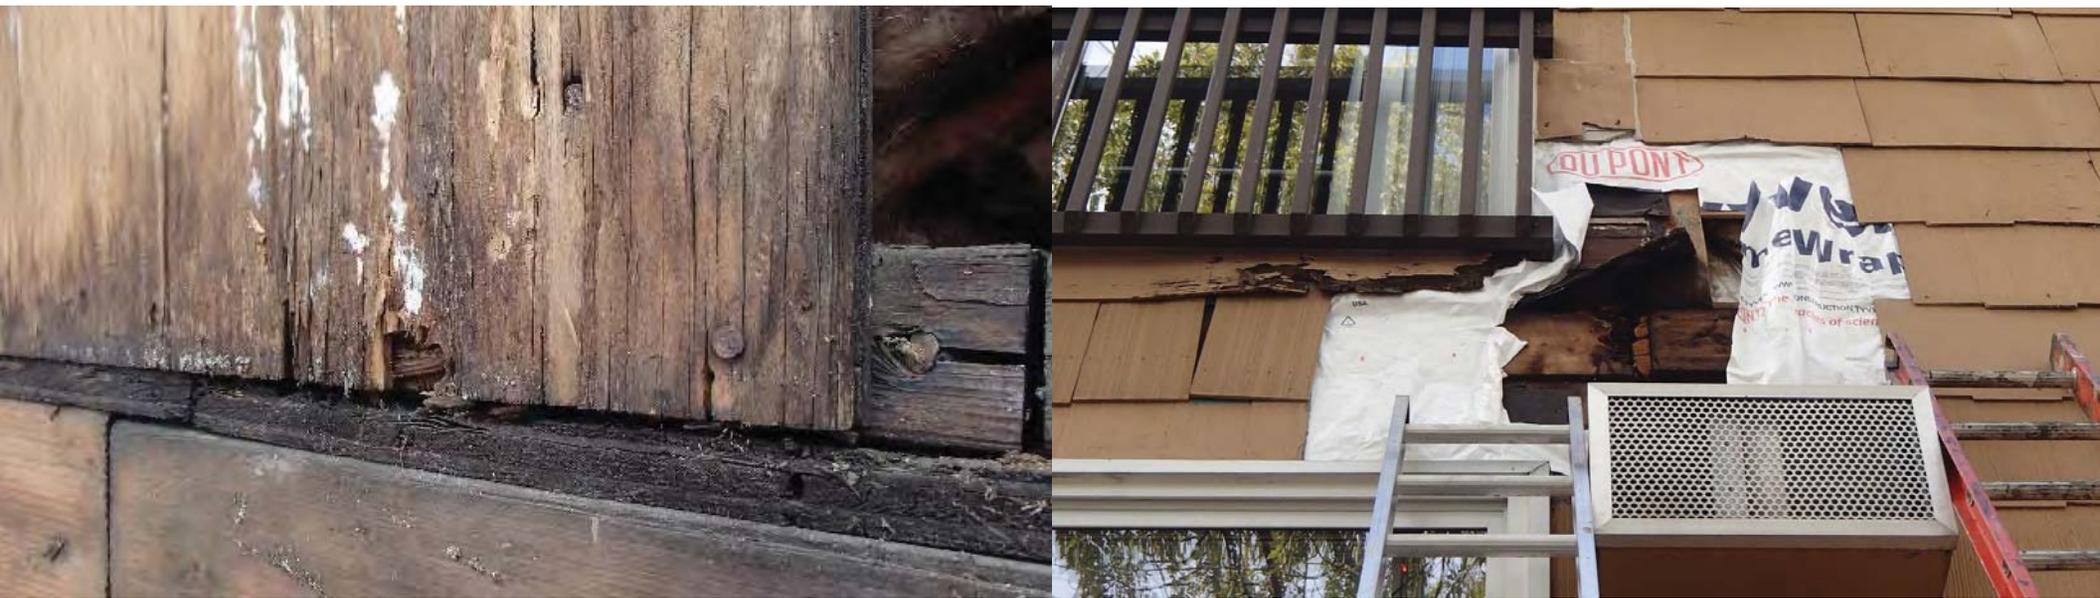
Exhibit 3.3

Degraded Plywood Sheathing

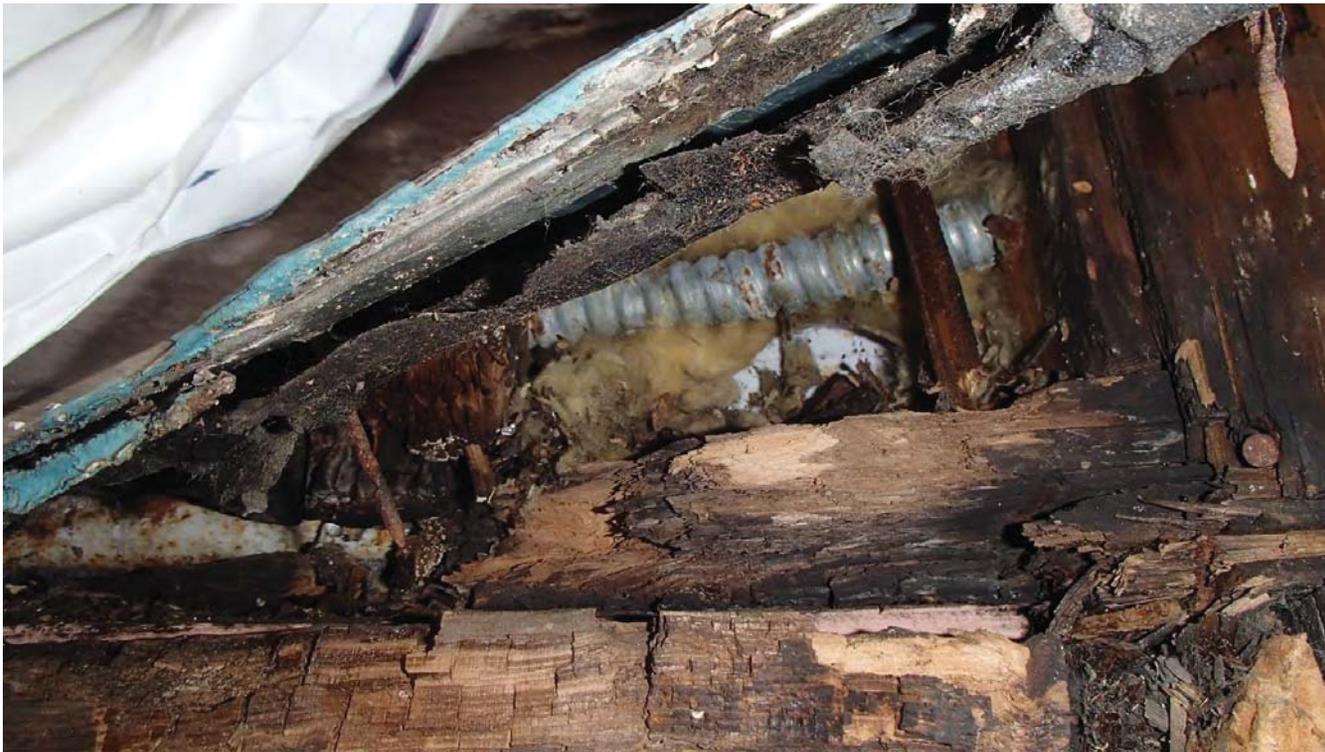
Exhibit 3.4

Damaged Floor Joists

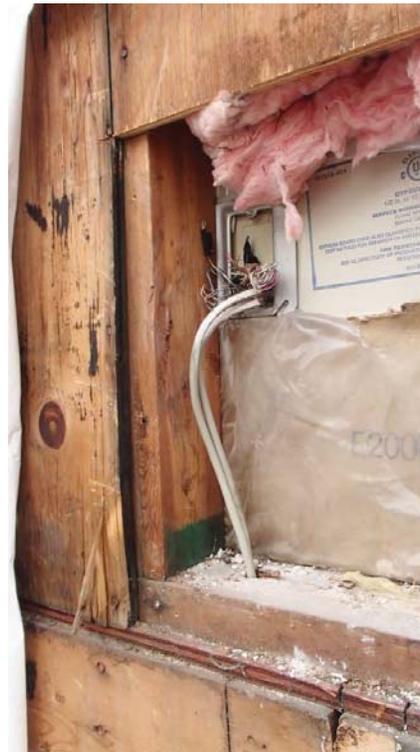
Exhibit 3.5

Incomplete Vapor Retarder

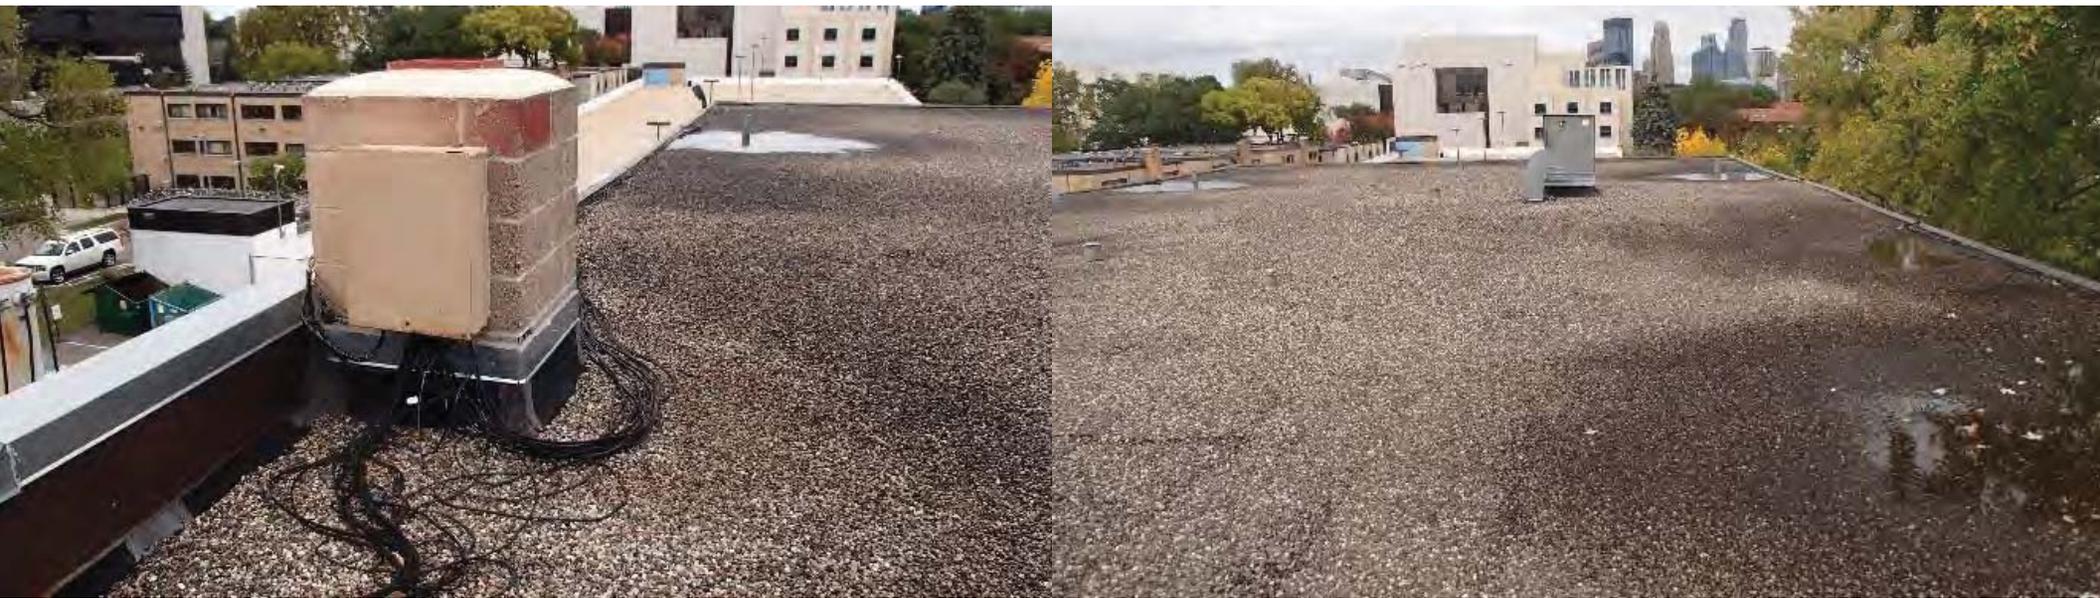
Exhibit 3.6

AMBE LTD prepared a condition assessment report for the roof. The roof dates from the original construction and is beyond its expected service life. Roof slope to drain outlets is inadequate allowing ponding of water. The ponding water and deteriorating roofing condition appears to contribute to the water intrusion into the walls below. Based on the assessment AMBE LTD recommends a complete roofing and insulation replacement.

Roof Ponding and infiltration at “parapet”

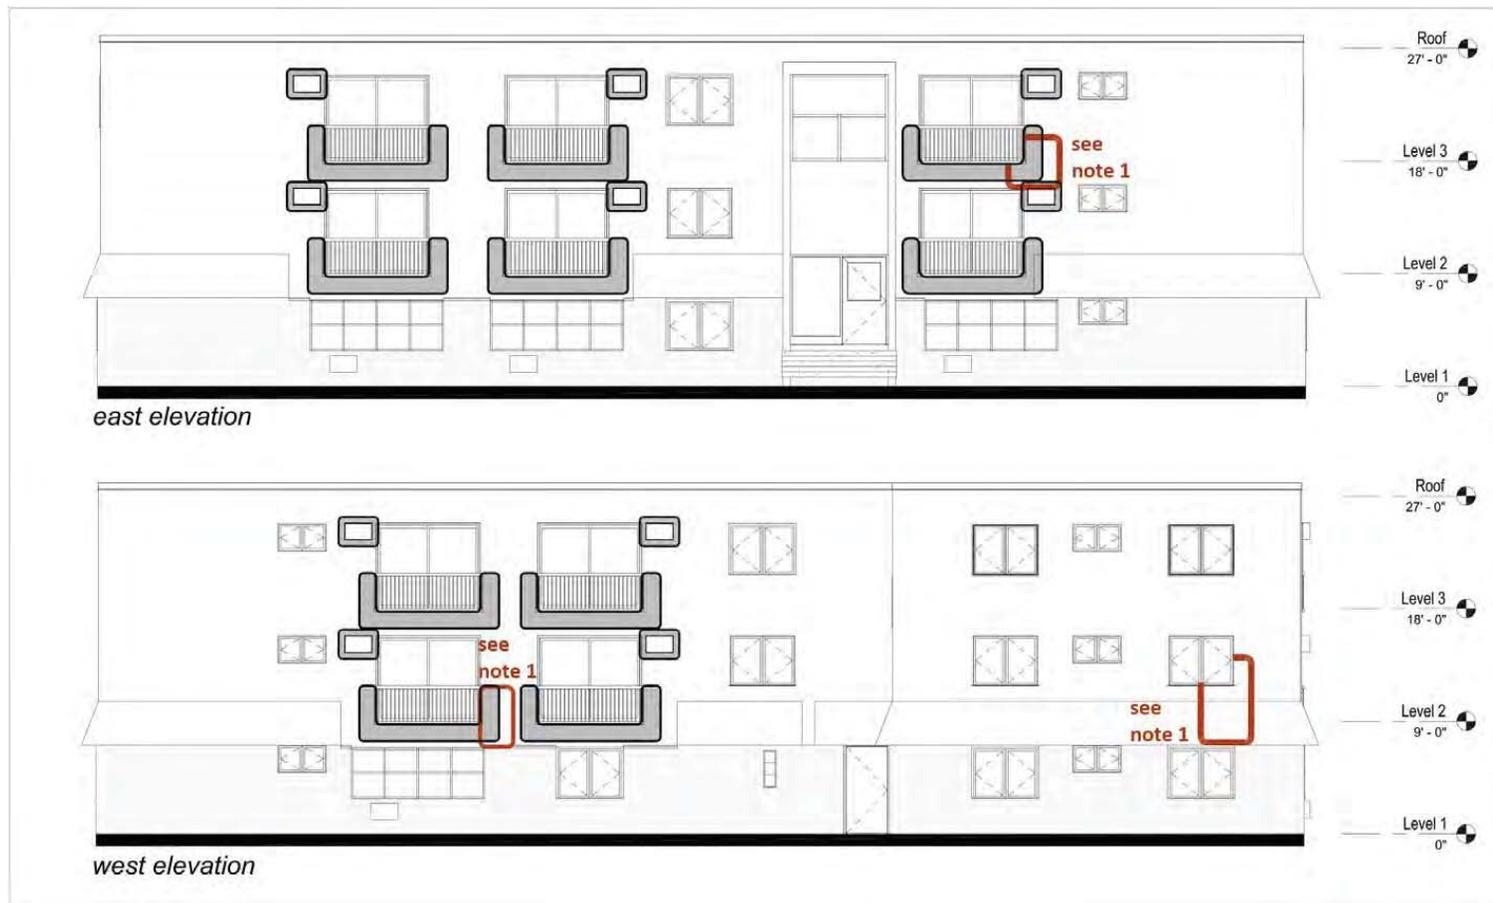
Exhibit 3.7

Example of infiltration and framing areas
