1715 Oliver Ave N Pictures

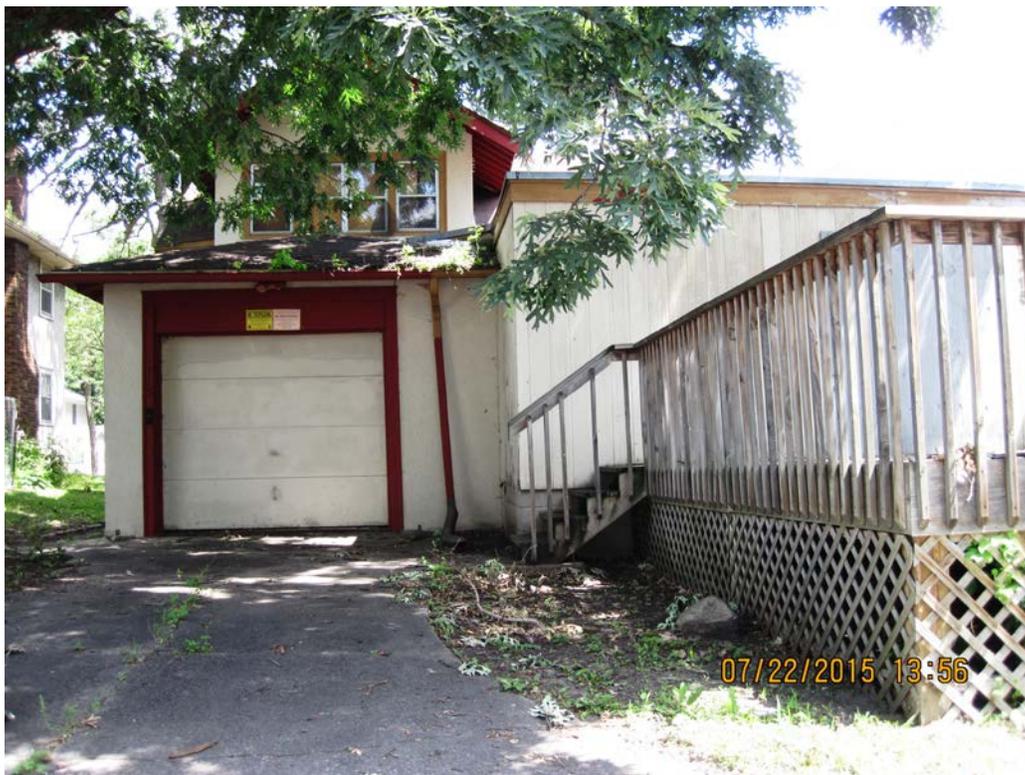
Rear exterior 1715 Oliver Ave North. Note condition, paint and negative grade

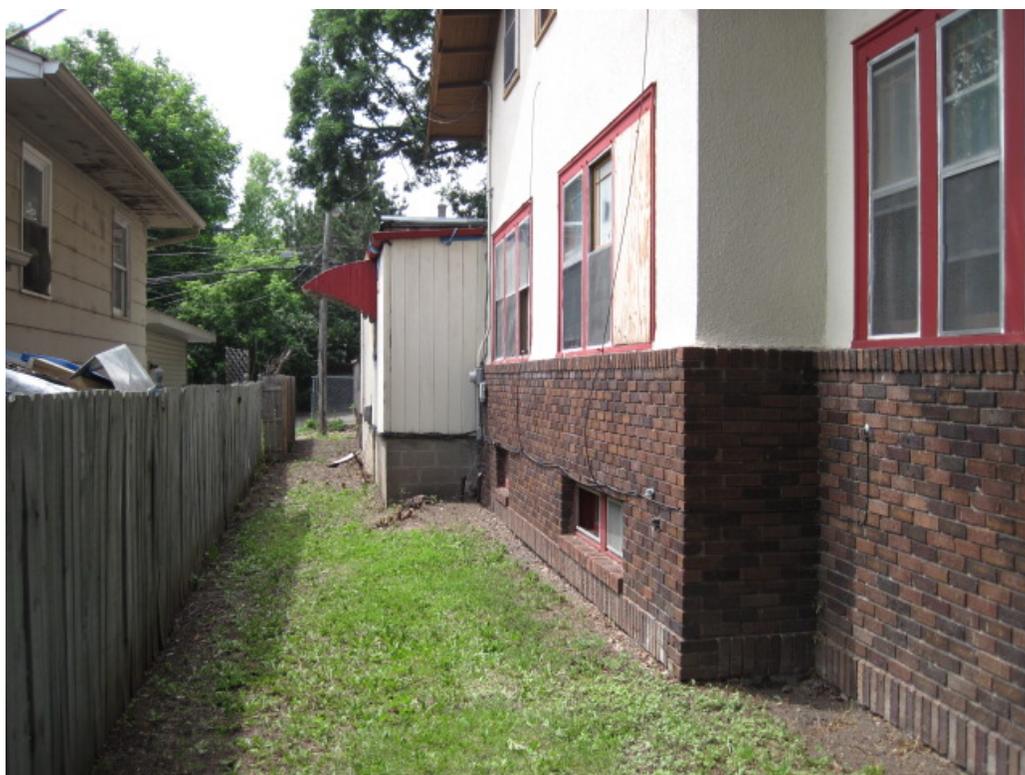
Lead based paint hazard suspected due to age and condition

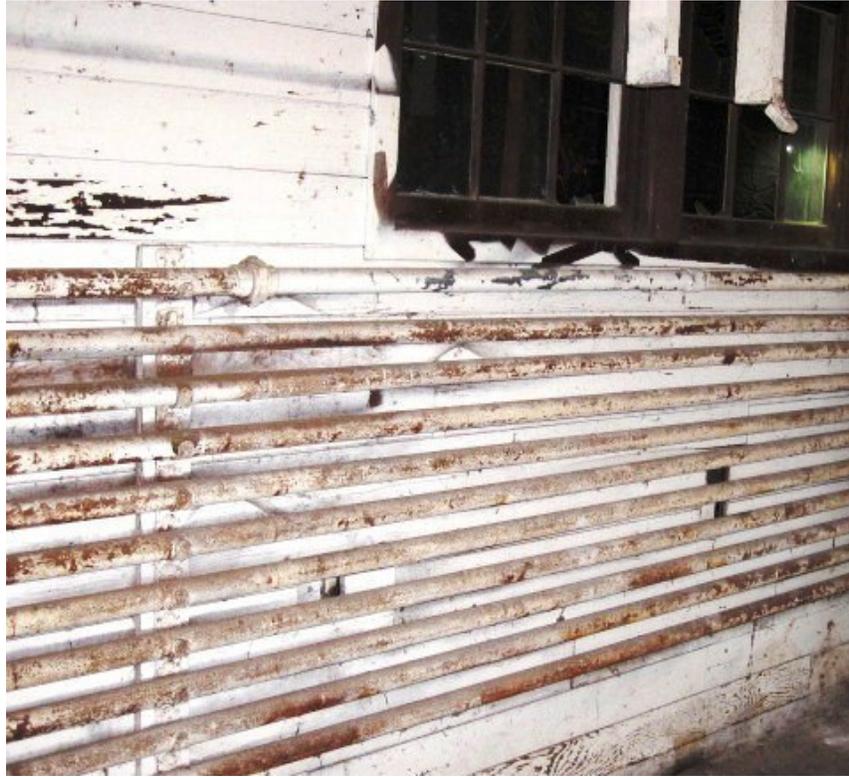
Note original heated garage by way of exposed hot water pipes.

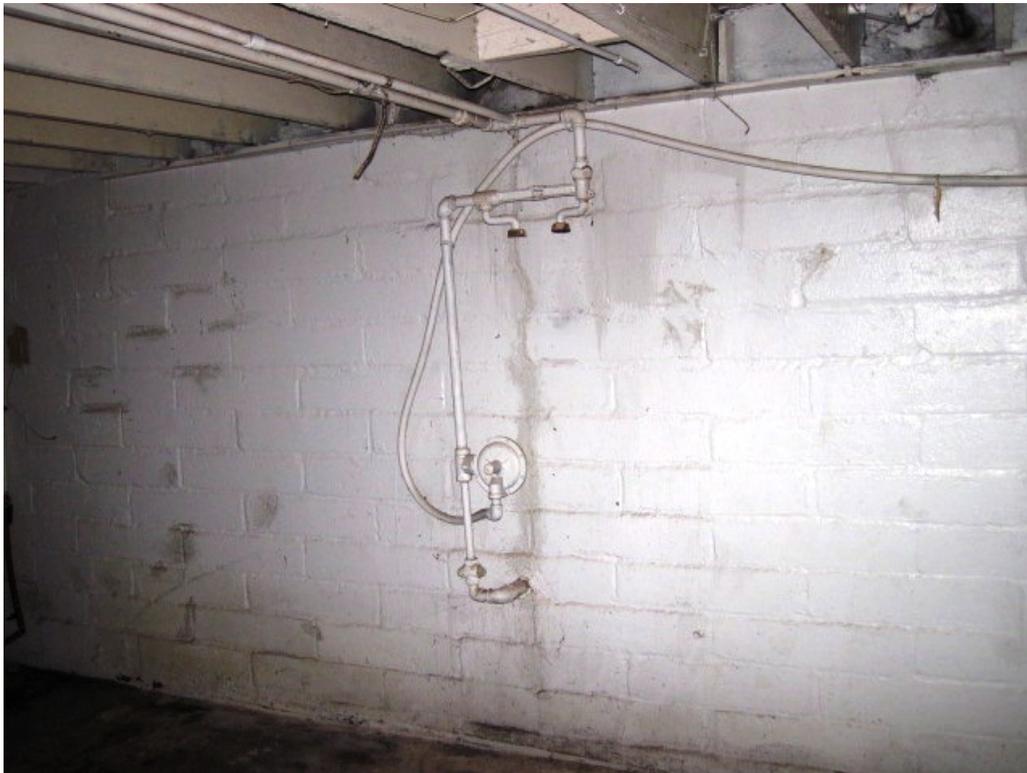
Foundation exhibits areas of water intrusion

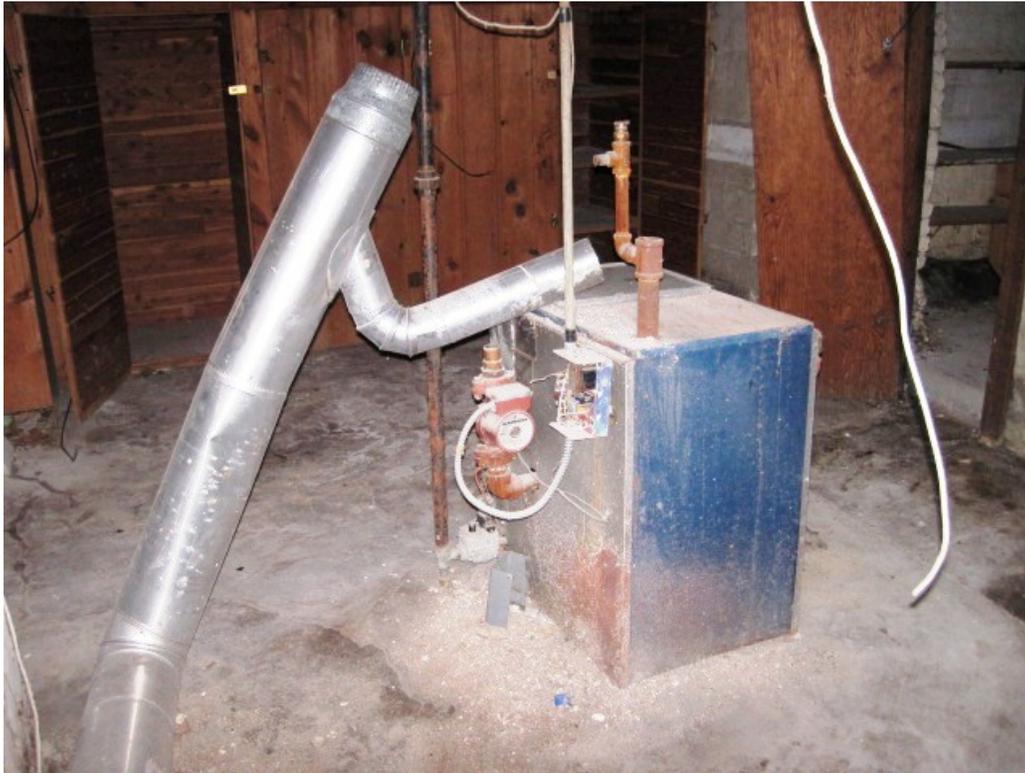
Mechanical 4826 Girard Ave North. Note age and condition

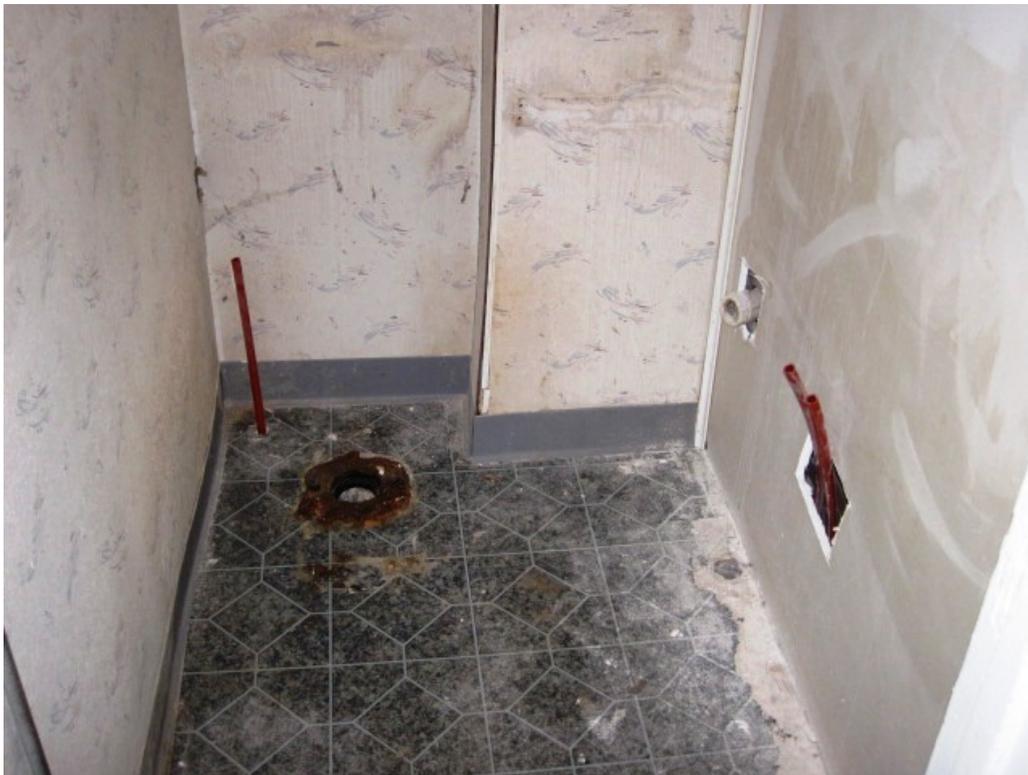
Bathroom – all surfaces and fixtures need attention

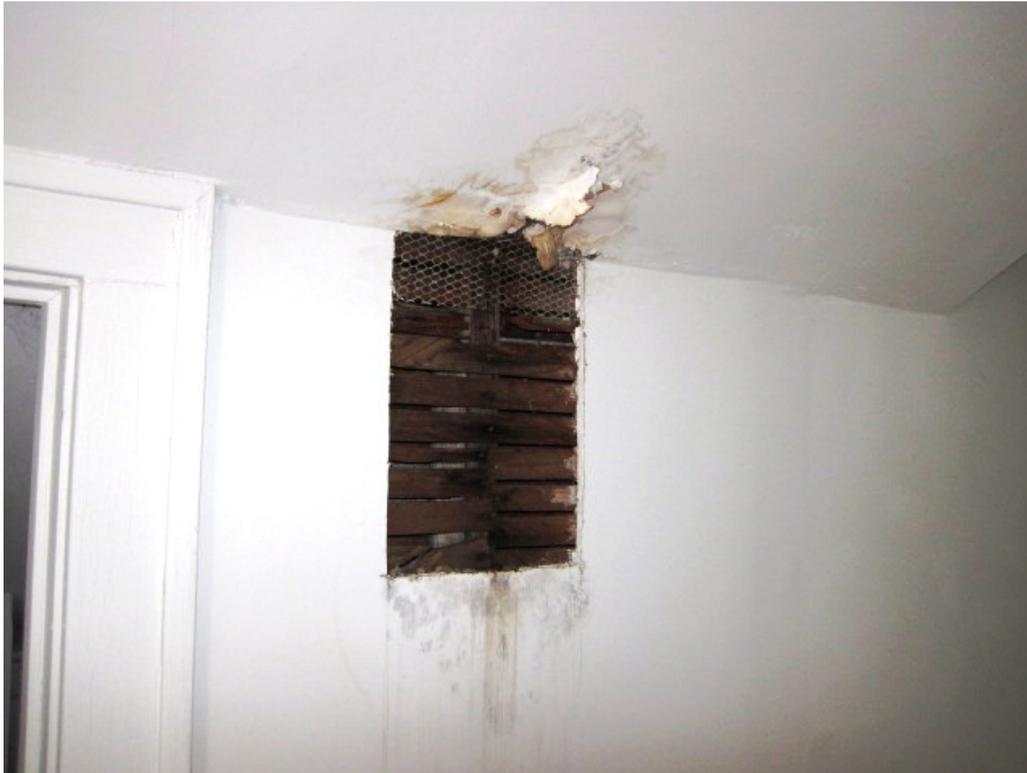
2<sup>nd</sup> floor area: Areas of water intrusion noted

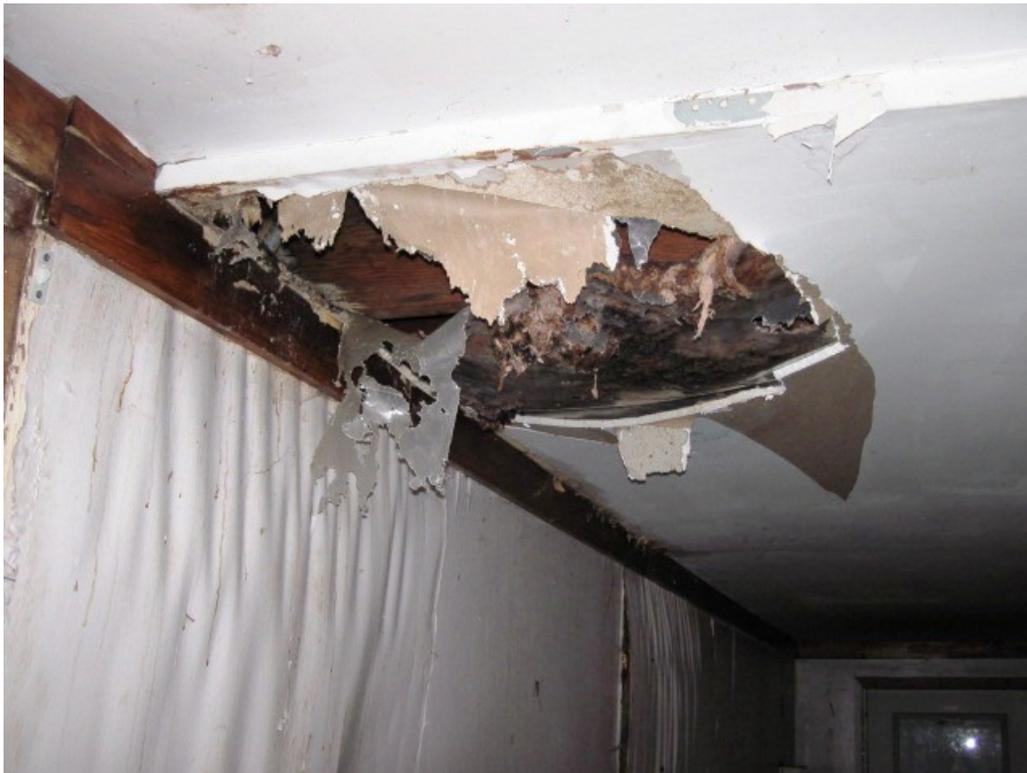
Plaster is in poor condition due to water intrusion

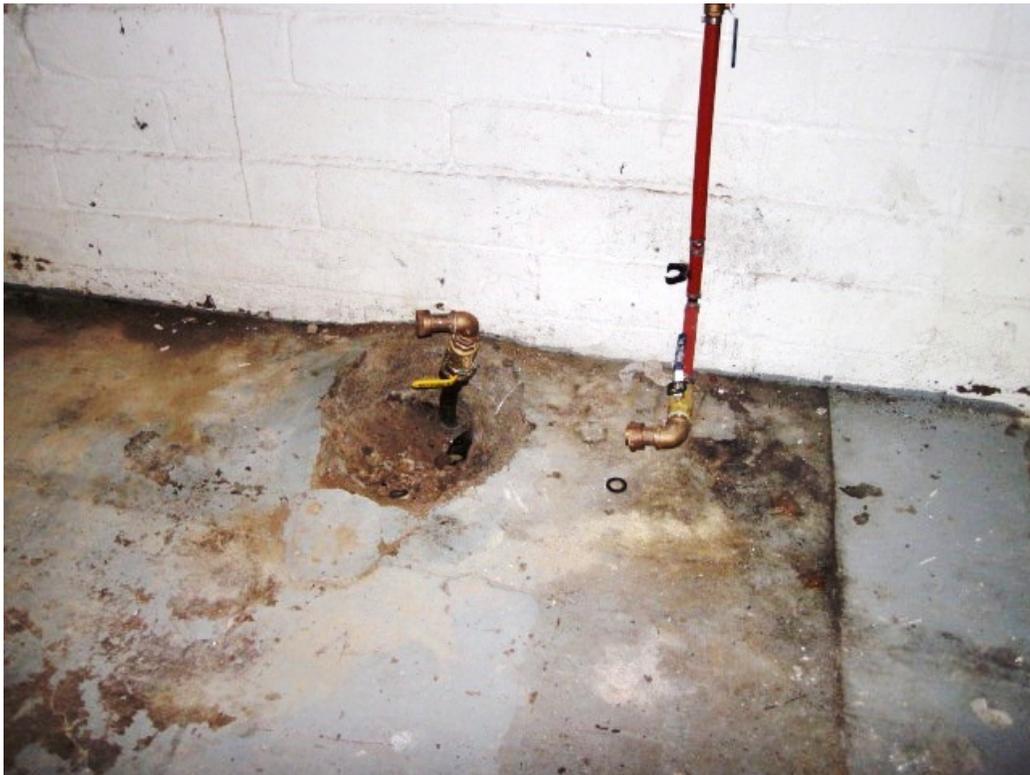
Water meter could not be located on site
