3027 Dupont Avenue North

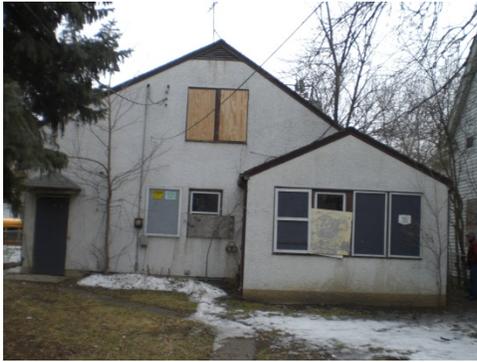
Rear - Needs all new windows/roof

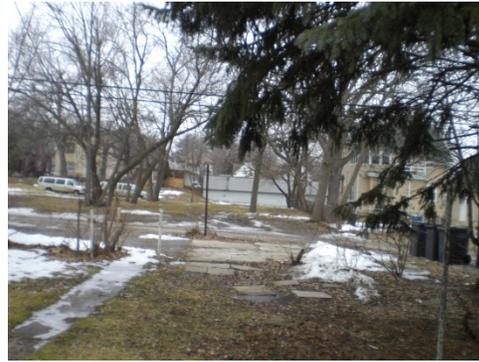
Parking surface needs replacement

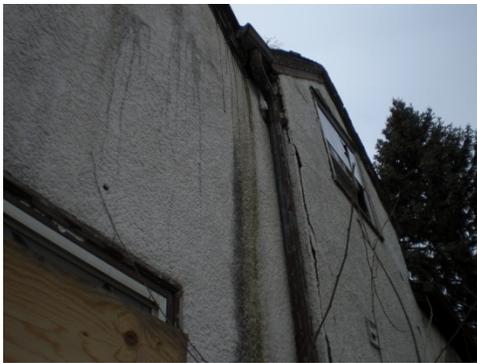
No overhang - water intrusion/cracking

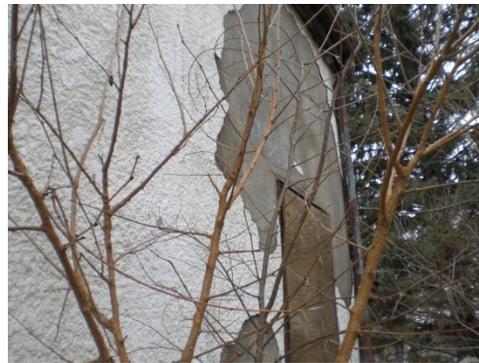
Stucco failure and moisture intrusion

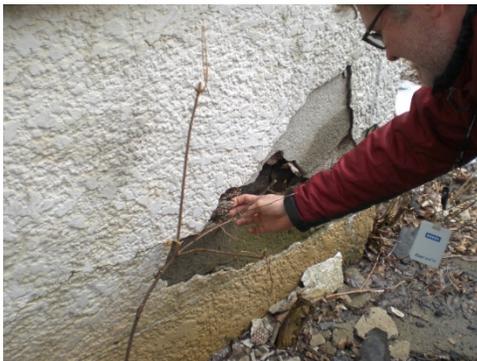
Settlement and stucco failure

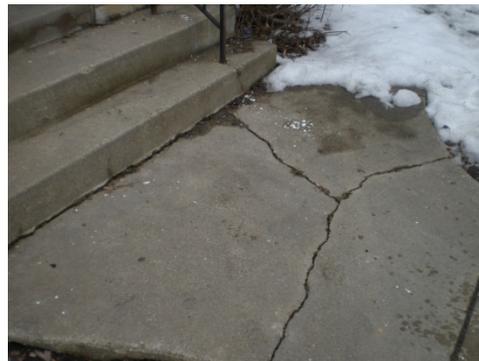
Concrete need replacement

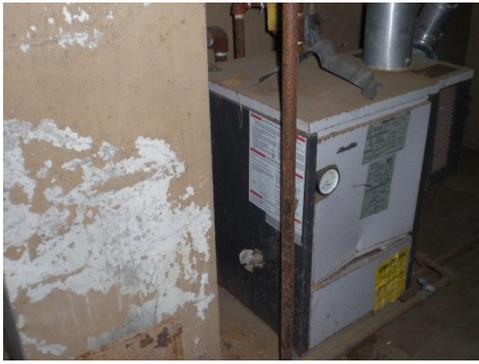
Mechanicals require replacement

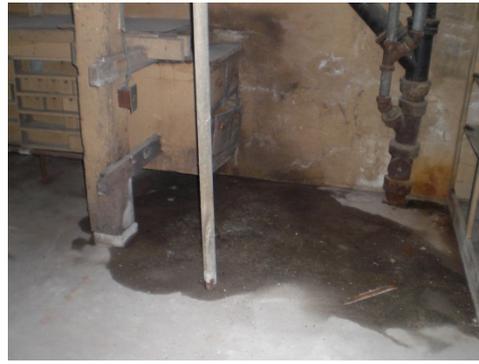
Moisture present in basement

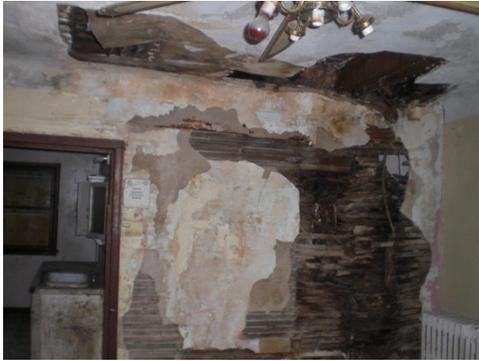
Water damage throughout

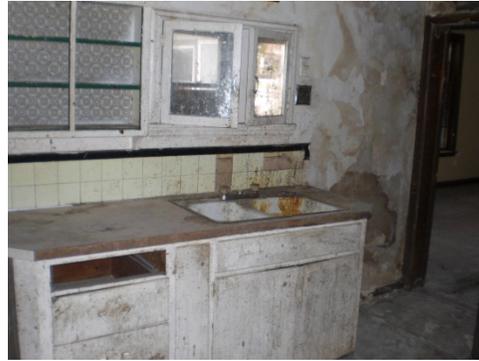
Kitchen requires replacement

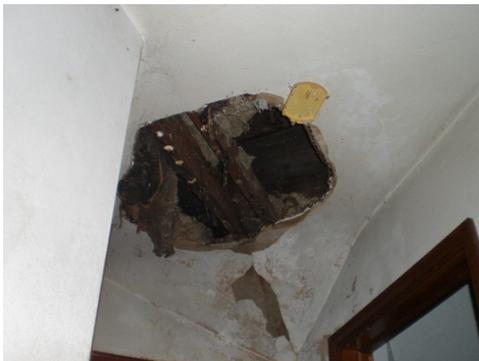
Water damage from failing roof

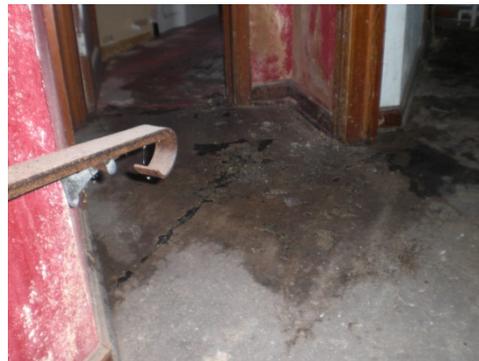
Unsafe floors from water damage
