Inspection Report

**Community Planning & Economic
Development**

3534 Fremont Ave North

June 15, 2015

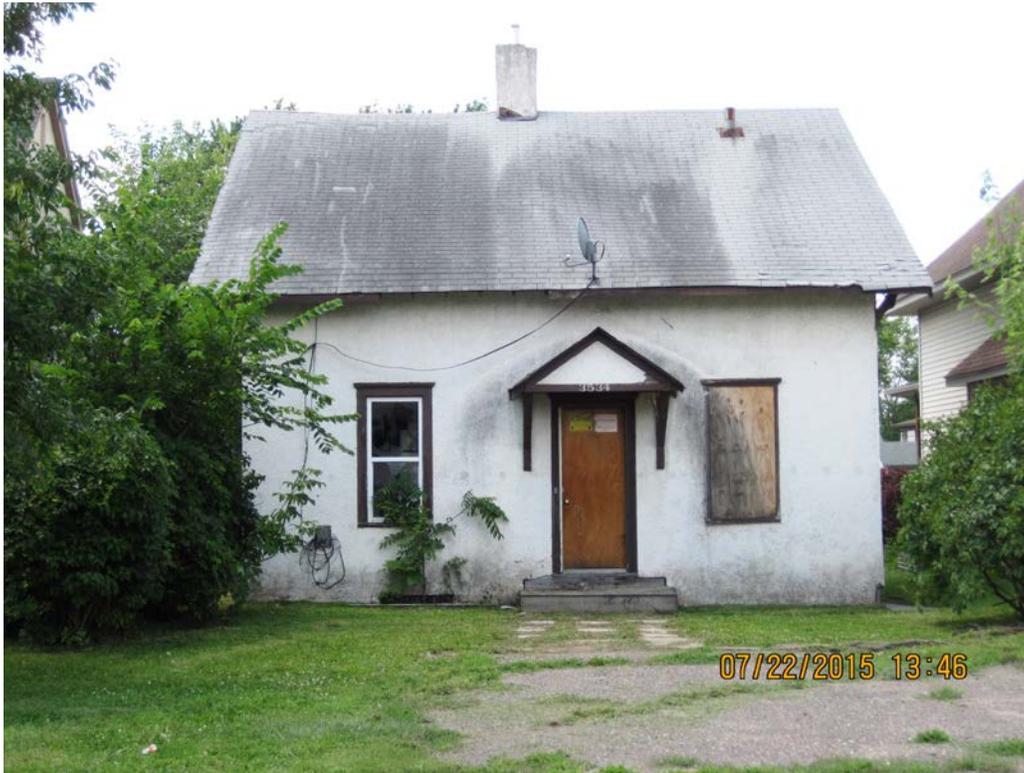
Rear exterior 3534 Fremont Ave North. Note roof condition, paint and negative grade

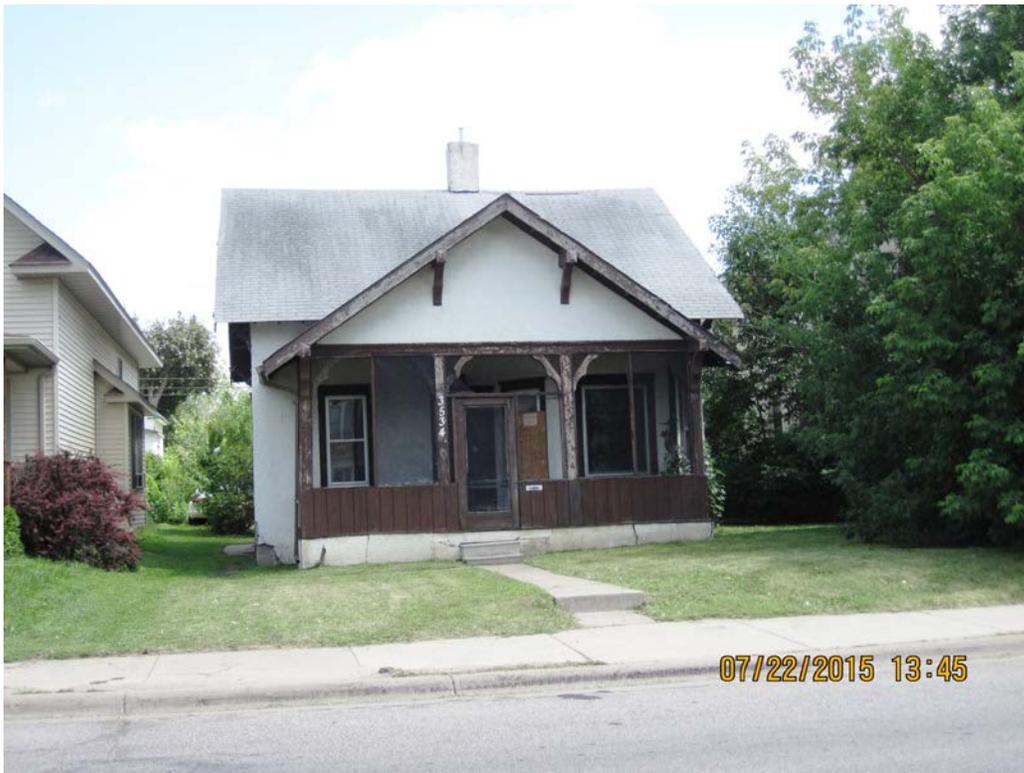
Lead based paint hazard suspected due to age and condition

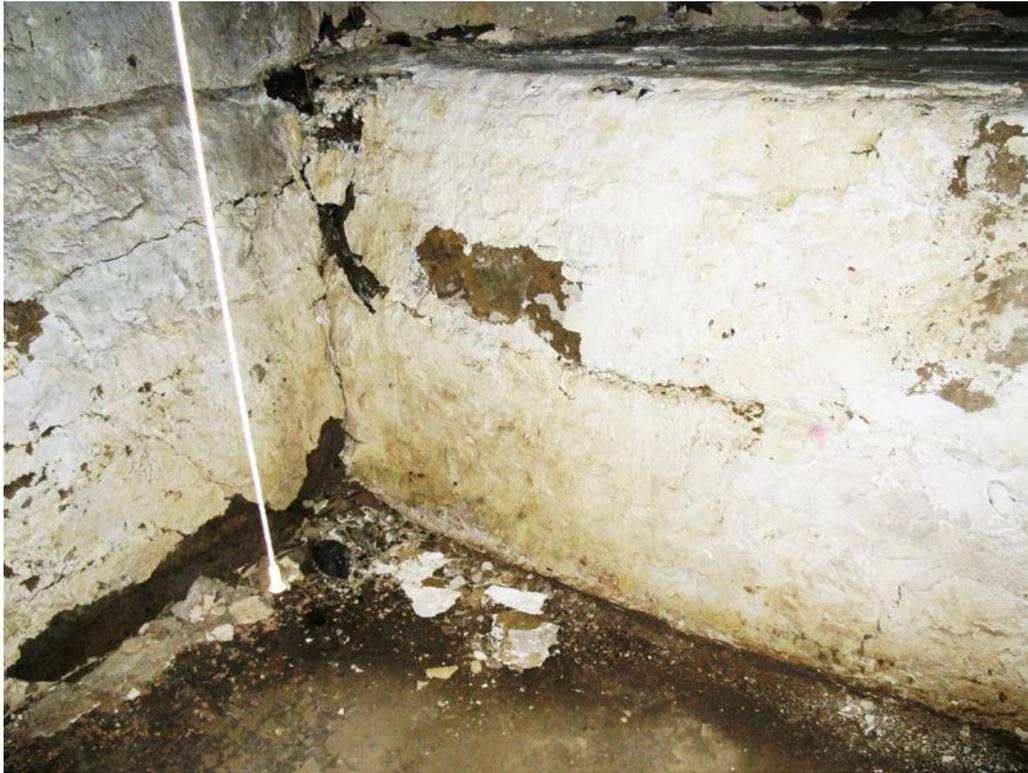
Foundation exhibits areas of water intrusion

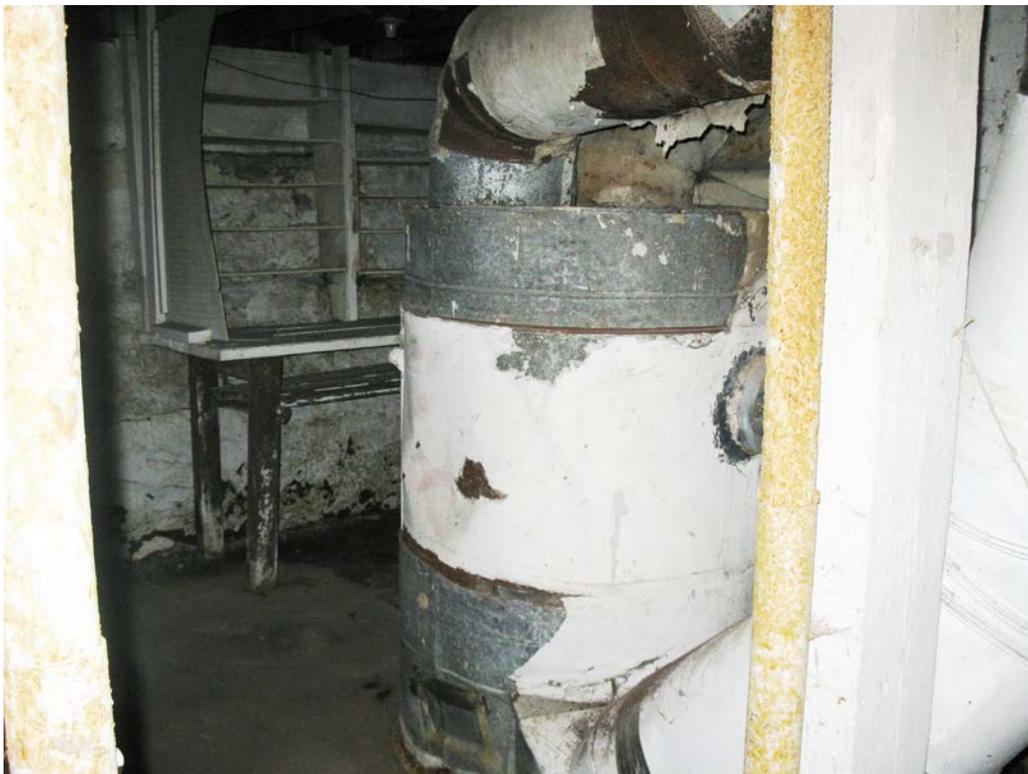
Mechanical 3534 Fremont Ave North. Note age and condition

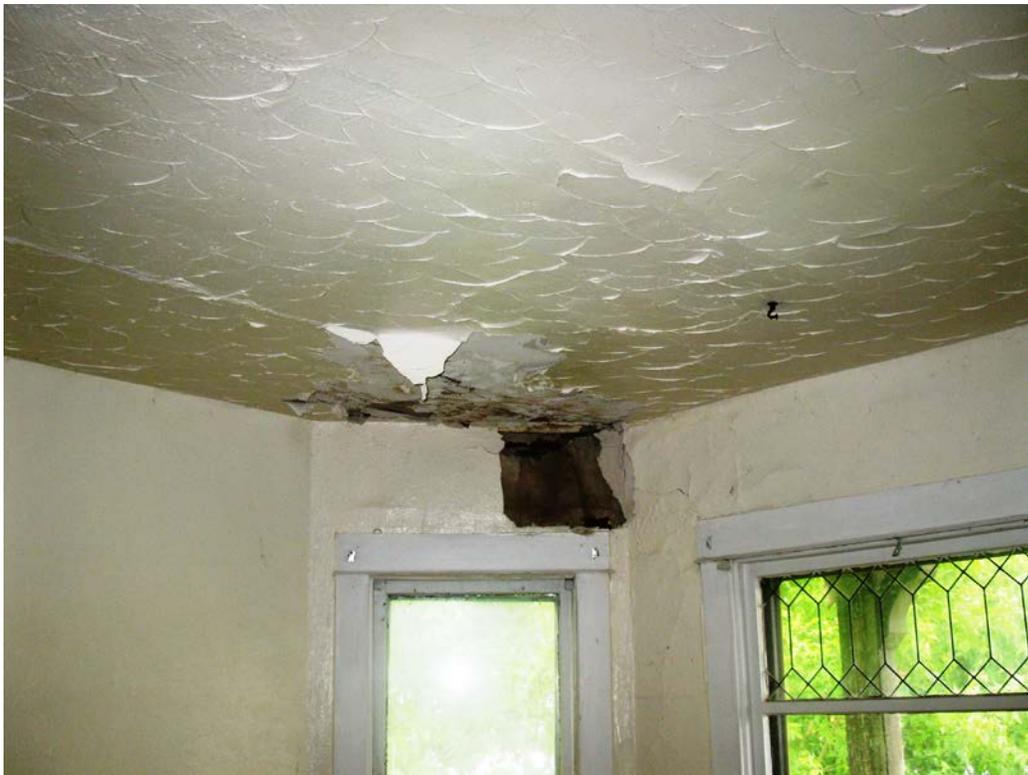
Plaster is in poor condition due to water intrusion

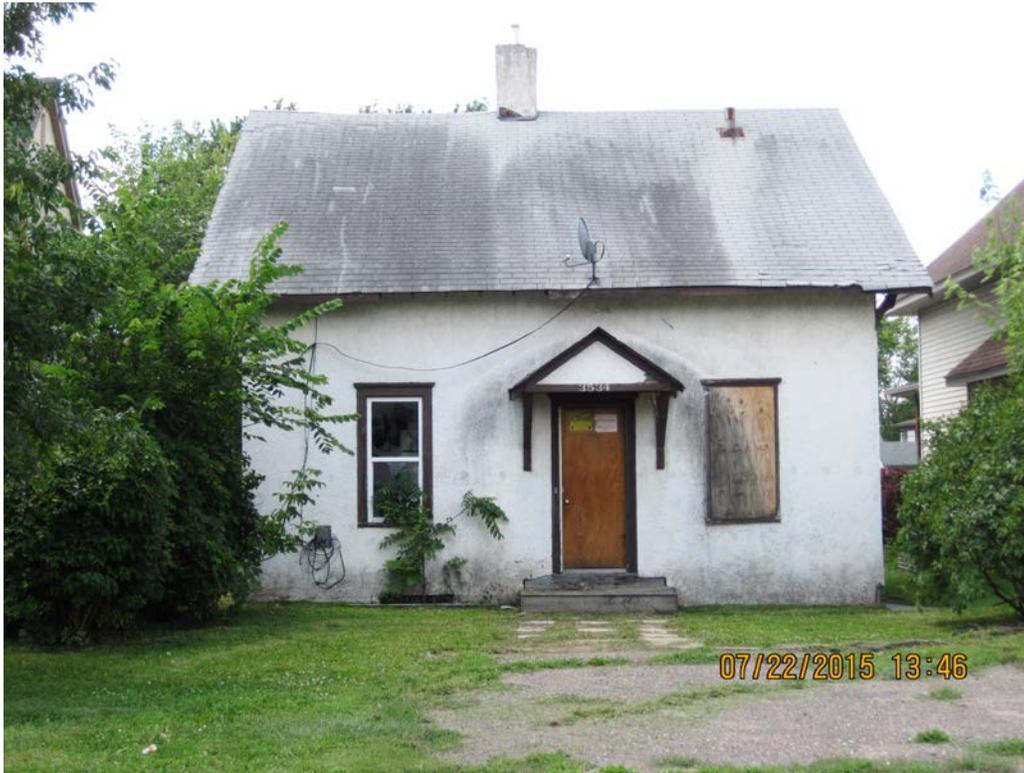
Off street parking available. No garage on site. Provide suitable parking pad

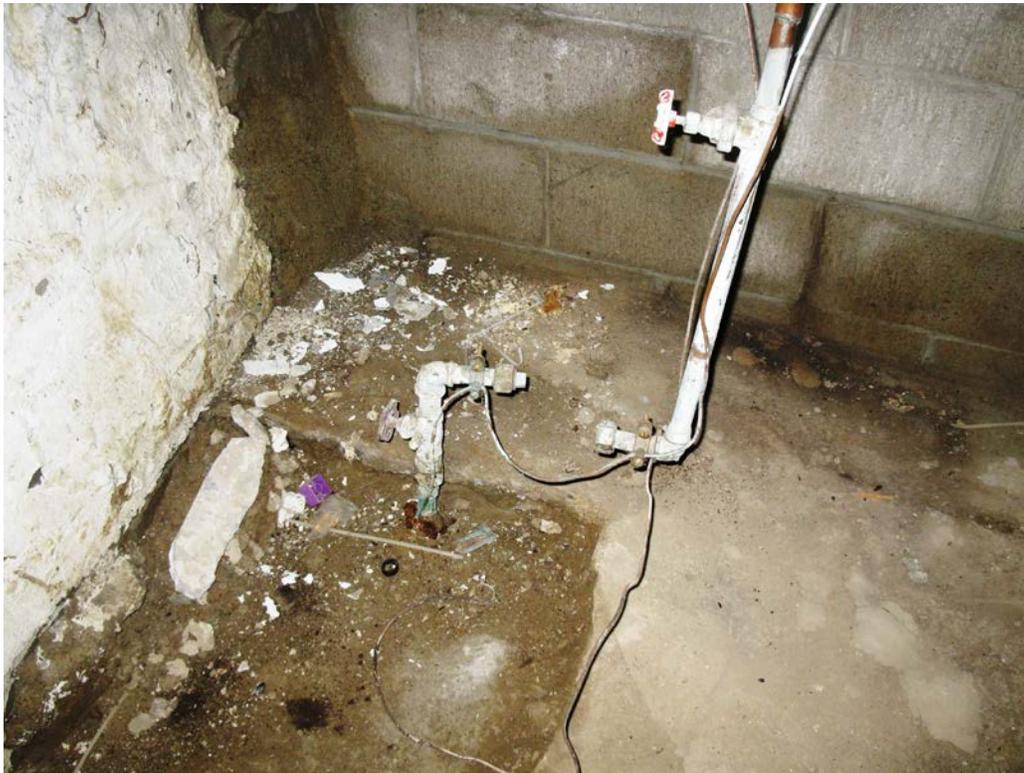
Water meter found on site
