# Inspection Report

City of Minneapolis  
Department of Community Planning  
& Economic Development - CPED

## 3718 Fremont Ave North

March 3, 2016

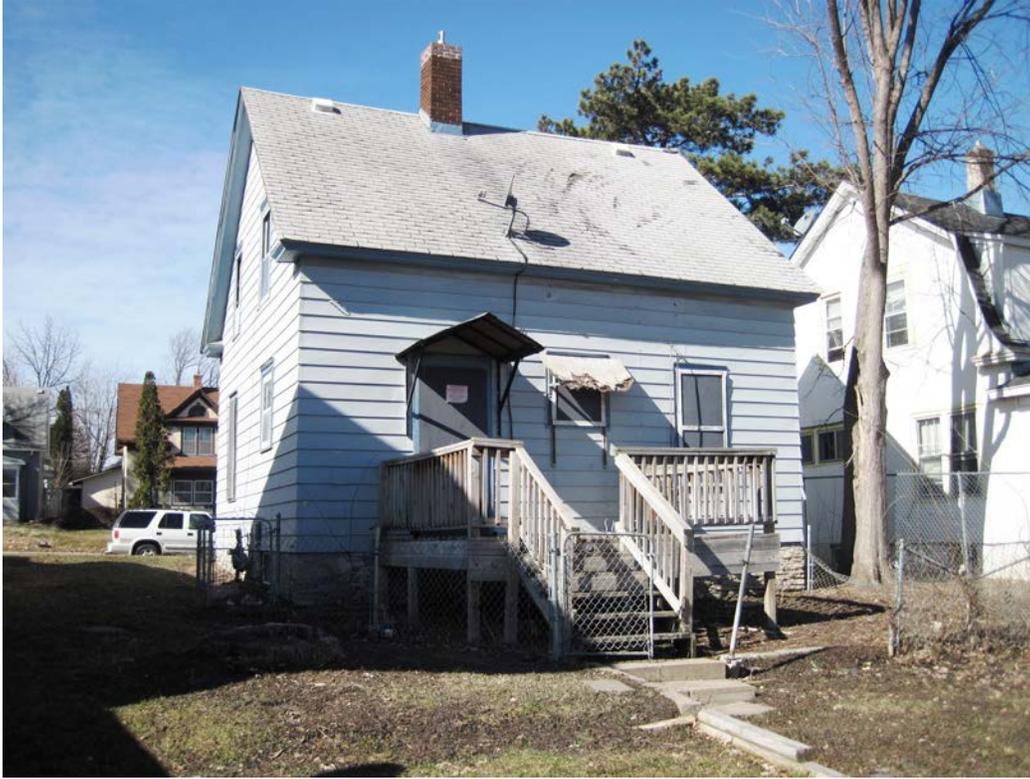
Rear exterior 3718 Fremont Ave North. Note roof condition, paint and negative grade

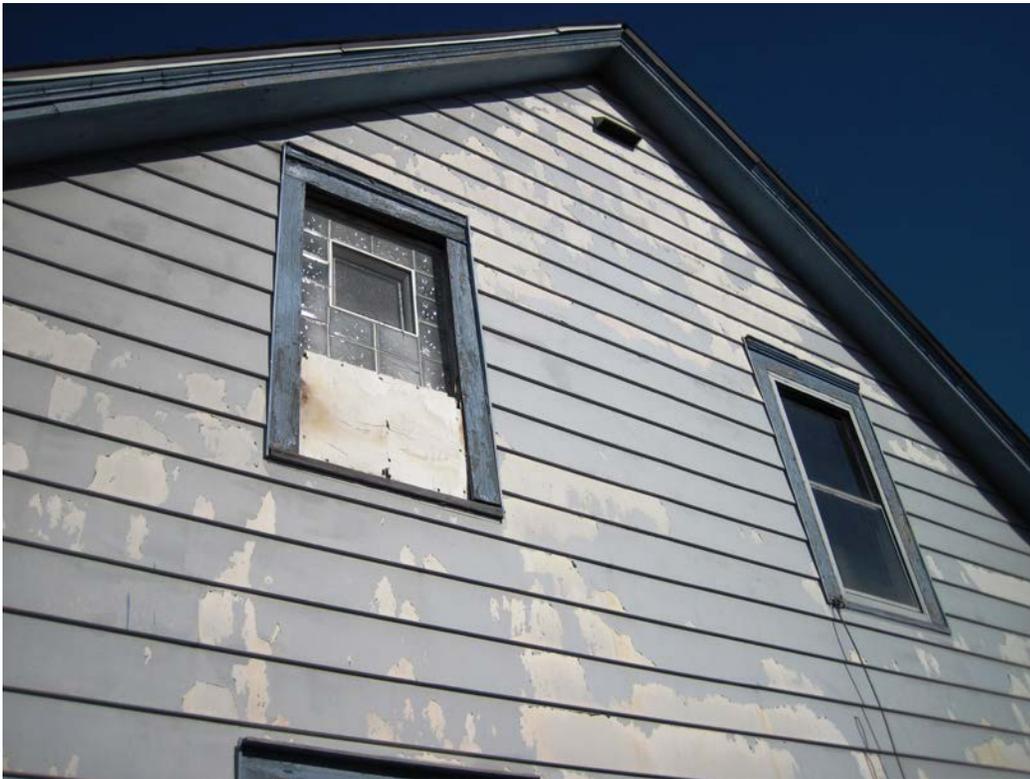
Lead based paint hazard suspected due to age and condition

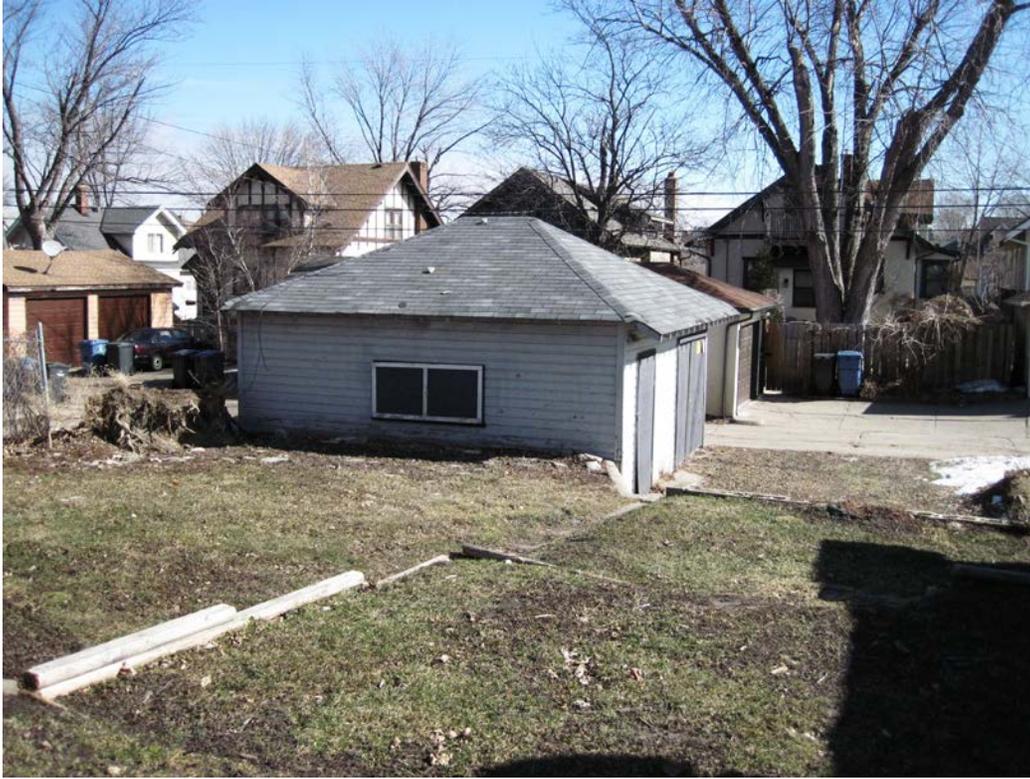
Substantial repairs to garage necessary also provide parking pad and approach

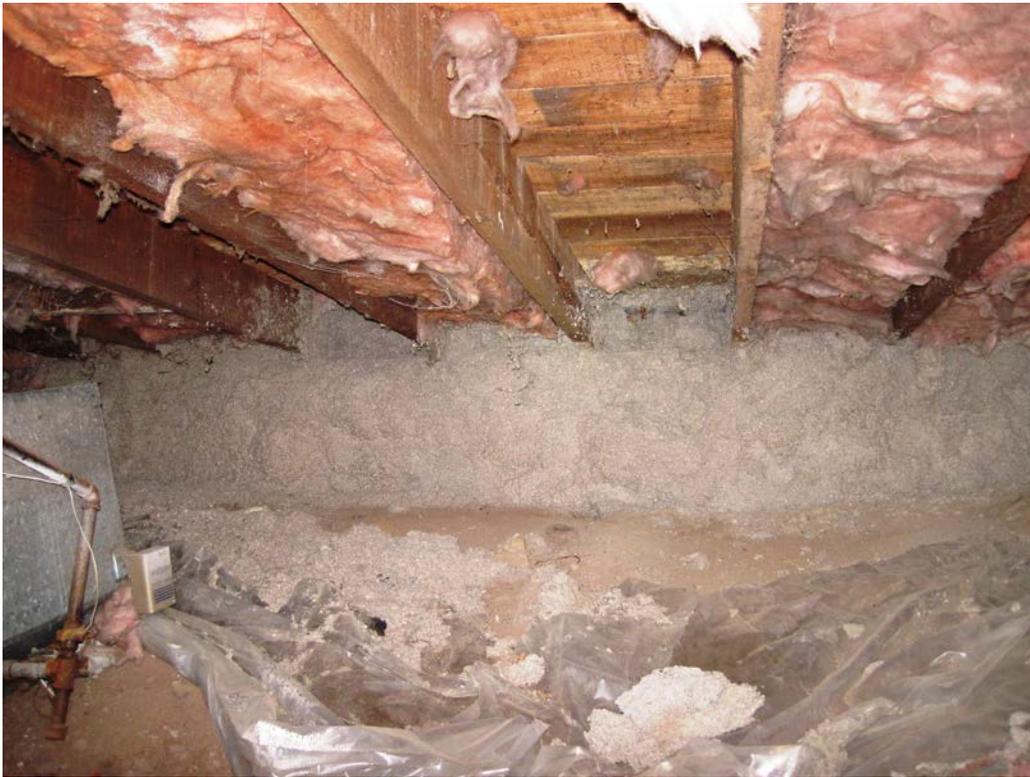
Most of support structure is crawl space with unknown bearing capacity. Structural Engineer report required.

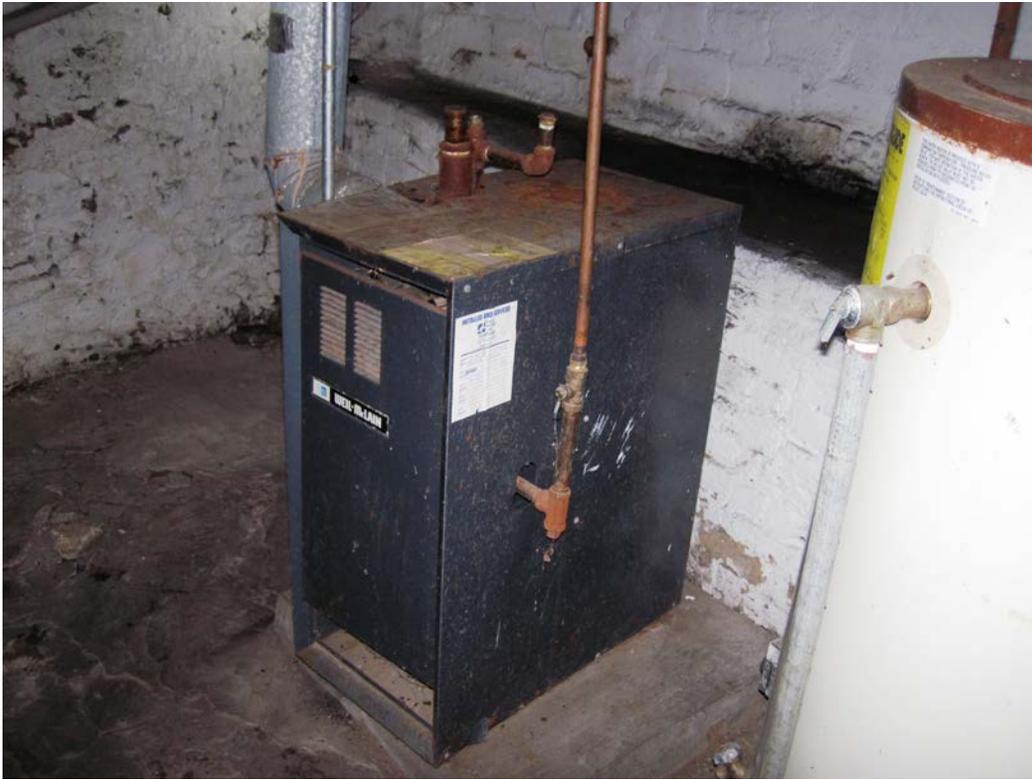
Mechanical 3718 Fremont Ave North. Replace with new.

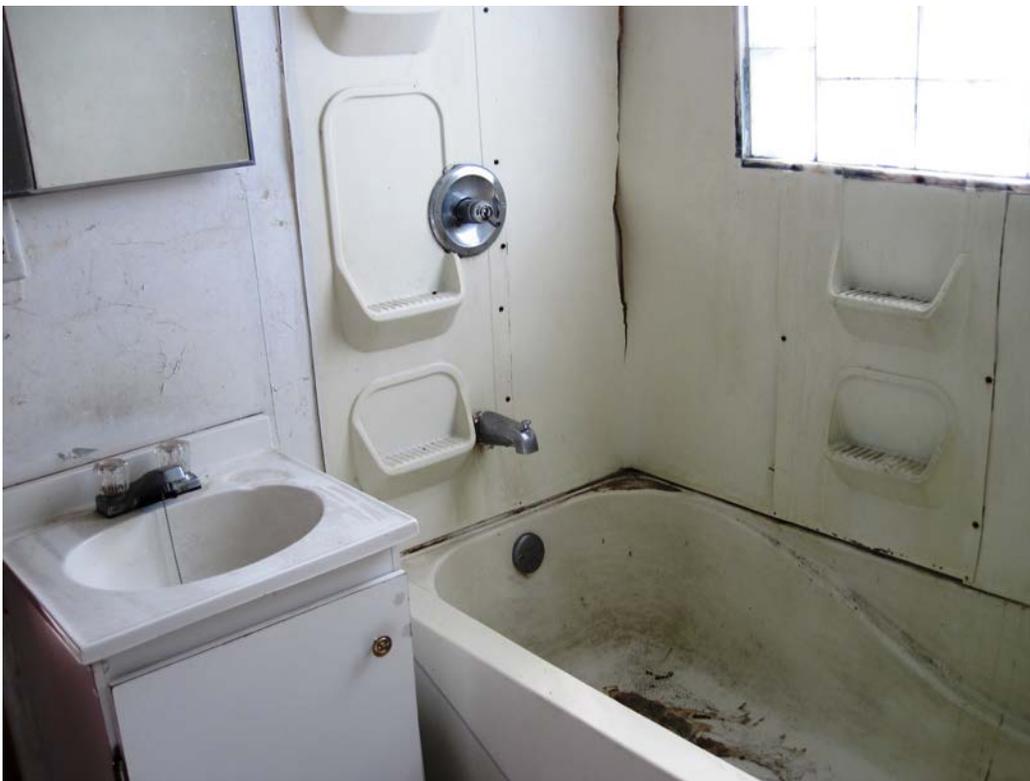
Bathroom – all surfaces and fixtures need attention

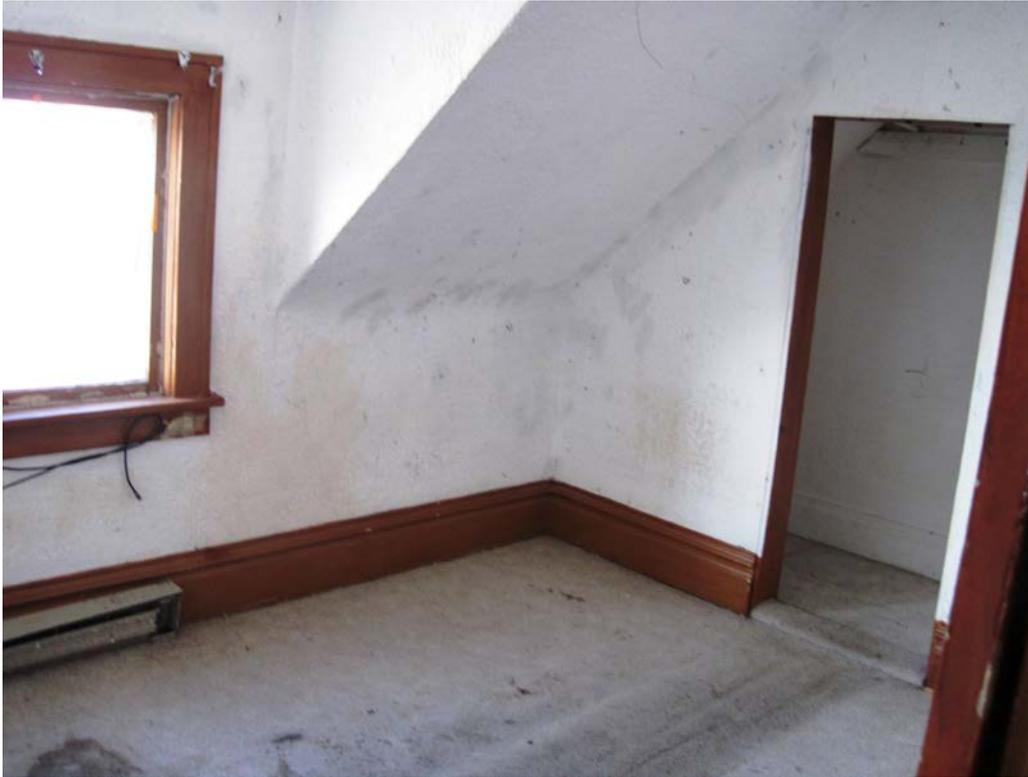
2<sup>nd</sup> floor area: exhibits functionally obsolete layout. Note low head room

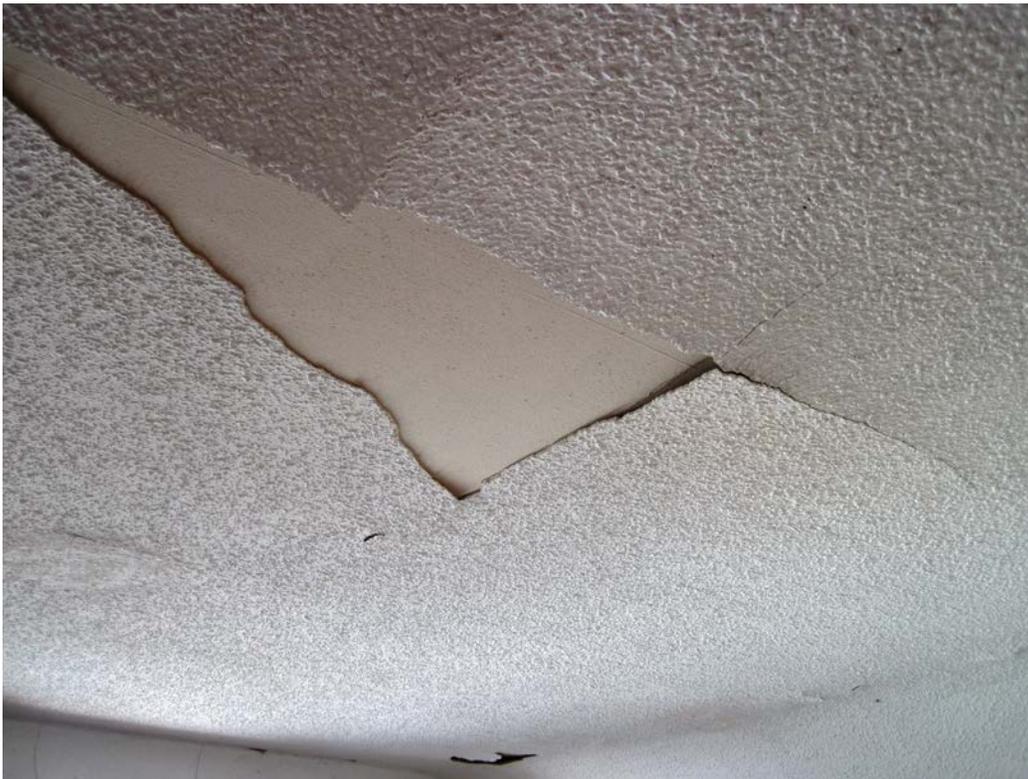
Plaster is in poor condition due to water intrusion

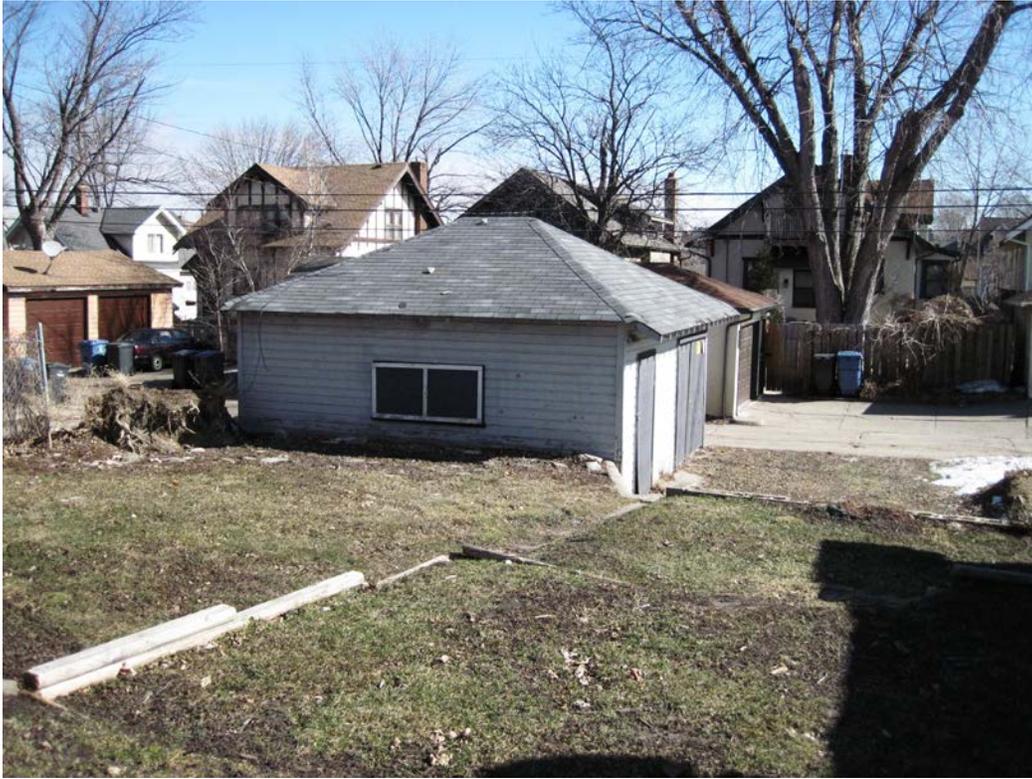
Off street parking available.

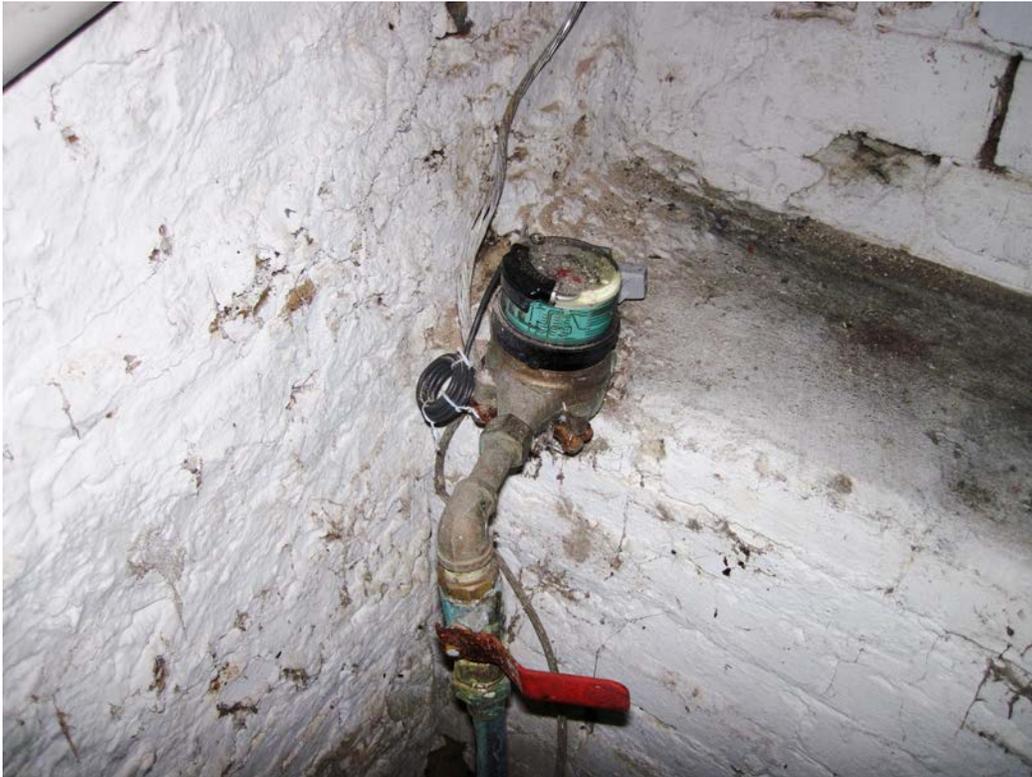
Water meter found on site
