# MMA-based Transit Priority Lane Treatment Evaluation Report

December 2025

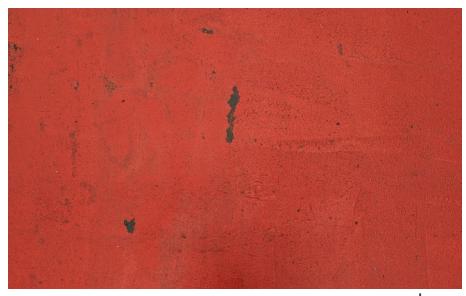
Figure 4: Chipping observed on the 3 <sup>rd</sup> Ave S/12 <sup>th</sup> St block section.
Flaking	<ul style="list-style-type: none"><li>Flaking refers to larger sections of paint peeling away from the surface.</li><li>This can create a rough, uneven, and potentially hazardous surface.</li></ul>	<ul style="list-style-type: none"><li>Weathering, chemical exposure, and heavy traffic.</li><li>Can be exacerbated by improperly applied paint treatments or improper surface preparation prior to installation.</li></ul>

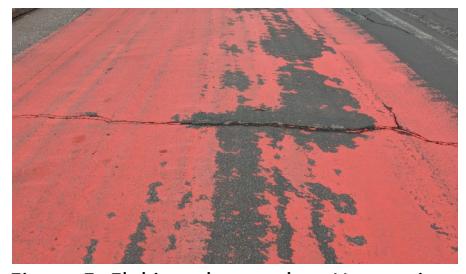
Figure 5: Flaking observed on Hennepin Ave.

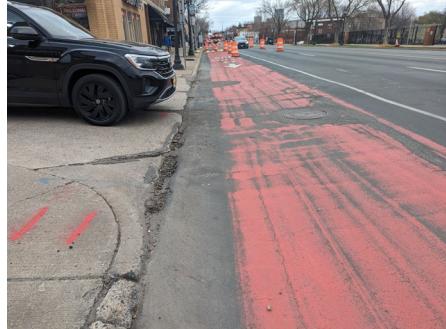
<p>Figure 6: Lane degradation observed next to a driveway on Hennepin Ave.</p>
Curb Edge Degradation	<ul style="list-style-type: none"> <li>Curb side damage or lack of curb edge retention that is observed on the edges of MMA-treated lanes next to curbs and sidewalks.</li> <li>The curb side of the road deteriorates at a faster rate than the rest of the lane.</li> </ul>	<ul style="list-style-type: none"> <li>Frequent exposure to different sources of friction such as vehicle tires, particularly at bus stops, driveways, and TPLs used for parking.</li> </ul>

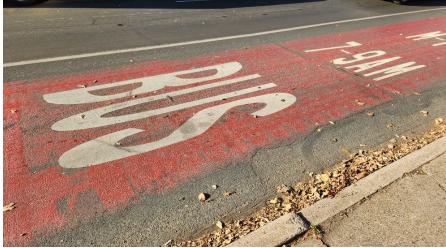
<p>Figure 7: Loss of paint closer to the curb on Hennepin Ave.</p>

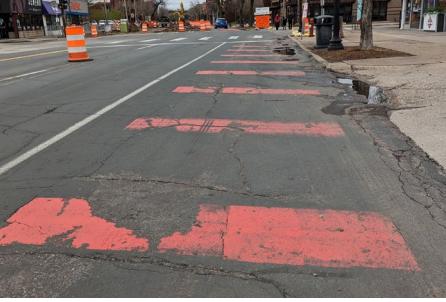
<p>Figure 8: Loss of paint observed before an intersection on Hennepin Ave.</p>
Patching Materials and Tire Staining	<ul style="list-style-type: none"> <li>Black streaks that appear on the paint both across the drive lane as well as on the wheel paths.</li> </ul>	<ul style="list-style-type: none"> <li>The mixture used to patch the roadway surface (asphalt crack fills) permeates through the paint coating with tire rubber debris contributing to the stain.</li> </ul>

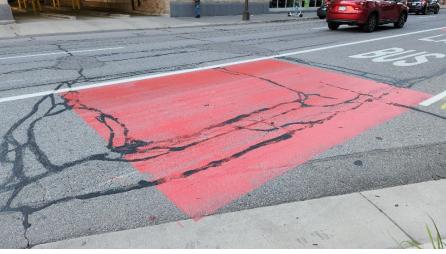
<p>Figure 9: Roadway patching permeating through the MMA treatment on 7<sup>th</sup> St S.</p>

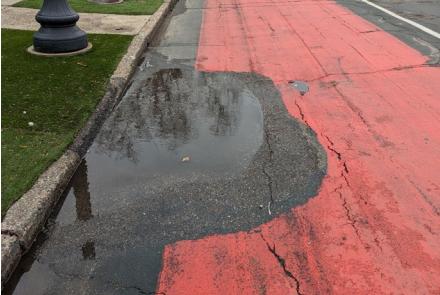
<p>Figure 10: Pavement damage that has affected the paint on Hennepin Ave.</p>

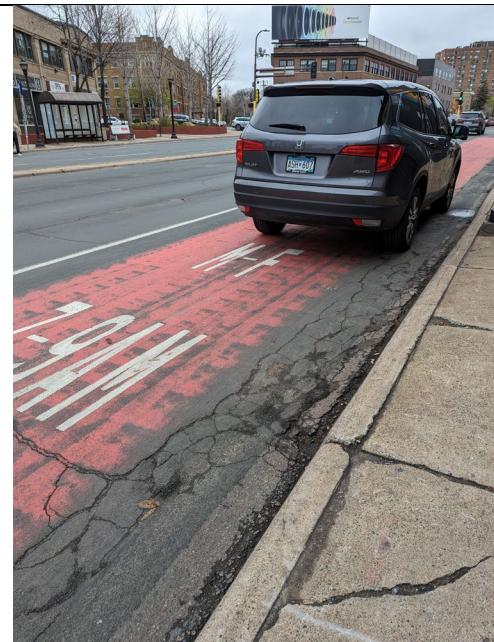
Figure 11: Lane degradation seen on Hennepin Ave where parking is allowed at limited hours

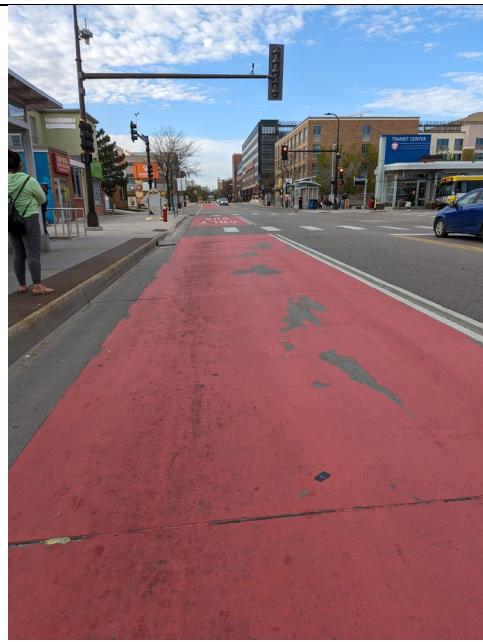
Figure 12: Flaking seen at the Chicago Ave & Lake St bus stop

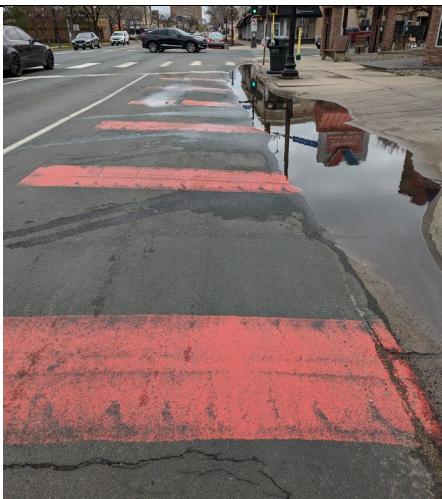
Figure 13: Dashed area degradation and pavement damage seen next to the Hennepin Ave & W 24<sup>th</sup> St bus stop and adjacent driveway

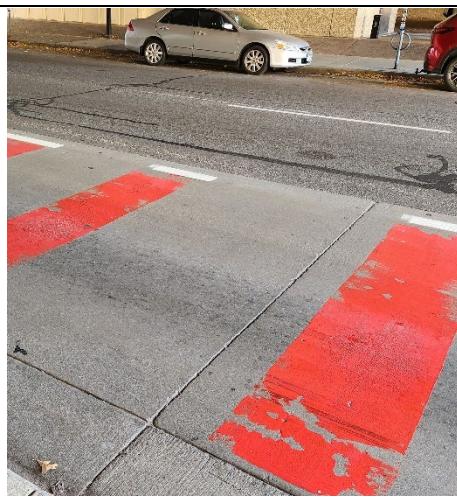
Figure 14: Dashed area degradation seen at Park & 7<sup>th</sup> bus stop on 7<sup>th</sup> St.

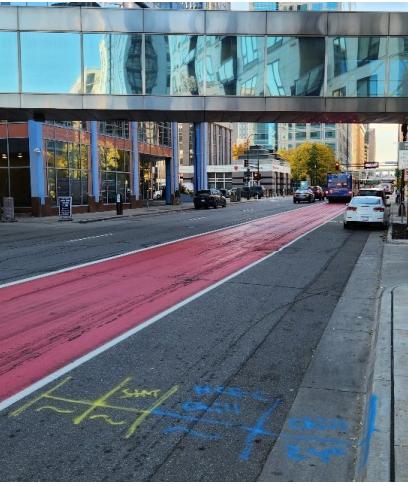
<b>7th St. S between 1st Ave. N. and Chicago Ave.</b>

<p><b>Observations:</b> Observations were made along 10 blocks (0.86 miles) on days with dry weather conditions. The two blocks between Chicago Ave and Portland Ave showed the most wear (flaking and degradation of the lane, curb edge, dashed lines), particularly at the 7<sup>th</sup> St and Park Ave bus stop. Many blocks also showed roadway patching permeating through the paint. The 3rd Ave S to 2nd Ave S and Hennepin Ave to 1st Ave N blocks showed the least amount of wear as a likely result of the paint refresh in 2023.</p> <p><b>Context:</b> The TPL was installed in 2021 by spraying. This is a full-time TPL in an offset lane. No surface preparation was done prior to installing the paint on the asphalt pavement. The frequency of buses using this TPL is 317 per day (7 bus routes) although general traffic also often use the bus lane even though not permitted.</p>

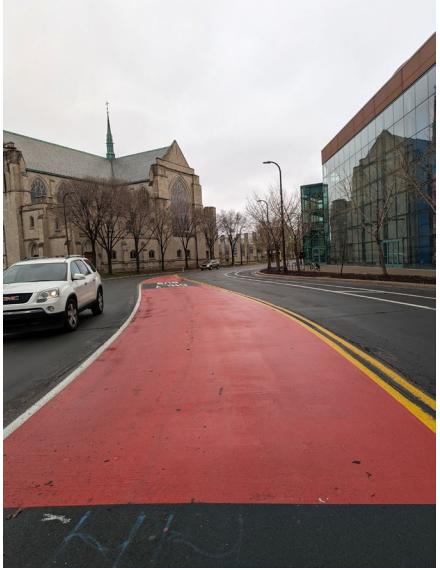
<b>3rd Ave/12<sup>th</sup> St S</b>

<p><b>Observations:</b> Observations were made after a day of rain (pre-and post-street sweeping). Very little wear was observed. Only some chipping was present. The MMA looked bright and in good condition overall.</p> <p><b>Context:</b> This TPL is located in a single block section at the 12th St S &amp; 3rd Ave S intersection, northeast of the Minneapolis Convention Center. The TPL was installed in 2021 by hand. This is a full-time TPL in an offset lane that is 0.03 miles long. The street was swept/blown prior to installing the paint on the asphalt pavement. This TPL does not directly serve any bus stops.</p>
<b>Hennepin Ave. from Franklin Ave. to Lake St. W.</b>

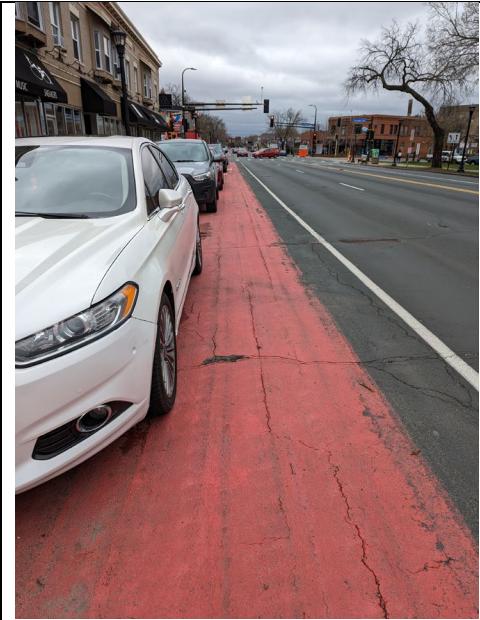
Figure 17: Vehicles parked along the TPL on Hennepin Ave

**Observations:** Observations were made after a day of rain (pre-and post-street sweeping). Observations are limited to the section between 26th St and Franklin Ave W (3 blocks northbound and 1 block southbound) because Lake St to 26th St was closed for construction. Both northbound and southbound sections showed significant wear -- chipping, flaking, lane and dashed line degradation, patching materials/tire staining, and pavement damages such as cracks and potholes that damaged the paint. Several vehicles were parked in the bus lane as parking is permitted outside of designated bus only lane hours. More pavement damage including potholes were observed at bus stops and in front of some driveways. Dashed area degradation was mostly present at nearside bus stops.

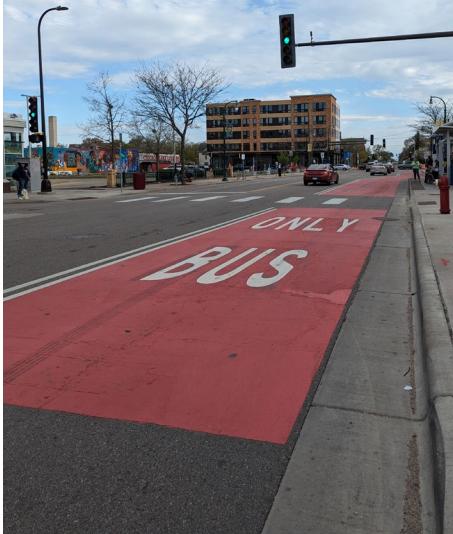
Figure 18: The paint on Chicago Ave showing some chipping and tire staining

**Observations:** Observations were made on days with dry weather conditions (pre- and post-street sweeping). The paint showed some chipping and flaking in some sections of the corridor. Flaking and some minor lane degradation was mostly present in front of the Chicago Ave and Lake St bus stop. The paint was bright and in good condition overall. This is likely because the paint was installed in 2022 as part of the METRO D Line construction.
