**Request for City Council Committee Action  
From the Department of Community Planning & Economic Development  
and the Minneapolis Arts Commission**

**Subject:** Proposed Deaccession and of the Northeast Neighborhood Gateway by Artist Susan Fiene, Located at Central and Broadway Avenues

**Public Art Work Condition Survey**

**Title:** NORTHEAST GATEWAY

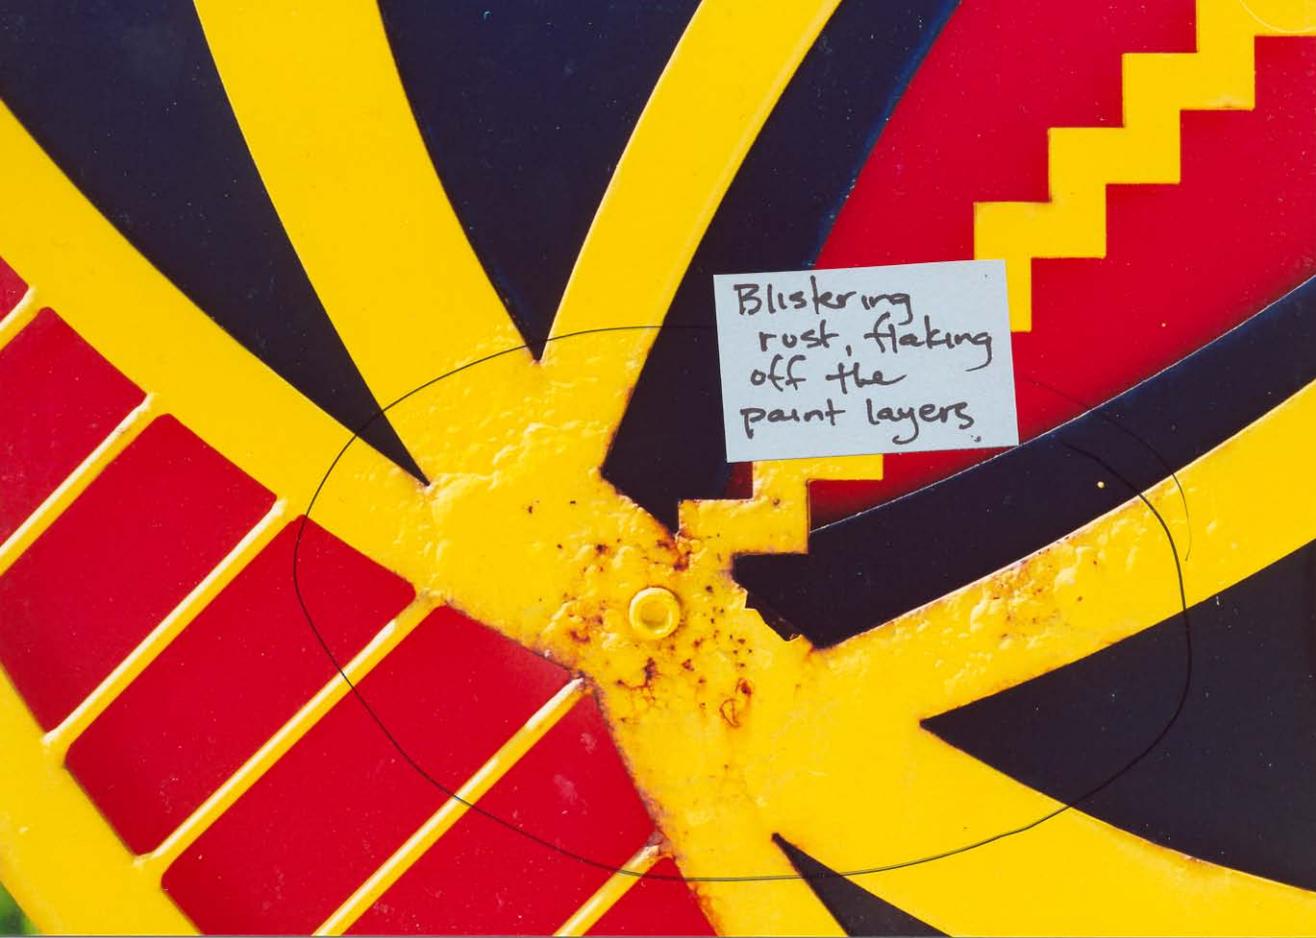
Blistering  
rust, flaking  
off the  
paint layers.
