Facade Evaluation for the

Hollywood Theater 2815 Johnson St NE Minneapolis, MN 55418

R740-09-1

BCG P08205

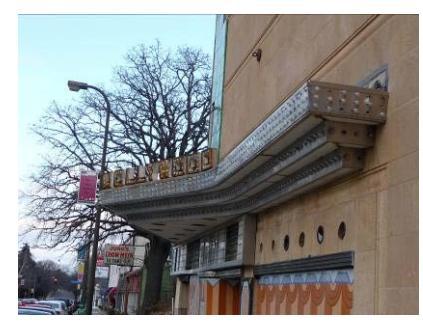
West Elevation Looking North

The Hollywood Theater is located at 2815 Johnson Street NE in Minneapolis, Minnesota. The building has been vacant for several years. The building has a newer roof and the interior finishes have been stabilized in the recent past.

The building is about 30' tall and constructed with a brick and stone masonry facade and a partial basement level. The building is constructed with steel columns and roof trusses, and brick and clay tile mass masonry infill walls. A stone masonry chimney exists at the northwest corner that has previously installed steel banding to prevent movement.

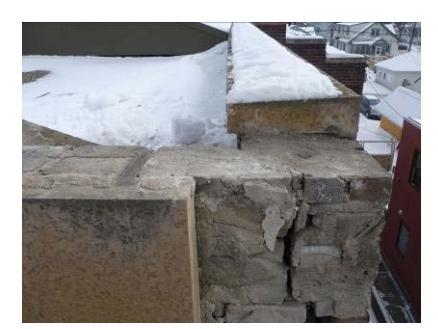
West Elevation, South Corner Parapet

- The southern most stone cap at the west elevation was removed to expose anchors for the stone below.
 - Stone caps are set in a bed of mortar with no dowel pins.
 - The top stone anchors for the face stone below are set in this mortar bed.
 - $\circ\,$ The top, southern face stone had loose top anchors and was removed and reset.
- At the top edge, 2 stone anchors were observed per stone. No bottom anchors were present. The stone sat on the next stone below and relied on mortar bond for lateral support at the bottom face.
- To temporarily stabilize the stone at this location, helical restoration ties were installed (4 per stone) at 3 stone at the parapet corner on January 22, 2009.
- BCG observed additional stone displacement along the top course of

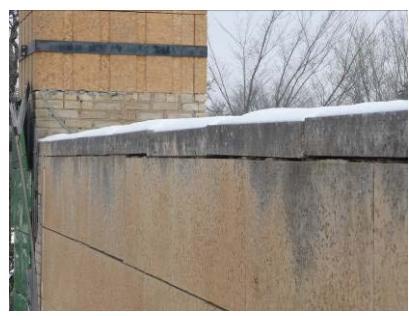
West Elevation Parapet Stone Displacement

stone along the parapet wall during review from the aerial lift.

- Stone cap mortar joints and mortar bed were severely deteriorated.
- Based on these observations, BCG recommended installation of (4) helical restoration ties per stone along the top course of stone (12 total) at the west elevation.
- Additional helical tie installation was completed on January 22, 2009.

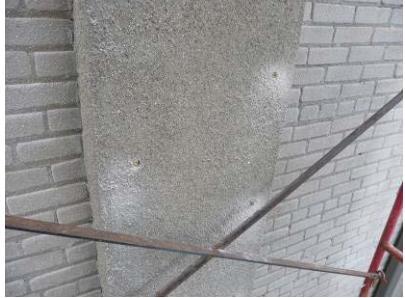
Restoration ties installed

- The entire column cover was shifted outward away from the building creating a gap as wide as 1 ½" at the top. The steel column and backup masonry is exposed at this opening.

- All keyed, or "toothed" in brick had fractured or debonded and pulled away from the wall, eliminating all lateral support of the brick column cover.
- Restoration ties were installed in the column cover at 16" on center on January 22, 2009, to stabilize the facade prior to observations or test cuts.

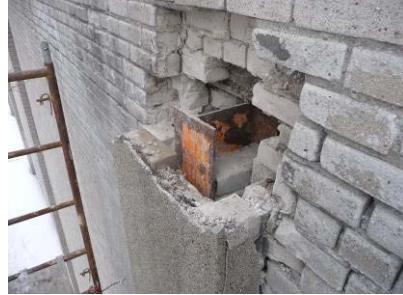
Test opening at north elevation

- An approximately 2 to 3 square foot test opening was made at the top of the column, exposing the top of the column and the backup masonry.
- The exposed column displayed surface corrosion over about 1/3 of its area. The remaining area displayed original red primer in varying condition.

- No significant section loss by corrosion was observed at the steel column.
- After observations were completed, salvaged and replacement brick masonry were reinstalled and a new sheet metal cap flashing was fastened to the top of the brick masonry column cover to prevent excessive water infiltration into the wall.

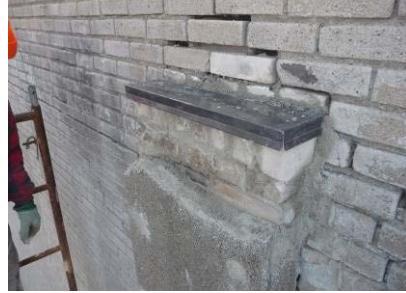
New sheet metal cap flashing

- Stabilization repairs completed on January 21, 2009 are considered a temporary stabilization, not a longer term repair to restore the masonry column cover to its original condition. Due to freezing temperatures during stabilization repairs, newly installed masonry mortar will deteriorate at an accelerated rate and will require repointing in the next few years.
- In its current condition, additional distress will continue to progress at an increased rate at this location. The temporary stabilization repairs did not restore the water tightness of the wall system at this location. The existing brick masonry cracking and deterioration will require repair in the future.
- Our observations at this location gave no indication that widespread hidden distress is present at other steel columns or masonry column covers.

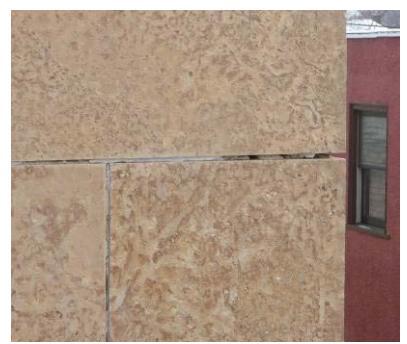
West Elevation mortar joint deterioration

- The mortar joints at the stone facade are in poor condition with extensive erosion and deterioration.
- Removed stone at the southwest corner parapet did not expose significant steel stone tie corrosion.
- Steel stone ties exist at the top edge of the stone only. Lateral support at the bottom edge of the stone is provided by frictional forces between the stone and mortar joints.
 - o Therefore, mortar joint condition will eventually determine the

lateral stability of the stone facade.

- No signs of stone movement or other distress was observed at the west elevation at the time of our review except along the parapet where stabilization repairs were completed.
- No other immediate repairs are recommended at this time at the west elevation limestone facade.

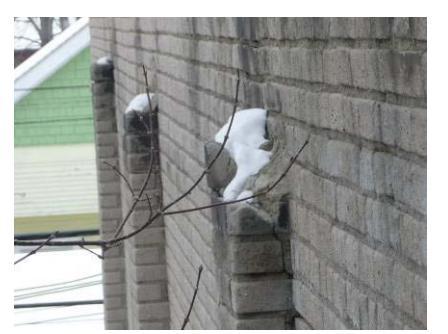
Brick masonry column covers at the north elevation

- The remaining brick masonry column covers at the north and south elevation were generally in fair condition with only isolated cracking at the "toothed" brick providing lateral support.
- In general, the exposed horizontal brick at the top of each column cover are in poor condition with significant deterioration to the mortar joints and brick body.
 - We recommend installing a metal cap flashing at the top of each column cover on the north and south elevations.
 - The cost of this work is estimated to be about \$6,000 for a total of 8 locations.
- The brick masonry mortar joints at the north, east, and south elevations are generally in poor condition with significant erosion observed especially at the upper half of the walls.
- Vertical cracking was observed at many locations through the brick masonry units and mortar joints.
