**APPLICATION FOR CERTIFICATE OF APPROPRIATENESS
HERITAGE PRESERVATION COMMISSION
MINNEAPOLIS, MINNESOTA**

2925 Cedar Avenue South

Describe existing feature and its condition: Layman's Cemetery was established in 1853. The steel-picket and limestone-pillar fence was constructed around the perimeter of the cemetery on Lake Street and Cedar Avenue as part of the 1928-1936 Cemetery Redesign. The steel pickets are generally 6'4" tall and in sections that are 28 linear feet. Phase II will focus on restoring the forty sections along East Lake Street. Overall, the steel portions of the fence are in poor condition.		
Photo no. <u>1-13</u> Drawing no. <u>G01 and G04</u>		
Number 2	Architectural feature <u>paint</u> Approximate date of feature <u>1928-1929</u>	Describe work and impact on existing feature: 2. Original Paint Color Analysis: An architectural historian will use the Secretary of Interior Standard methods to sand away layers of paint to determine the original color. It is believed that an area beneath the horizontal channels is the most likely area to find any remaining original paint since this area likely experienced the least fading. A goal of the project is to restore the fe

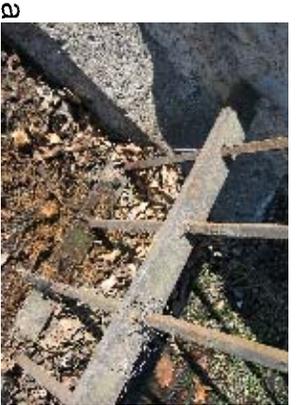
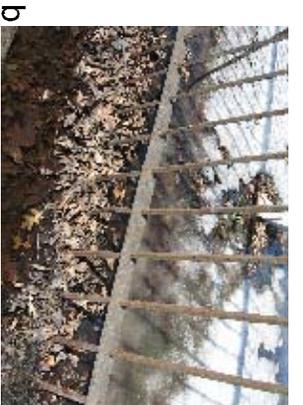
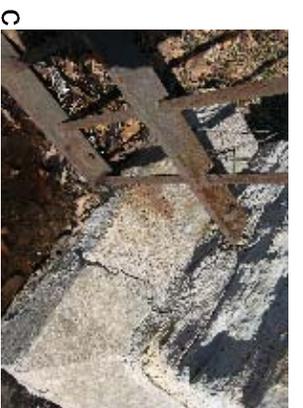
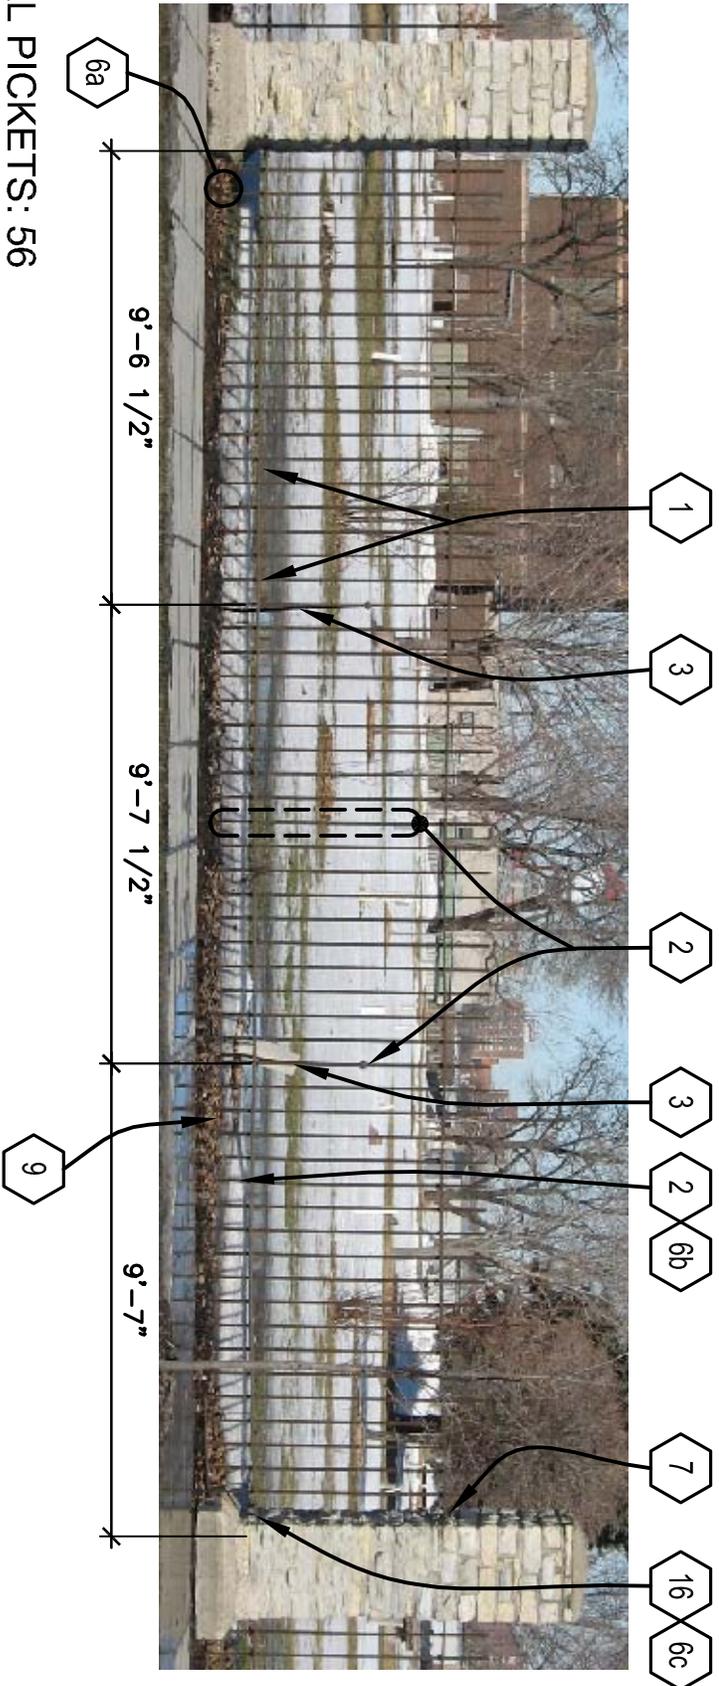
A29

OVERALL CONDITION: C

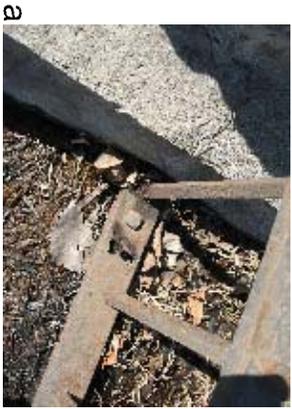
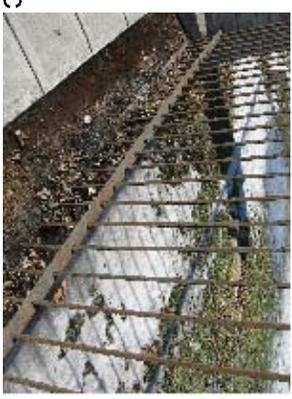
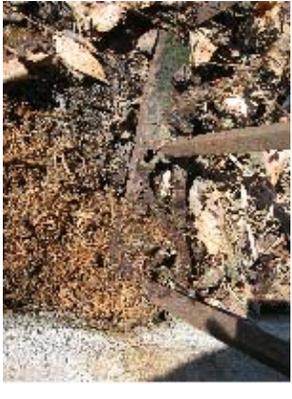
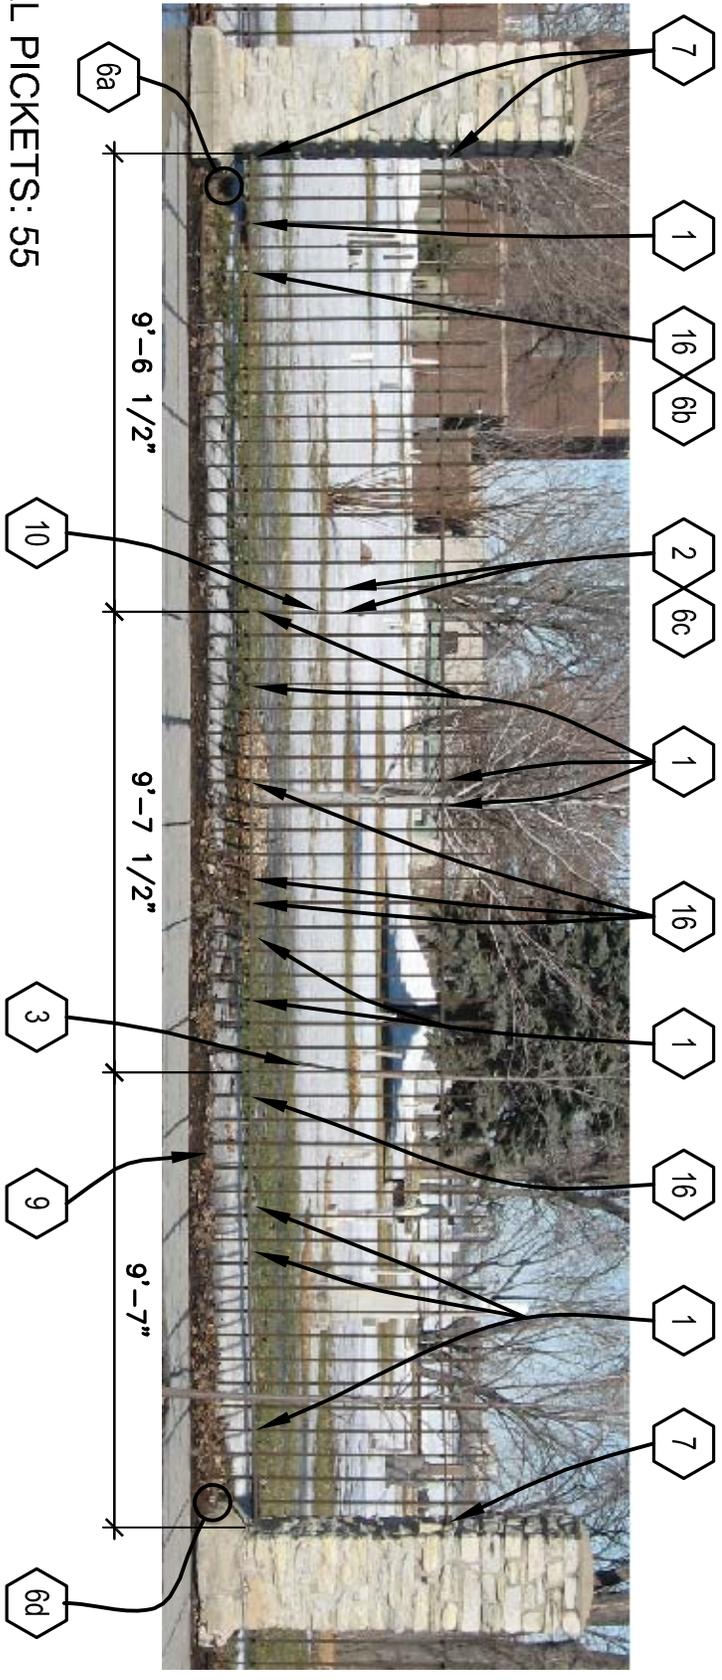
A30

OVERALL CONDITION: D

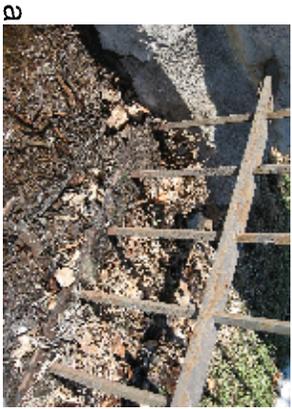
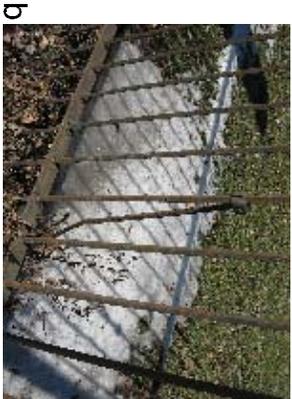
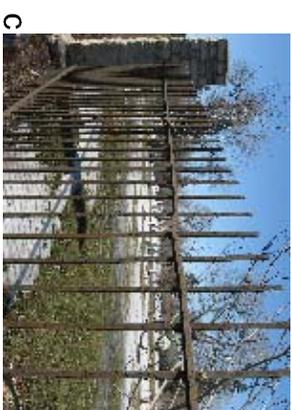
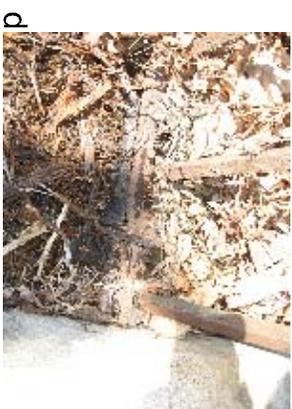
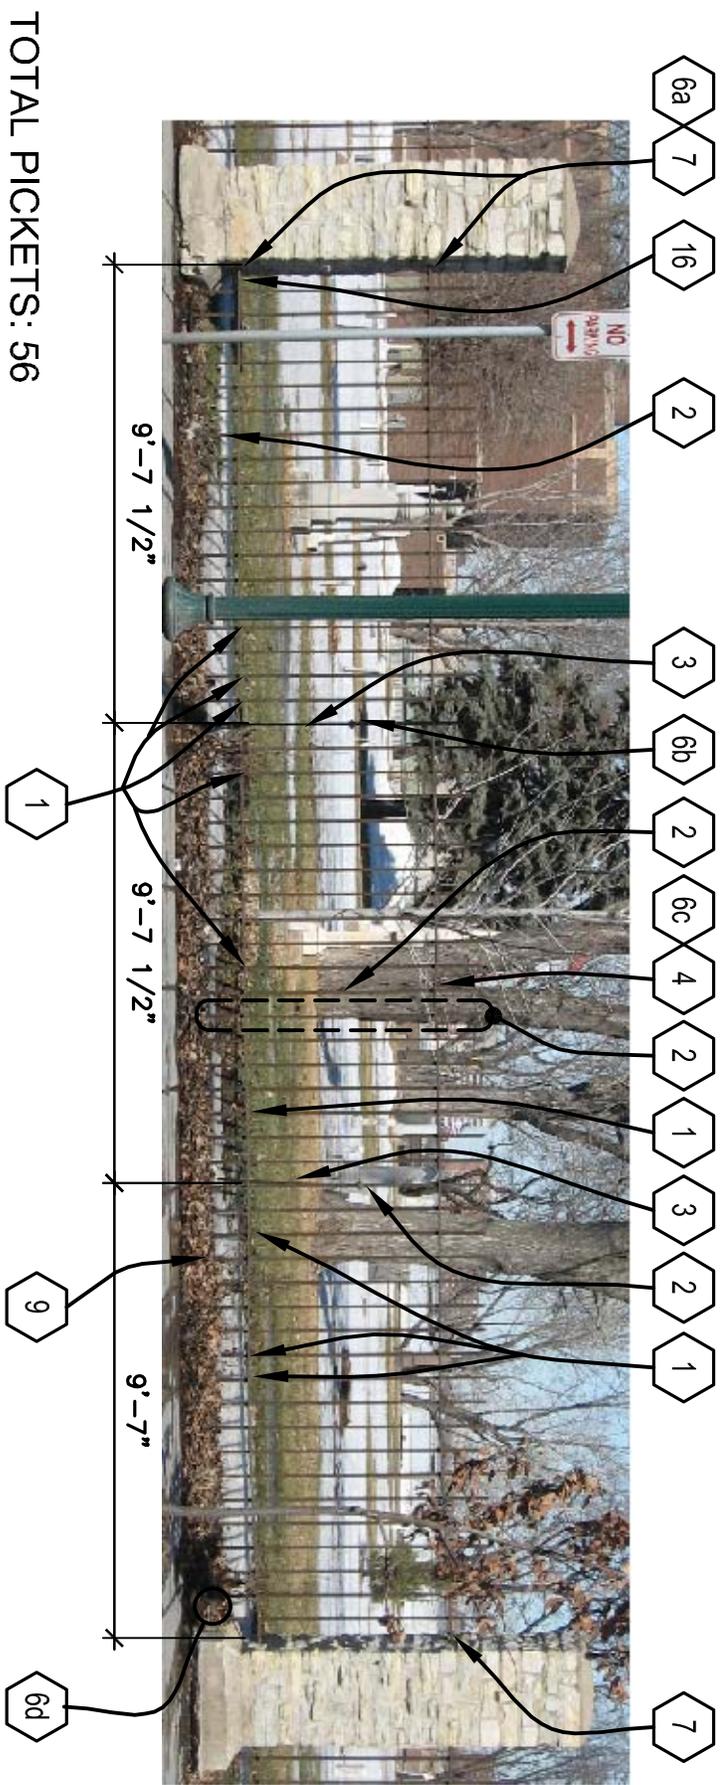
A31

OVERALL CONDITION: D

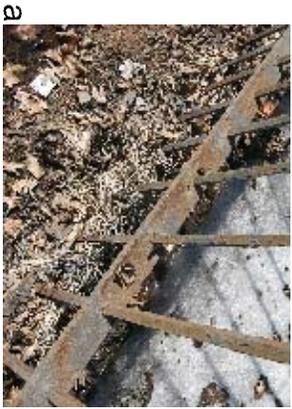
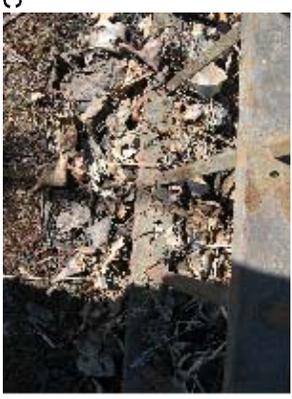
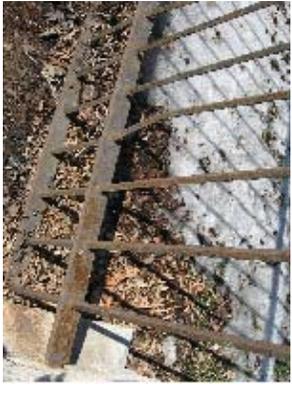
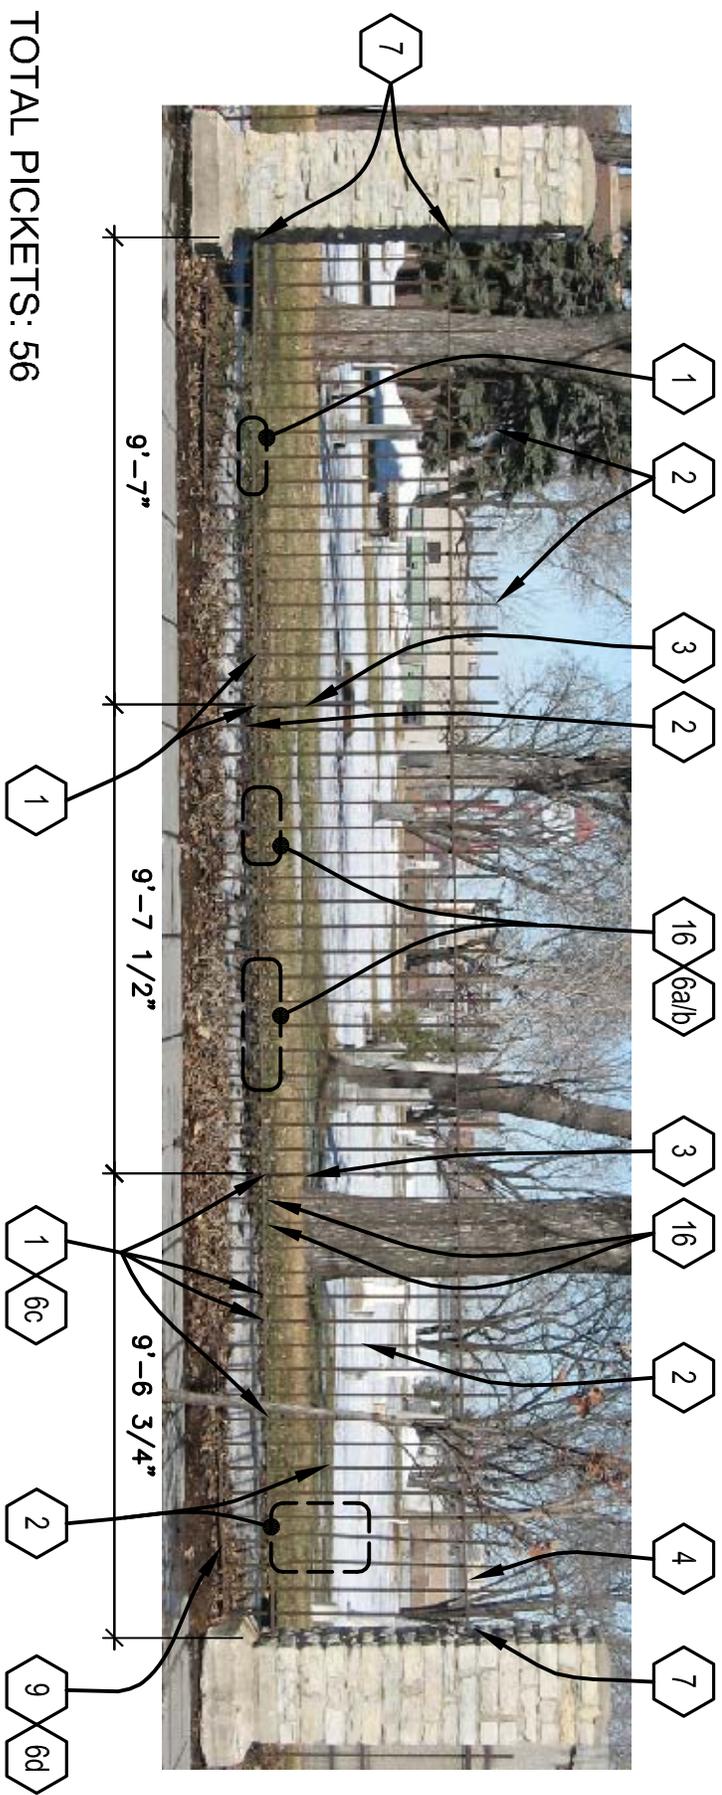
DRAWING NUMBER:
A32

SECTION 32
OVERALL CONDITION: D

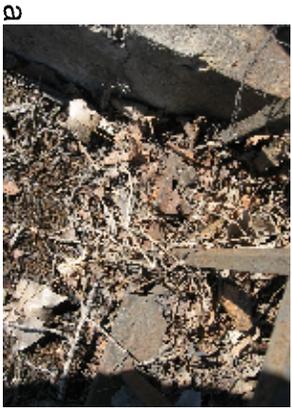
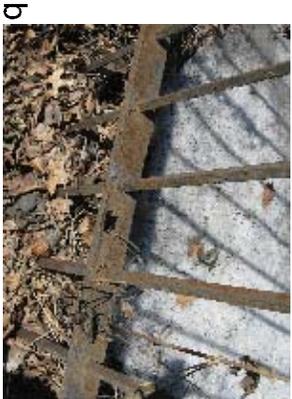
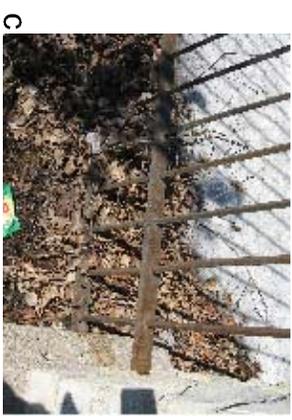
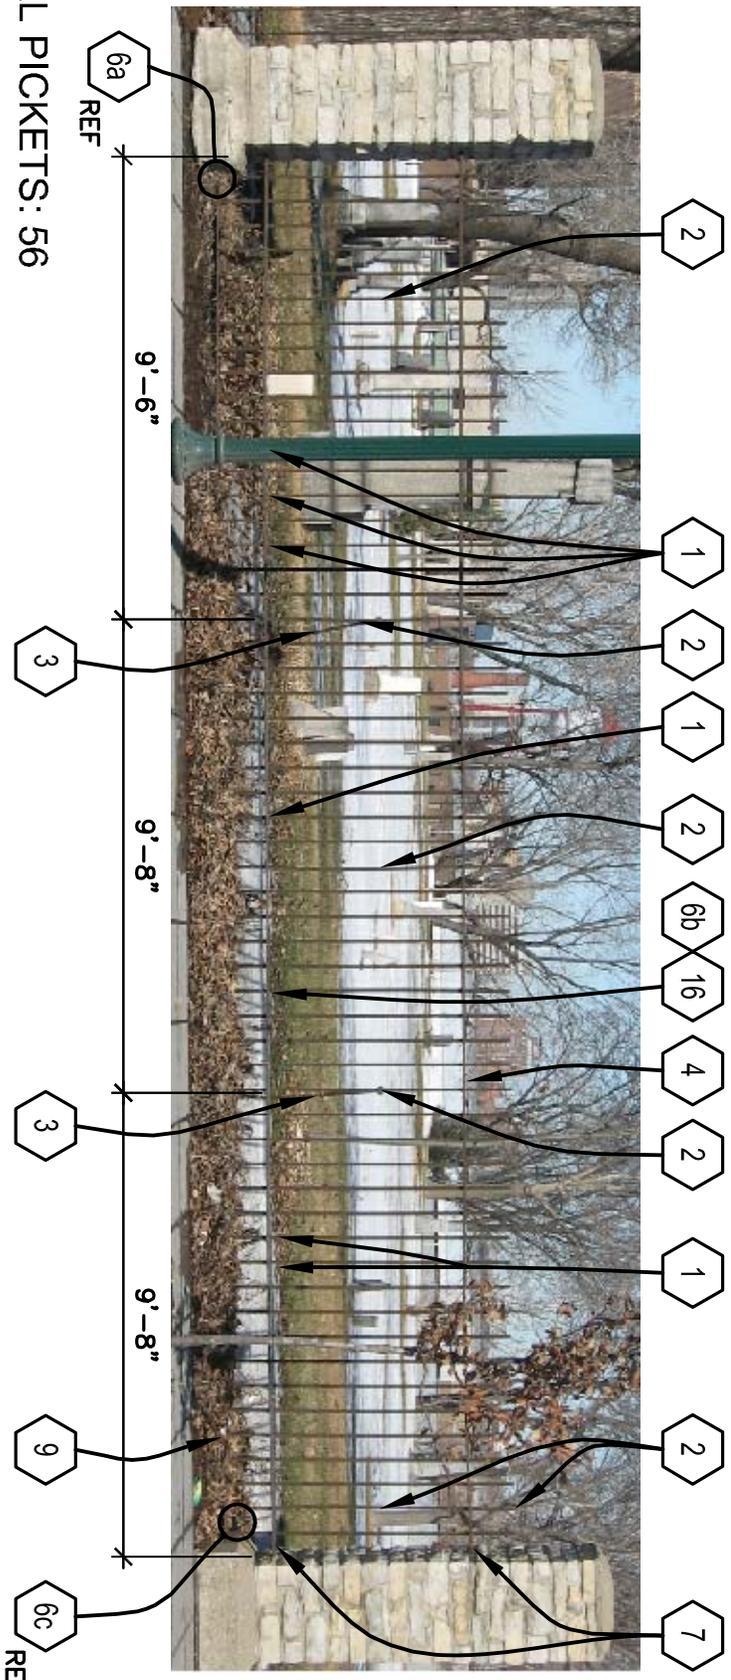
A33

OVERALL CONDITION: C

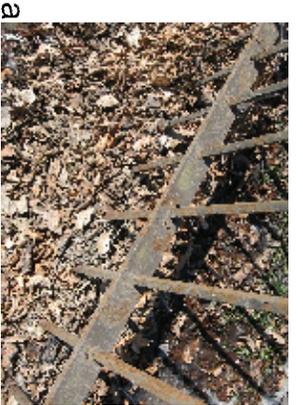
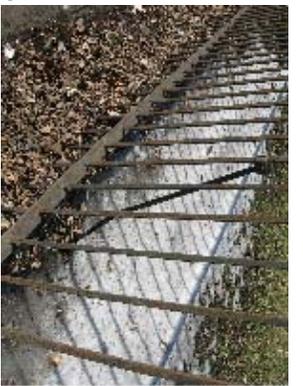
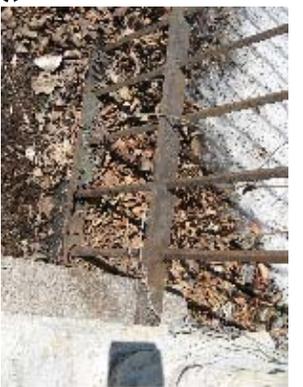
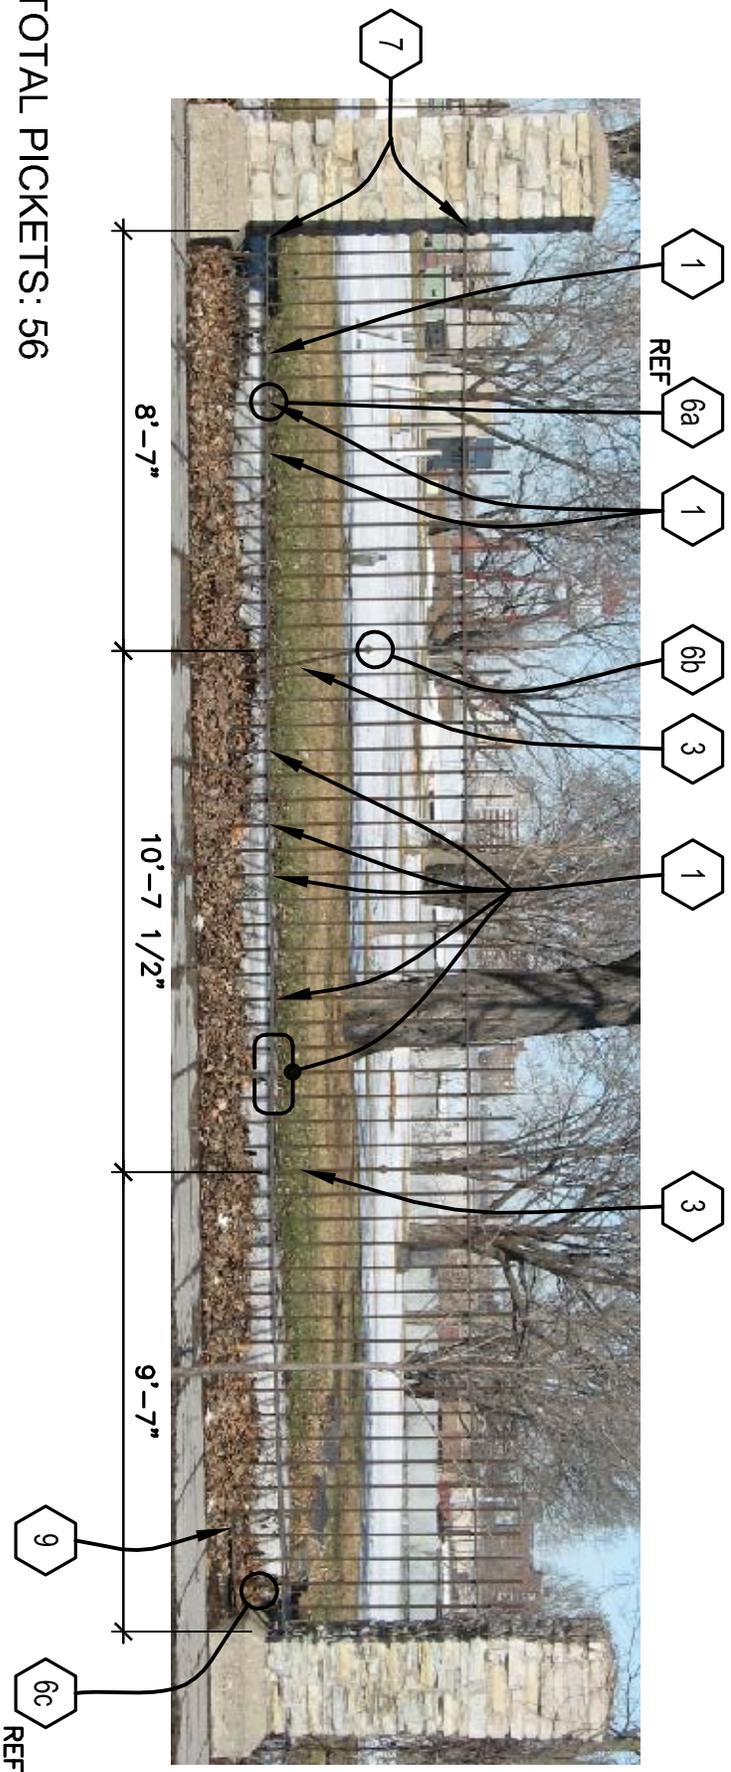
A34

OVERALL CONDITION: C

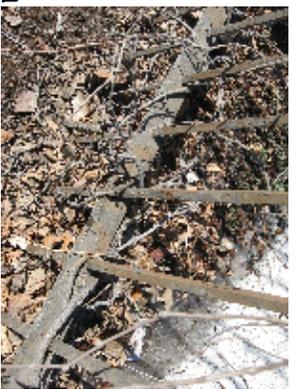
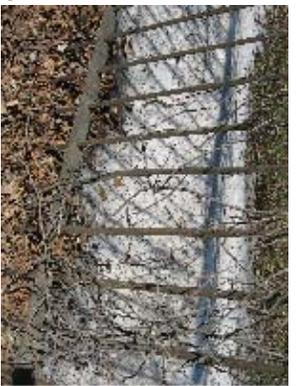
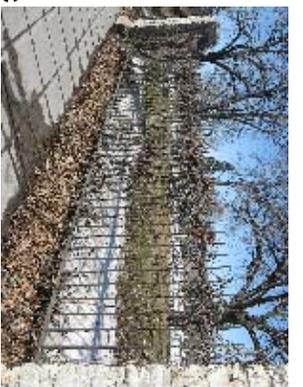
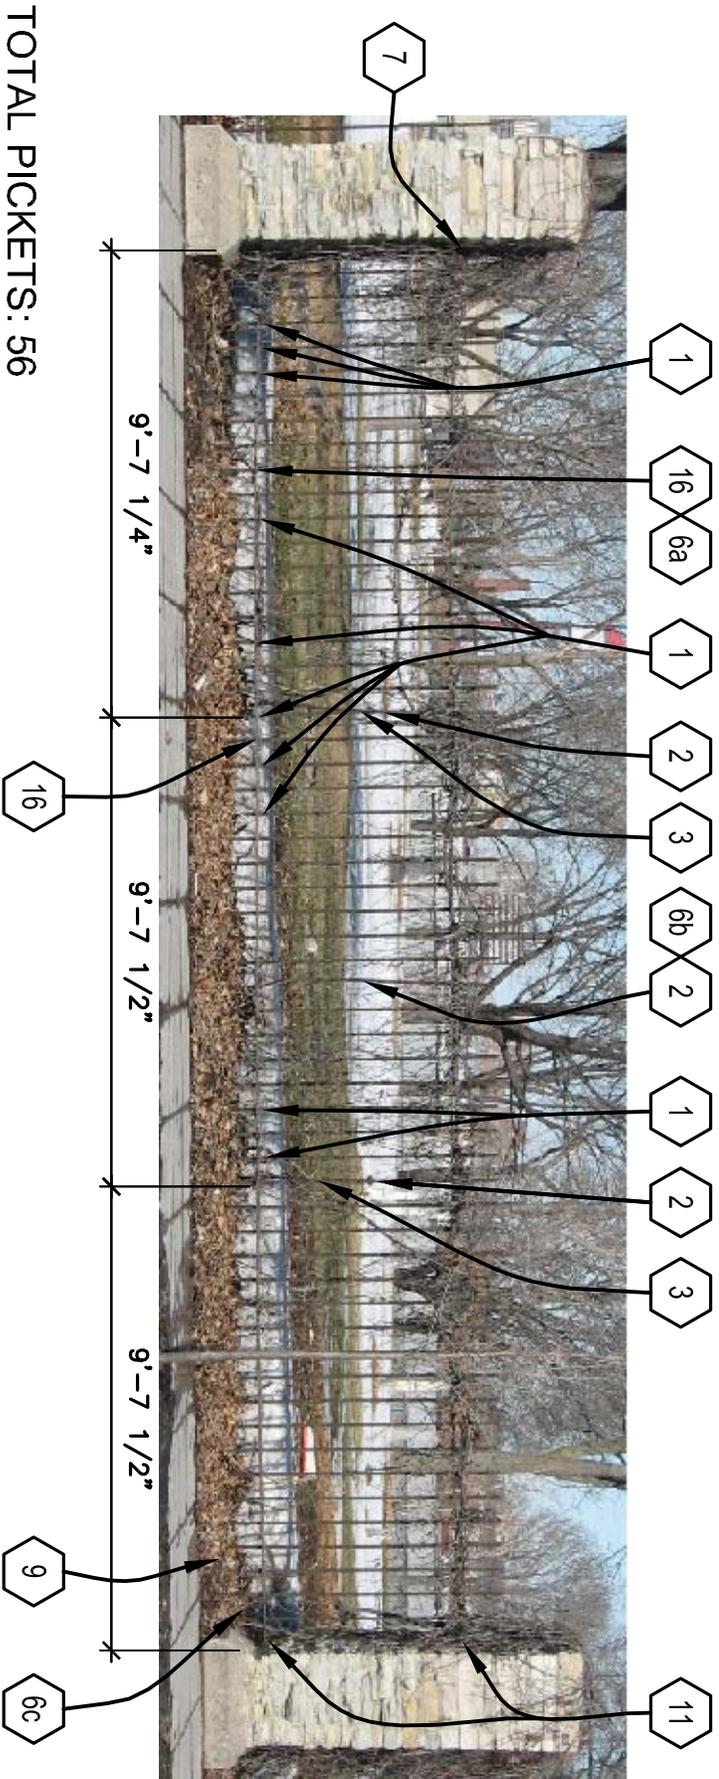
A35

OVERALL CONDITION: C

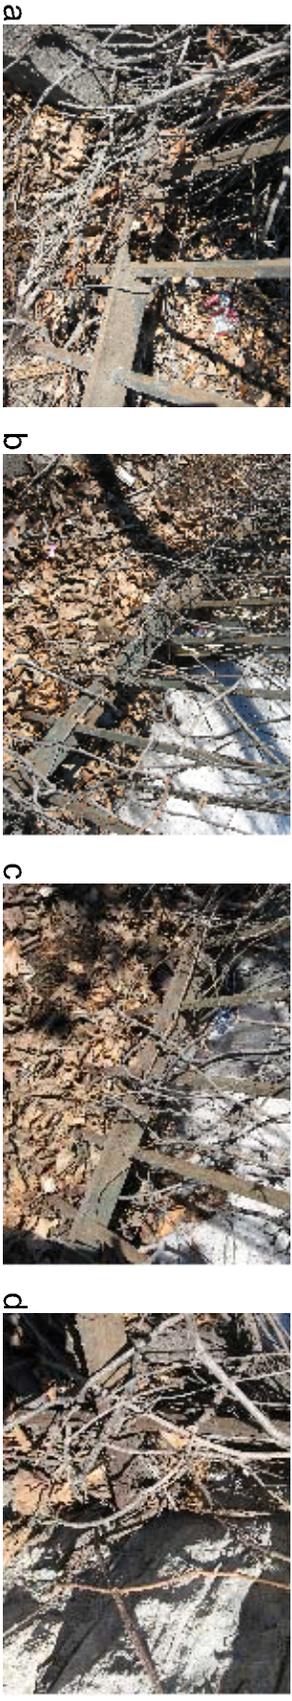
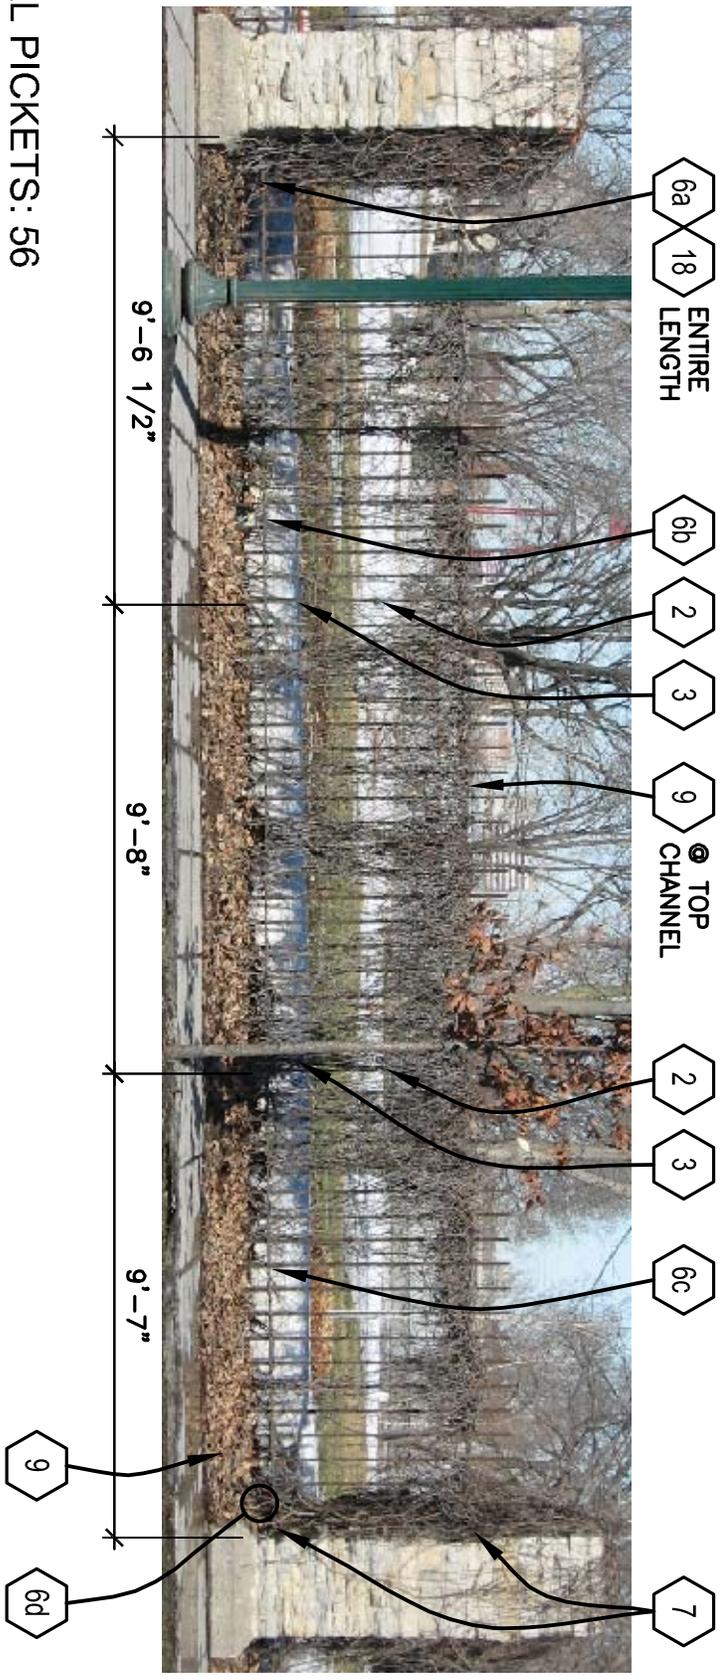
A36

NOTE: REPLACE ALL HORIZONTAL CHANNELS. EXTREME DETERIORATION AT ENDS.

SECTION 36
OVERALL CONDITION: F

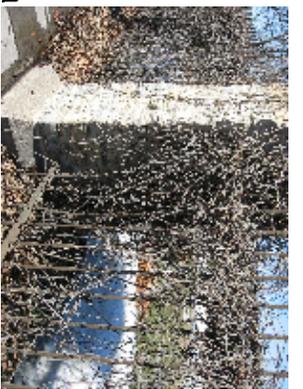
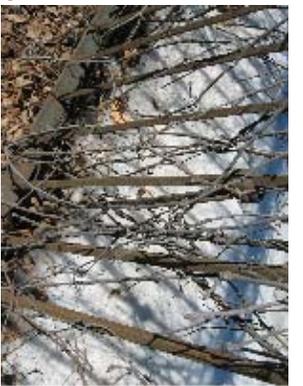
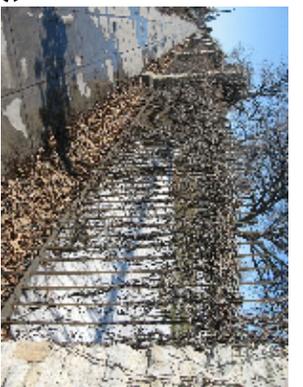
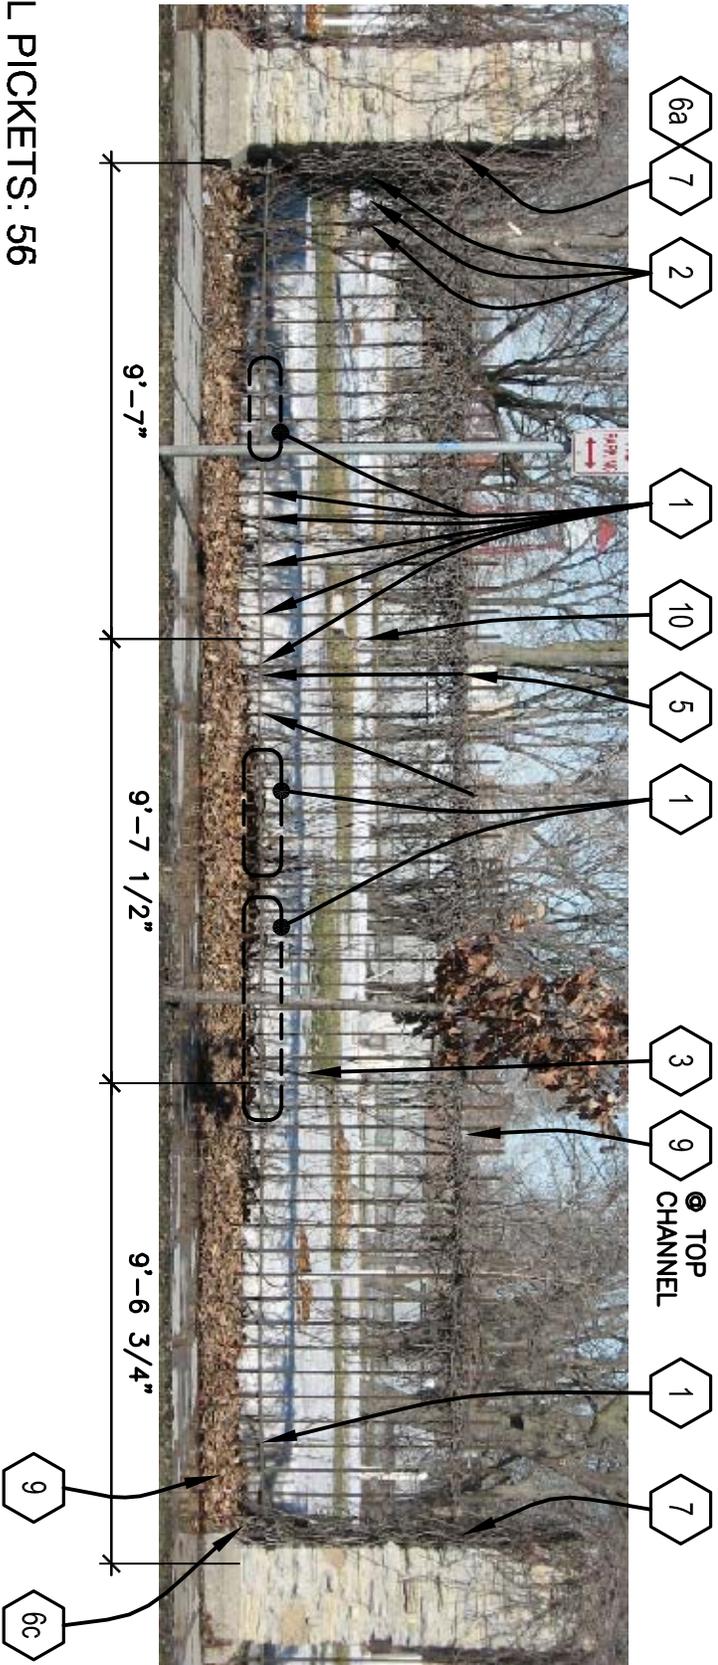
OVERALL CONDITION: D

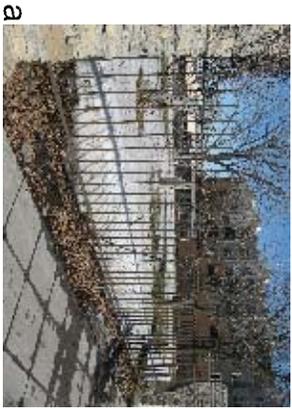
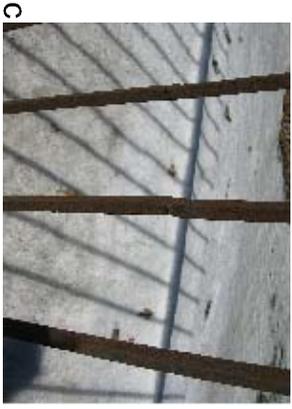
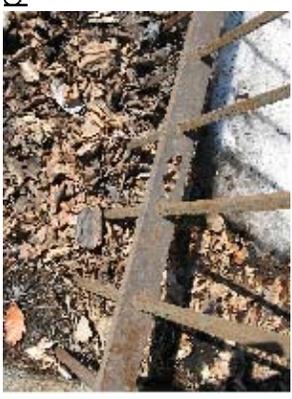
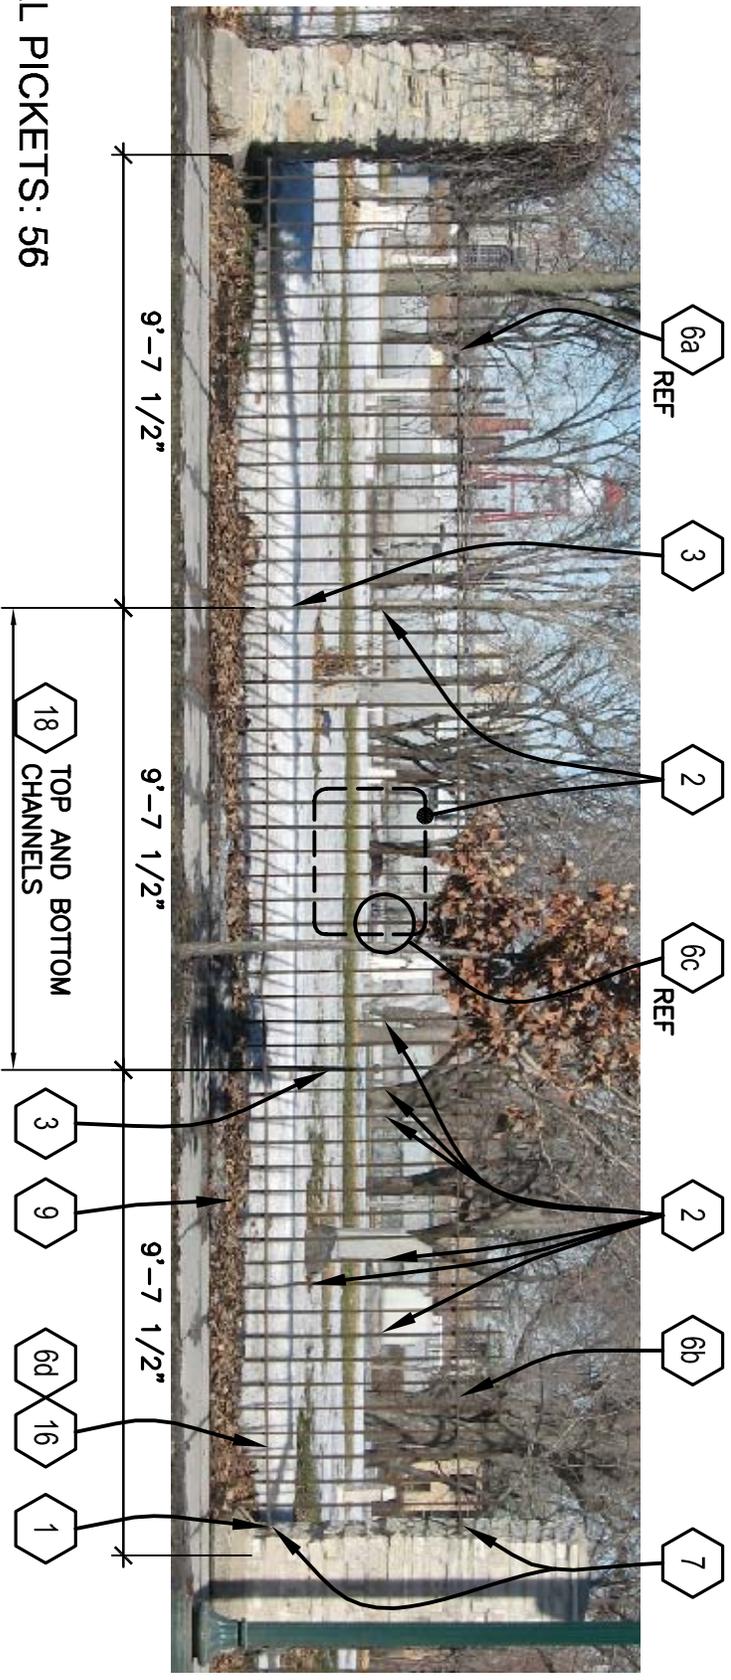
A38

OVERALL CONDITION: F

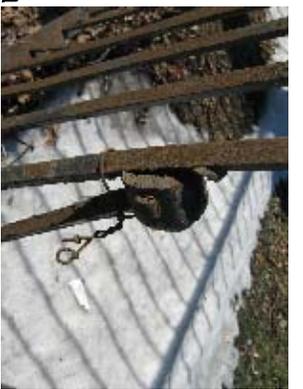
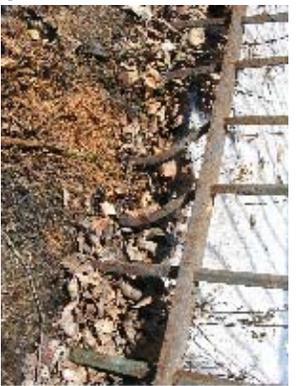
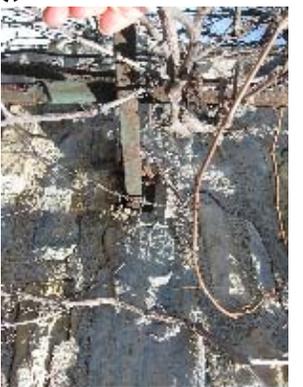
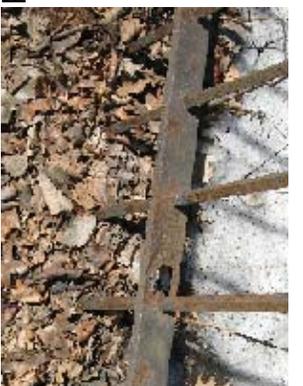
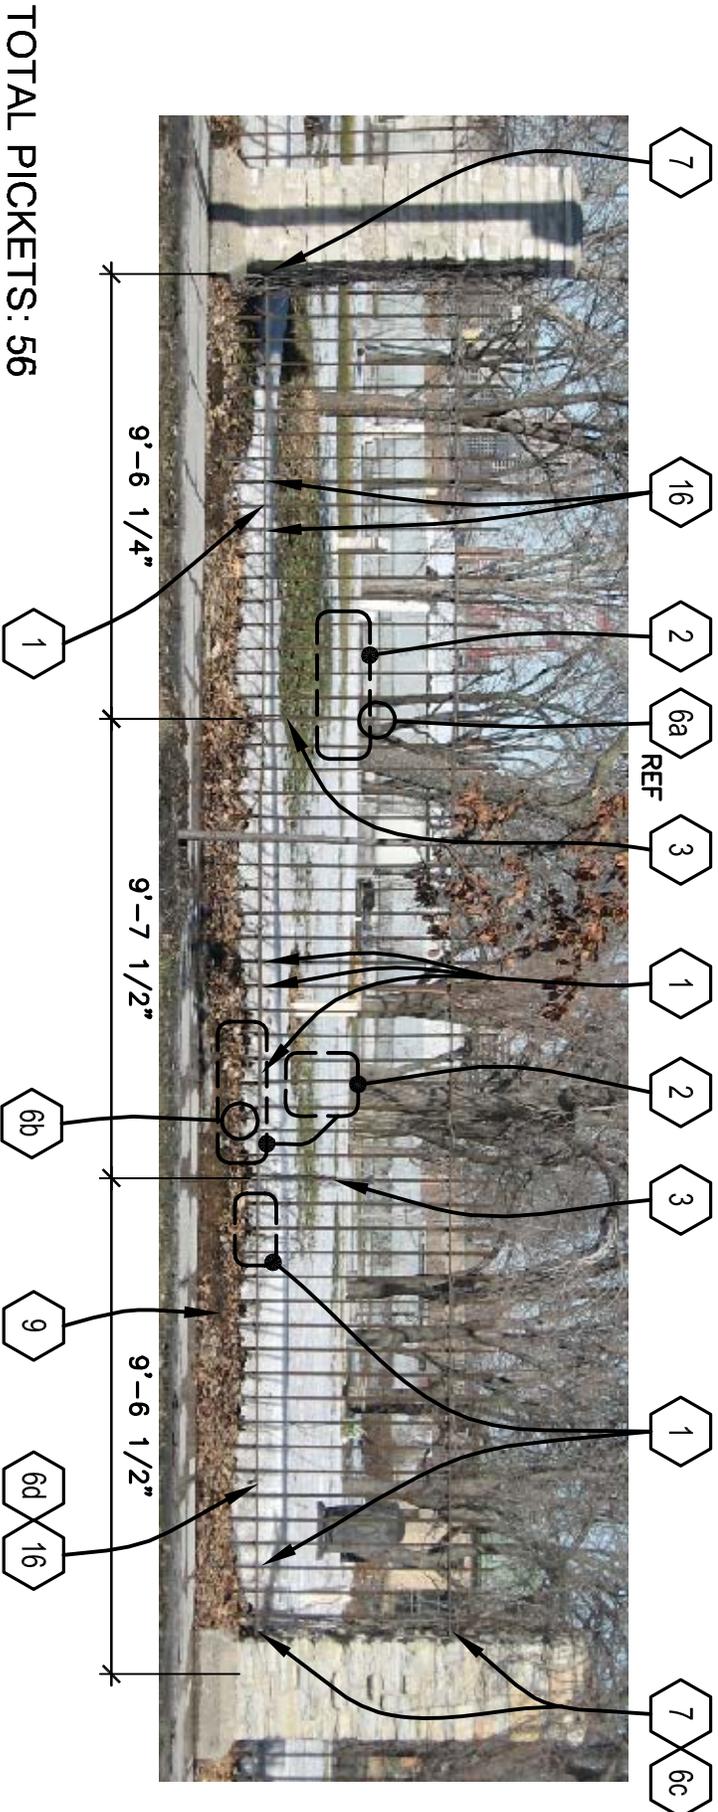
A39

OVERALL CONDITION: D

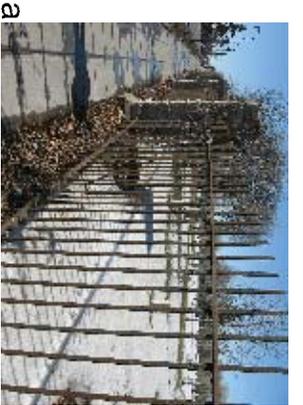
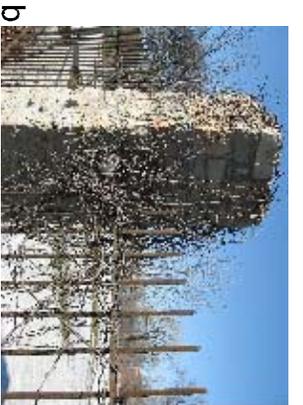
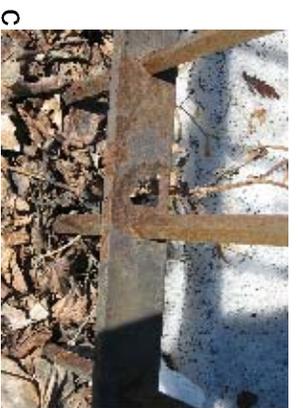
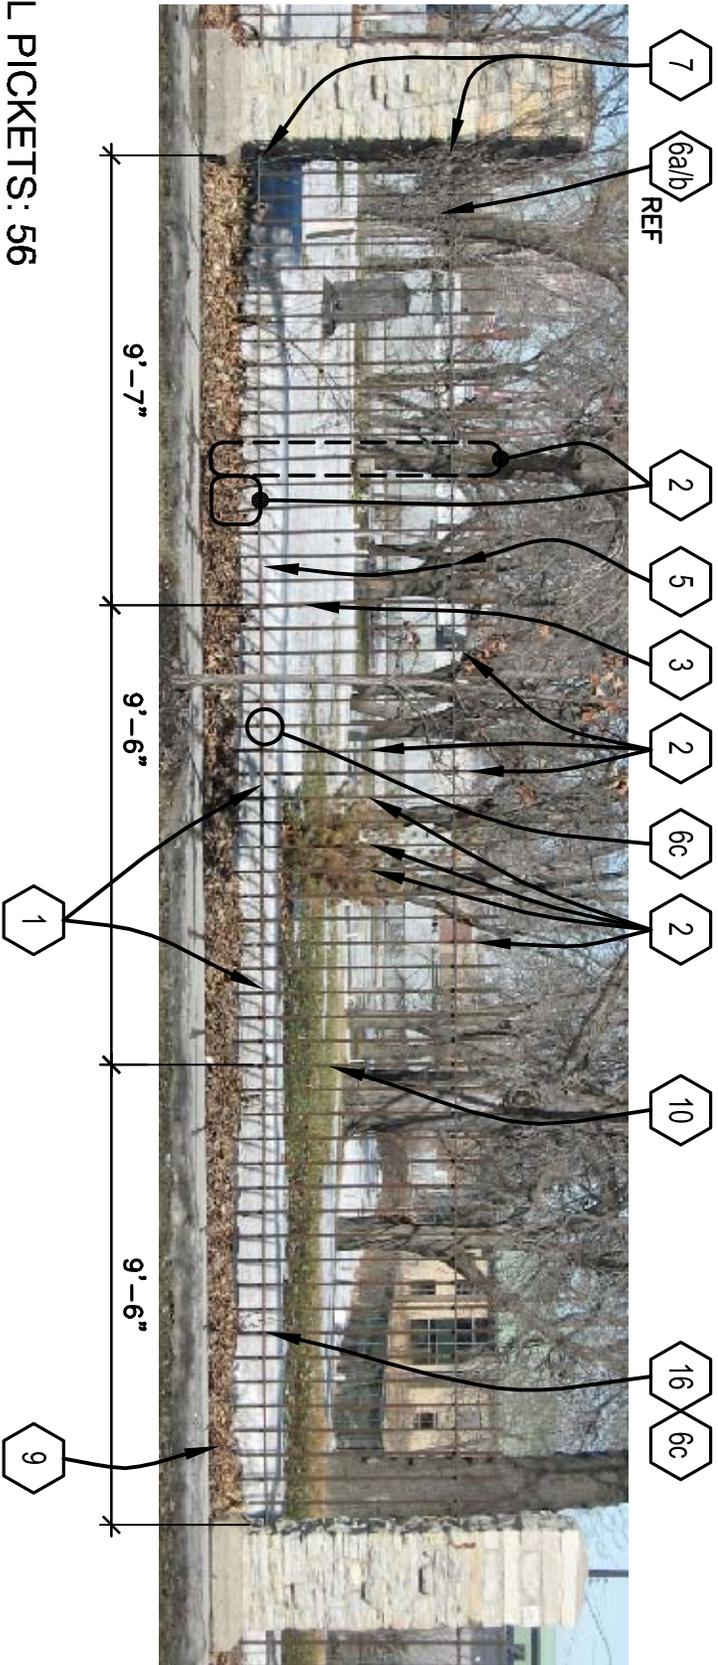
A40

OVERALL CONDITION: C

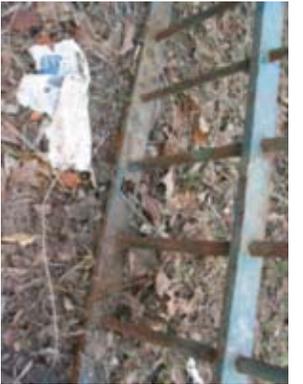
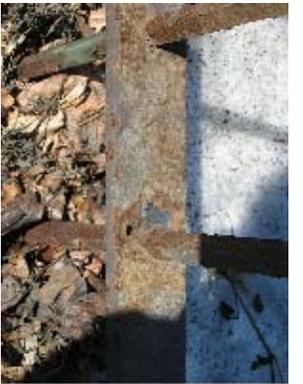
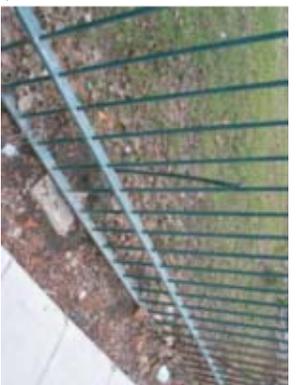
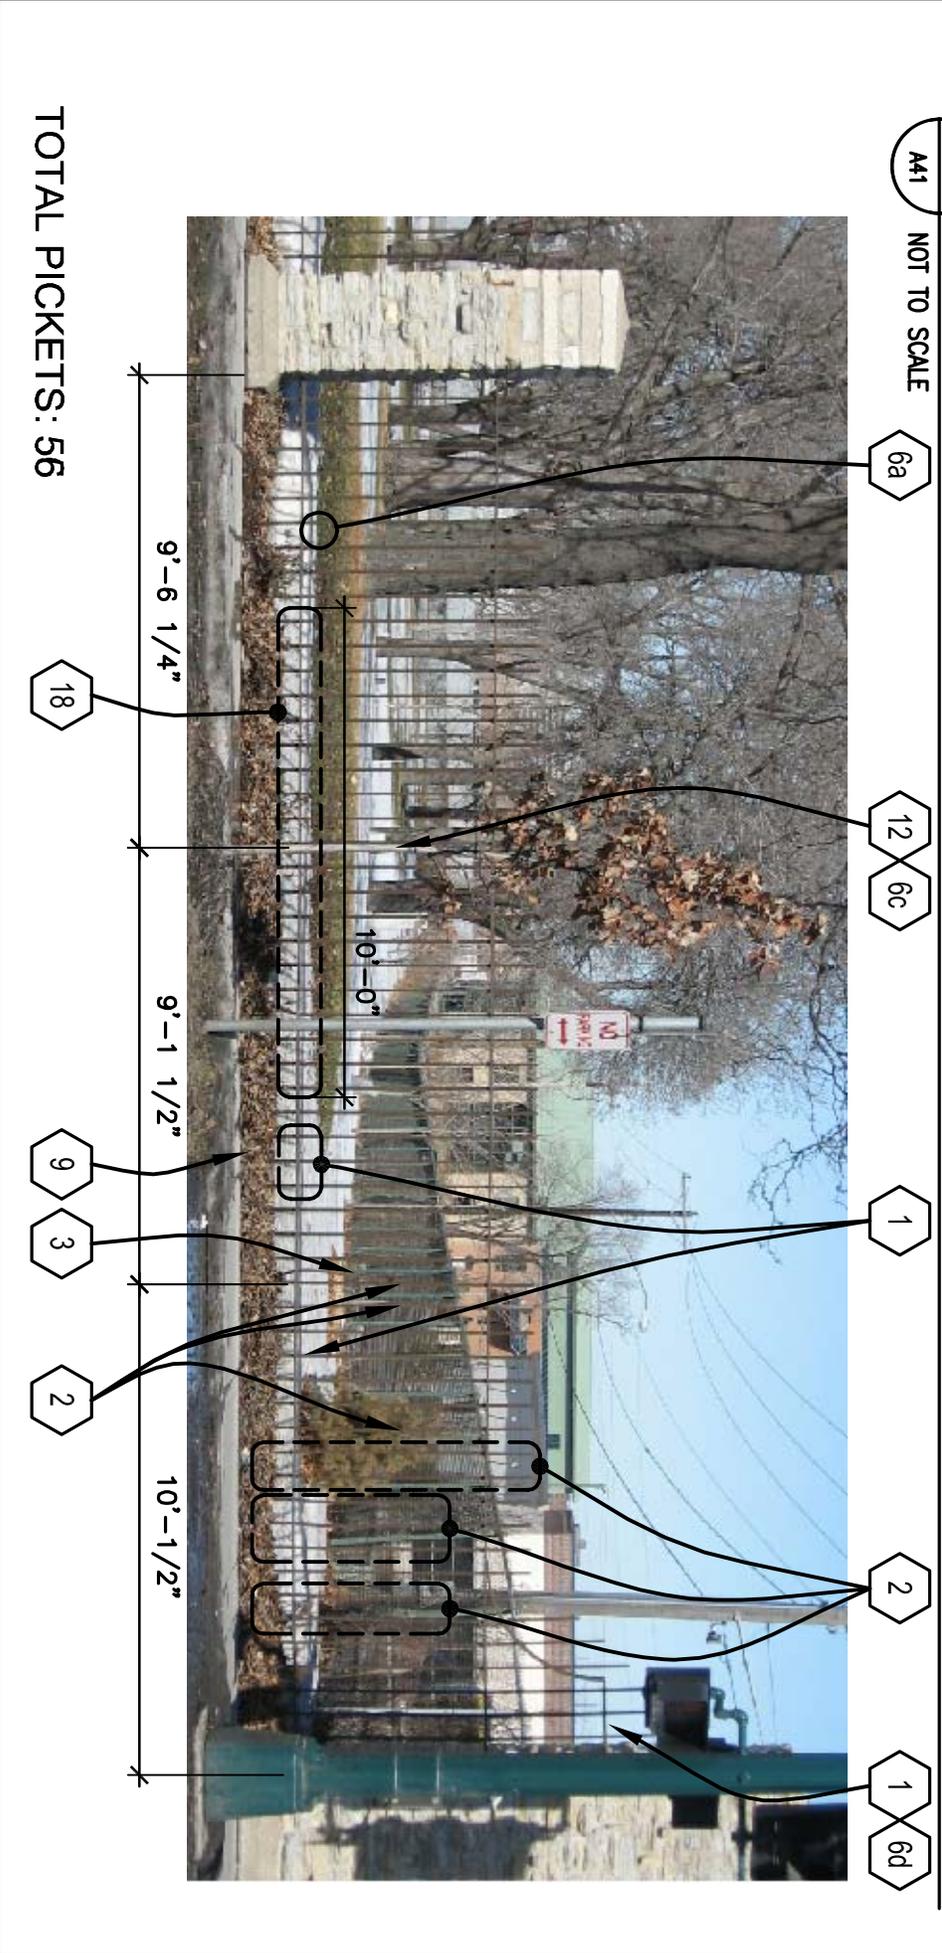
A41

OVERALL CONDITION: D

HORZ BAR
DIRECTLY
ATTACHED
TO MASONRY
PIER @ TOP
& BOTTOM.
INSTALL NEW
BRACKETS
TO PIER
AND BOLT.

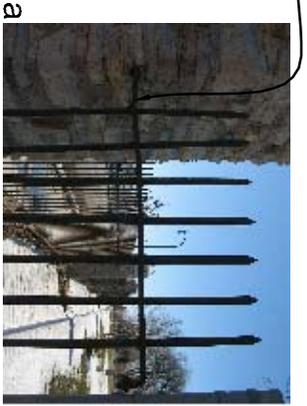
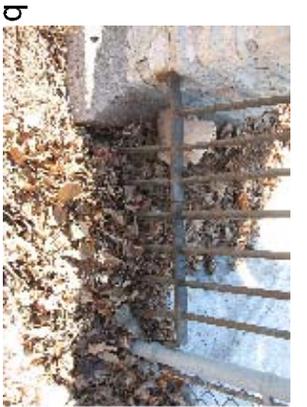
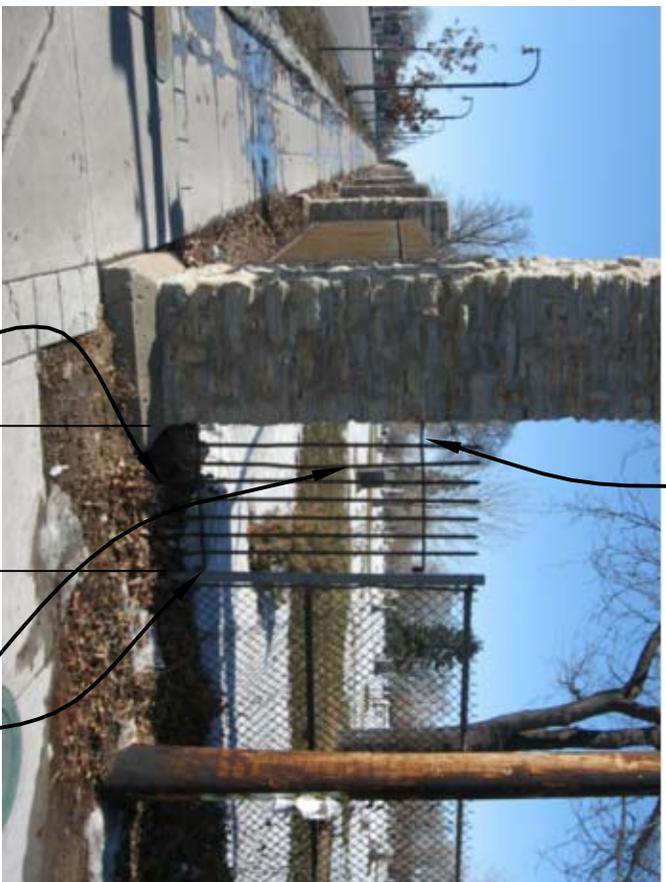
A42

OVERALL CONDITION: C
