**APPLICATION FOR CERTIFICATE OF APPROPRIATENESS
HERITAGE PRESERVATION COMMISSION
MINNEAPOLIS, MINNESOTA**

2925 Cedar Avenue South

Describe existing feature and its condition: Layman's Cemetery was established in 1853. The steel-picket and limestone-pillar fence was constructed around the perimeter of the cemetery on Lake Street and Cedar Avenue as part of the 1928-1936 Cemetery Redesign. The steel pickets are generally 6'4" tall and in sections that are 28 linear feet. Phase II will focus on restoring the forty sections along East Lake Street. Overall, the steel portions of the fence are in poor condition.		
Photo no. <u>1-13</u> Drawing no. <u>G01 and G04</u>		
Number 2	Architectural feature <u>paint</u> Approximate date of feature <u>1928-1929</u>	Describe work and impact on existing feature: 2. Original Paint Color Analysis: An architectural historian will use the Secretary of Interior Standard methods to sand away layers of paint to determine the original color. It is believed that an area beneath the horizontal channels is the most likely area to find any remaining original paint since this area likely experienced the least fading. A goal of the project is to restore the fe

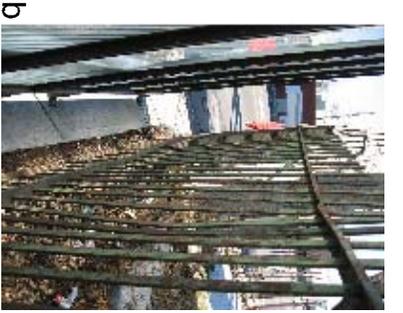
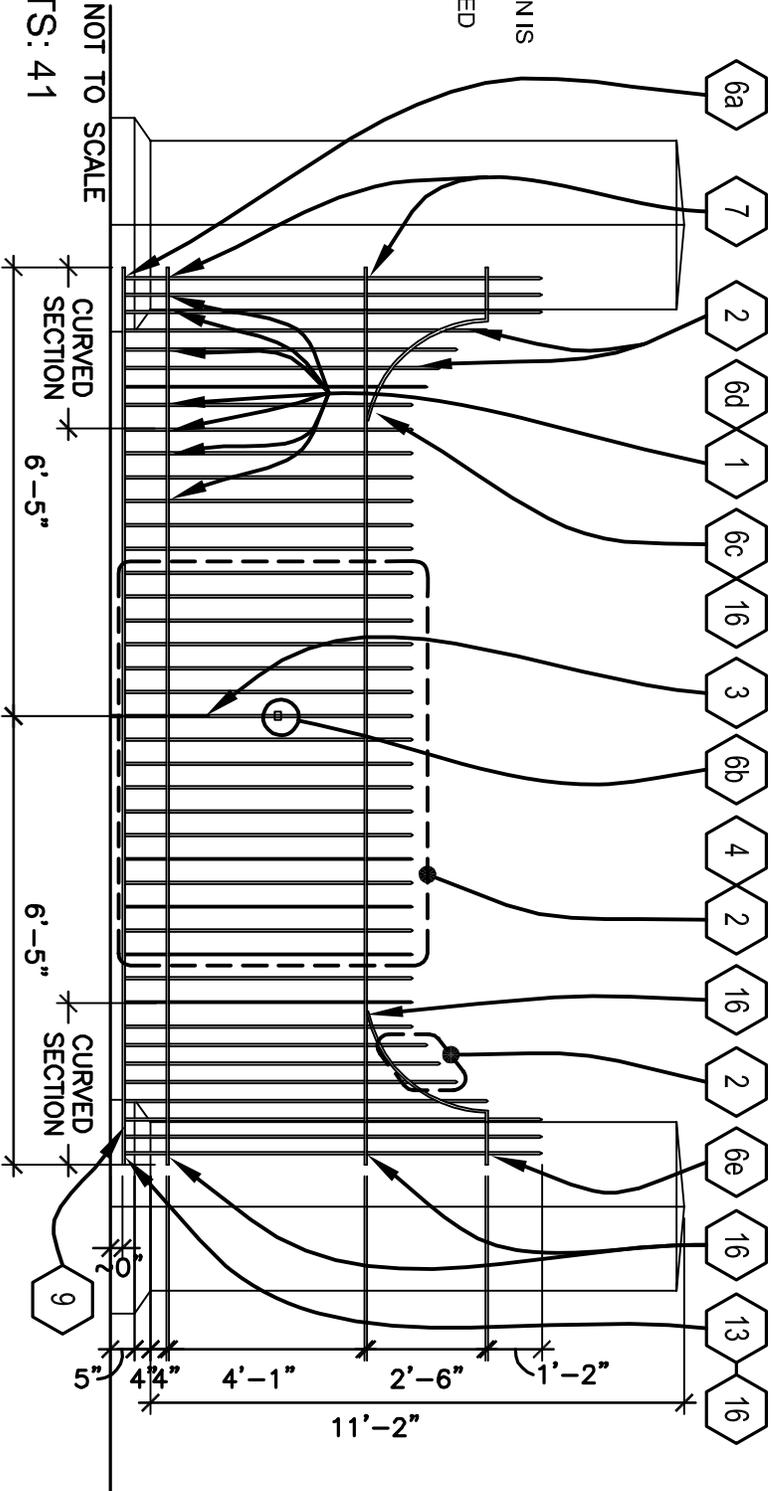
NOTE: ENTIRE SECTION IS BOWED IN BETWEEN PICKETS 15-31 AND NEED STRAIGHTENING - SEE DETAIL BUBBLE & KEYNOTES AT RIGHT.

OVERALL CONDITION: F
