HERITAGE PRESERVATION APPLICATION SUMMARY

Property Location: 121-125 Washington Avenue North
Project Name: The Washington
Prepared By: John Smoley, Ph.D., (612) 673-2830
Applicant: Preservation Design Works
Project Contact: Meghan Elliott
Ward: 3
Neighborhood: Downtown West
Request: To rehabilitate the buildings
Required Applications:

APPENDIX B: THE WASHINGTON – WINDOW RECOMMENDATIONS

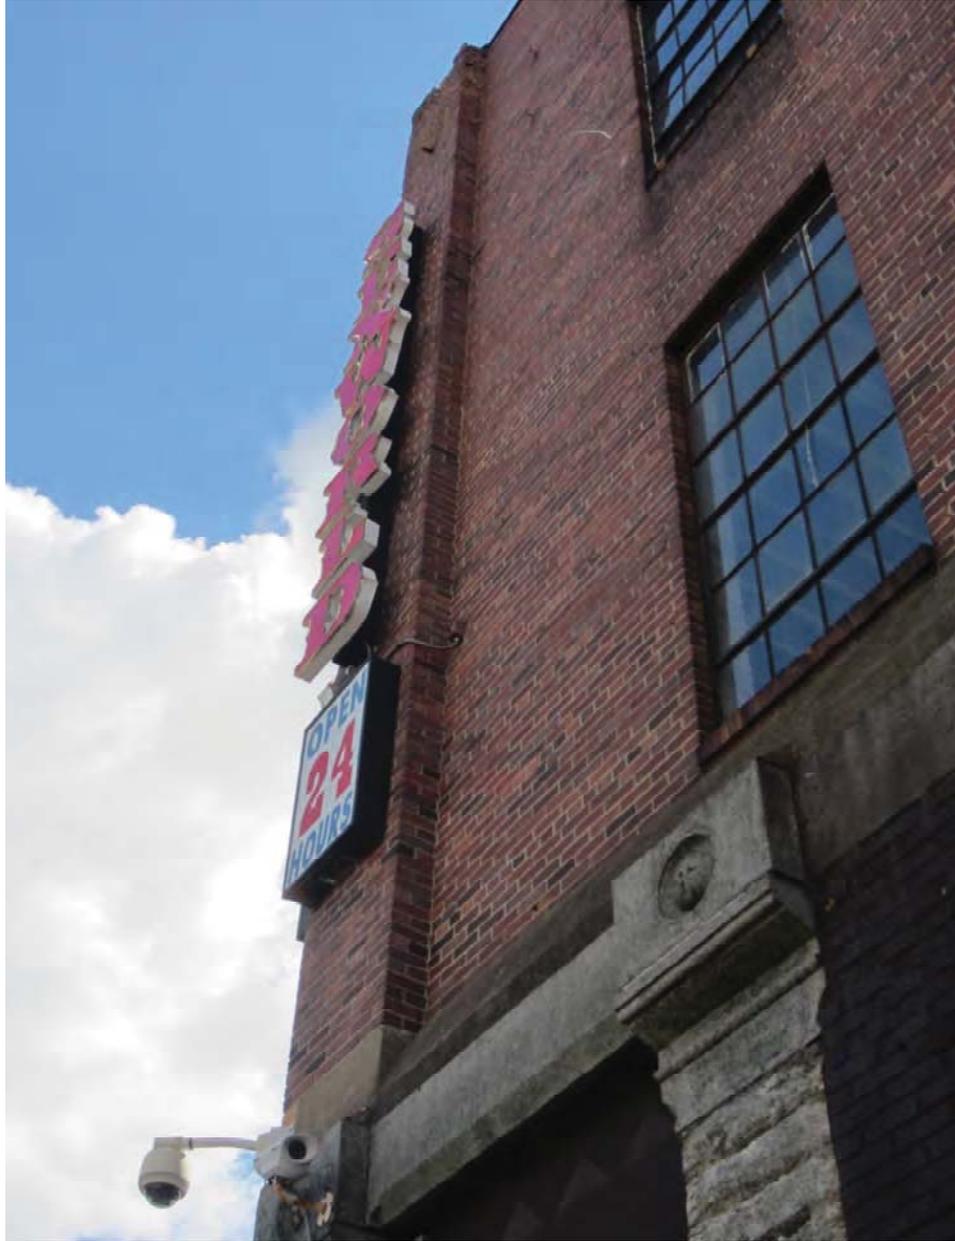
Figure 2: Current photograph of 125 & 129 Washington Avenue North. Note that the face of the brick is stepped back from the stone storefront cornice band and a tapered concrete beam was added above the stone cornice to support the new brick wall. No evidence of brick being toothed in exists. The original stone pilaster has been replaced with brick. Source: Preservation Design Works. Summer 2015.

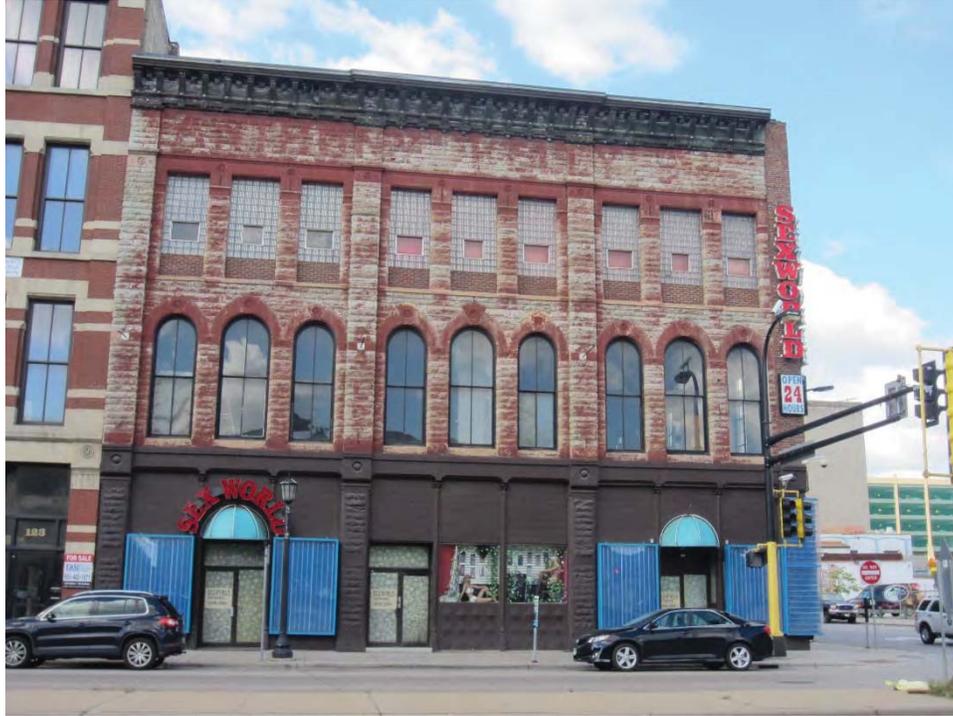
Figure 3: Current photograph of 125 & 129 Washington Avenue North, looking south at the north façade. Note that the stone pilaster at the corner has been replaced with brick and the decorative cornice is missing above the pilaster.
Source: Preservation Design Works (PVD). Summer 2015.

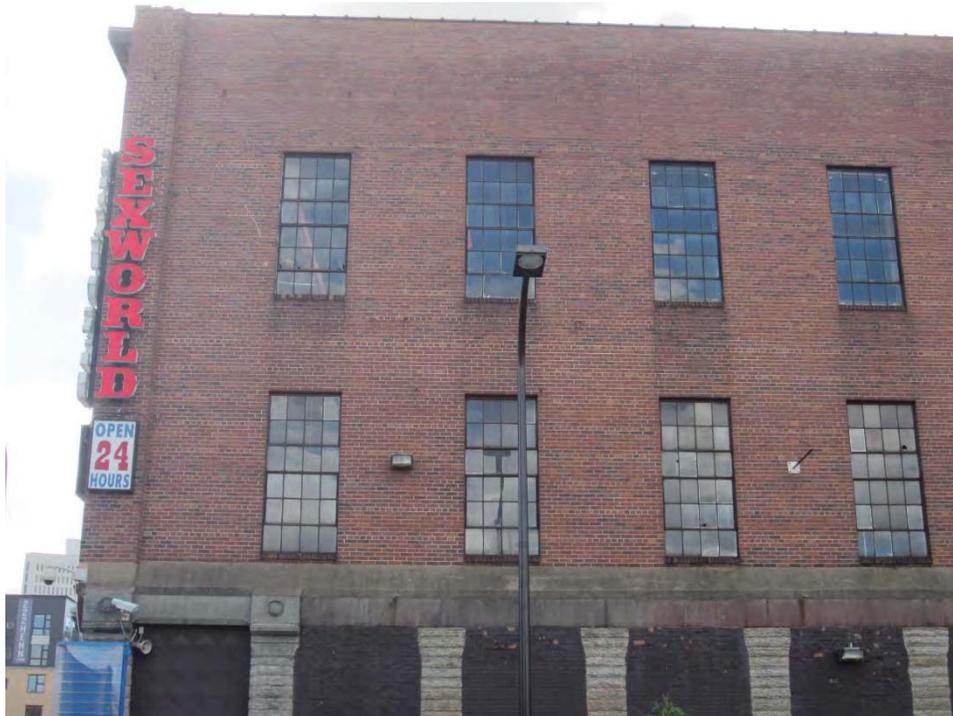
Figure 4: Current photograph of 125 & 129 Washington Avenue North. Note, the tapered beam installed above the stone storefront cornice band that supports the brick above. There is no evidence of toothed in brick, original lintels or sills at openings. The stone pilaster at the corner has been replaced with brick and the decorative cornice has been replaced with a terra cotta cap. Source: Preservation Design Works. Summer 2015.

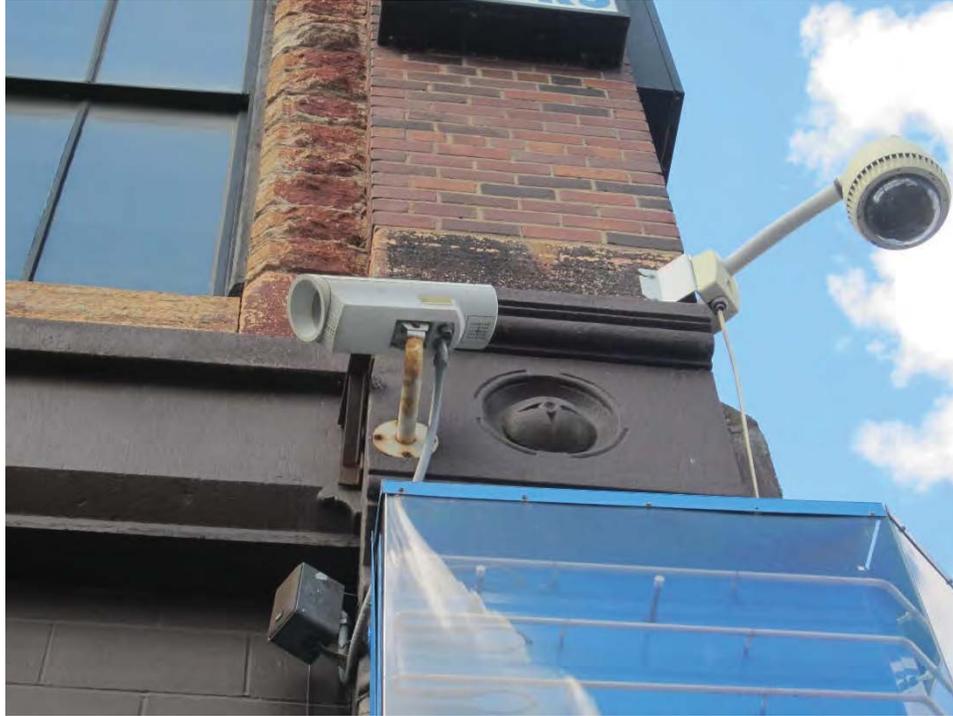
Figure 5: Current photograph of 125 & 129 Washington Avenue North. Note the brick pilaster in lieu of stone as is evident in the c. 1925 photograph and there is no reveal at the corner.
 Source: Preservation Design Works.

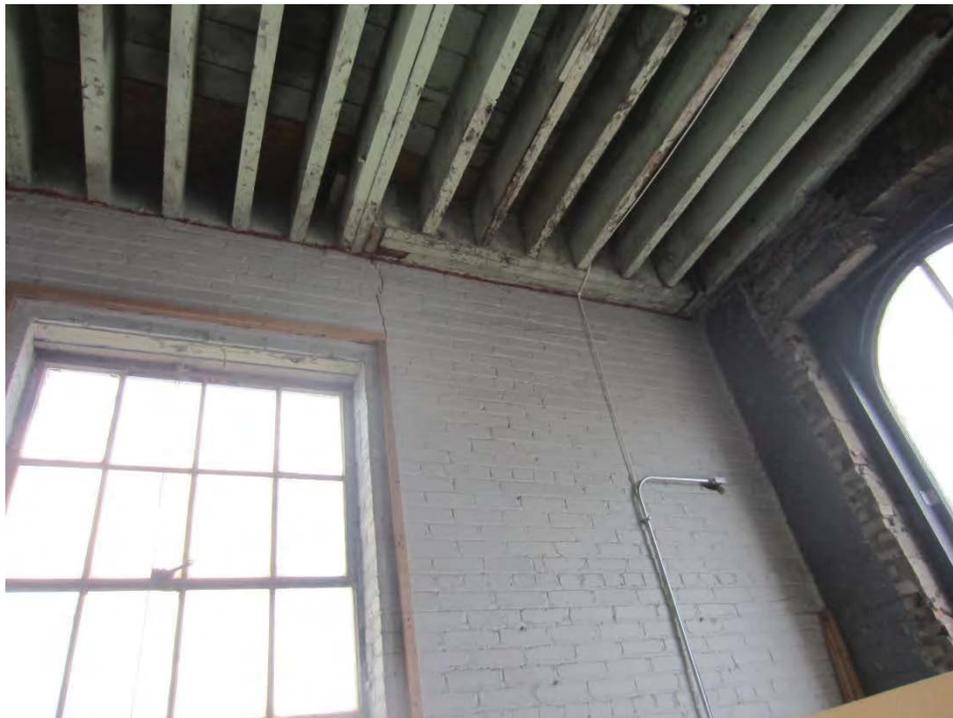
Figure 6: Current photograph of 125 & 129 Washington Avenue North. Note the original framing, including the built-up window header, the cracking at the top of the window, and lack of evidence of original opening sills or lintels. There are five (5) built-up window headers along the west elevation, consistent with the location of the original openings in the c. 1925 photo. Also, note at the right-hand side of the picture, the painted versus unpainted brick, where window trim would have been installed over the brick. Source: Preservation Design Works. Summer 2015.

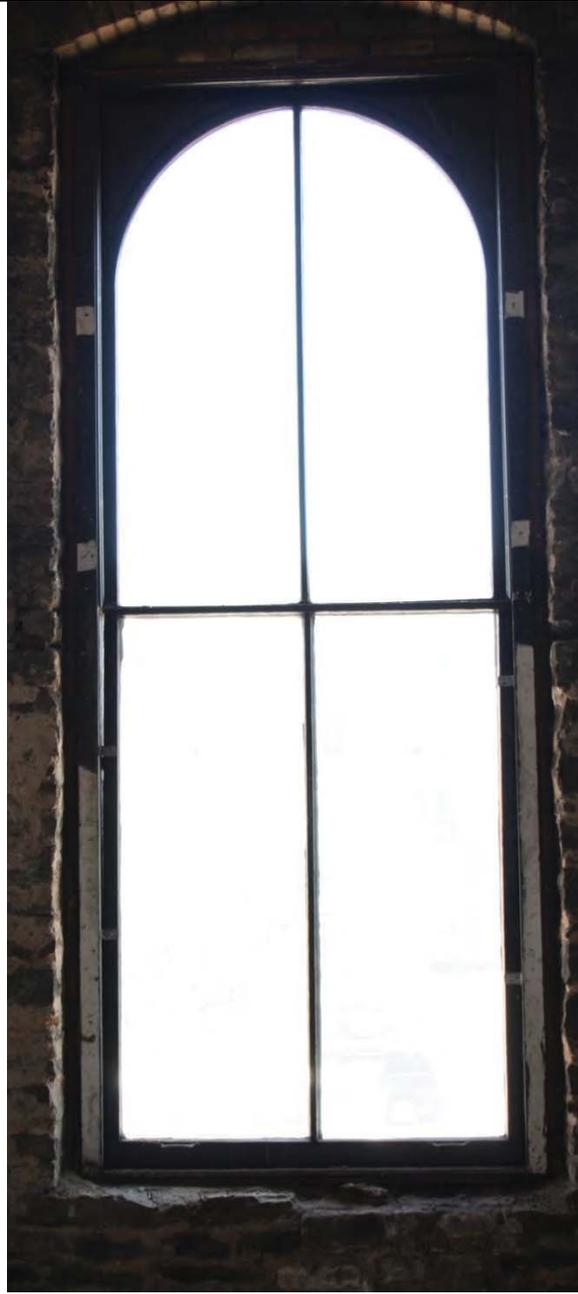
Photographic Documentation: 2.01

Window Number: 2.01	Reference Drawings: A1
<p>Description: Historic wood, painted, double-hung semi-circular arch-top window with vertical center muntin at both sashes. The window opening is arched at the exterior with a stone arch with a voussiour and stone sill. The opening is square at the interior; the frame has a flat top with an arch to accommodate the upper sash. The stool and jambs are stone; the interior header is a combination of a shallow brick arch and running bond brick. There is a double-ogee profiled stop at the interior sides and top, square stop at the exterior sides and top, round trim at the sides and top at the exterior and no finish trim at the interior. The window operated on sash cords and pulleys originally, but contains no other evidence of hardware. This window is one of three larger windows on the north elevation.</p>	
<p>Conditions: There are steel angles installed at the exterior, supporting the upper sash, as well as the interior to secure the lower sash. The stool is stone and is generally in fair to poor condition, with spalled or loose stone and loose, missing or deteriorated mortar joints. The left-hand corner of the bottom rail of the lower sash is deteriorated and weathered. The top rail of the lower sash is deteriorated at both exterior corners and a large chunk of wood is missing at the left-hand exterior side. The right-hand side of the bottom rail of the upper sash has a hole and the wood along the entire length of the sash is soft and weathered. The left side exterior stop is missing completely. The interior stop is partially missing near the bottom of the window at both sides. The exterior trim is typically weathered and deteriorated at the right side (generally toward the bottom). The wood is checked and the grain is raised. Mortar joints are deteriorated and missing in some areas at the arch and flat brick at the header. One brick is chipped. There are two pulls at the bottom rail of the lower sash. The sash cord pulleys remain, but the cords are missing. The glazing compound is missing or deteriorated at both the upper and lower sash. The paint finish is peeling and flaking in a few areas and missing completely in other areas.</p>

Assessment: Fair (rehabilitate)					
	Excellent	Good	Fair	Poor	Missing
Glazing Compound				X	
Frame			X		
Sash			X		
Exterior Trim			X		
Exterior Stop			X		
Exterior Wood Sill			X		
Interior Trim					NA
Interior Stop			X		
Interior Stool				X	
Interior Header			X		
Hardware				X	
Muntins		X			
Finish			X

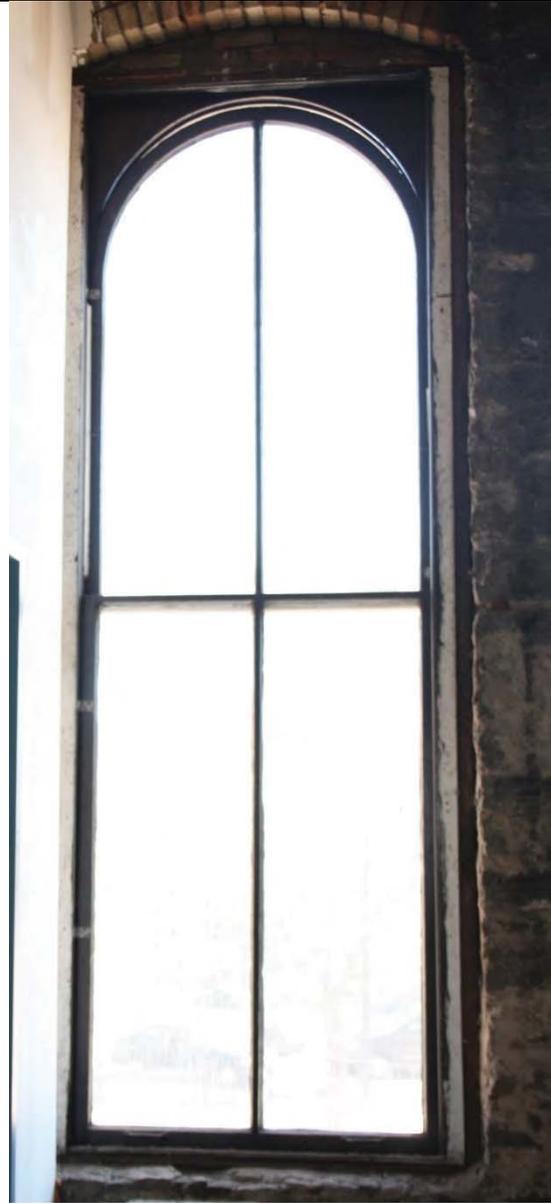
Photographic Documentation: 2.02

Window Number: 2.02	Reference Drawings: A1
<p>Description: Historic wood, painted, double-hung semi-circular arch-top window with vertical center muntin at both sashes. The window opening is arched at the exterior with a stone arch with a voussiour and stone sill. The opening is square at the interior; the frame has a flat top with an arch to accommodate the upper sash. The stool and jambs are stone; the interior header is a combination of a shallow brick arch and running bond brick. There is a double-ogee profiled stop at the interior sides and top, square stop at the exterior sides and top, round trim at the sides and top at the exterior and no finish trim at the interior. The window operated on sash cords and pulleys originally, but contains no other evidence of hardware.</p>	
<p>Conditions: The upper sash is slightly dropped. There are steel angles installed at the exterior, supporting the upper sash, as well as the interior to secure the lower sash. The stool is stone and is generally in fair to poor condition, with spalled or loose stone and loose, missing or deteriorated mortar joints. There is a piece of the right-hand corner of the bottom rail of the lower sash that is loose and raised. The top rail of the lower sash is deteriorated at both exterior corners. There is typically wood loss in these areas. The center of the bottom rail of the upper sash is deteriorated; it is soft and weathered. The left side interior stop is missing completely. The exterior square stop is broken and partially missing at the right-hand side of the window. A replacement (double-ogee style) stop has been temporarily installed. The exterior trim is typically weathered and deteriorated at the right side (generally toward the bottom). The wood is checked and the grain is raised. Mortar joints are deteriorated and missing in some areas at the arch at the header. There are two pulls at the bottom rail of the lower sash. The sash cord pulleys remain, but the cords are missing. The glazing compound is missing or deteriorated at both the upper and lower sash. The paint finish is peeling and flaking in a few areas and missing completely in other areas. There are three broken panes.</p>

Assessment: Fair (rehabilitate)					
	Excellent	Good	Fair	Poor	Missing
Glazing Compound				X	
Frame			X		
Sash			X		
Exterior Trim			X		
Exterior Stop			X		
Exterior Wood Sill			X		
Interior Trim					NA
Interior Stop				X	
Interior Stool			X		
Interior Header			X		
Hardware				X	
Muntins		X			
Finish

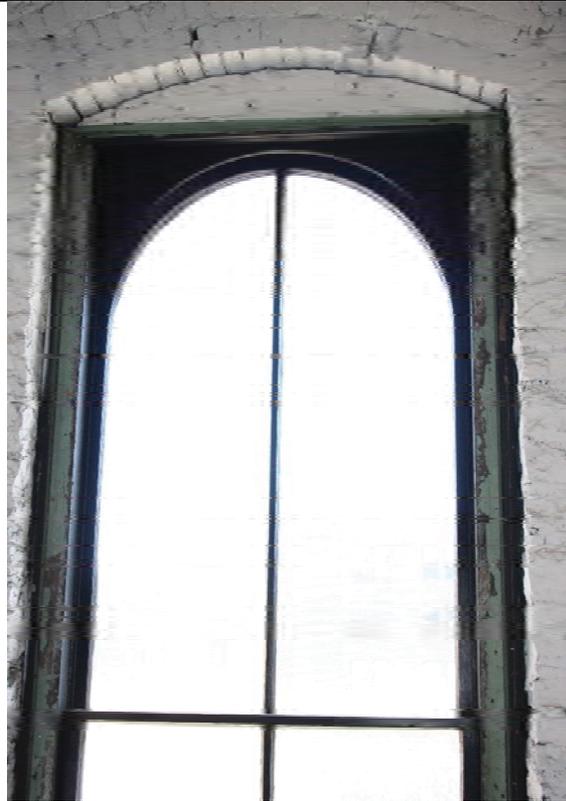
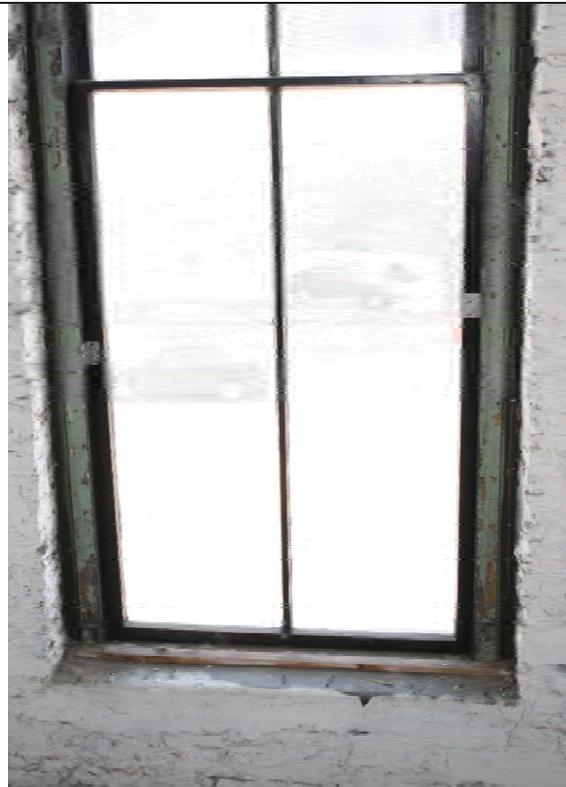
Photographic Documentation: 2.03

Window Number: 2.03	Reference Drawings: A1
<p>Description: Historic wood, painted, double-hung semi-circular arch-top window with vertical center muntin at both sashes. The window opening is arched at the exterior with a stone arch with a voussiour and stone sill. The opening is square at the interior; the frame has a flat top with an arch to accommodate the upper sash. The stool and jambs are stone; the interior header is a combination of a shallow brick arch and running bond brick. There is a double-ogee profiled stop at the interior sides and top, square stop at the exterior sides and top, round trim at the sides and top at the exterior and no finish trim at the interior. The window operated on sash cords and pulleys originally, but contains no other evidence of hardware.</p>	
<p>Conditions: There are steel angles installed at the exterior, supporting the upper sash, as well as the interior to secure the lower sash. The stool is stone and is covered with concrete. There is a wire coming through the right-hand corner of the bottom rail of the lower sash. The top rail of the lower sash is deteriorated at both exterior corners. There is typically wood loss in these areas. The bottom rail of the upper sash is deteriorated; it is checked along the entire length and the grain is raised. The interior stop is partially missing at the right side of the window towards the bottom. The exterior trim is typically weathered and deteriorated at the right side (generally toward the bottom). The wood is checked and the grain is raised. The exterior wood sill is heavily deteriorated with numerous checks and raised grain. The sash cord pulleys remain, but the cords are missing. The glazing compound is typically missing or deteriorated at both the upper and lower sash. The paint finish is peeling and flaking in a few areas and missing completely in other areas. There is one broken pane.</p>

Assessment: Fair (rehabilitate)					
	Excellent	Good	Fair	Poor	Missing
Glazing Compound				X	
Frame			X		
Sash			X		
Exterior Trim			X		
Exterior Stop			X		
Exterior Wood Sill				X	
Interior Trim					NA
Interior Stop				X	
Interior Stool				X	
Interior Header			X		
Hardware				X	
Muntins		X			
Finish			X

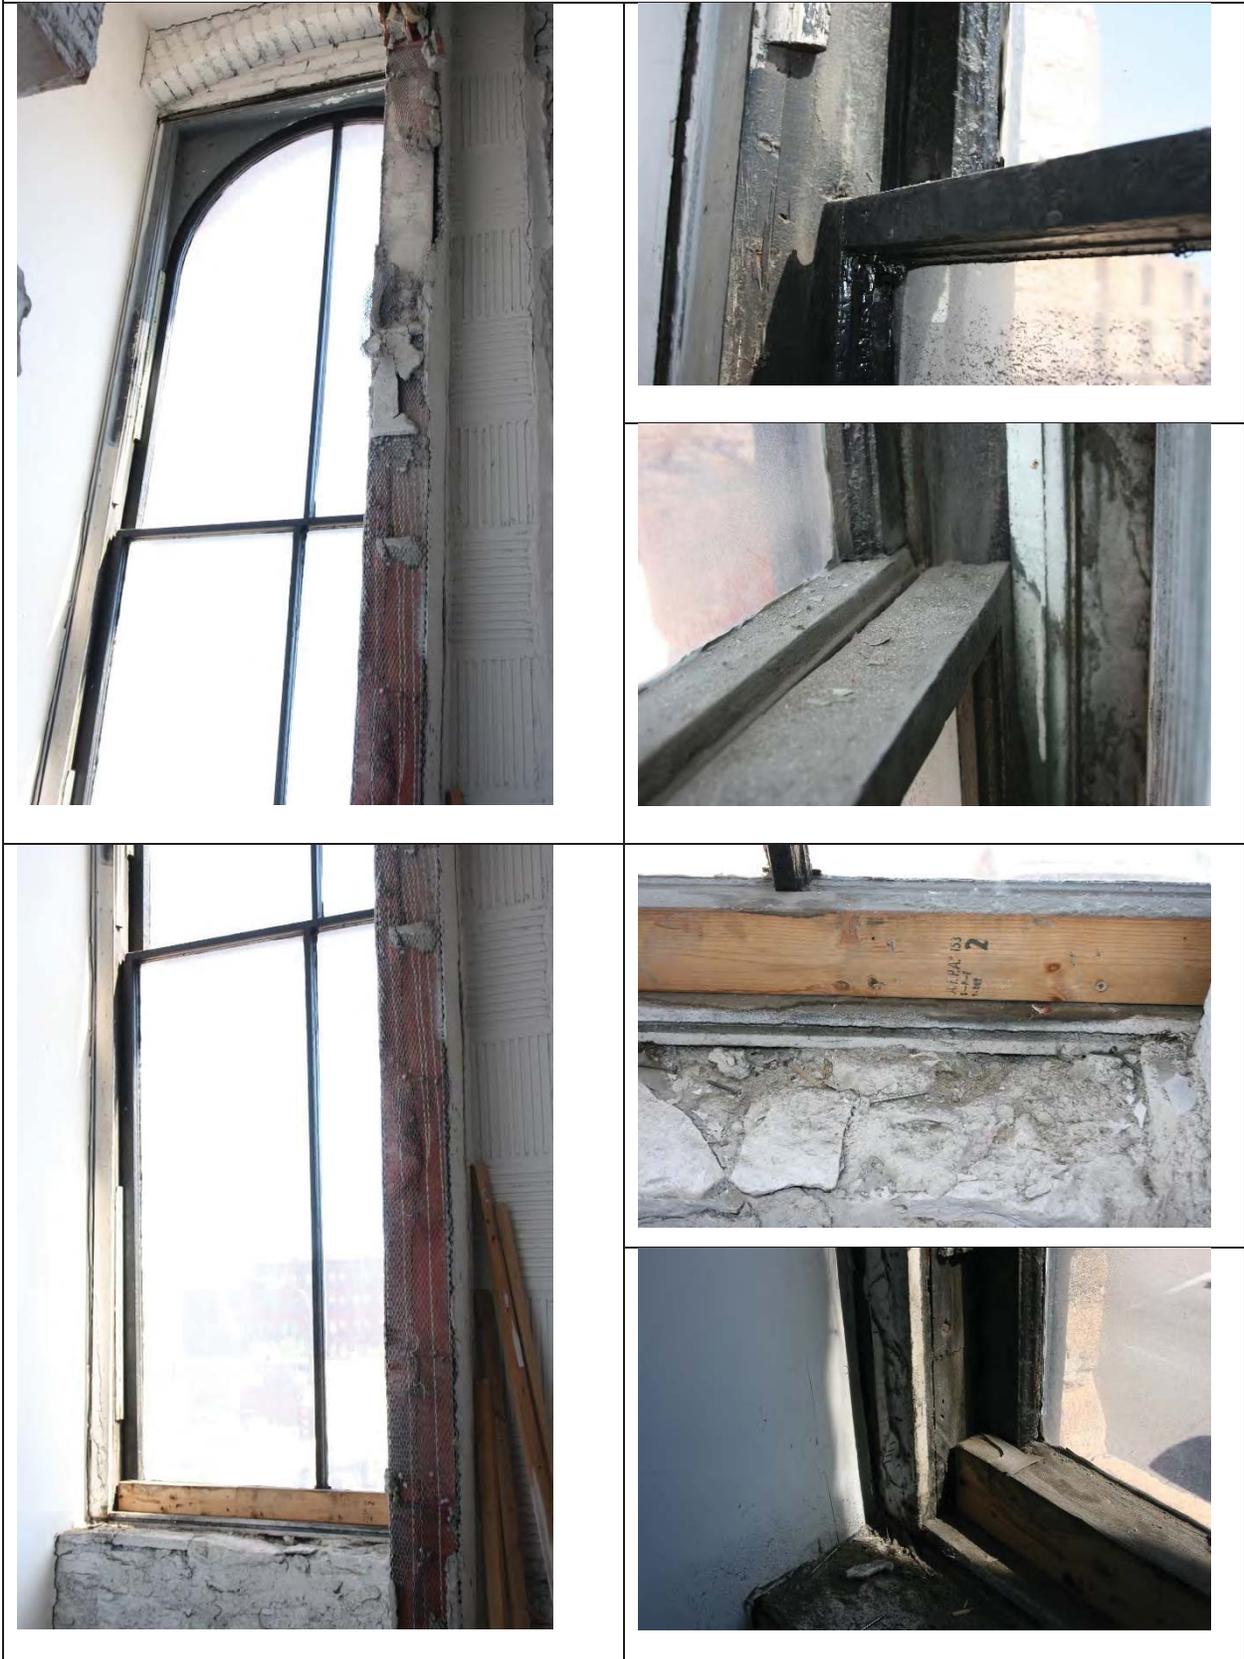
Photographic Documentation: 2.04

Window Number: 2.04	Reference Drawings: A1
<p>Description: Historic wood, painted, double-hung semi-circular arch-top window with vertical center muntin at both sashes. The window opening is arched at the exterior with a stone arch with a voussieur and stone sill. The opening is square at the interior; the frame has a flat top with an arch to accommodate the upper sash. The stool and jambs are stone; the interior header is a combination of a shallow brick arch and running bond brick. There is a double-ogee profiled stop at the interior sides and top, square stop at the exterior sides and top, round trim at the sides and top at the exterior and no finish trim at the interior. The window operated on sash cords and pulleys originally, but contains no other evidence of hardware. A clay tile wall was installed at some point, partially obstructing the right side of the window. All components were able to be evaluated. This window is one of three larger windows on the north elevation.</p>

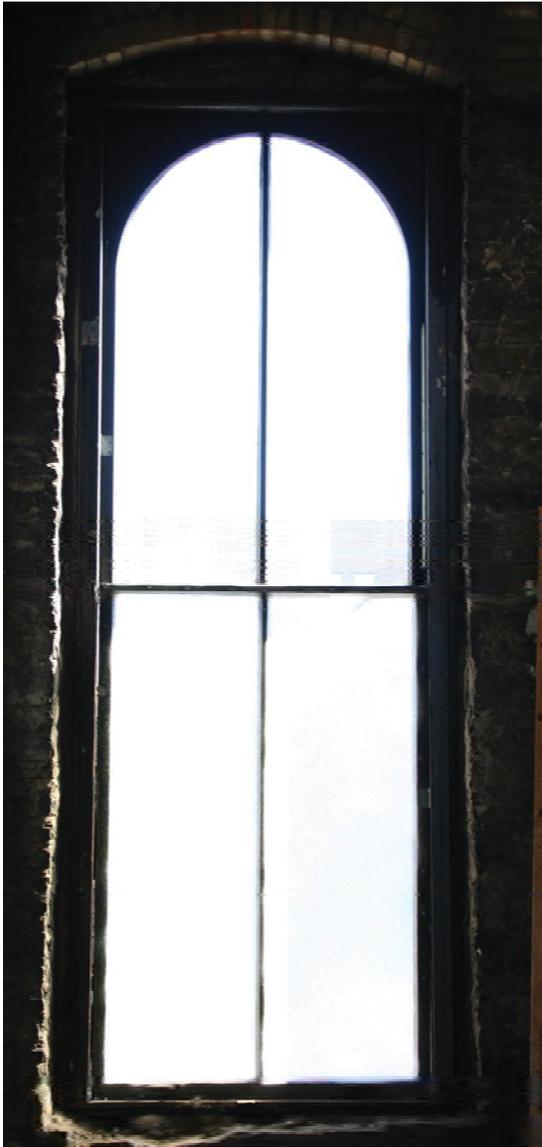
Photographic Documentation: 2.05

Window Number: 2.05	Reference Drawings: A1
<p>Description: Historic wood, painted, double-hung semi-circular arch-top window with vertical center muntin at both sashes. The window opening is arched at the exterior with a stone arch with a voussiour and stone sill. The opening is square at the interior; the frame has a flat top with an arch to accommodate the upper sash. The stool and jambs are stone; the interior header is a combination of a shallow brick arch and running bond brick. There is a double-ogee profiled stop at the interior sides and top, square stop at the exterior sides and top, round trim at the sides and top at the exterior and no finish trim at the interior. The window operated on sash cords and pulleys originally, but contains no other evidence of hardware.</p>	
<p>Conditions: There are steel angles installed at the interior to support and secure both the upper and lower sash. The lower sash is covered in a fiberglass sheet material. There is a board installed at the interior side of the lower sash to secure the fiberglass sheet. One pane of glass is missing completely behind the fiberglass at the lower sash. The stool is stone and is generally in fair to poor condition, with spalled and missing stone and loose or deteriorated mortar joints. A portion of wood at the right frame is missing – it appears to be chiseled or chipped off. The top rail of the lower sash is deteriorated at both exterior corners. Typically there is wood loss in these areas. The bottom rail of the upper sash is heavily checked and deteriorated. Soft wood was not observed at this site visit. Daylight was observed between the sash and frame at the right side. The interior stop is missing completely at both sides. A partial replacement interior stop was installed at the right side of the window. The exterior trim is typically weathered and deteriorated at the right side (generally toward the bottom). The wood is checked and the grain is raised. The exterior wood sill is deteriorated with numerous checks and raised grain. There is a crack in the flat portion of the brick header. There are two pulls at the bottom rail of the lower sash. The sash cord pulleys remain, but the cords are missing. The glazing compound was not visible at all parts of the window, but was in poor condition where observed at the upper sash. The paint finish is peeling and flaking in a few areas and missing completely in other areas. A total of two panes are broken or missing.</p>

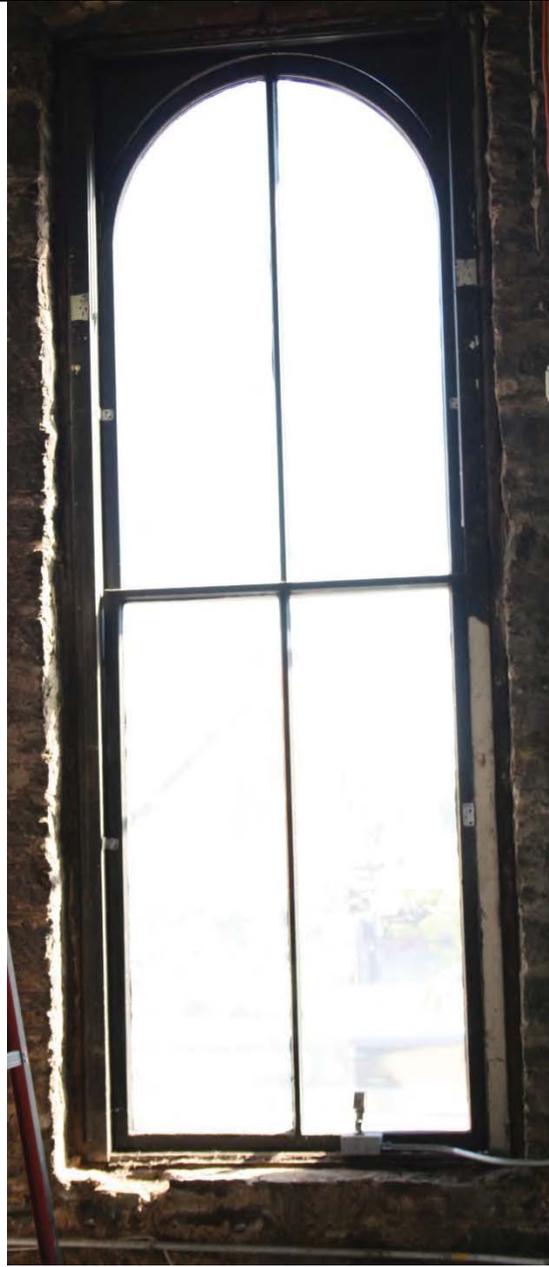
Photographic Documentation: 2.06

Window Number: 2.06	Reference Drawings: A1
<p>Description: Historic wood, painted, double-hung semi-circular arch-top window with vertical center muntin at both sashes. The window opening is arched at the exterior with a stone arch with a voussour and stone sill. The opening is square at the interior; the frame has a flat top with an arch to accommodate the upper sash. The stool and jambs are stone; the interior header is a combination of a shallow brick arch and running bond brick. There is a double-ogee profiled stop at the interior sides and top, square stop at the exterior sides and top, round trim at the sides and top at the exterior and no finish trim at the interior. The window operated on sash cords and pulleys originally, but contains no other evidence of hardware.</p>	
<p>Conditions: The upper sash is slightly dropped. There are steel angles installed at the exterior to support the upper sash and at the interior to secure the lower sash. The stool is stone and is generally in fair to poor condition, with spalled and missing stones and loose or deteriorated mortar joints. A portion of the wood frame near the top right corner appears to be carved or chipped away. The top rail of the lower sash is deteriorated at both exterior corners. Typically there is wood loss in these areas. The bottom rail of the upper sash is checking and soft, weathered wood was observed at the left side. The profile at the bottom rail of the lower sash appears to be deteriorated and weathered. A portion of the center muntin is missing towards the bottom rail of the lower sash. Also, a portion of the wood frame at the bottom of the window has been chipped off. The bottom rail of the lower sash is deteriorated; soft wood was observed in a few locations. The interior stop is missing completely at both sides. The exterior square stop is missing from the spring line of the arch down to the sill at both sides. The exterior trim is typically weathered and deteriorated at the left side (generally toward the bottom). The wood is checked and the grain is raised. The exterior wood sill is deteriorated with numerous checks and raised grain. The sash cord pulleys remain, but the cords are missing. The glazing compound is cracking and falling off and is in poor condition. There is a crack in the flat portion of the brick header above. The paint finish is peeling and flaking in a few areas and missing completely in other areas.</p>

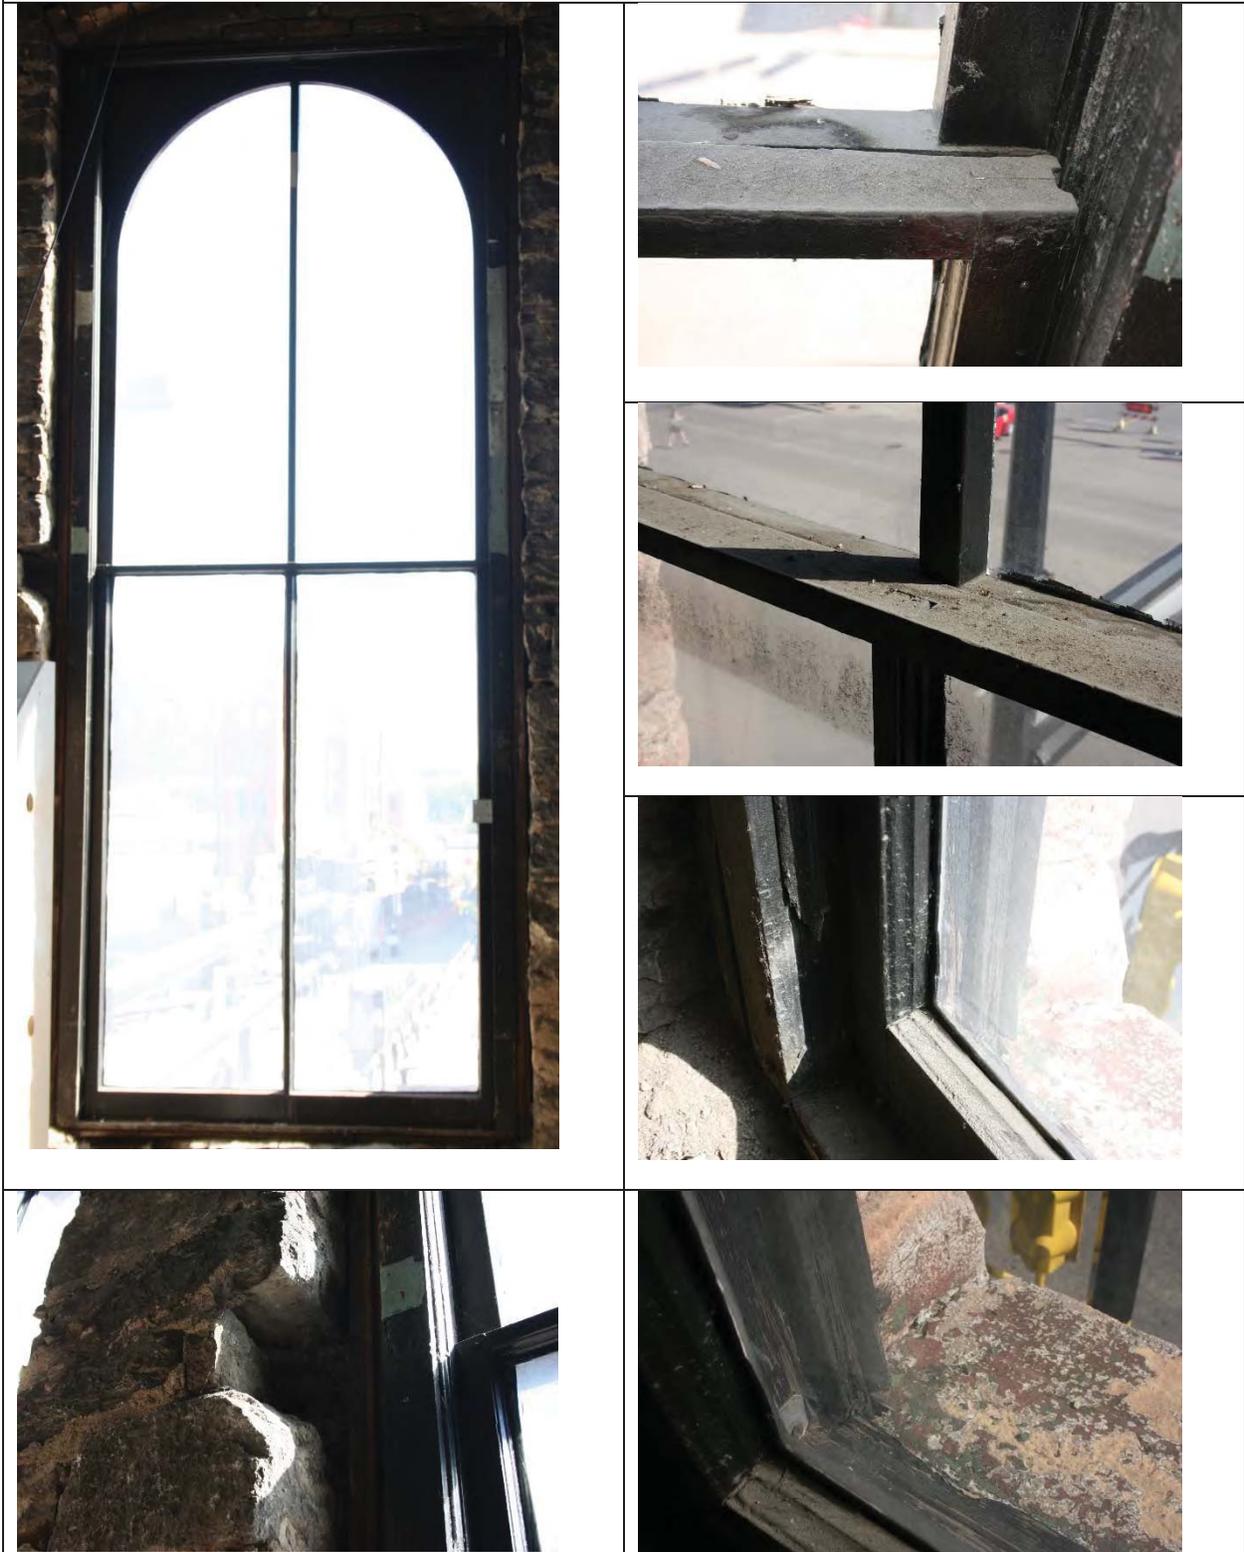
Photographic Documentation: 2.07

Window Number: 2.07	Reference Drawings: A1
<p>Description: Historic wood, painted, double-hung semi-circular arch-top window with vertical center muntin at both sashes. The window opening is arched at the exterior with a stone arch with a voussieur and stone sill. The opening is square at the interior; the frame has a flat top with an arch to accommodate the upper sash. The stool and jambs are stone; the interior header is a combination of a shallow brick arch and running bond brick. There is a double-ogee profiled stop at the interior sides and top, square stop at the exterior sides and top, round trim at the sides and top at the exterior and no finish trim at the interior. The window operated on sash cords and pulleys originally, but contains no other evidence of hardware. This window is one of three larger windows on the north elevation.</p>	
<p>Conditions: The upper sash has been replaced. The wood members are flat with no profile. There are steel angles installed at the exterior to support the upper sash and at the interior to secure the lower sash. Steel angles have been placed at the exterior toward the bottom of the lower sash. The stool is stone and is generally in fair to poor condition, with spalled and missing stones and loose or deteriorated mortar joints. There is stone missing at the left interior jamb. The top rail of the lower sash is deteriorated at both exterior corners. Typically there is wood loss in these areas. The interior stop is missing completely at the right side and partially at the left side. The exterior square stop is missing at the right side. The exterior trim is typically weathered and deteriorated at the left side (generally toward the bottom). The wood is checked and the grain is raised. The exterior wood sill is deteriorated with numerous checks and raised grain. The lower frame at the interior has pulled apart and appears to be chipped or deteriorated. The sash cord pulleys remain, but the cords are missing. The glazing compound is cracked and falling off and is in poor condition. The mortar joints in the flat brick header above are missing or deteriorated. The paint finish is peeling and flaking in a few areas and missing completely in other areas.</p>

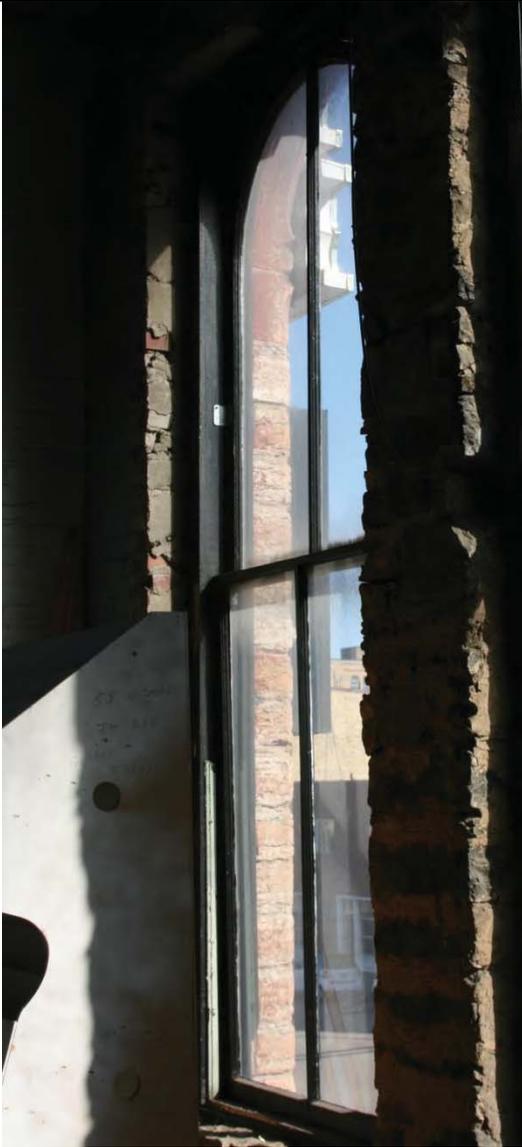
Photographic Documentation: 2.08

Window Number: 2.08	Reference Drawings: A1
<p>Description: Historic wood, painted, double-hung semi-circular arch-top window with vertical center muntin at both sashes. The window opening is arched at the exterior with a stone arch with a voussiour and stone sill. The opening is square at the interior; the frame has a flat top with an arch to accommodate the upper sash. The stool and jambs are stone; the interior header is a combination of a shallow brick arch and running bond brick. There is a double-ogee profiled stop at the interior sides and top, square stop at the exterior sides and top, round trim at the sides and top at the exterior and no finish trim at the interior. The window operated on sash cords and pulleys originally, but contains no other evidence of hardware.</p>	
<p>Conditions: The upper sash has dropped slightly. There are steel angles installed at the interior and exterior to support the upper sash. The stool is stone and is generally in fair to poor condition, with spalling and missing stones and loose or deteriorated mortar joints. The top rail of the lower sash is deteriorating at both exterior corners. Typically there is wood loss in these areas. The interior stop is partially missing at both sides. The exterior trim is typically weathered and deteriorated at both sides (generally toward the bottom). The round trim at the left side is missing a portion toward the sill. The wood at the exterior trim is checked and the grain is raised. The exterior wood sill is deteriorated with numerous checks and raised grain. The sash cord pulleys remain, but the cords are missing. The glazing compound is cracked and falling off and is in poor condition. The right-hand corner of the brick header has been previously repaired with a combination of poured concrete and brick laid in a running bond pattern. The concrete has infilled a portion of the flat brick area below the arch. The paint finish is peeling and flaking in a few areas and missing completely in other areas.</p>

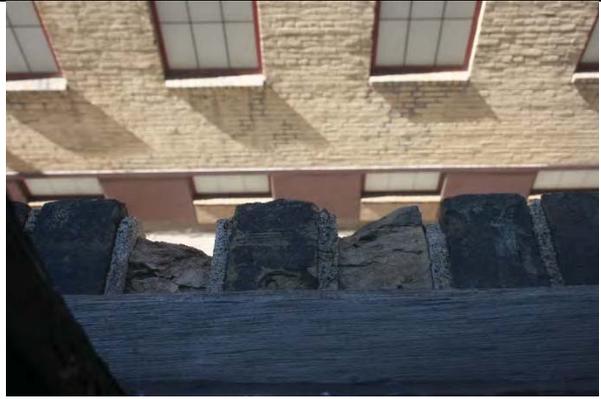
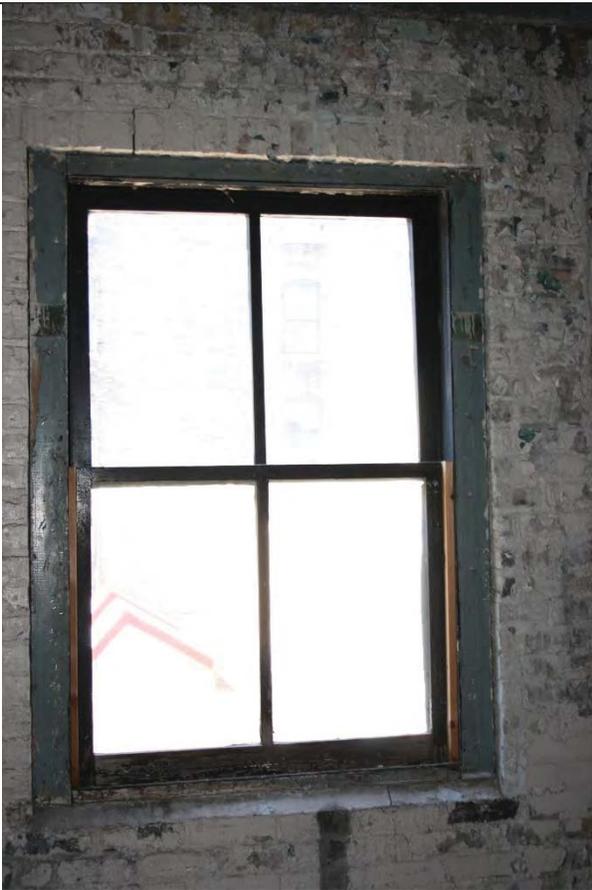
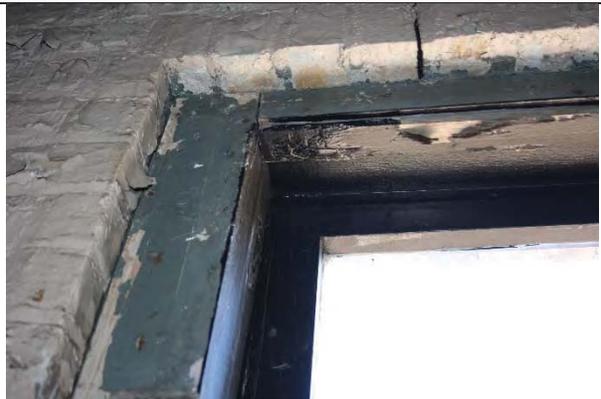
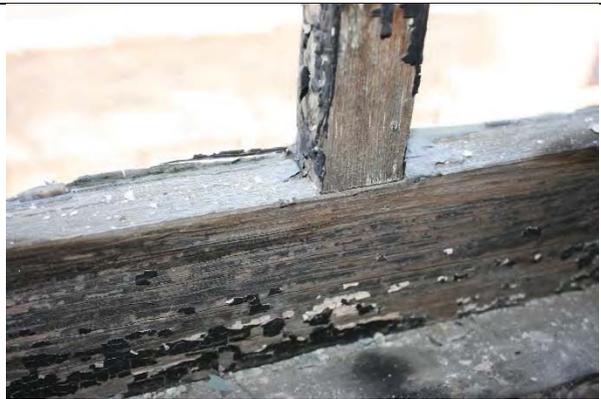
Photographic Documentation: 2.23

Window Number: 2.23	Reference Drawings: A3
<p>Description: Non-historic, wood, painted, double-hung, true divided lite window. This is a two over two window with a center vertical mullion. The top of the window is flat with a rowlock course of brick at the interior header. No other lintel was observed. All components of the window are simple, flat pieces of wood lacking a decorative profile, typical to the original wood windows in the building. No hardware or evidence of hardware was observed other than the pulleys for the sash cord system. The interior surround is brick and the interior stool is brick with a sloped parge coat. The exterior surround is also brick with a brick rowlock sill and header course for the header. The exterior wood frame acts as an additional sill, similar to the original wood windows.</p>	
<p>Conditions: The stool is generally in good condition; there is one crack. There are two square wood stops at the interior and exterior of the lower sash. The exterior wood sill is in good to fair condition; it is lightly checked and lacks a finish. Wood at the exterior is checked. The exterior brick sill is in poor condition. There are four bricks that have significantly spalled. There is a crack in a mortar joint in the rowlock lintel. The sash cord hardware remains, but is no longer operable. There is no other hardware on the window. The exterior square stop is missing at the left side and top. The glazing compound is generally in poor condition, as it is falling off. The paint finish is peeling and flaking. There is one broken pane.</p>

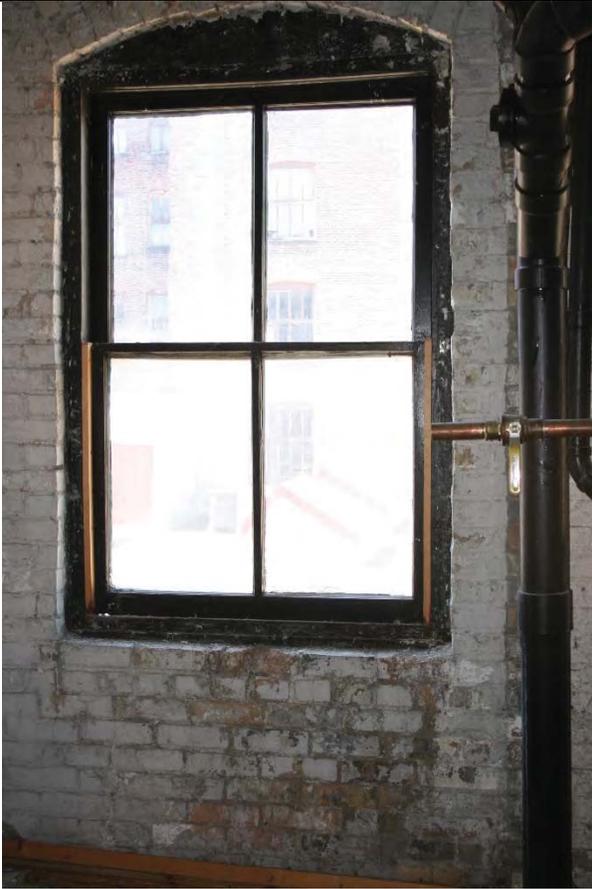
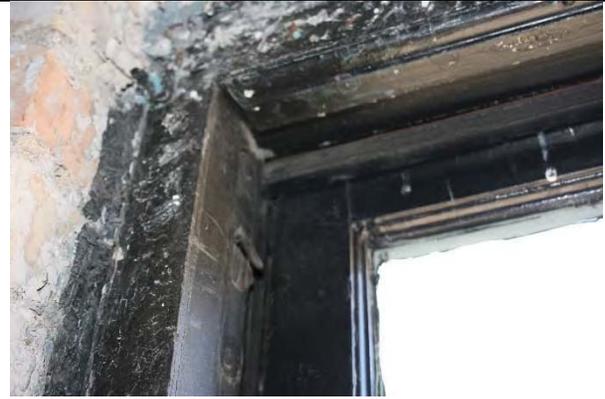
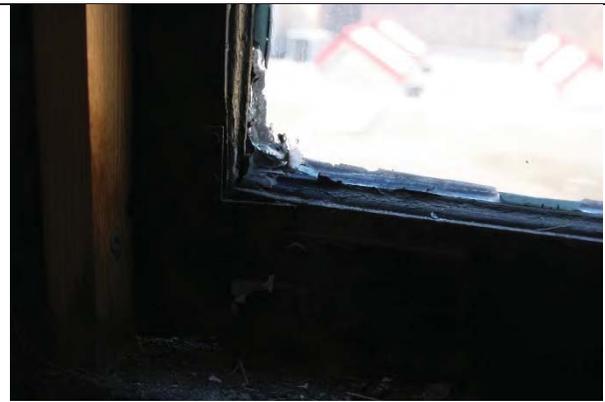
Photographic Documentation: 2.24

Window Number: 2.24	Reference Drawings: A3
<p>Description: Historic wood, painted, double-hung, two over two, true divided lite window with a radiating arched header at the exterior. The exterior surround is brick with a brick rowlock sill. The wood frame is flat at the top of the sash and rounded to fit into the brick arch header at both the interior and exterior. The interior window surround is painted brick, the interior stool is brick, and the header is also a radiating brick arch. There is a double-ogee profiled stop at the interior sides and top, square stop at the exterior sides and top, and round trim at the sides and top at the exterior. The window operated on a metal tape sash cord system (which is no longer operable), and contains no other evidence of hardware.</p>	
<p>Conditions: There are steel angles installed at the interior to support the upper sash. In addition an angle is installed at the lower sash corner at the left-hand side. Daylight was also observed in this location. The brick stool is generally in fair condition, with two chipped bricks. There are two square wood stops at the interior of the lower sash and one temporary wood stop at the exterior supporting the upper sash. The profiled interior wood stop is missing at both sides. The top rail of the lower sash is deteriorated at the left-hand side corner. There is typical wood loss in this location. In addition, the entire top rail is deteriorated; the wood is soft, it is checked, and the grain is raised. The bottom rail of the upper sash is deteriorated and has dropped slightly from the glass. The exterior wood sill is in poor condition; it is heavily checked and deteriorated. There are mortar droppings on the exterior brick sill. The sash cord hardware remains, but is no longer operable. There is no other hardware on the window. The glazing compound is generally in poor condition, as it is falling off. The paint finish is peeling and flaking. There is one broken pane.</p>

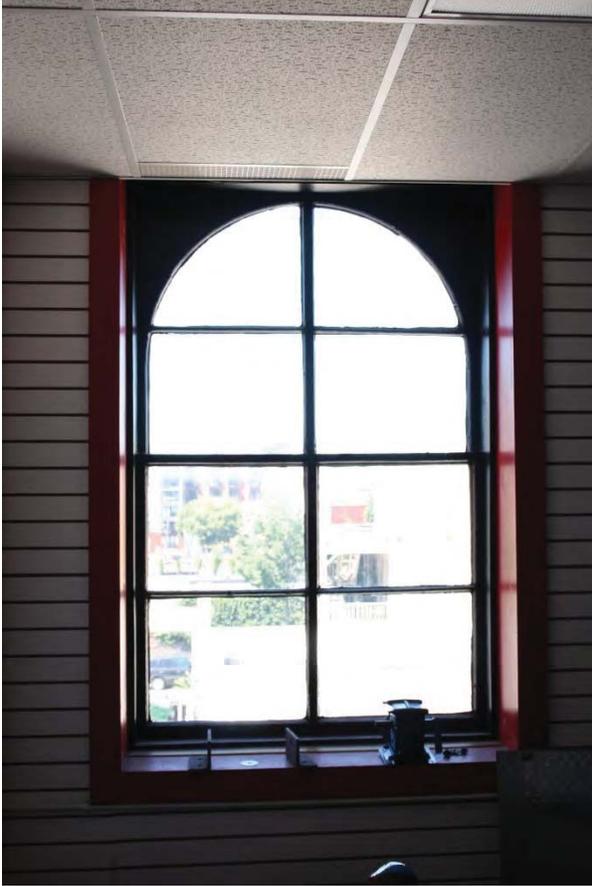
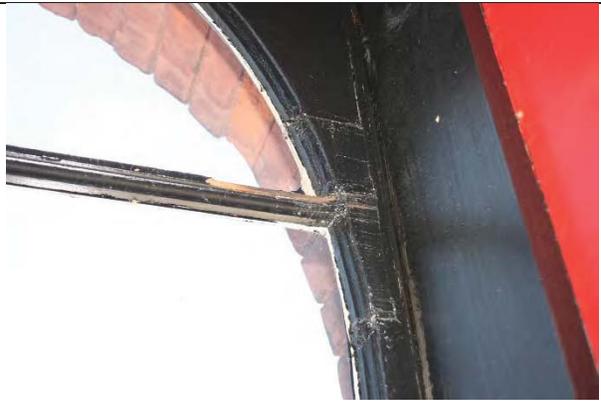
Photographic Documentation: 3.17

Window Number: 3.17	Reference Drawings: A2
<p>Description: Modified historic wood, painted, double-hung, four over four window with an arch top. The sashes are original, but have been set in new frame and casing trim and fixed shut. The top of the upper sash is flat to fit the square opening at the interior. All sides of the opening have been cased with flat, painted wood trim. The dropped ceiling is slightly below the level of the top of the window opening. The exterior surround is brick with a stone sill and radiating brick arch header with a projecting brick hood.</p>	
<p>Conditions: There are steel angles installed at the exterior to support the upper sash. The stool is covered with flat, painted, wood trim. The stone sill is in good condition. There is a wood stop installed at the exterior of the bottom frame. The bottom rail of the lower sash is deteriorated (the wood is soft). The horizontal muntins, at both the upper and lower sash, are checked and deteriorated. The horizontal muntin at the upper sash is missing a chunk of wood at the right-hand side. The upper sash is cracked and broken at both sides at the spring line of the arch, at the horizontal muntin intersection and slightly above the muntin. There are no historic interior or exterior stops visible. The upper and lower sash are caulked together and the window is fixed shut. No sash cord hardware remains, as the frame has been replaced with flat casing trim. The exterior trim and sill are checked, most significantly at the right-hand side. The glazing compound is typically in poor condition; it is cracked, loose or missing. The paint finish at the interior is in good to fair condition with small areas flaking or missing. The exterior paint finish is in fair condition due to typical weathering.</p>
