HERITAGE PRESERVATION APPLICATION SUMMARY

Property Location: 121-125 Washington Avenue North
Project Name: The Washington
Prepared By: John Smoley, Ph.D., (612) 673-2830
Applicant: Preservation Design Works
Project Contact: Meghan Elliott
Ward: 3
Neighborhood: Downtown West
Request: To rehabilitate the buildings
Required Applications:

APPENDIX B: THE WASHINGTON – WINDOW RECOMMENDATIONS

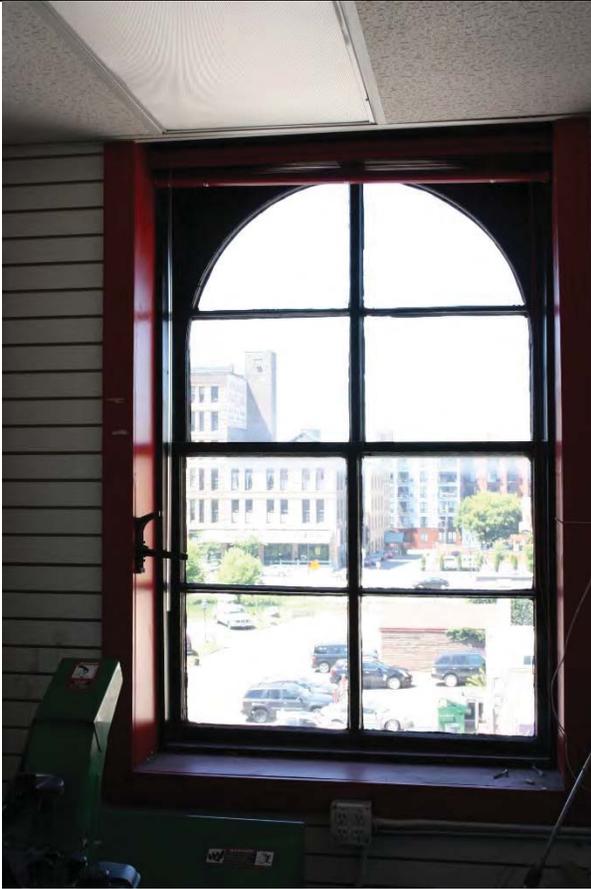
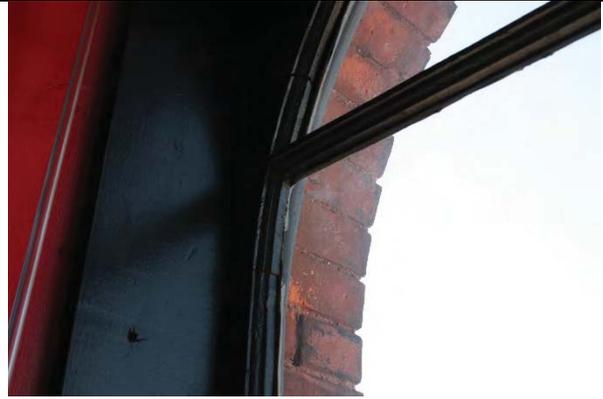
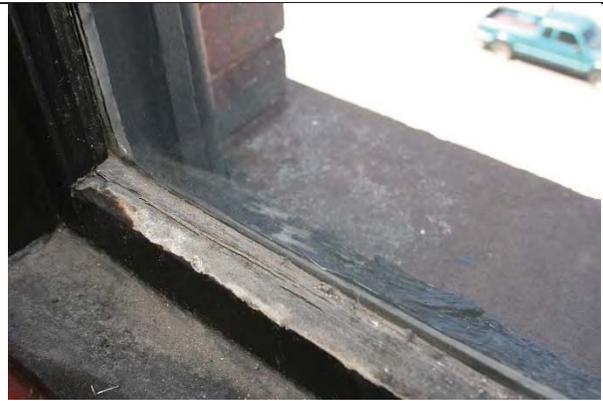
Photographic Documentation: 3.18

Window Number: 3.18	Reference Drawings: A2
<p>Description: Modified historic wood, painted, double-hung, four over four window with an arch top. The sashes are original, but have been set in new frame and casing trim and fixed shut. The top of the upper sash is flat to fit the square opening at the interior. All sides of the opening have been cased with flat, painted wood trim. The interior stool and header are not visible. The dropped ceiling is slightly below the level of the top of the window opening. The exterior surround is brick with a stone sill and radiating brick arch header with a projecting brick hood.</p>	
<p>Conditions: There are steel angles installed at the exterior to support the upper sash. The stool is covered with flat, painted, wood trim. The stone sill is in good condition. There is a wood stop installed at the exterior of the bottom frame. The bottom rail of the lower sash is deteriorated (the wood is soft). The horizontal muntins, at both the upper and lower sash, are checked and deteriorated. The horizontal muntin at the upper sash also has a large crack. The upper sash is cracked and broken at both sides at the spring line of the arch, at the horizontal muntin intersection and slightly above the muntin. There are no historic interior or exterior stops visible. The upper and lower sash are caulked together and the window is fixed shut. No sash cord hardware remains, as the frame has been replaced with flat casing trim. The exterior trim and sill are checked, most significantly at the right-hand side. The glazing compound is typically in poor condition; it is cracked, loose or missing. The paint finish at the interior is in good to fair condition with small areas flaking or missing. The exterior paint finish is in fair condition due to typical weathering.</p>

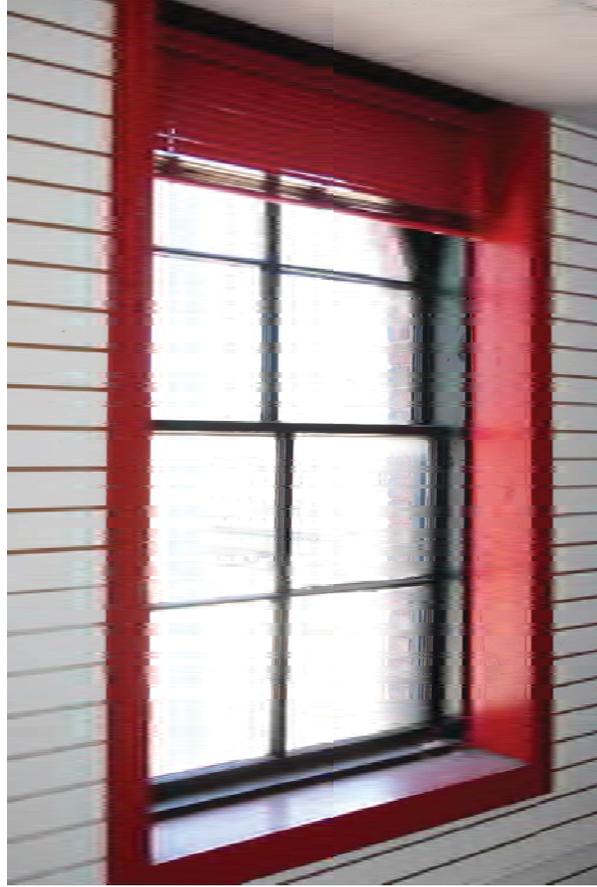
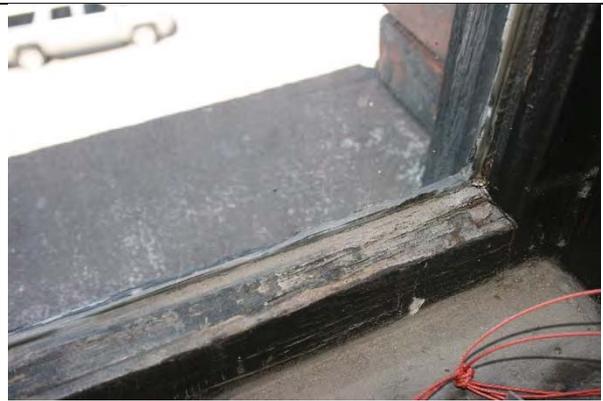
Photographic Documentation: 3.19

Window Number: 3.19	Reference Drawings: A2
<p>Description: Modified historic wood, painted, double-hung, four over four window with an arch top. The sashes are original, but have been set in new frame and casing trim and fixed shut. The top of the upper sash is flat to fit the square opening at the interior. All sides of the opening have been cased with flat, painted wood trim. The dropped ceiling is slightly below the level of the top of the window opening. The interior stool and header are not visible. The exterior surround is brick with a stone sill and radiating brick arch header with a projecting brick hood.</p>	
<p>Conditions: There are steel angles installed at the exterior to support the upper sash. The stool is covered with flat, painted, wood trim. The stone sill is in good condition. There are two wood stops installed at the exterior to secure the lower sash. The bottom rail of the lower sash is deteriorated (the wood is soft) and the grain is raised. The horizontal muntin at the lower sash is checked and deteriorated; the grain is raised. The top rail of the lower sash is deteriorated; there is wood loss and daylight can be seen through the caulk. The upper sash is cracked and broken at both sides at the spring line of the arch, at the horizontal muntin intersection and slightly above the muntin. There are no historic interior or exterior stops visible. The upper and lower sash are caulked together and the window is fixed shut. No sash cord hardware remains, as the frame has been replaced with flat casing trim. The exterior trim and sill are checked, most significantly at the right-hand side. The glazing compound is typically in poor condition; it is cracked, loose or missing. The paint finish at the interior is in good to fair condition with small areas flaking or missing. The exterior paint finish is in fair condition due to typical weathering. There is one broken pane.</p>

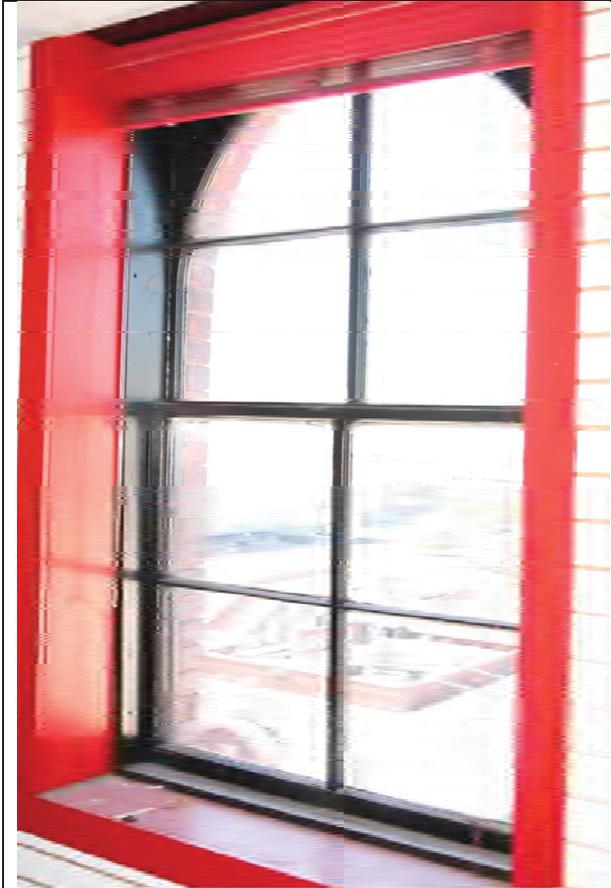
Photographic Documentation: 3.20

Window Number: 3.20	Reference Drawings: A2
<p>Description: Modified historic wood, painted, double-hung, four over four window with an arch top. The sashes are original, but have been set in new frame and casing trim and fixed shut. The top of the upper sash is flat to fit the square opening at the interior. All sides of the opening have been cased with flat, painted wood trim. The dropped ceiling is slightly below the level of the top of the window opening. The interior stool and header are not visible. The exterior surround is brick with a stone sill and radiating brick arch header with a projecting brick hood.</p>	
<p>Conditions: There are steel angles installed at the exterior to support the upper sash. The stool is covered with flat, painted, wood trim. The stone sill is in good condition. There is a wood stop installed at the exterior to secure the lower sash in place. The bottom rail of the lower sash is lightly checked and deteriorated (the wood is soft), especially at the intersection of the rail and vertical muntin. A piece of wood has been added to the top rail of the lower sash. The horizontal muntins at the upper sash is checked and deteriorated. The upper sash is cracked and broken at both sides at the spring line of the arch, at the horizontal muntin intersection and slightly above the muntin. There are no historic interior or exterior stops visible. The upper and lower sash are caulked together and the window is fixed shut. No sash cord hardware remains, as the frame has been replaced with flat casing trim. The exterior trim and sill are checked, most significantly at the right-hand side. The glazing compound is typically in poor condition; it is cracked, loose or missing. The paint finish at the interior is in good to fair condition with small areas flaking or missing. The exterior paint finish is in fair condition due to typical weathering.</p>

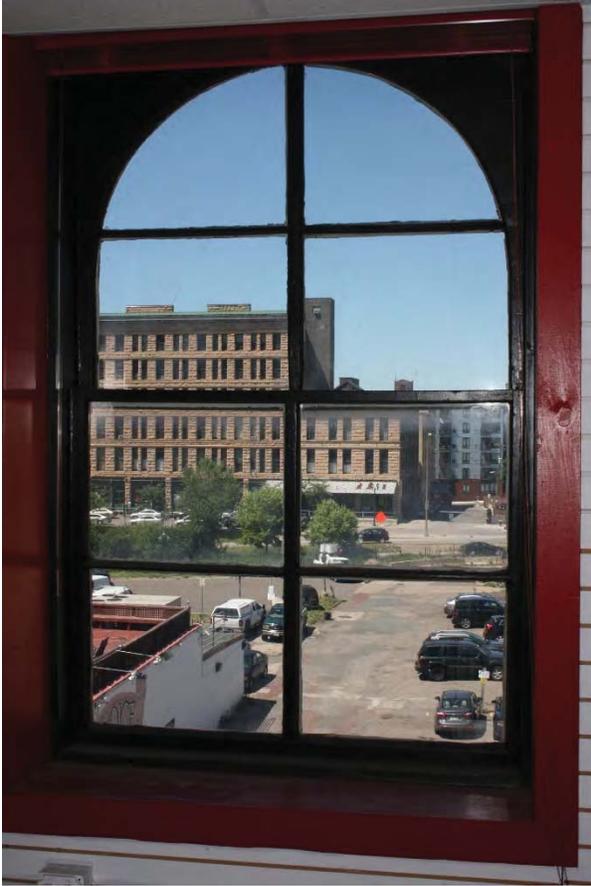
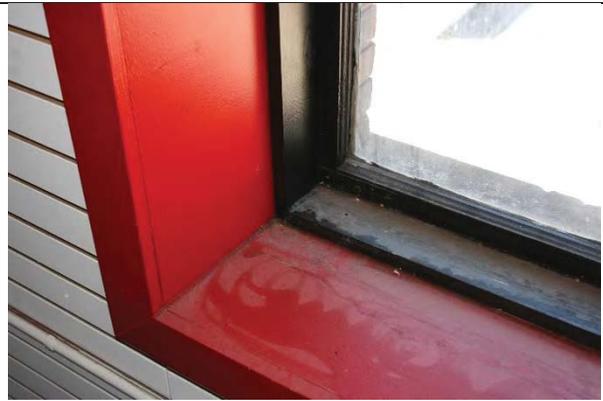
Photographic Documentation: 3.21

Window Number: 3.21	Reference Drawings: A2
<p>Description: Modified historic wood, painted, double-hung, four over four window with an arch top. The sashes are original, but have been set in new frame and casing trim and fixed shut. The top of the upper sash is flat to fit the square opening at the interior. All sides of the opening have been cased with flat, painted wood trim. The dropped ceiling is slightly below the level of the top of the window opening. The interior stool and header are not visible. The exterior surround is brick with a stone sill and radiating brick arch header with a projecting brick hood.</p>	
<p>Conditions: There are steel angles installed at the interior and exterior to support the upper sash. The stool is covered with flat, painted, wood trim. The stone sill is in good condition. There is a wood stop installed at the exterior of the bottom rail to secure the lower sash in place. The bottom rail of the lower sash is lightly checked and deteriorated. The horizontal muntins, at both the upper and lower sash are checked and deteriorated. The upper sash is cracked and broken at both sides at the spring line of the arch, at the horizontal muntin intersection and slightly above the muntin. There are no historic interior or exterior stops visible. The upper and lower sash are caulked together and the window is fixed shut. No sash cord hardware remains, as the frame has been replaced with flat casing trim. The exterior trim and sill are heavily checked, most significantly at the right-hand side. The glazing compound is typically in poor condition; it is cracked, loose or missing. The paint finish at the interior is in good to fair condition with small areas flaking or missing. The exterior paint finish is in fair condition due to typical weathering. There is one broken pane.</p>

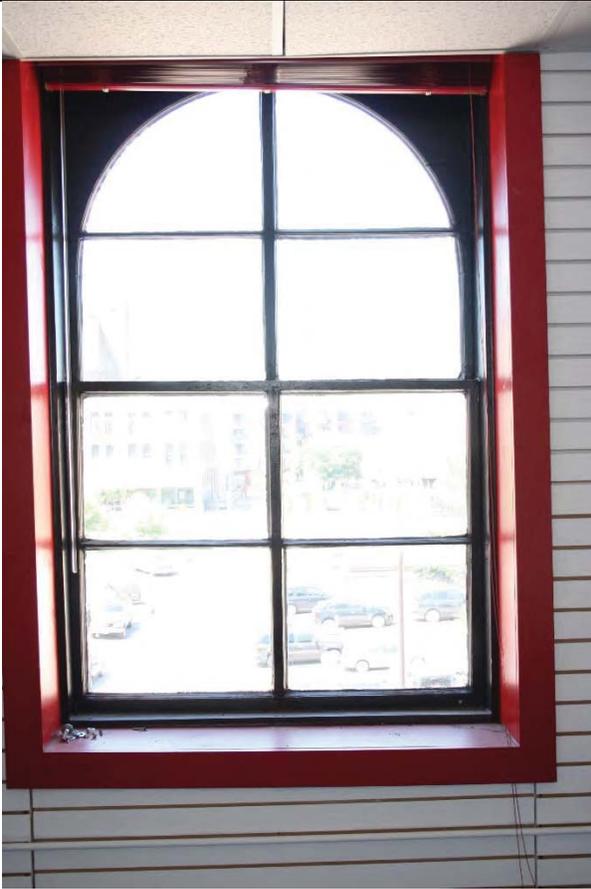
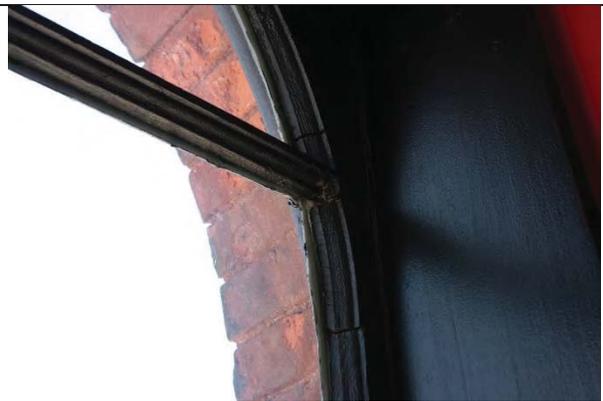
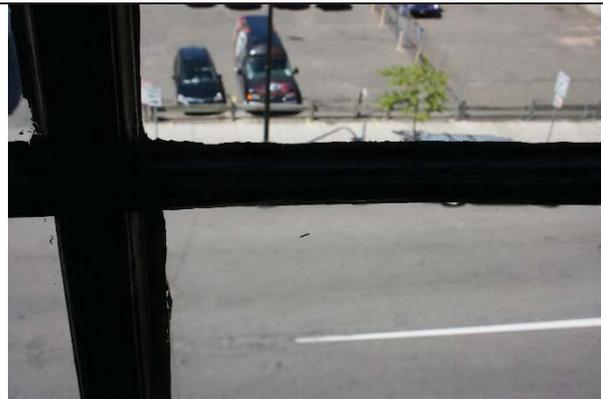
Photographic Documentation: 3.22

Window Number: 3.22	Reference Drawings: A2
<p>Description: Modified historic wood, painted, double-hung, four over four window with an arch top. The sashes are original, but have been set in new frame and casing trim and fixed shut. The top of the upper sash is flat to fit the square opening at the interior. All sides of the opening have been cased with flat, painted wood trim. The dropped ceiling is slightly below the level of the top of the window opening. The interior stool and header are not visible. The exterior surround is brick with a stone sill and radiating brick arch header with a projecting brick hood.</p>	
<p>Conditions: There are steel angles installed at the exterior to support the upper sash. The stool is covered with flat, painted, wood trim. The stone sill is in good condition. There is a block of wood installed at the exterior of the lower sash to secure in place. The bottom rail of the lower sash is lightly checked and deteriorated (the wood is soft). The horizontal muntin at the lower sash is checked and deteriorated. The upper sash is cracked and broken at both sides at the spring line of the arch, at the horizontal muntin intersection and slightly above the muntin. There are no historic interior or exterior stops visible. The upper and lower sash are caulked together and the window is fixed shut. No sash cord hardware remains, as the frame has been replaced with flat casing trim. The exterior trim and sill are heavily checked and cracked, most significantly at the right-hand side. The glazing compound is typically in poor condition; it is cracked, loose or missing. The paint finish at the interior is in good to fair condition with small areas flaking or missing. The exterior paint finish is in fair condition due to typical weathering. There is one broken pane.</p>
