Federal Environmental Assessment
per the
National Environmental Policy Act (24 CFR Part 58)
& **National Historic Preservation Act (36 CFR Part 800)**

**Emerge Career & Technology Center, 1830 and 1834 Emerson Avenue North
Minneapolis, MN**

March 21, 2012

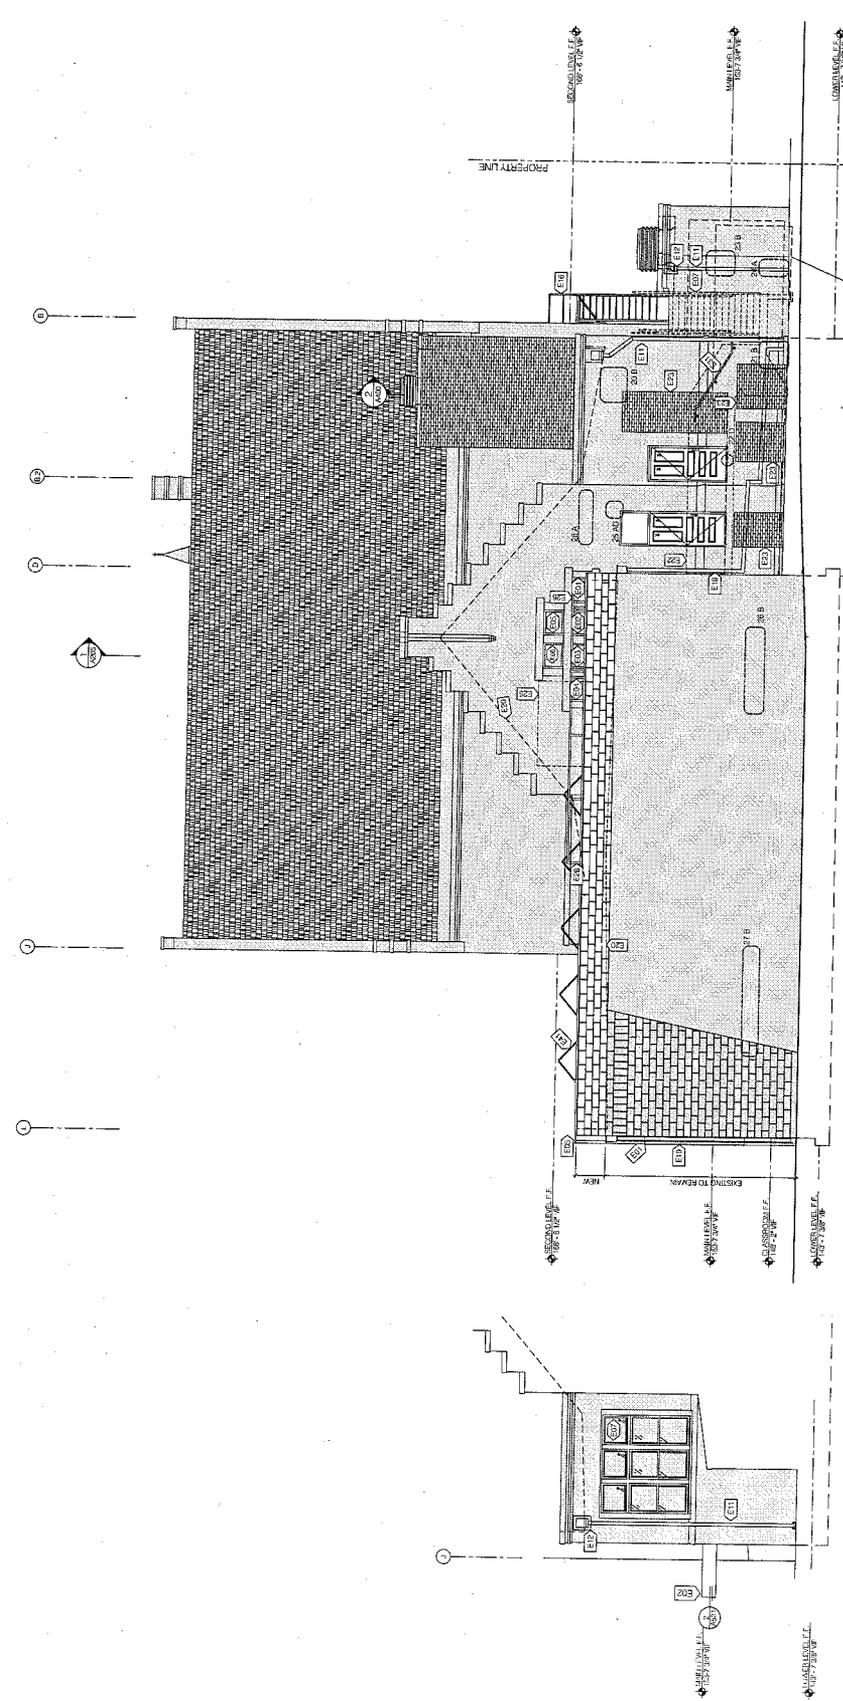
Project Number 0711
Sheet Name East Elevations
Sheet Number A203

1 EAST ELEVATION
 (A203) 3/16" = 1'0"

2 PARTIAL EAST ELEVATION
 (A203) 3/16" = 1'0"

A	REPLACE DAMAGED BRICK
B	REPOINT MORTAR TO MATCH EXISTING ADJACENT
C	REWORK EFFLUESCENCE
D	PATCH PALE IN BRICK MASONRY

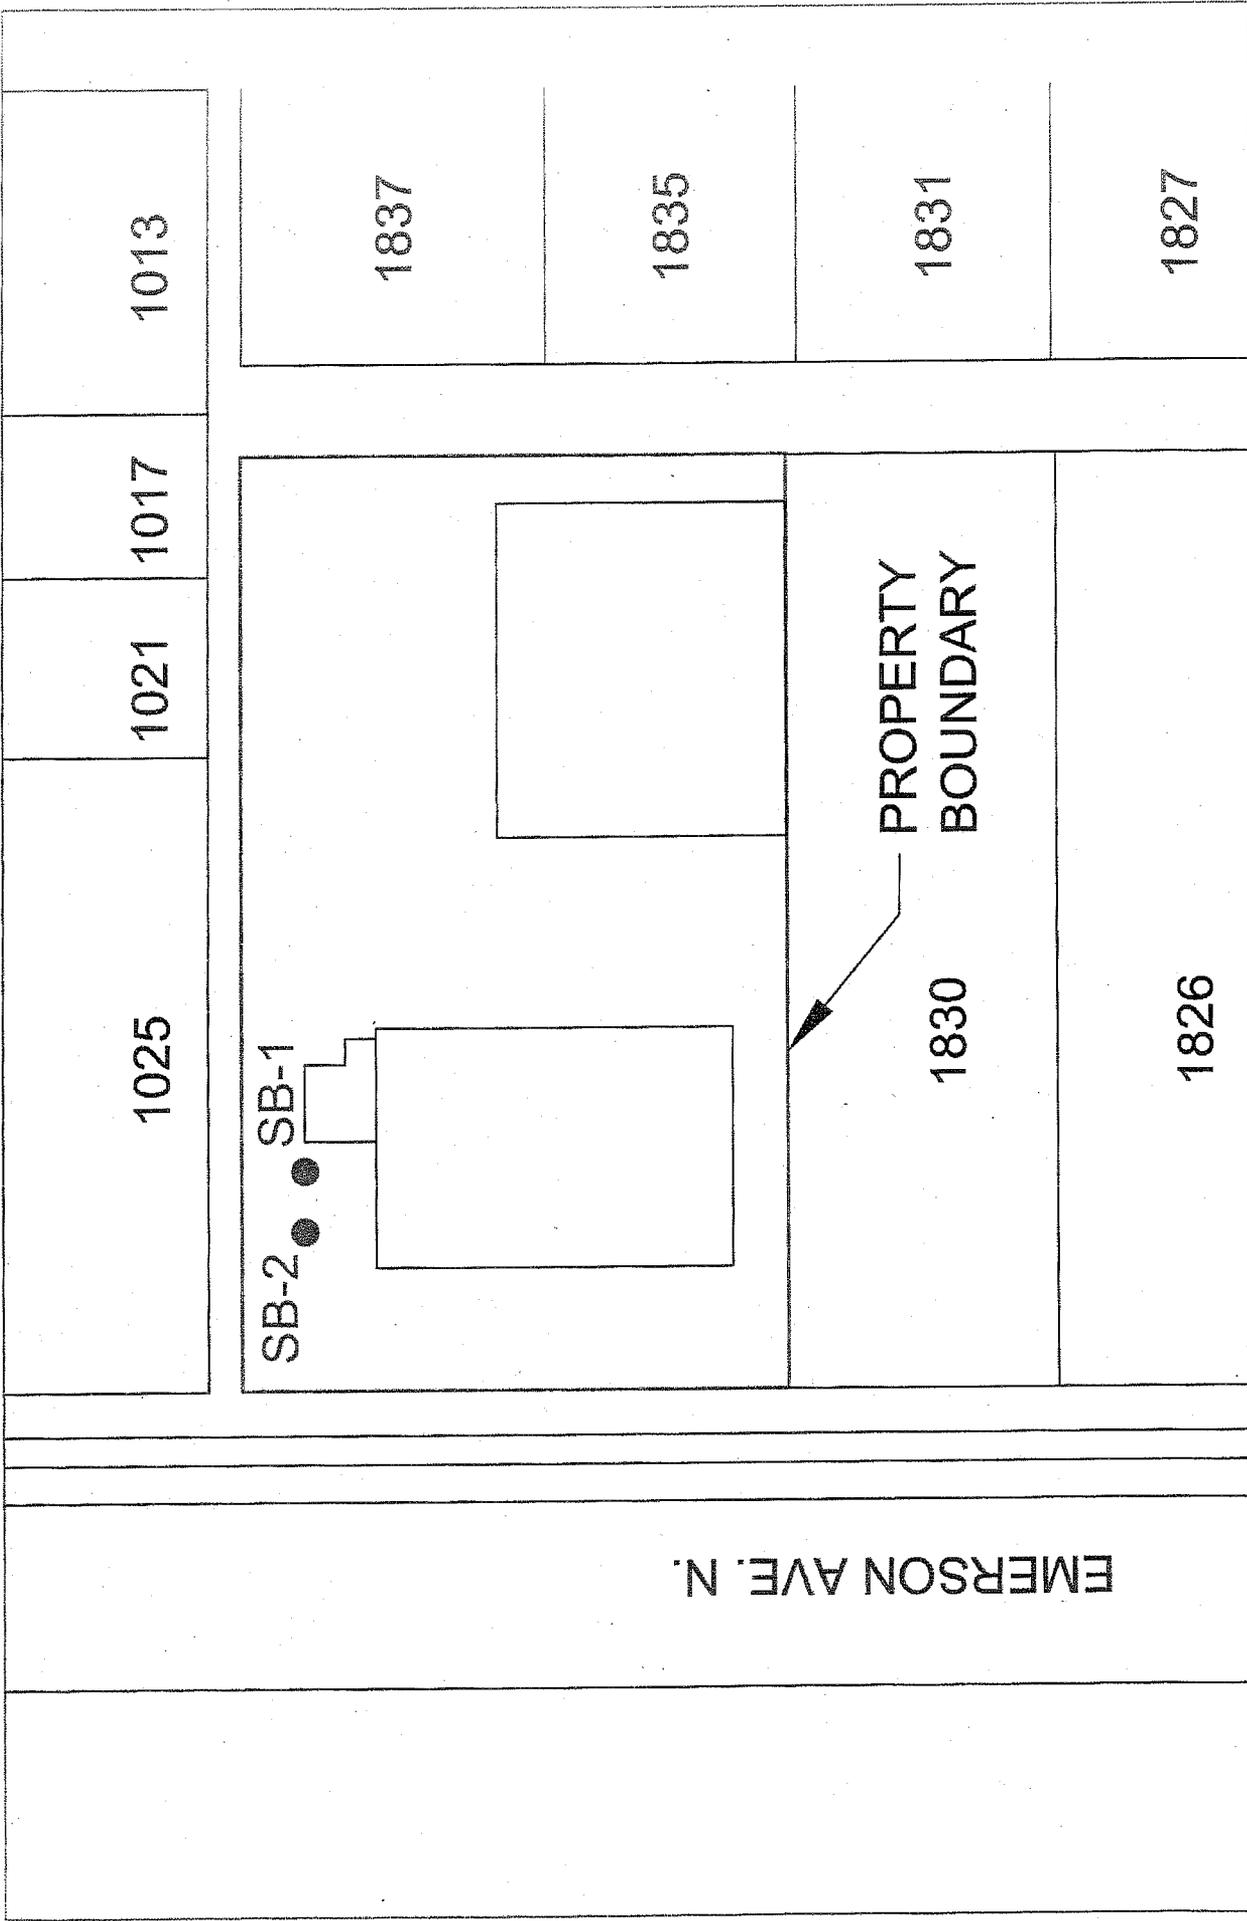
19001 SITE DIAGRAM.dwg

Peer was retained to complete this Phase II Environmental Site Assessment in order to evaluate subsurface conditions in the vicinity of a fill pipe on the north side of the building that is possibly associated with the current or past presence on an underground storage tank.

The two six soil borings were advanced to a depth of 28 feet below ground surface (bgs) at the Site on January 12, 2009. An attempt was made to reach groundwater, but based on local site conditions, it was determined that ground water may not be encountered within 35 to 45 feet bgs. The soil borings were completed using truck-mounted push-probe sampling equipment.
