Federal Environmental Assessment
per the
National Environmental Policy Act (24 CFR Part 58)
and the **National Historic Preservation Act (36 CFR Part 800)**

The Cameron
756 4th Street North, Minneapolis, MN

Responsible Entity: City of Minneapolis

March 15, 2013

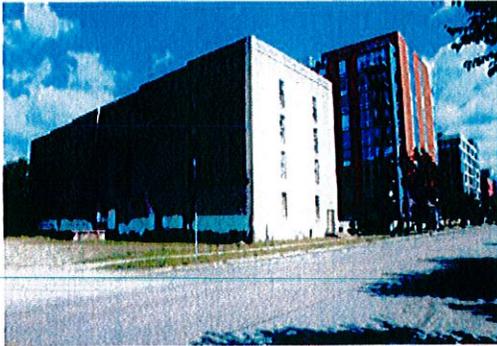
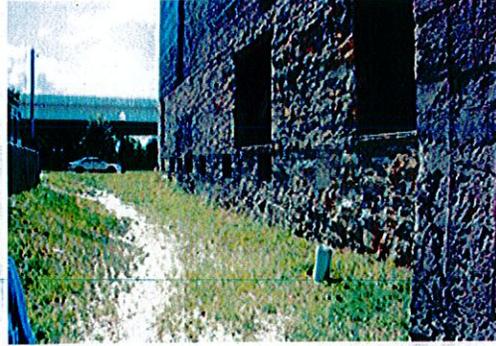
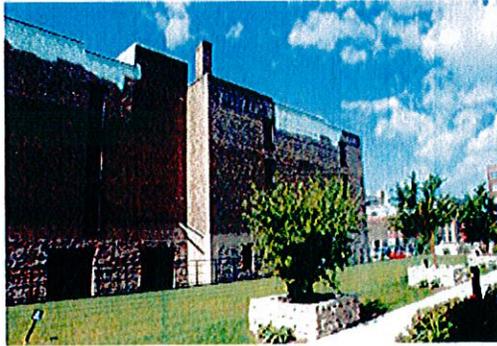
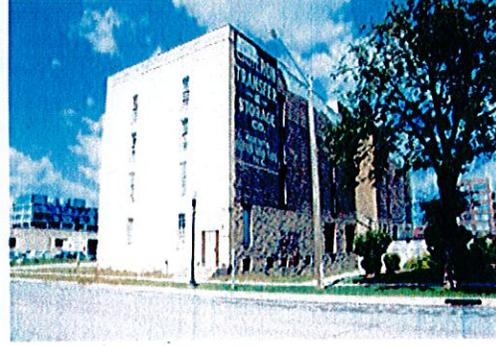
1. Site

- a. **Landscape** - Currently the site is overgrown. The site grading needs to be modified to slope away from the building foundation. There is no storm water management and the roof of the building drains of the North side of the building and spills out on grade.
- b. **Hardscape** - Is very minimal and in poor condition. There is a stoop along 4th Street North and a large concrete loading dock mid-building on the East side. There is a dirt and gravel area to the West of the building that is used for truck traffic to leave the alley off the North side of the property. There is currently no accessible route to enter the building from the public right-of-way.

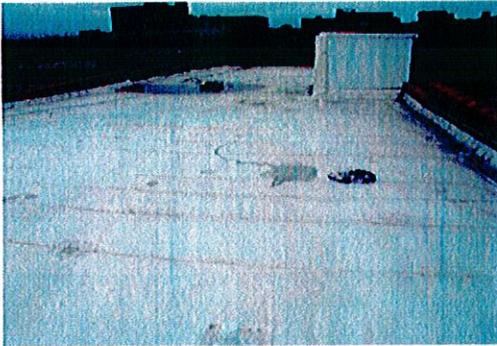
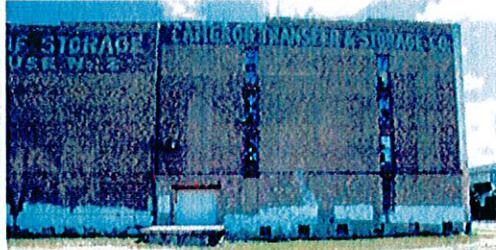
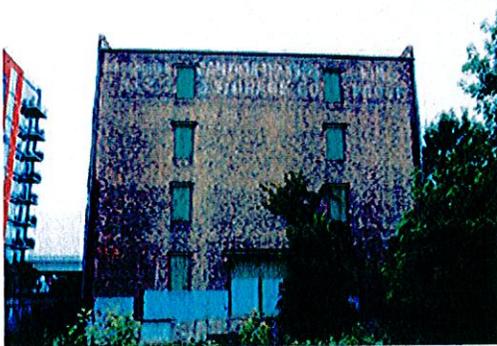
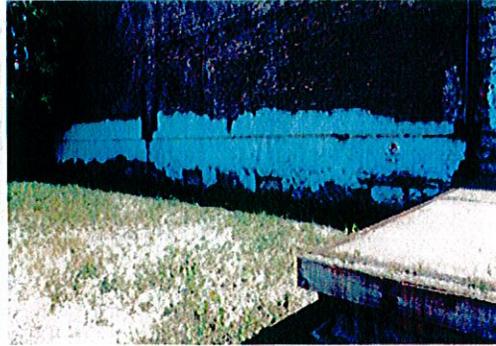
2. Building Envelope

- a. **Roof** - Existing roof slopes from South to North to a long (building wide) gutter with 2 down spouts on either side. The existing roof membrane appears to be light colored EPDM that appears that it was direct glued to the substrate and run up the parapet to a continuous keeper bar. The membrane has pulled away and bubbled up in many areas. There is also a fairly large (4' in diameter) area of ponding. Finally there is a roof leak at the center of the building where the wood structure beneath is being damaged. The roof system does not comply with current energy code. Our recommendation is that it needs to be completely replaced and the damaged substrate and structure repaired.

- b. **Exterior Walls** - All walls are solid brick that narrow as the wall goes up. They are bearing in the wood portion of the structure and non-bearing in the concrete portion of the building. For the most part the brick is in good condition. Areas at the roof downspouts are showing some degradation and will need to be rebuilt. In addition there should be general cleaning of the brick and mortar on both inside and outside faces since there is a large amount of graffiti. Based on visual inspection there will be approximately 12%-18% of the brick walls which will need tuck pointing.

- i. Blocked up openings - These are typically infilled with brick, plywood or limestone.
- ii. Windows and that need to be replace - These are less than 50% of the total number of windows and doors.
- iii. Windows and doors that can be repaired - If this was not a historic building, then all the windows and doors would be replace given the compromised nature and cost to repair.

d. **Foundation** - In general the foundation which appears to be limestone at the exterior and concrete pad footings at interior columns based on initial investigations. There is no exterior drain tile or waterproofing system at the building perimeter.

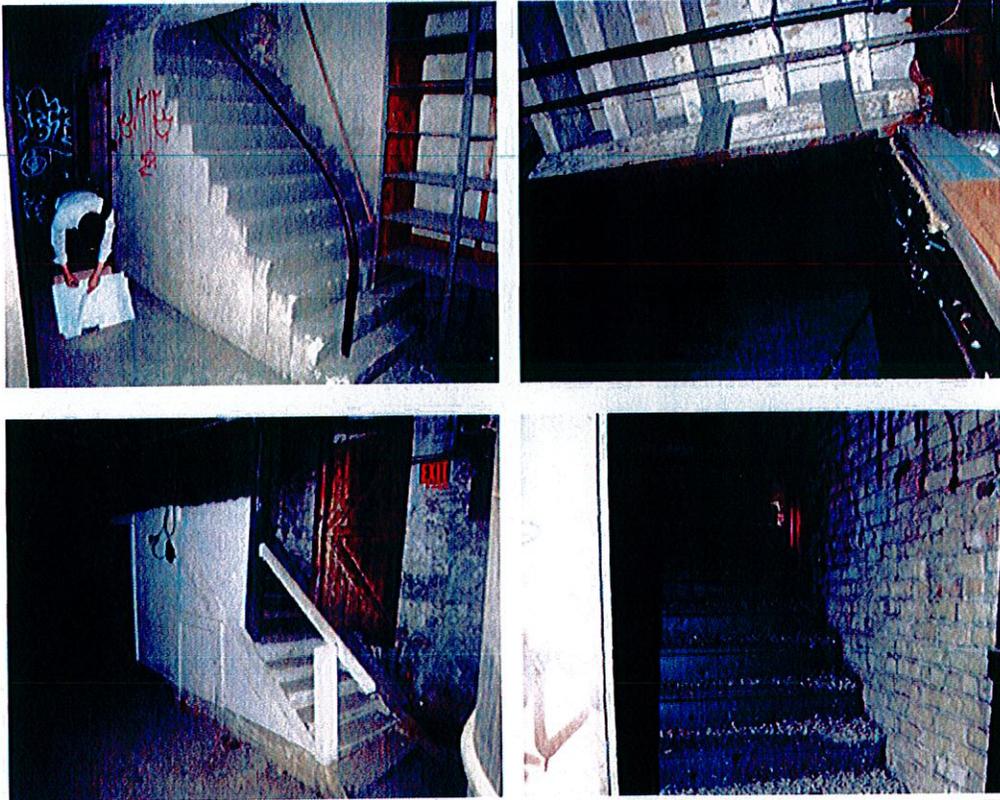
- a. **Elevator** - There is no working elevator in the building. There is an existing elevator floor opening that can potentially be reused for a new elevator system to be retrofitted into the structure.
- b. **Stairs** - There are two existing stair structures. One in the wood portion of the building, built out of wood. The other in the concrete portion of the

building, built out of concrete. In both cases the stairs do not comply with current code requirements of rise and run, width, handrails, etc. New stairs will need to be built. There is currently no safe roof access.

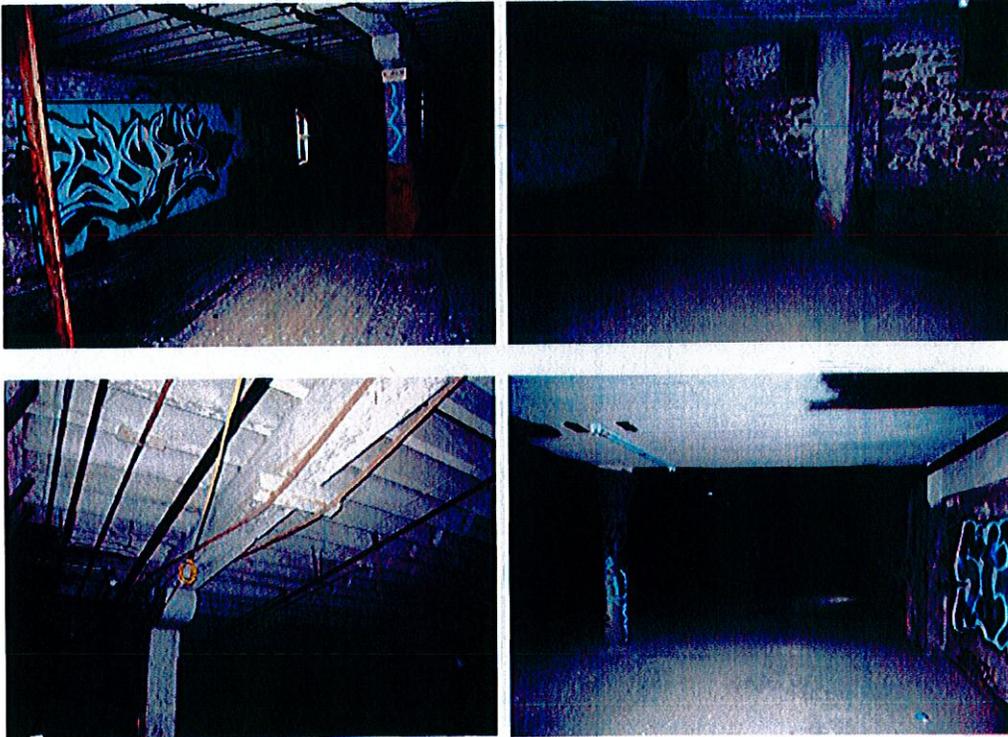
- a. **Slab on Grade** - The slab on grade is very rough. It was further damaged to do structural review of existing building structure. Slab will need to be patched and a topping slab of concrete or gypcrete will be required to bring the floor up to code.
- b. **Wood Floor Structure** - In general the structure is in good condition including the T&G flooring. There are a couple of locations where the floor is worn through and will need to be replaced. Also the roof leak mentioned earlier in this document will need to be repaired. All wood floors will need to be sanded and refinished or have a subfloor and new floor added.
- c. **Concrete Floor Structure** - The concrete floor is in very good condition and only minor patching is required. Because of the proposed new use, there will most likely be a gypcrete and sound matt added to receive the new finish floor.

- d. **Interior Walls** - There is a very limited number of interior walls and they are all non-bearing and expected to be demolished and the adjacent structure patched, since the walls do not help in the re-use of the building as housing.

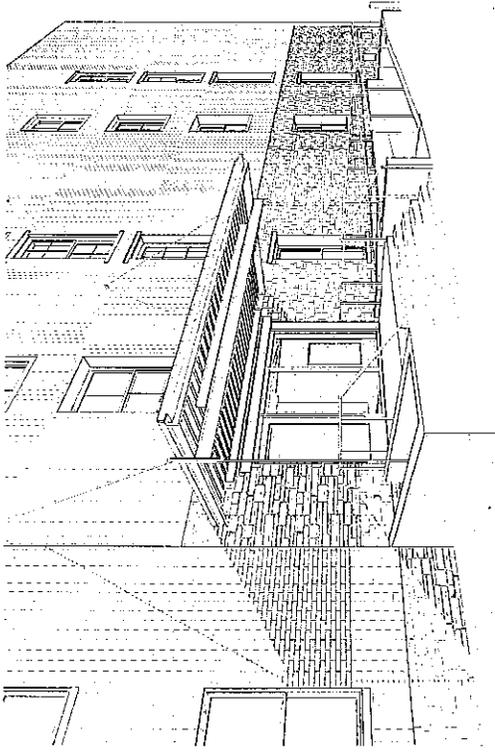
3. PERSPECTIVE VIEW OF CANOPY AT MAIN ENTRY

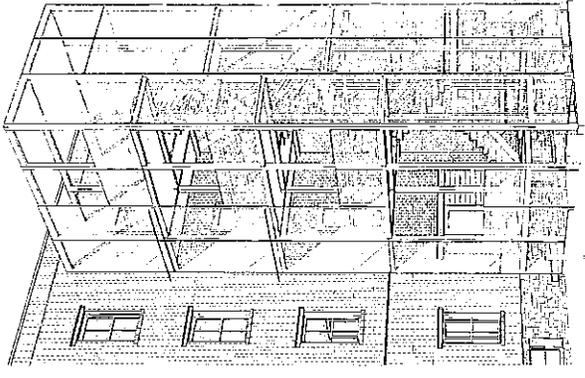
4. PERSPECTIVE OF EXTERIOR STAIR

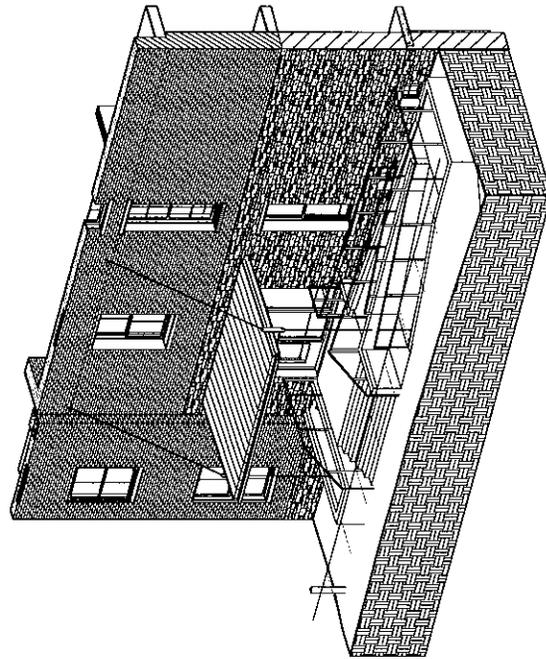
ENTRY CANOPY SECTION

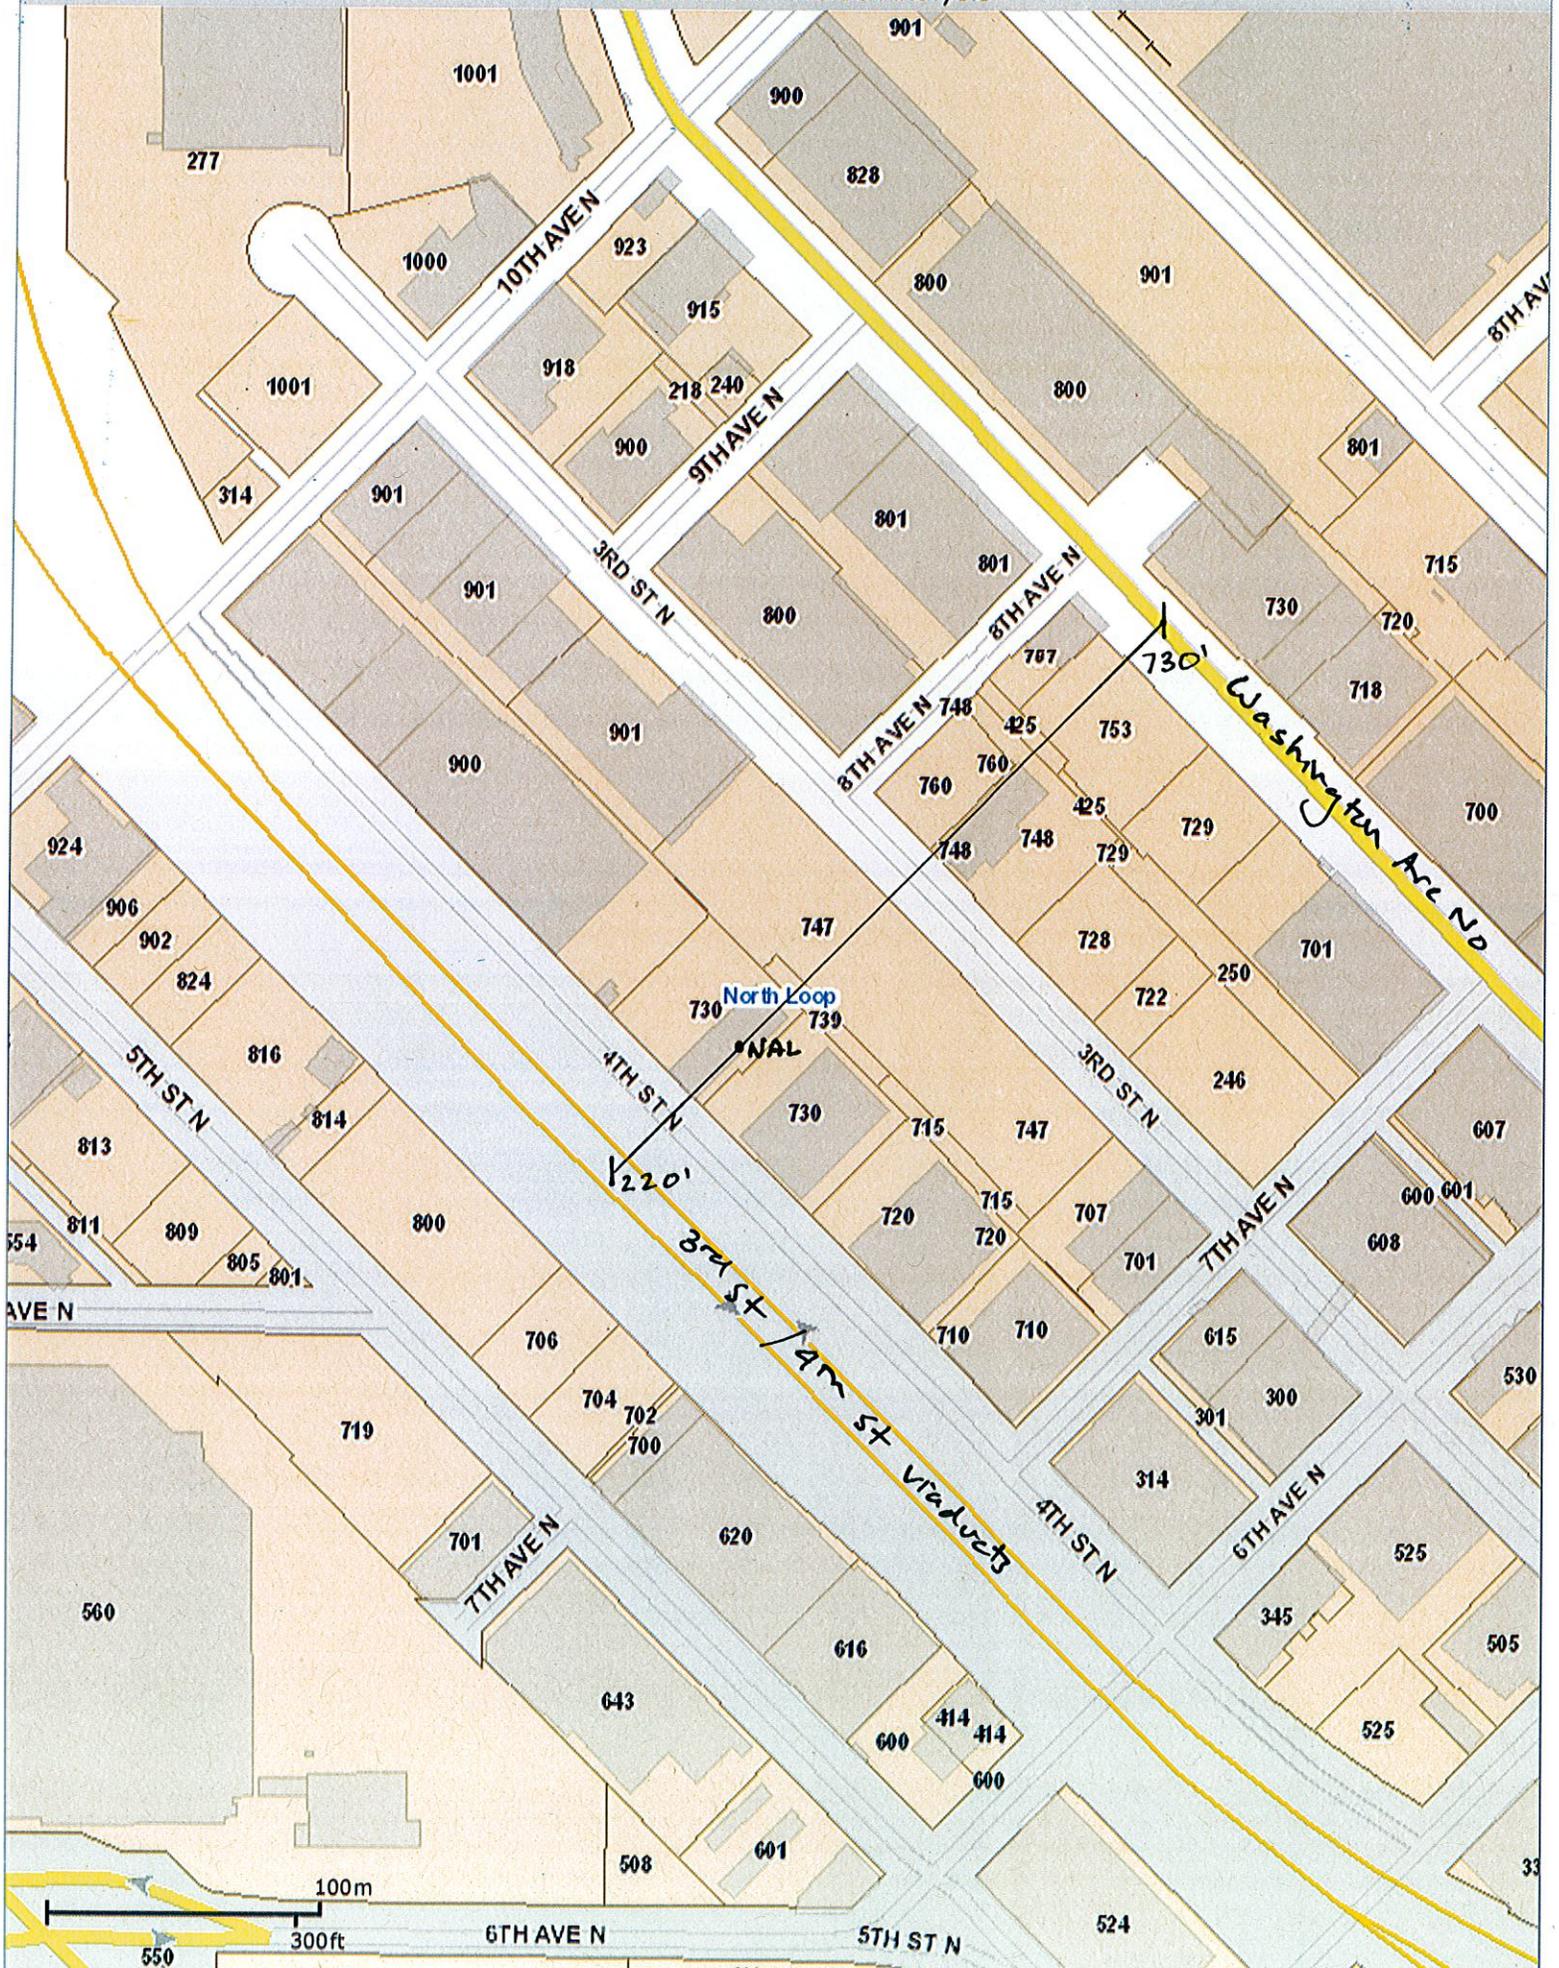
The Cameron - Noise Analysis

- **Washington Avenue North:** The street, located 730 feet from the Noise Assessment Location (NAL), has a Total Average Daily Traffic (ADT) of 19,394 vehicles (2010 figures) in the vicinity of the NAL. The street is a County State Aid (CSA) road and a truck route. The Minneapolis Public Works Department estimates that trucks constitute 3-5% of all traffic on MSA roadways.
- **3rd Street/4th Street viaducts:** The streets, located 220 feet from the Noise Assessment Location (NAL), have a Total Average Daily Traffic (ADT) of 9,125 vehicles (2010 figures) in the vicinity of the NAL. The streets are part of the Interstate Highway System and are truck routes. The Minneapolis Public Works Department estimates that trucks constitute 3-5% of all traffic on roadways.

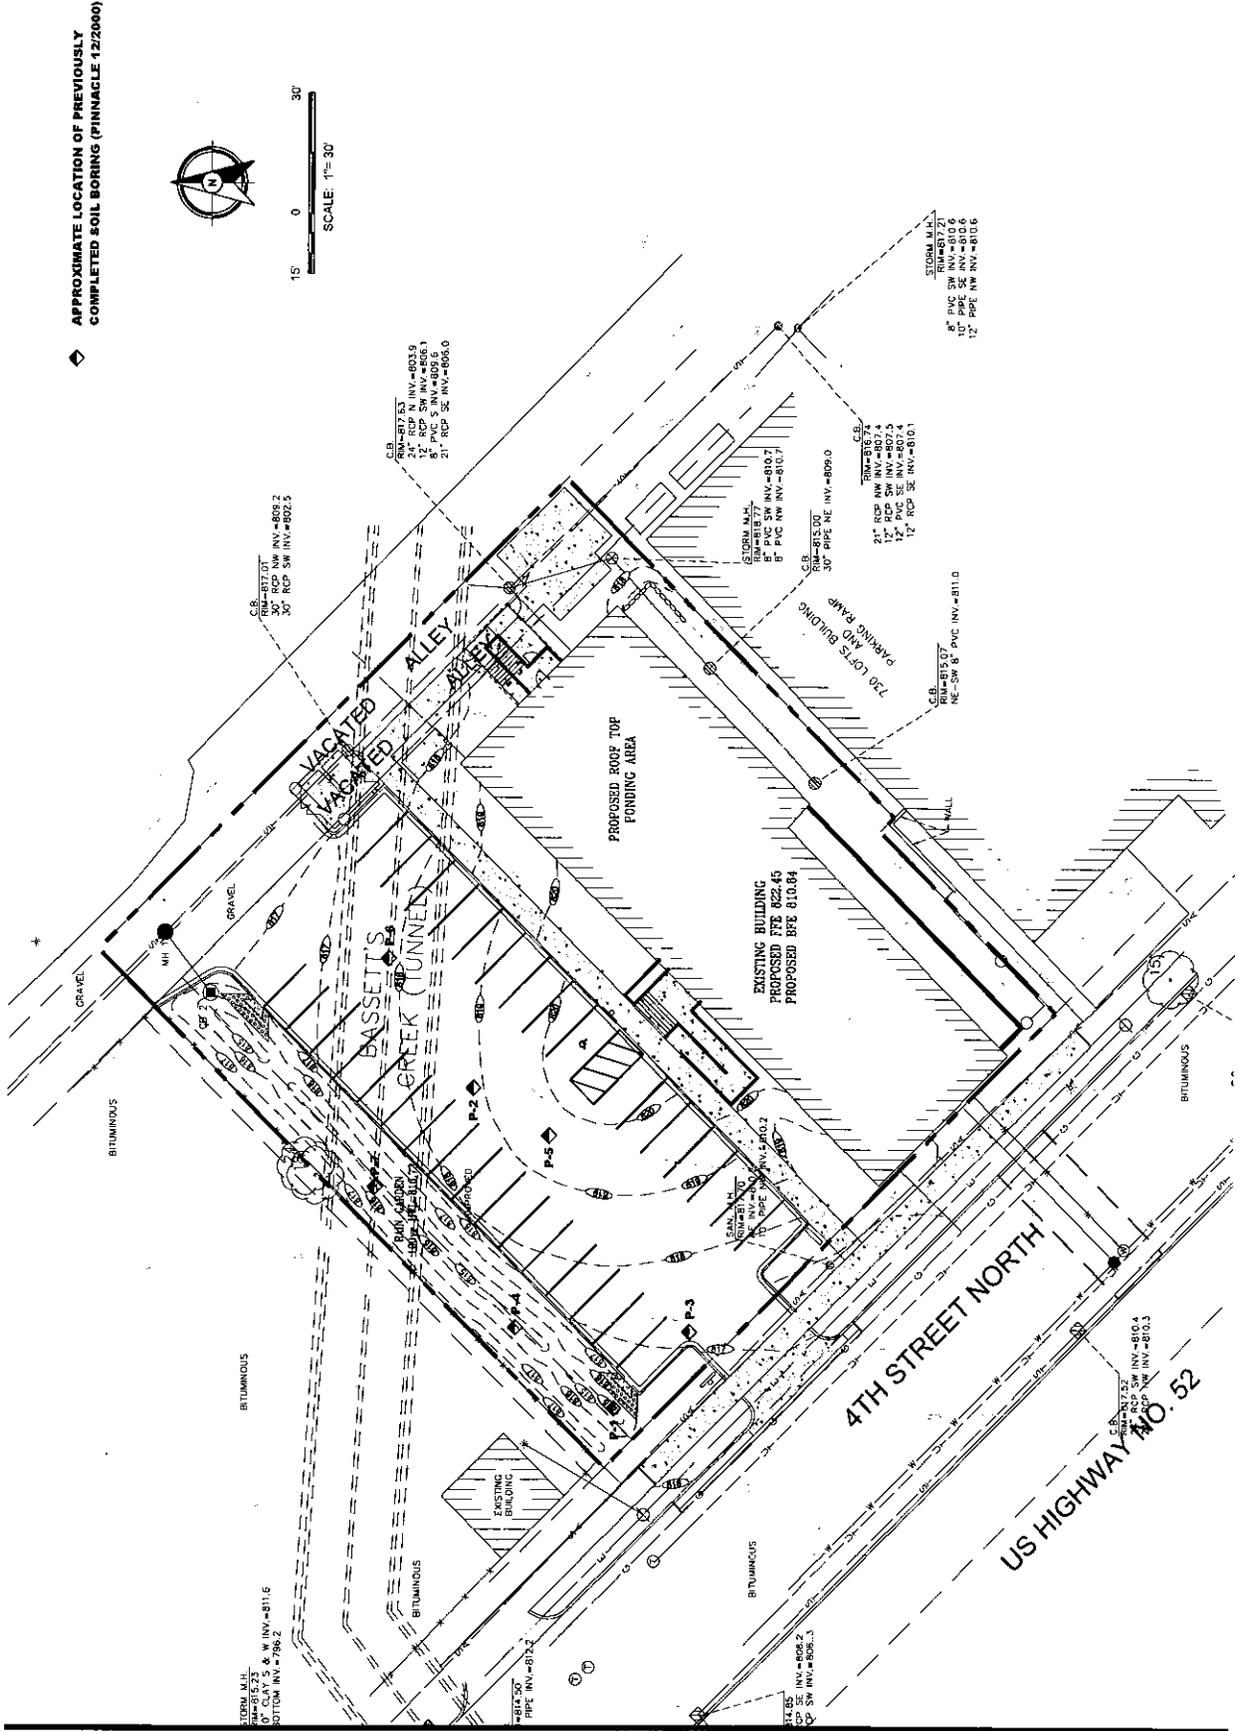
APPROXIMATE LOCATION OF PREVIOUSLY COMPLETED SOIL BORING (PINNACLE 122000)
