Martin Olav Sabo Bicycle & Pedestrian Bridge

Martin Olav Sabo

Bicycle & Pedestrian Bridge

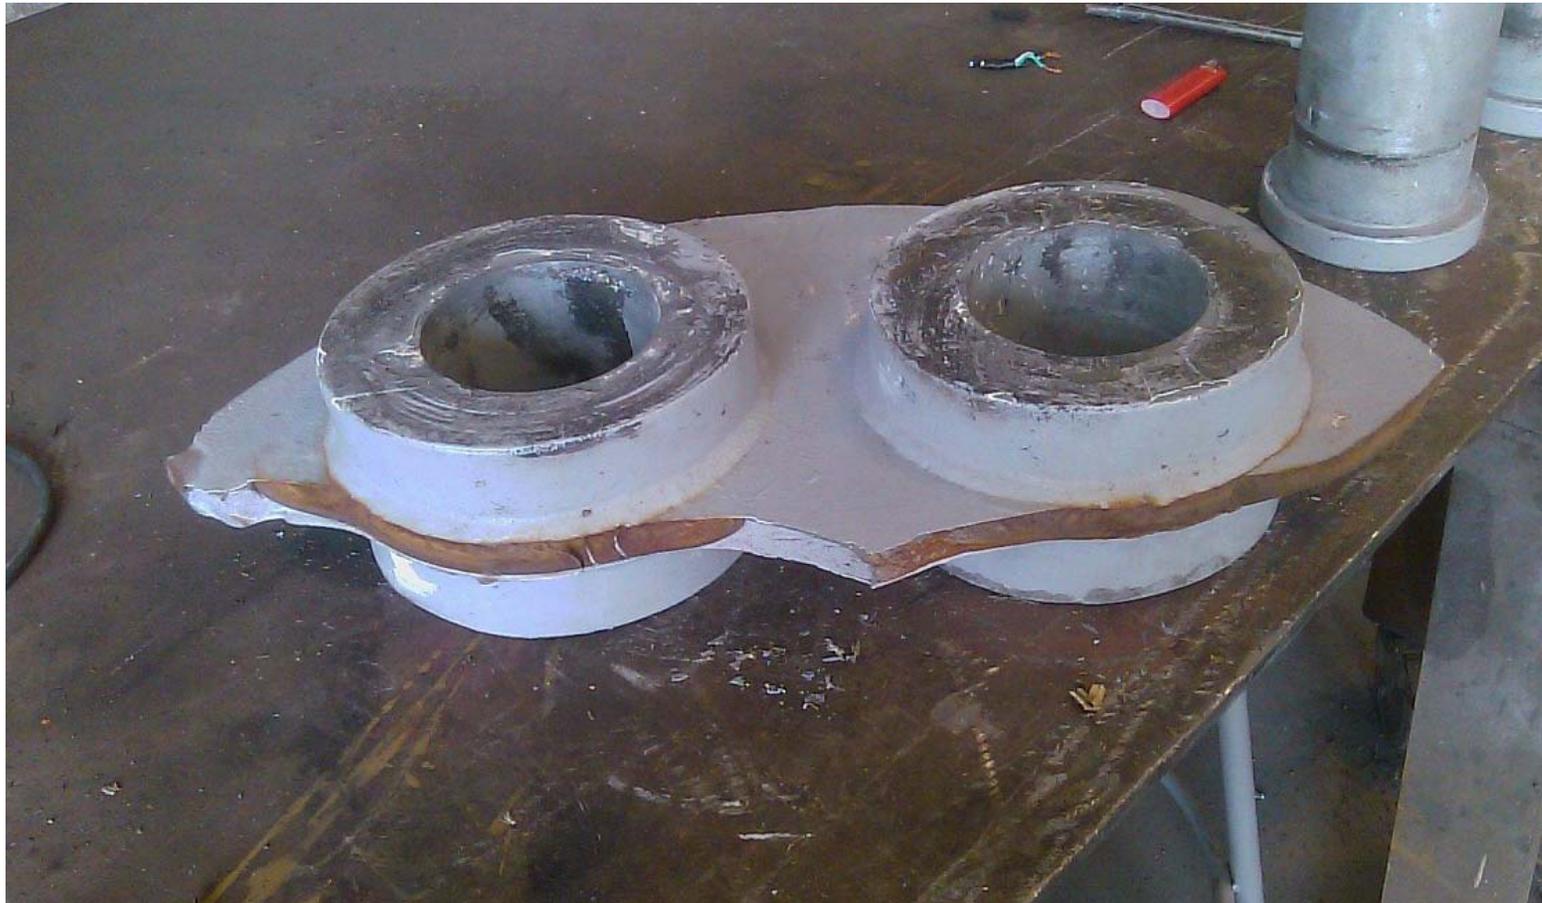
Failed Diaphragm Plate (#9)

- ▶ 911 call at ~10:06 p.m. Sunday reported concern with cable on bridge
- ▶ City staff arrives on site to find cable set 9 detached from pylon with broken diaphragm plate
- ▶ MnDOT, Metro Transit, consulting engineers join city staff on site
- ▶ Inspection indicates the #8 diaphragm plate is also compromised
- ▶ MnDOT closes TH55 & Metro Transit stops LRT service
- ▶ City crew begins work to shore up bridge

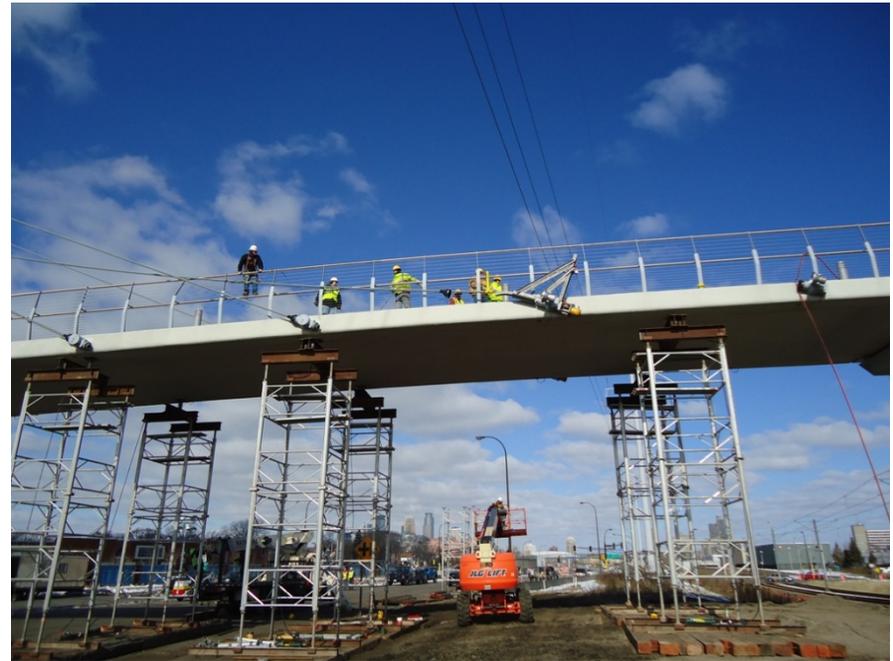
Bridge Stabilization Activities

- ▶ Cable set #8 de-tensioned on Thursday
- ▶ Cable set #8 removed on Friday, LRT service begins at 1:15 pm
- ▶ Non-destructive testing of diaphragm plates completed Saturday
- ▶ Sunday ~6pm – Hiawatha Avenue reopened
