Figure 5-1. USGS 7.5 Minute Map

Figure 5-2. AUAR Boundary, Subdistricts, and Cover Types

Figure 6-1. Roadway Network Options

**STAR TRIBUNE PROPERTY
BLOCKS 68, 69, 70, 74 AND 75
MINNEAPOLIS, MINNESOTA**

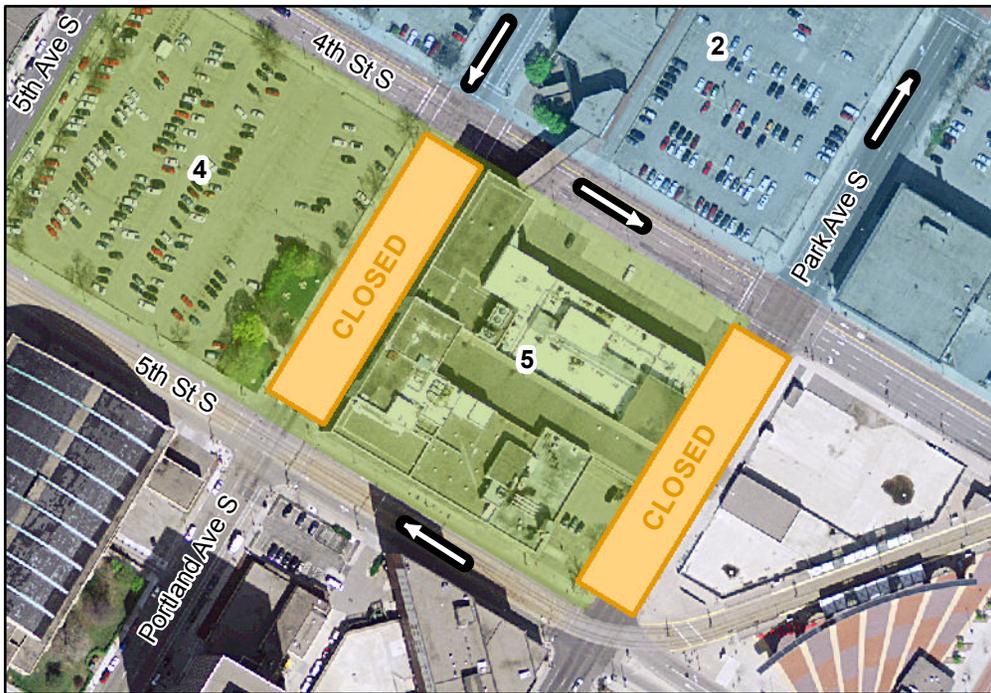
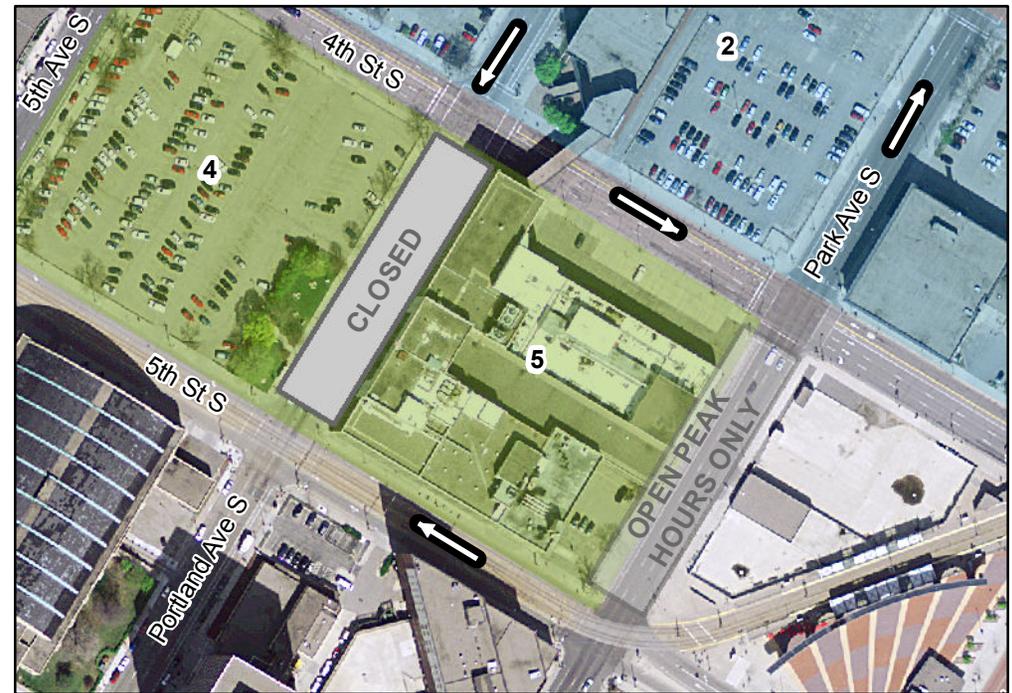
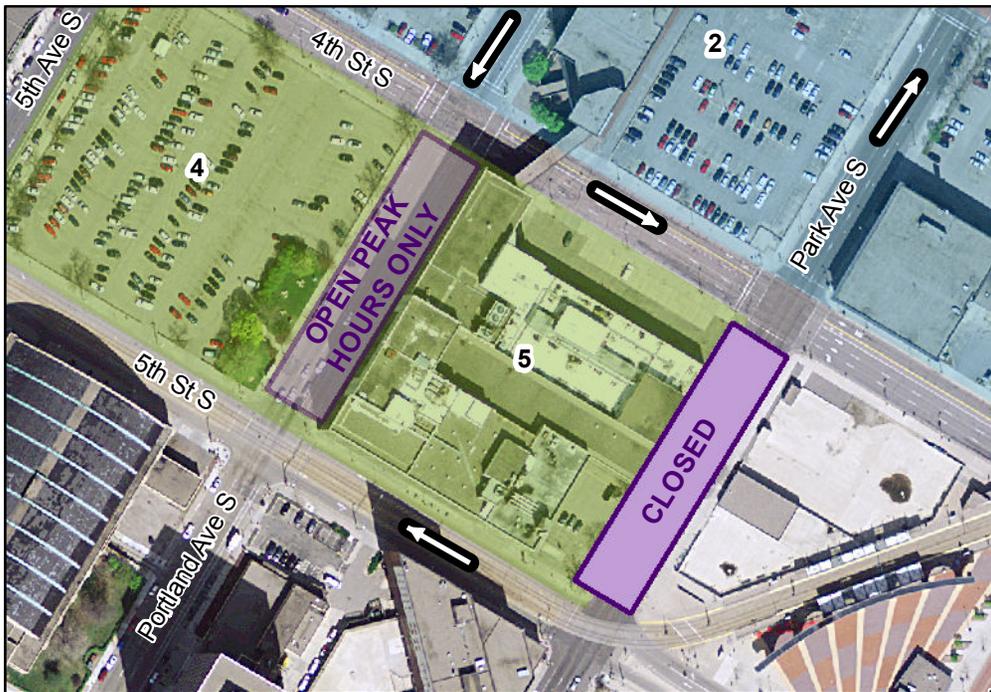
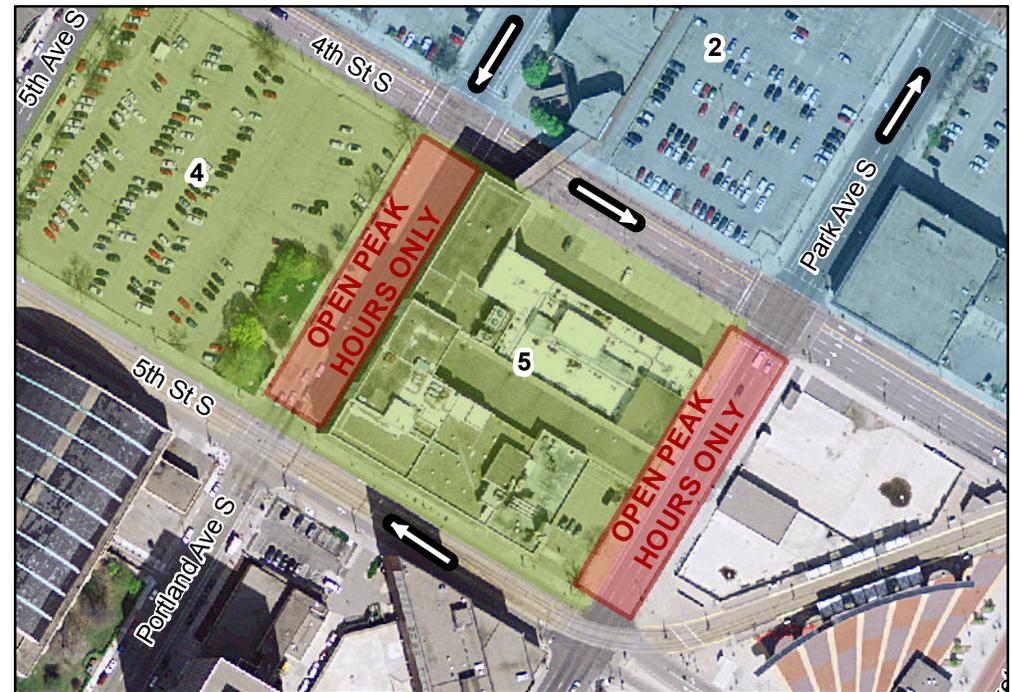
Option 1

Option 2

Option 3

Option 4

Note: Options 2-4 assume Park and Portland are reduced to 2 lanes, with bike lanes and no parking

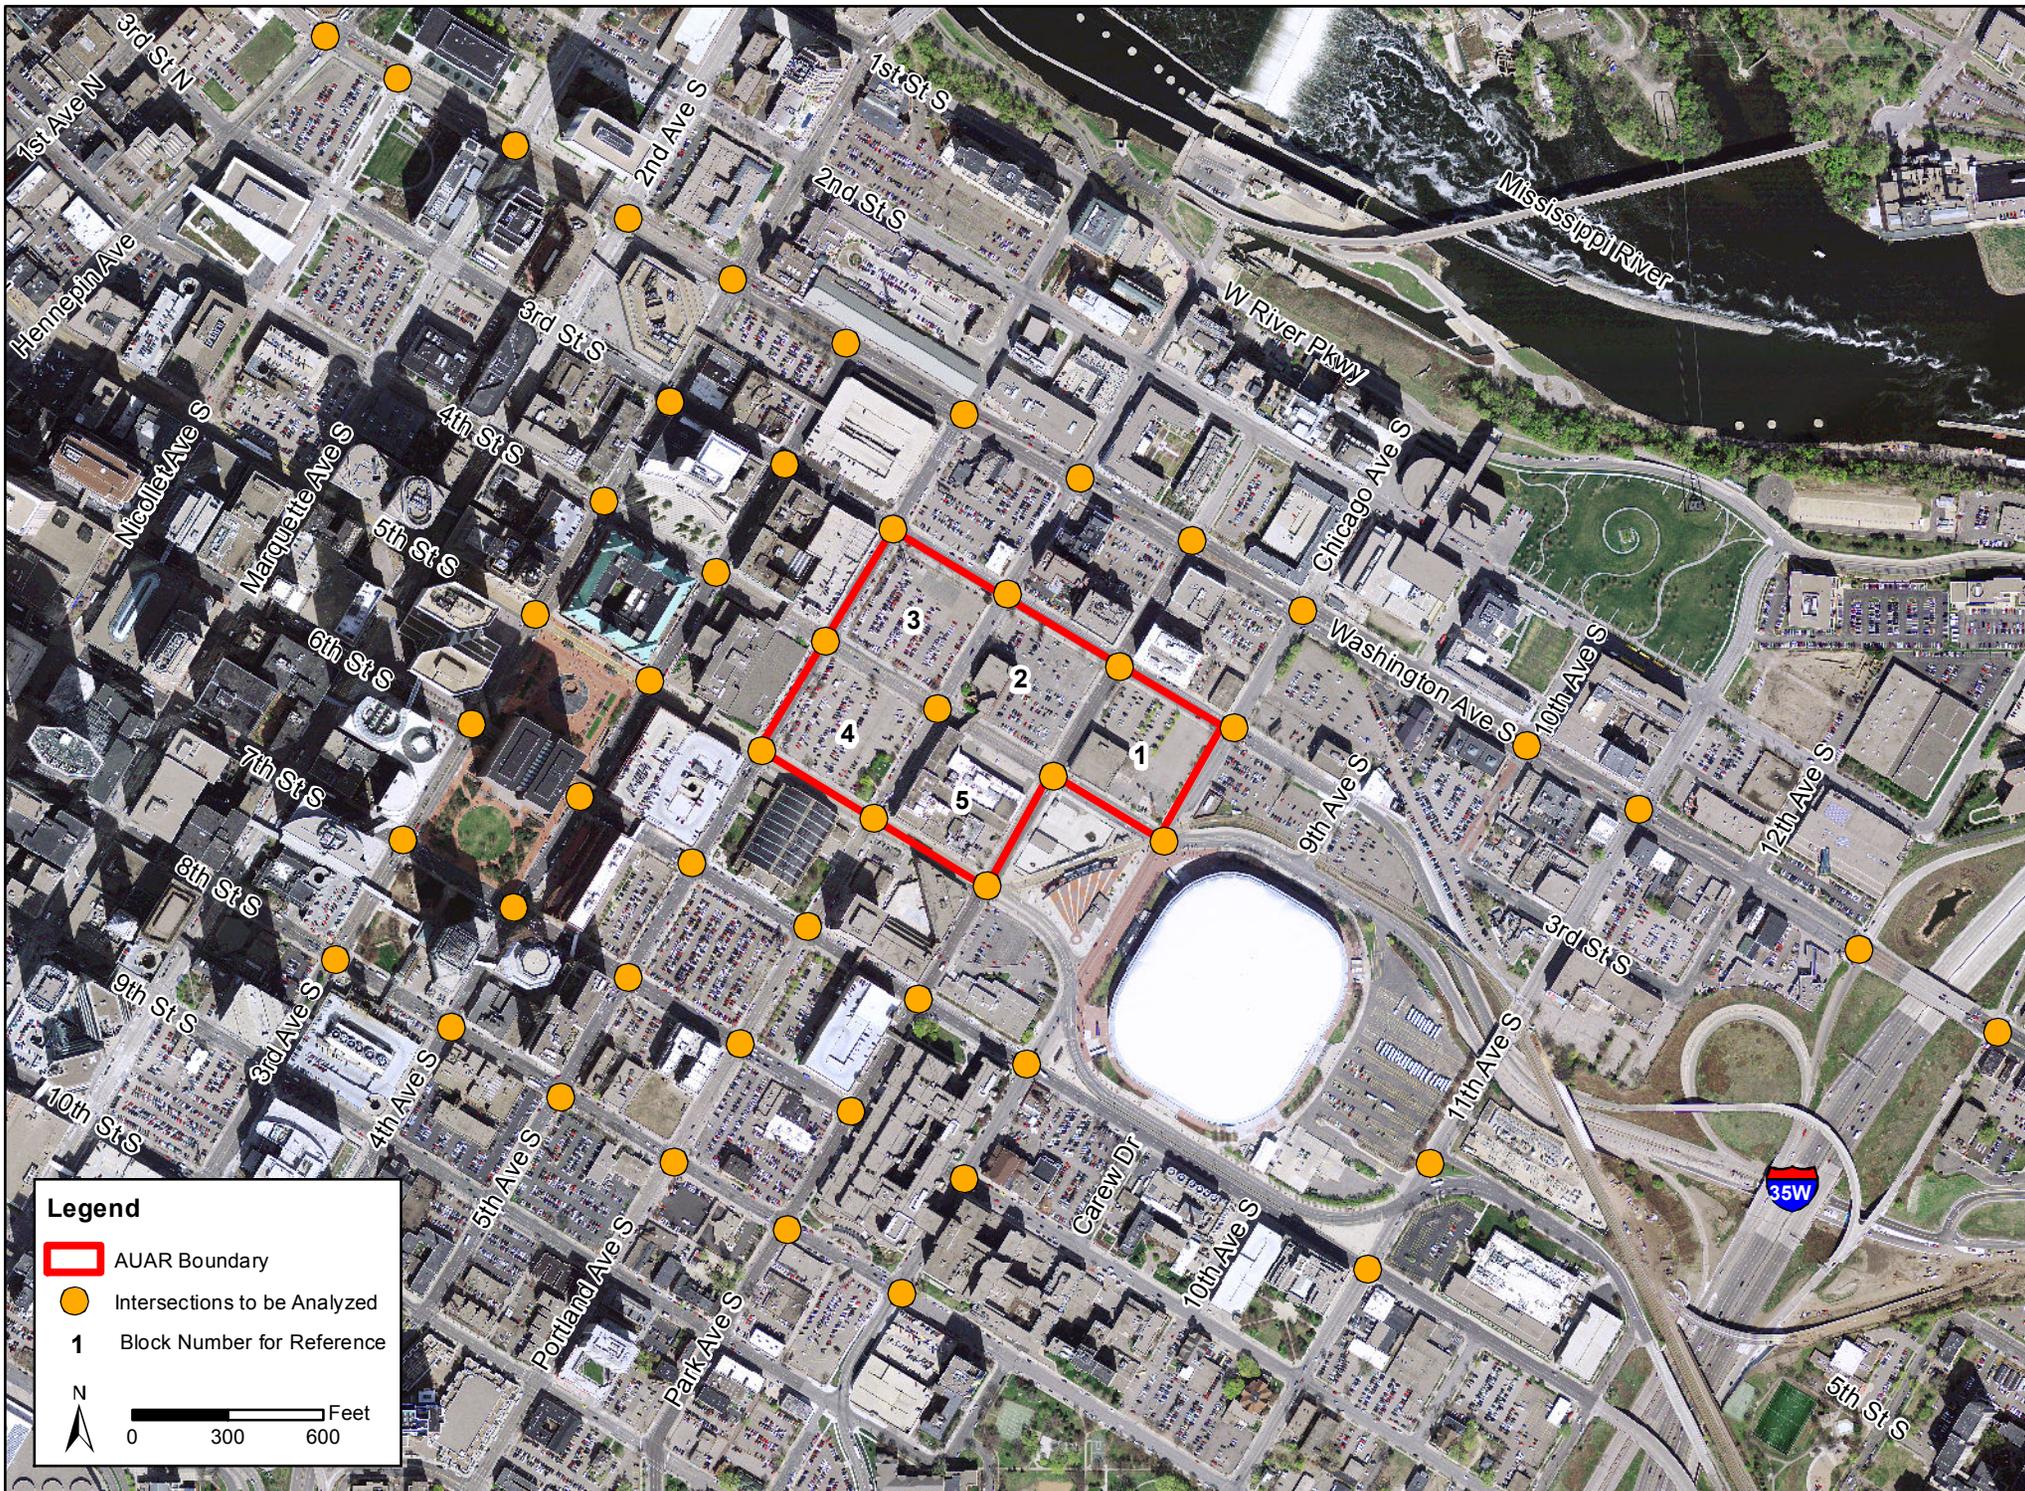
Figure 21-1. Traffic Study Area

- AUAR Boundary
- Intersections to be Analyzed
- 1** Block Number for Reference

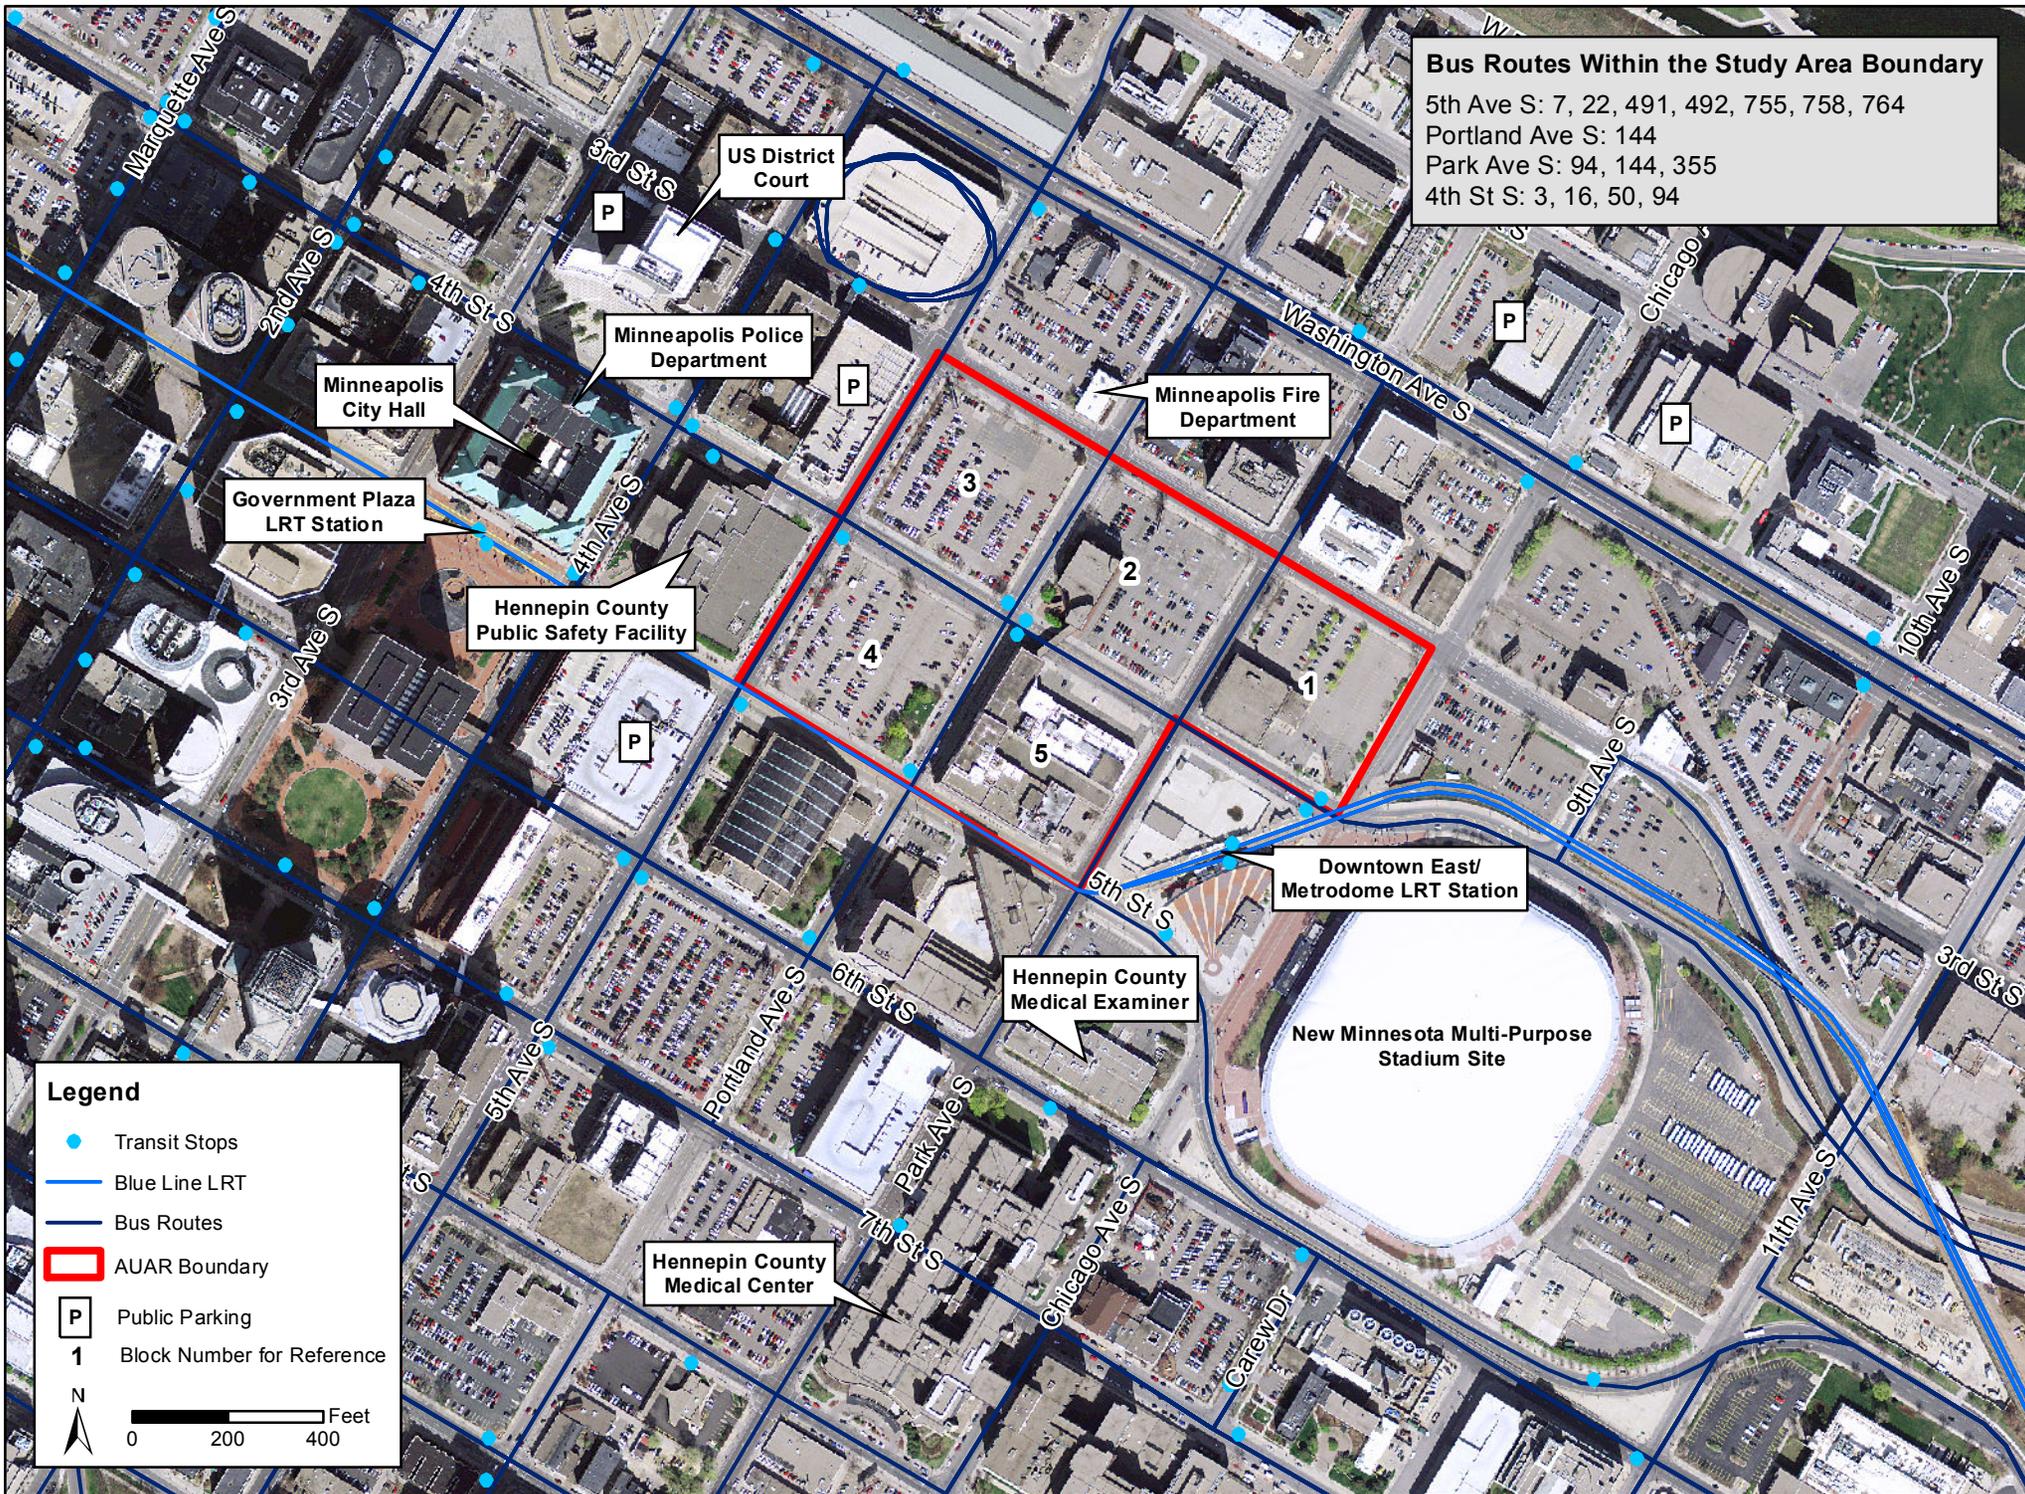
Figure 28-1. Community Facilities and Services

Bus Routes Within the Study Area Boundary
 5th Ave S: 7, 22, 491, 492, 755, 758, 764
 Portland Ave S: 144
 Park Ave S: 94, 144, 355
 4th St S: 3, 16, 50, 94
