IV. Historic Context and Precedent Case Studies

Heritage Street Paving Map - Period of Significance

Case Study: Sacramento, CA - "R" Street Redevelopment

Case Study: Brooklyn, New York - Dumbo District Street Reconstruction

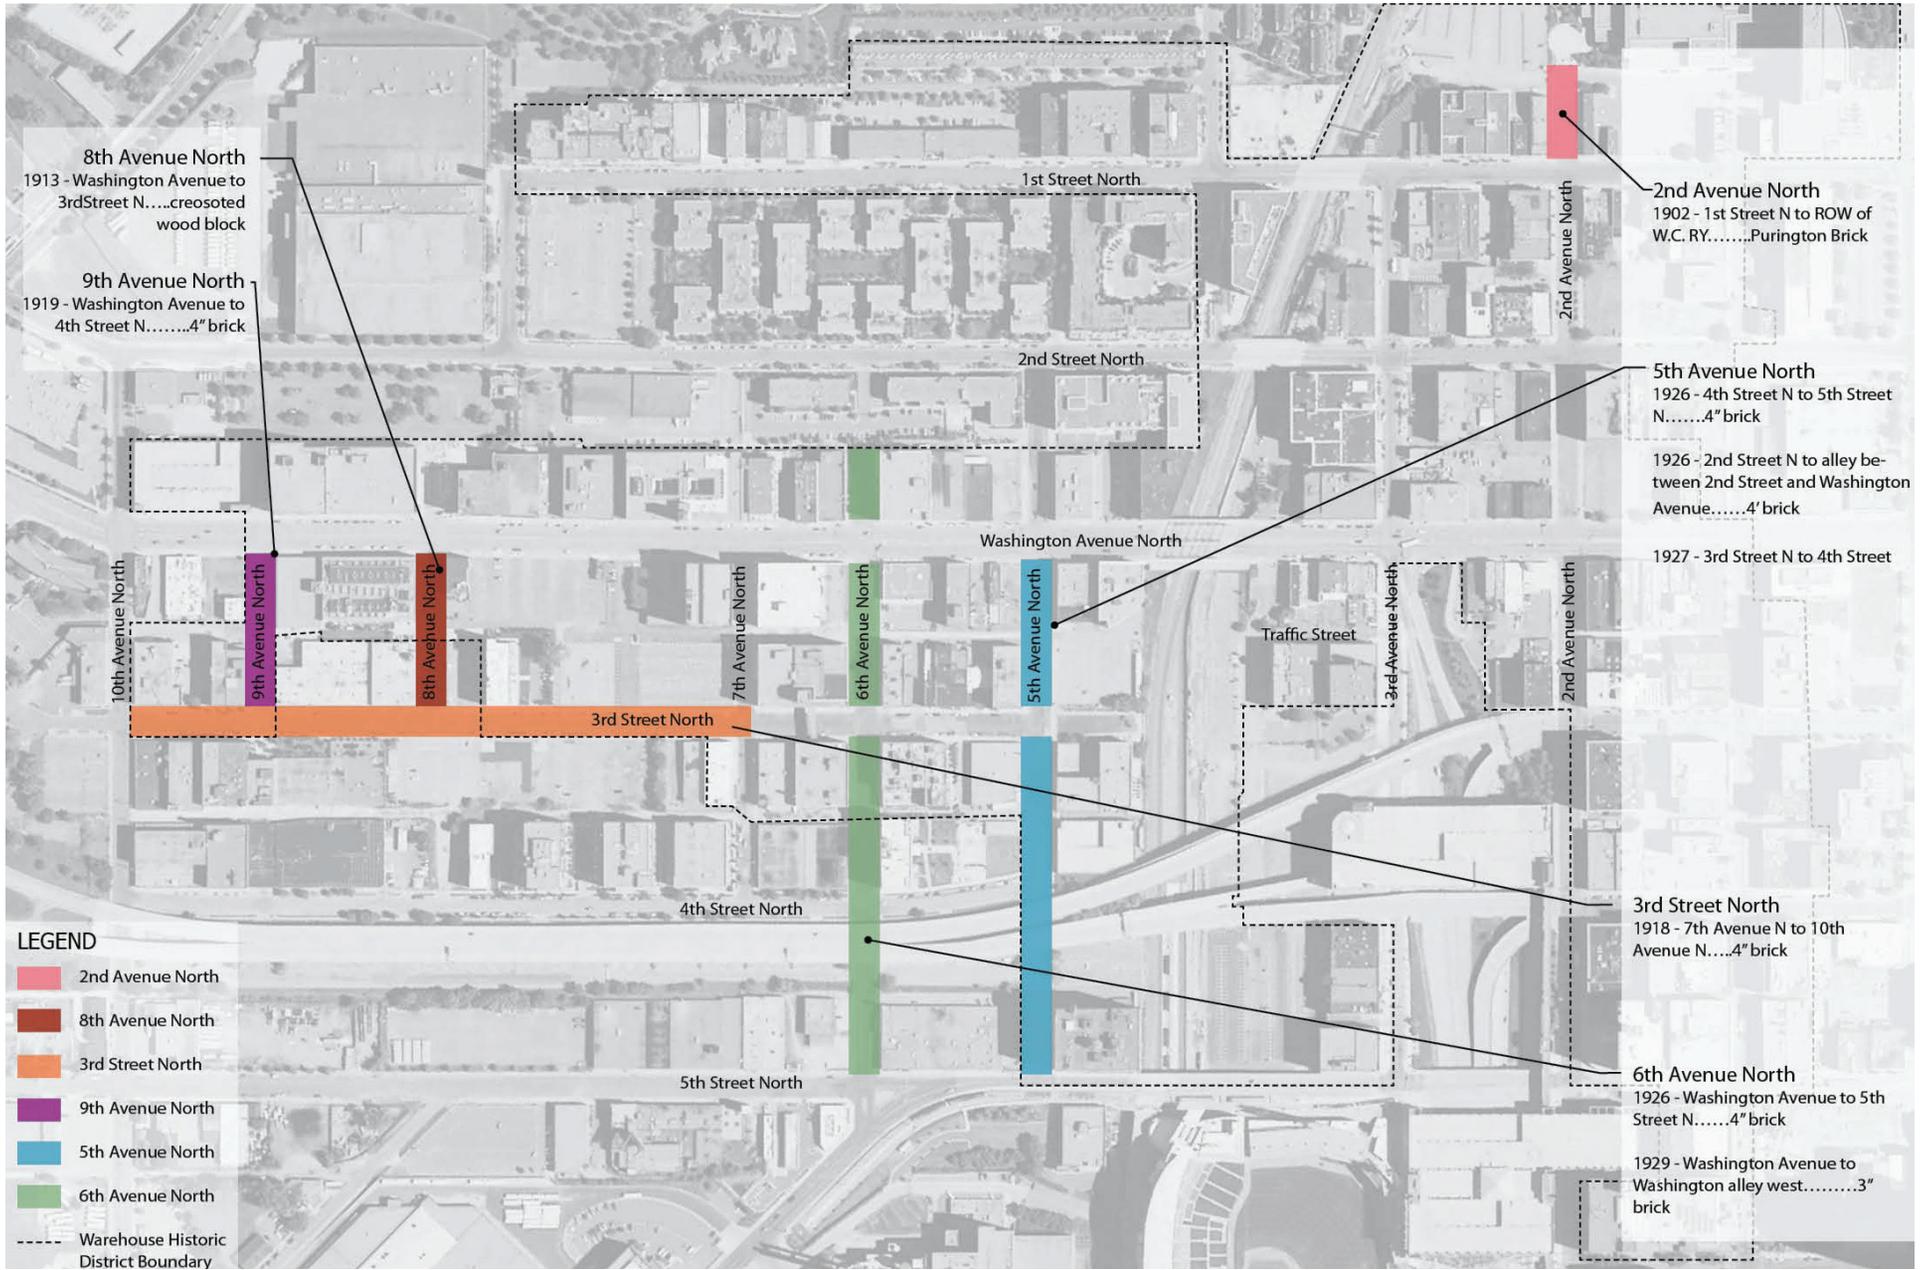
Heritage Street Paving Map - Period of Significance

The following map identifies the specific Heritage Streets that were constructed with brick, wood or granite pavements during the period of significance (1865 to 1936) in the Historic Warehouse District. The year of construction for the Heritage Streets are as follows:

- 1902 - 2nd Avenue North (*1st Street North to ROW of W.C.RY*). Paved with Purington Brick.
- 1913 - 8th Avenue North (*Washington Avenue to 3rd Street North*). Paved with creosoted wood block.

- 1918 - 3rd Street North (*7th Avenue North to 10th Avenue North*). Paved with 4” brick.
- 1919 - 9th Avenue North (*Washington Avenue North to 4th Street North*). Paved with 4” brick.

- 1926 - 5th Avenue North (*4th Street North to 5th Street North*). Paved with 4” brick.
- 1926 - 5th Avenue North (*2nd Street N to alley between 2nd Street and Washington Avenue*). Paved with 4’ brick to replace (1903) sandstone blocks

- 1926 - 6th Avenue North (*Washington Avenue North to 5th Street North*). Paved with 4” brick to replace (1911) sandstone blocks
- 1927 - 5th Avenue North (*3rd Street North to 4th Street North*). Paved with 4” brick

- 1929 - 6th Avenue North (*Washington Avenue to Washington alley West*). Paved with 3” brick
- 1930 - 5th Avenue North (*Washington Avenue to 3rd Street North*). Paved with 4” brick

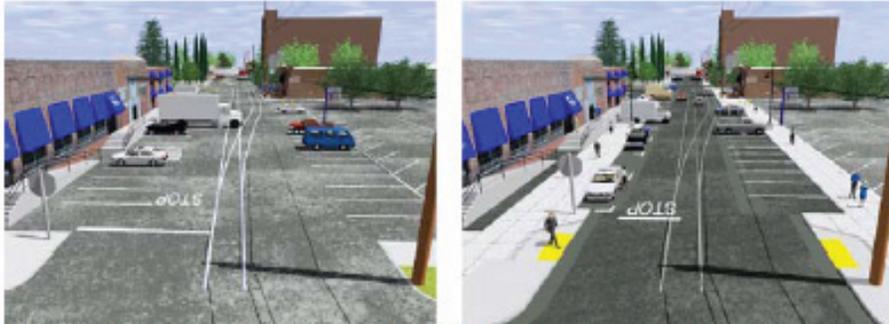
10th Street to 11th Street. Looking east from 10th Street, existing conditions (left) and with proposed improvements (right).

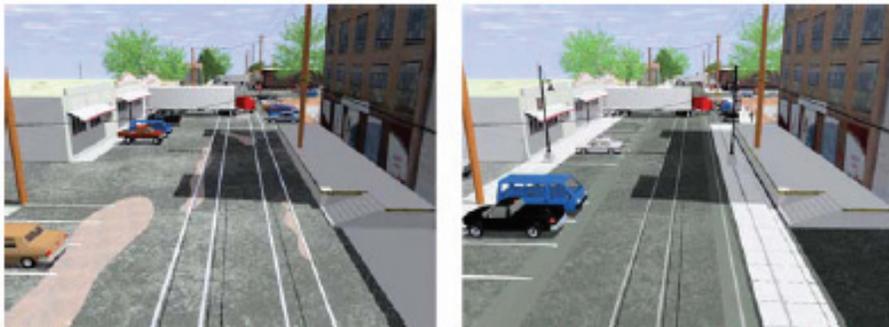
11th Street to 12th Street. Looking east from 11th Street, existing conditions (left) and with proposed improvements (right).

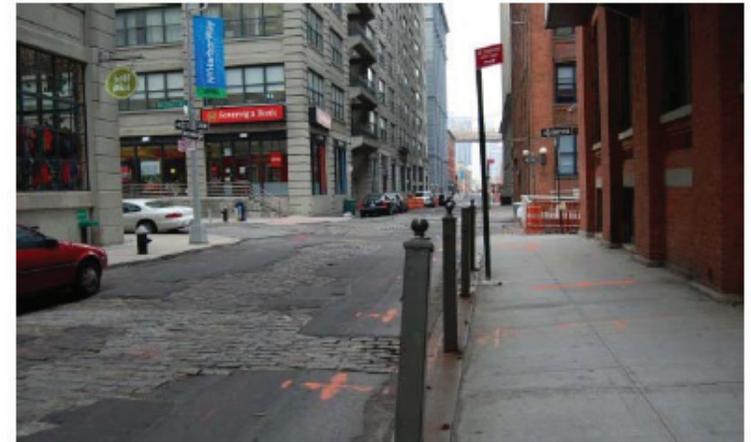
BEFORE reconstruction. October 2009, Water Street looking towards Washington St.

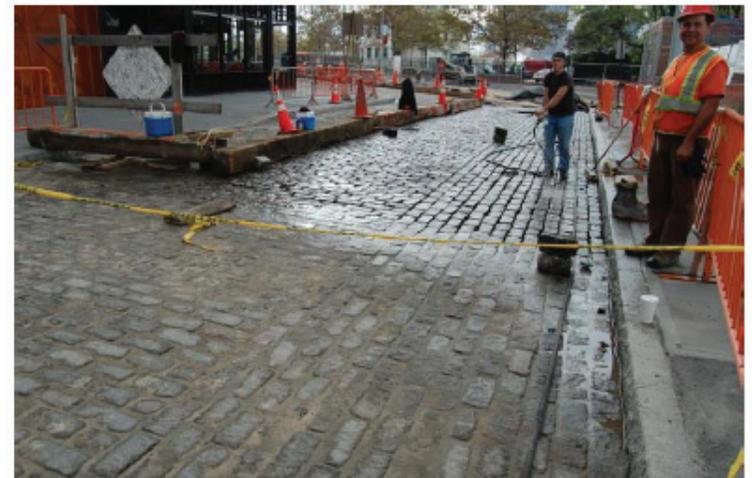
AFTER reconstruction. October 2010.
