Certificate of Appropriateness
BZH-26600

Proposal: Request for Certificate of Appropriateness to replace dentils

Project Name: 25 North 4th Street Dentil Replacement

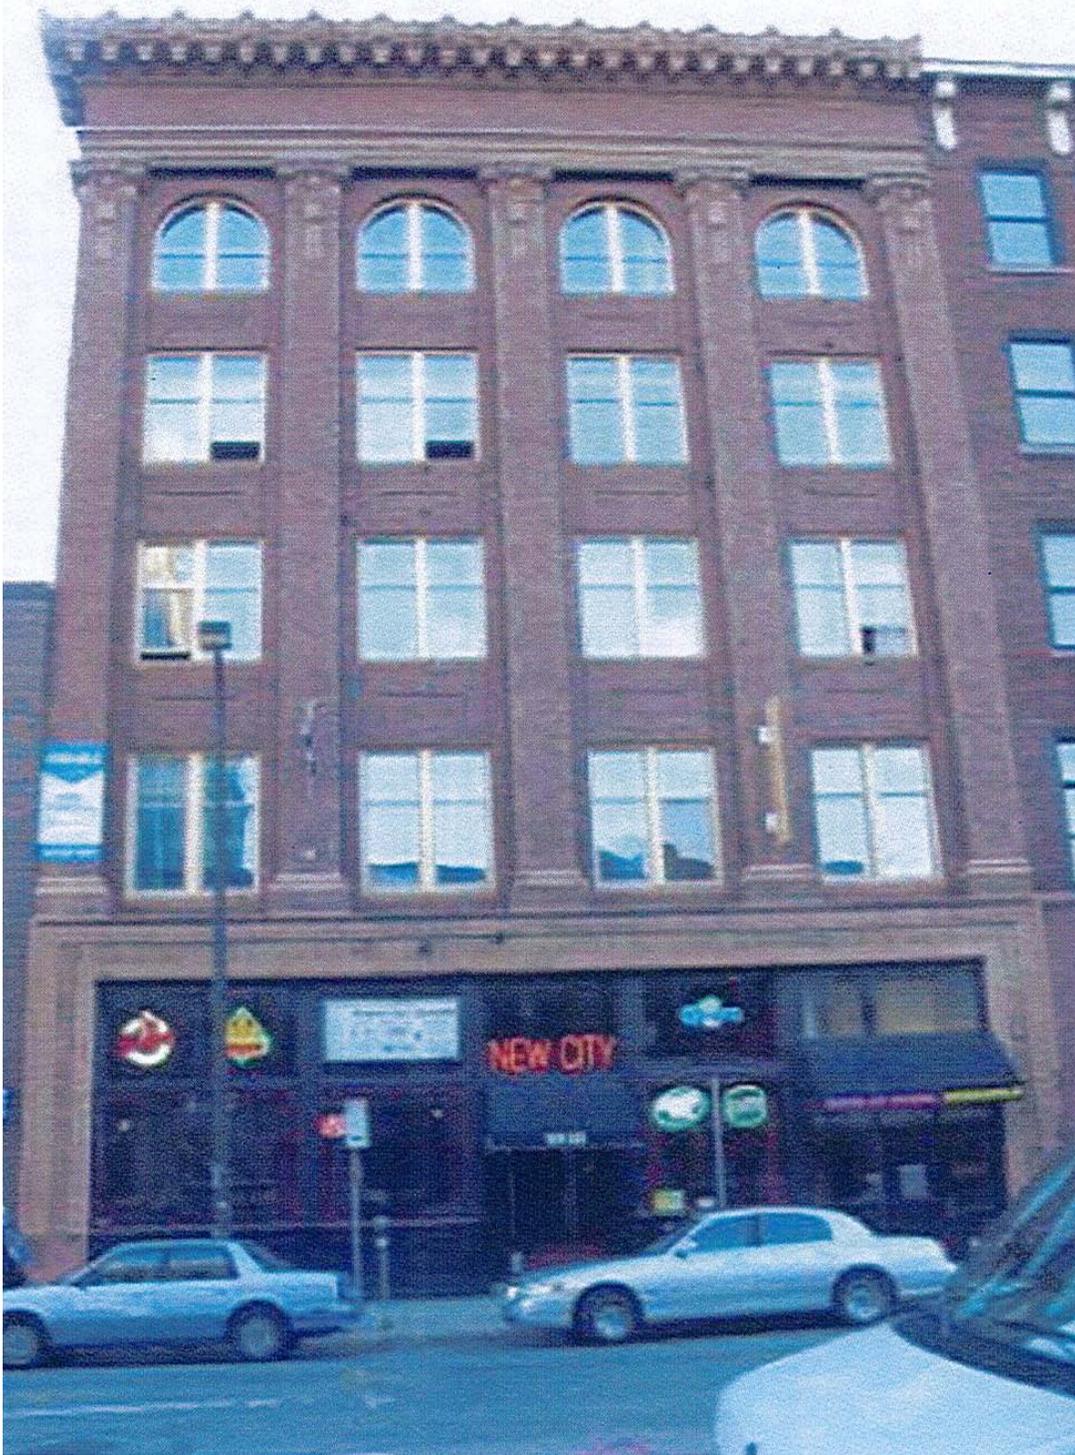
25 North 4th Street, 2010, photo submitted by Applicant

The Robitshek Building is a five-story Beaux Arts composition constructed with brick and stylized terra cotta. An egg-and-dart molding frames the first floor storefront while five defined columns with ornate capitals divide the upper stories into four bays. Paired windows in each bay are organized as a vertical element within a rounded arch. The bays are further defined by recessed spandrels. The elaborate cornice consists of projecting modillions and terra cotta medallions. The ground floor storefront and entry have been modified, but the building retains its integrity.
