**Phase II Environmental Site  
Assessment - 1401 Central  
Avenue in Minneapolis, MN**

STS Project 98408-XB

Environmental Profile

MCDA Block 34, Parcel 1  
(1401 Central Avenue NE)  
Minneapolis, Hennepin County  
Minnesota 55413

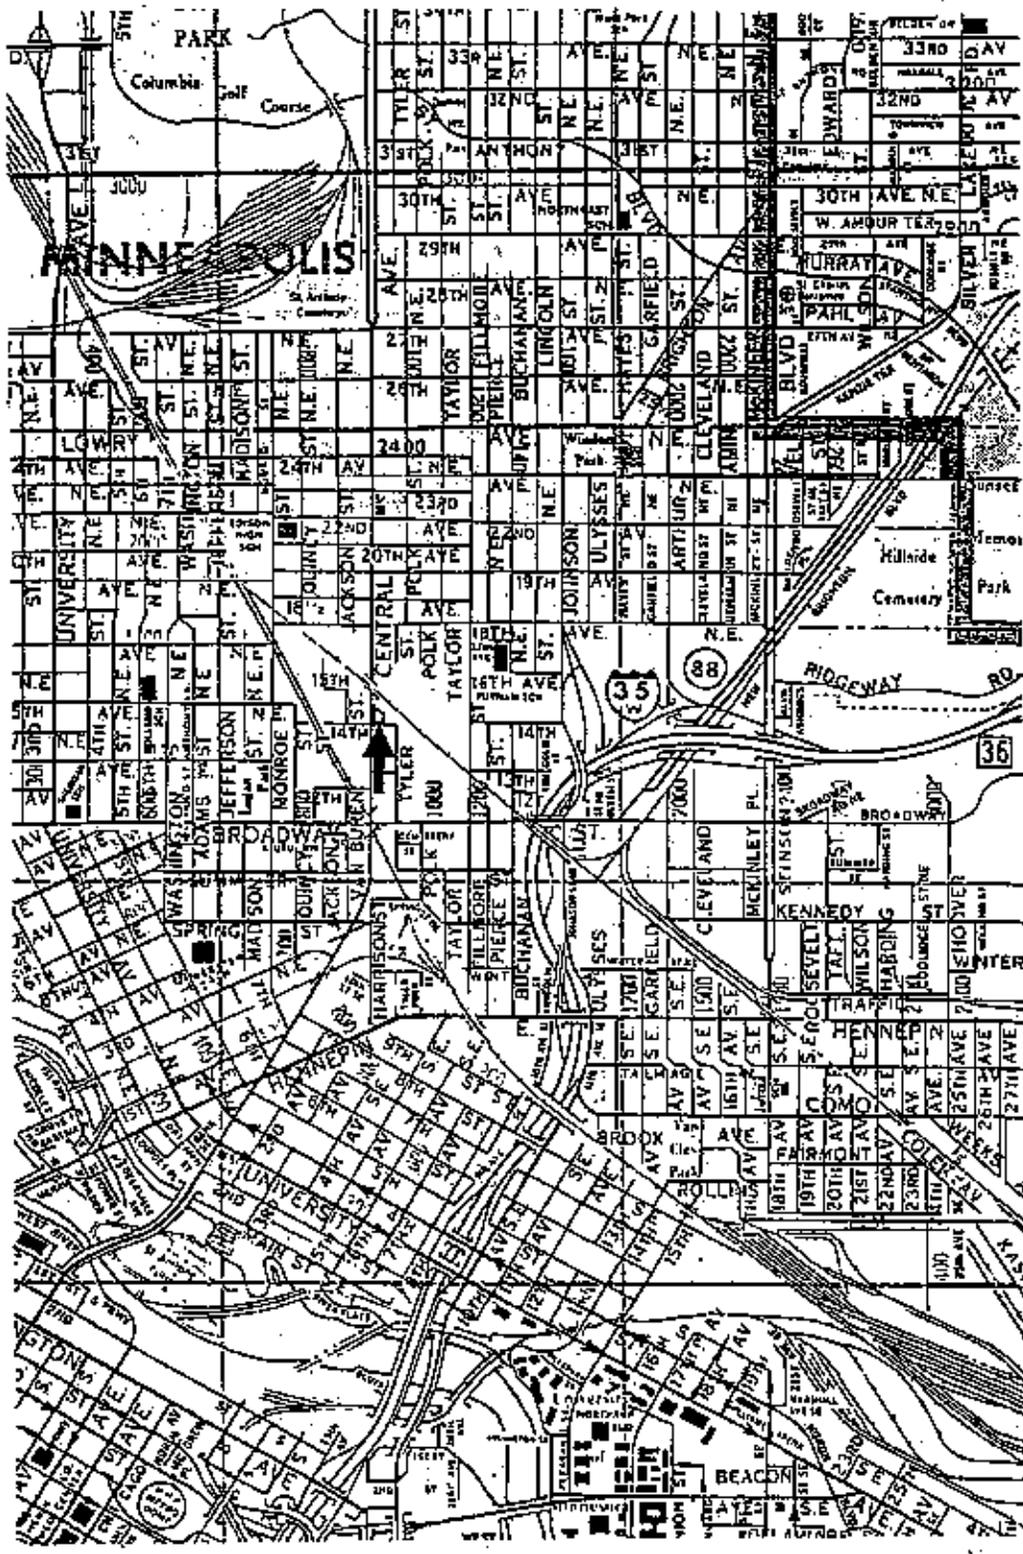
FIGURE 3-STREET MAP  
 ENVIRONMENTAL PROFILE  
 PN #1-00631  
 MCDA BLOCK 34, PARCEL 1  
 (1401 CENTRAL AVE. NE)  
 MINNEAPOLIS, MN 55413

Past land use is an indication of whether hazardous materials have been used at the site and introduced to the subsurface. Reproducible records are attached as Addendum 3. A current street map of the property is included for reference (Figure 3).

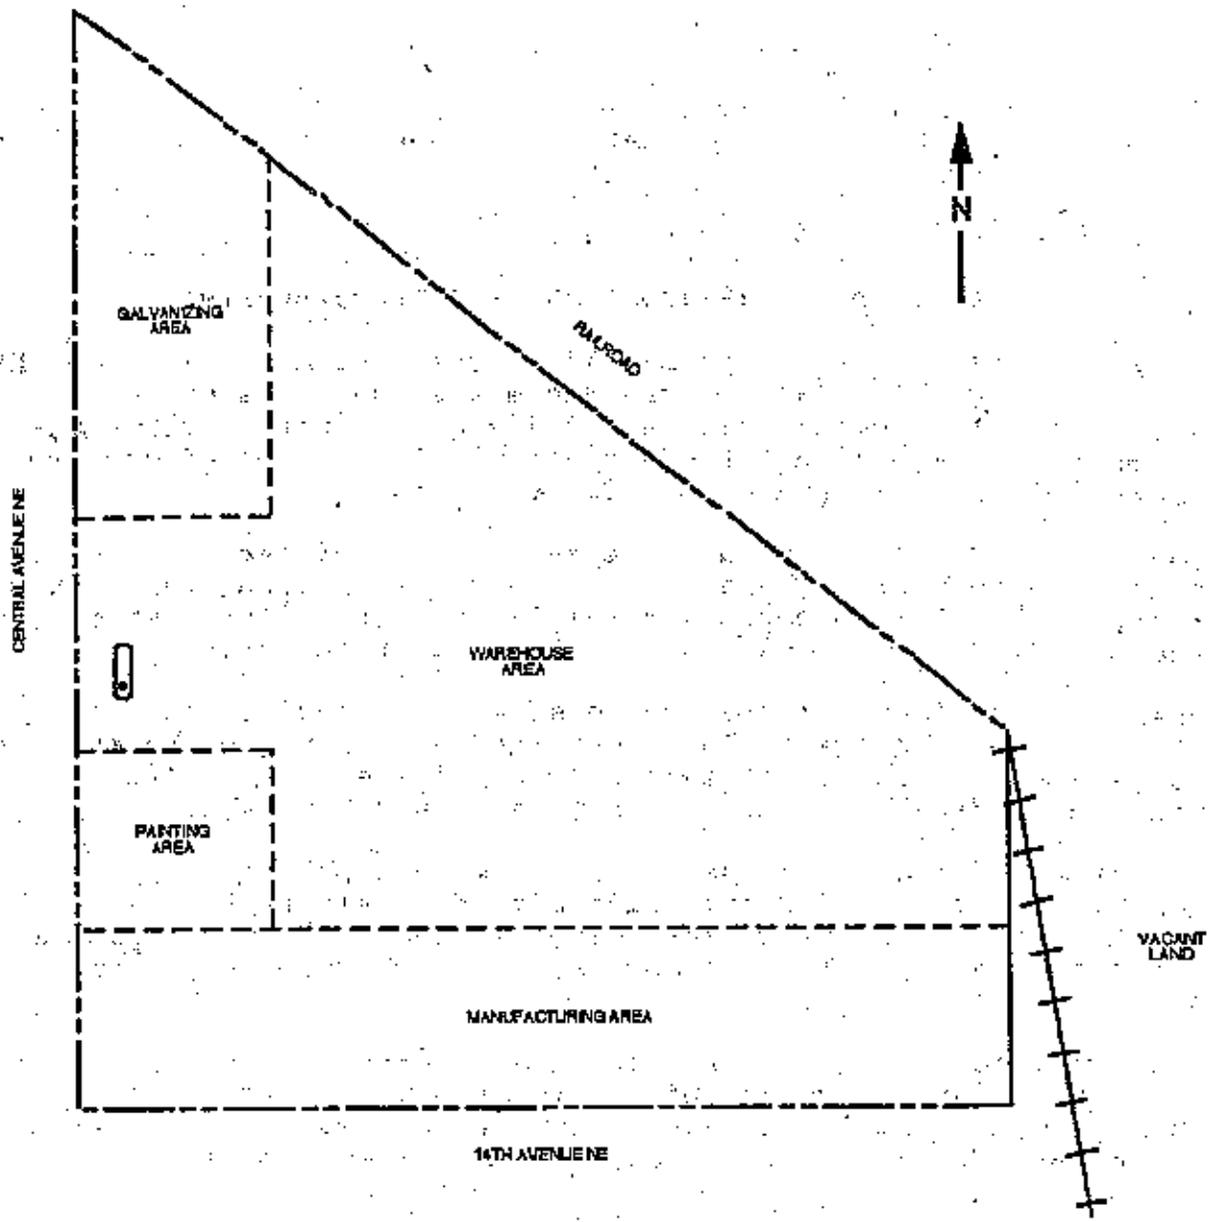
**LEGEND**

Site Reconnaissance was performed at the 1401 Central Avenue NE site on March 25, 1993. There was mud present obscuring surfaces. The reconnaissance was documented with photographs which are retained in EnPro's project file. Items of concern noted below are indicated on Figure 4.

There are no stains, odors, degraded pavement, or stressed vegetation indicative of spills, leaks, or disposal. No handling, storage, or disposal of materials was observed. There are no pipes indicative of underground storage tanks.

- PROPERTY LINE
- ||| RAILROAD SPUR
- ⊞ TANK LOCATION
- FORMER MANUFACTURING/ PROCESSING AREAS
