# CHURCH OF THE INCARNATION HISTORIC DISTRICT DESIGN GUIDELINES

Prepared for the Minneapolis Heritage Preservation Commission  
City of Minneapolis  
Community Planning & Economic Development (CPED)  
April 3, 2018

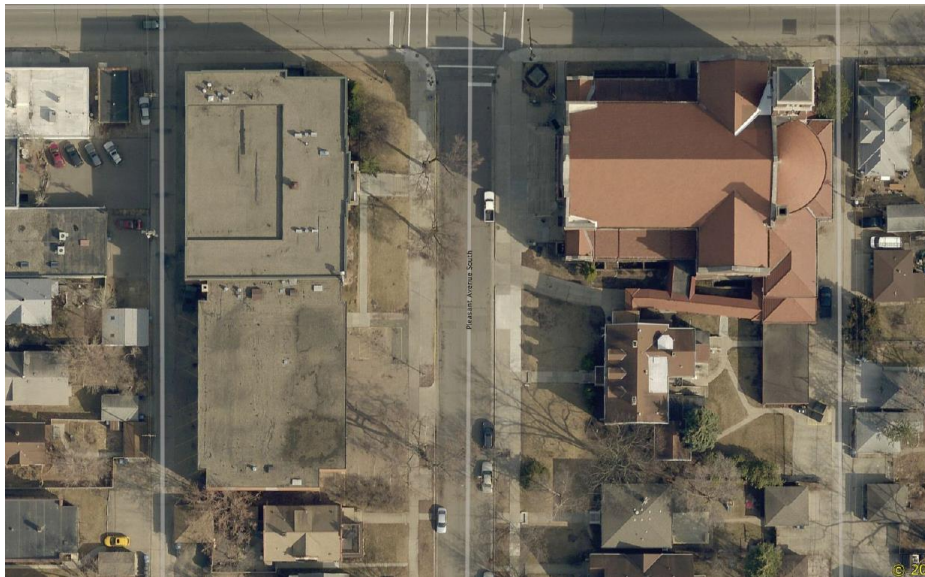
FIGURE 1. CHURCH OF THE INCARNATION HISTORIC DISTRICT, AERIAL PERSPECTIVE (TOP = NORTH)  
APRIL 1, 2015, CONNECTEXPLORER AERIAL IMAGE DATABASE.

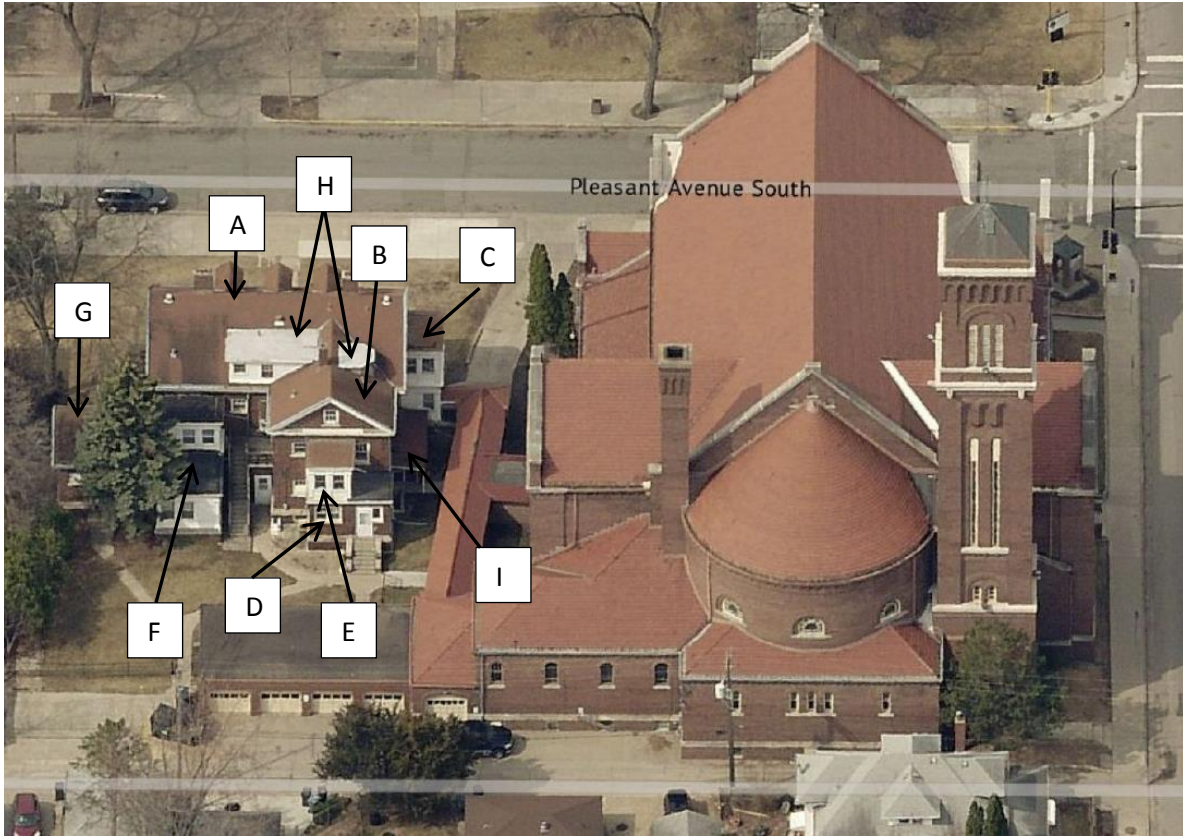
FIGURE 2. RECTORY AND CHURCH, EASTERN ELEVATION, APRIL 1, 2015, CONNECTEXPLORER AERIAL IMAGE DATABASE (LETTERS ADDED).

- i. This was most likely an extension of section F (see figure 2)
  - c. 1927: Construction of a 13 x 8 x 8 frame, second-story sleeping porch (building permit)

- i. This was most likely the second-story portion of section F
  - d. 1927: Construction of a 19 x 19 brick veneer addition (building permit)
    - i. This addition is section G

- c. The addition of a decorative sign in the tympanum of the entryway pediment (1934 photograph)
  - d. The construction of section I, the grooved plywood, shed-roofed addition on the north elevation of the rectory (see figure 2)

- i. Visual evidence indicates that this entire addition was most likely constructed after 1963
- e. The addition of mechanical equipment and a pipe on the east elevation of section B (visual evidence)

- f. The addition of lights to or replacement of lights on the north elevation of section F, the entrance to section G, the entrance to section D, and the ceiling of the front entryway porch (visual evidence)

- i. The materials used to construct the open porch and stairway installed on the east elevation of section A (wood), (visual evidence)
- j. Replacement of some older windows with new, white vinyl or painted aluminum windows, mechanical equipment, or infill panels (visual evidence)

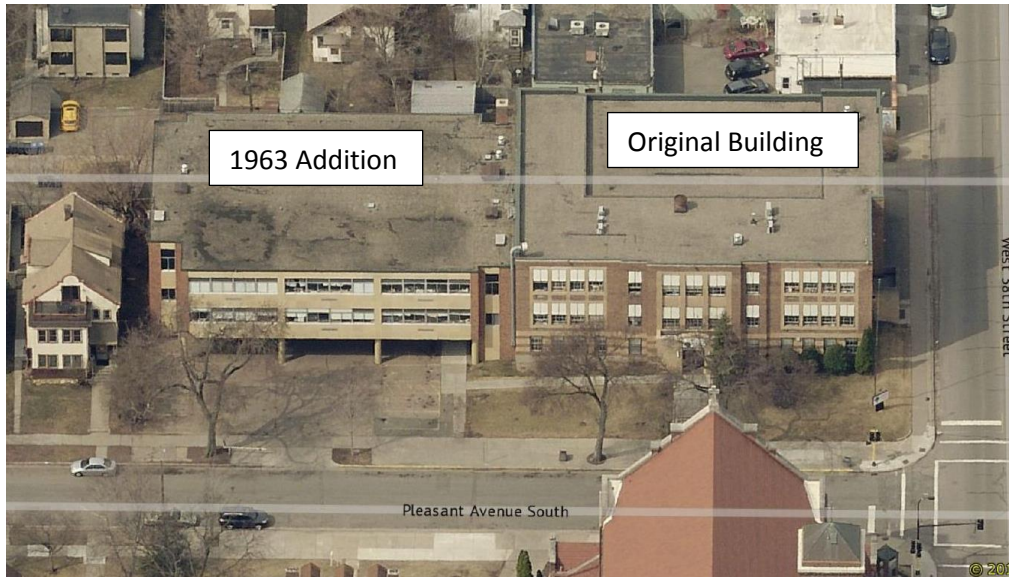
FIGURE 3. MOYNIHAN HALL, EASTERN ELEVATION, APRIL 1, 2015, CONNECTEXPLORER AERIAL IMAGE DATABASE.
