# Hennepin Avenue South Midblock Crossing Evaluation

July 26, 2019

# Project Design (Lake-31<sup>st</sup> Street)

## Midblock crossing design

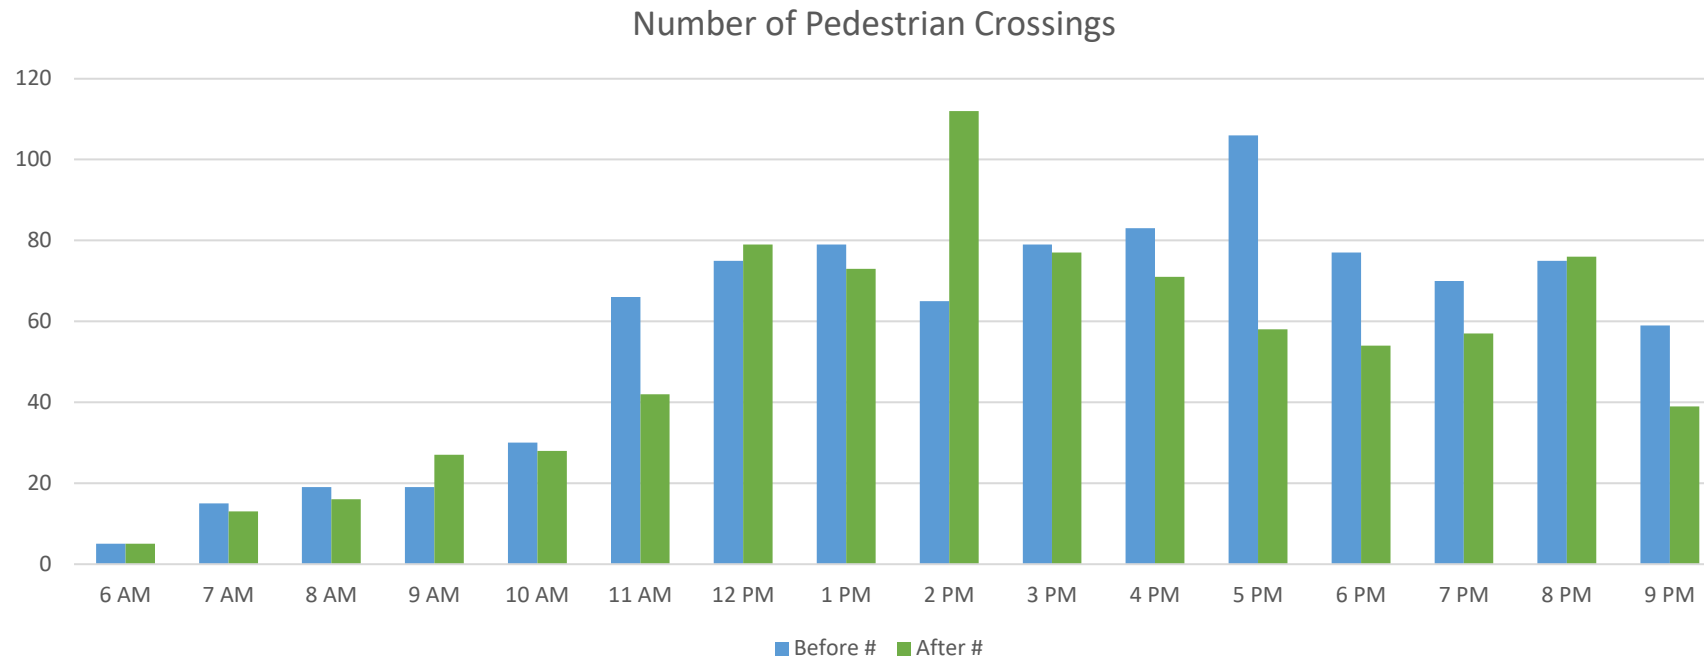
The number of pedestrian crossings decreased slightly, but was still high

- Before: 922 pedestrian were observed crossings in 705 groups
  - Many people were observed walking to/from parked vehicles on Hennepin Ave S
- After: 827 pedestrians were observed crossing in 566 groups
  - There was no on-street parking on Hennepin Ave S during the after conditions

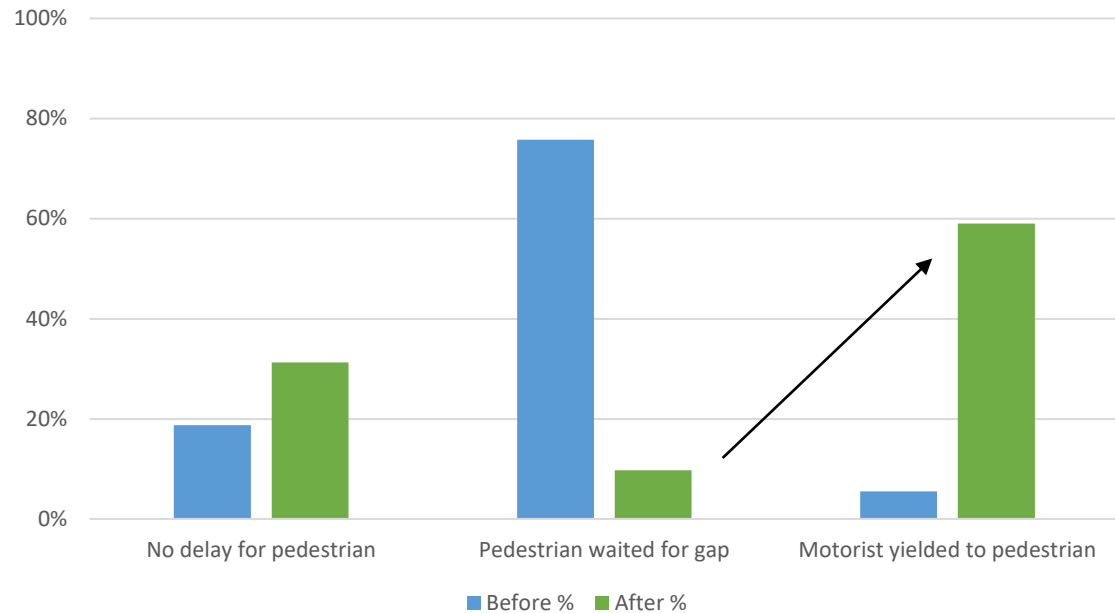
After installation, driver yielding behavior improved from 7% --> 86%

Pedestrian Crossing Experience  
(all events, including no driver present)

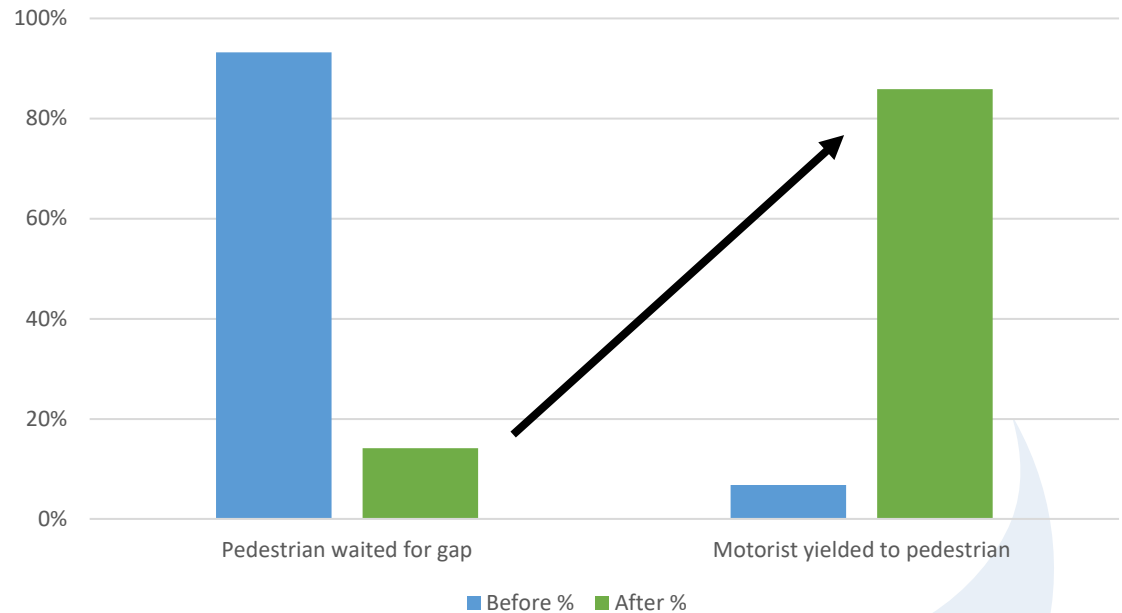
Pedestrian Crossing Experience  
(when driver present)

- Pedestrian crossings remained high after installation
- Pedestrian crossings became more predictable - midblock pedestrian crossings were more concentrated around the Calhoun Square entrance after installation
- Driver yielding increased substantially after installation
- Driver speeds decreased after installation
