SECTION @ BALCONY END BAY- EXISTING CONDITION

REV	RFP#2–R
	OCT 8,2003

orpheum theatre
910 hennepin ave
minneapolis, minnesota

1
5–1

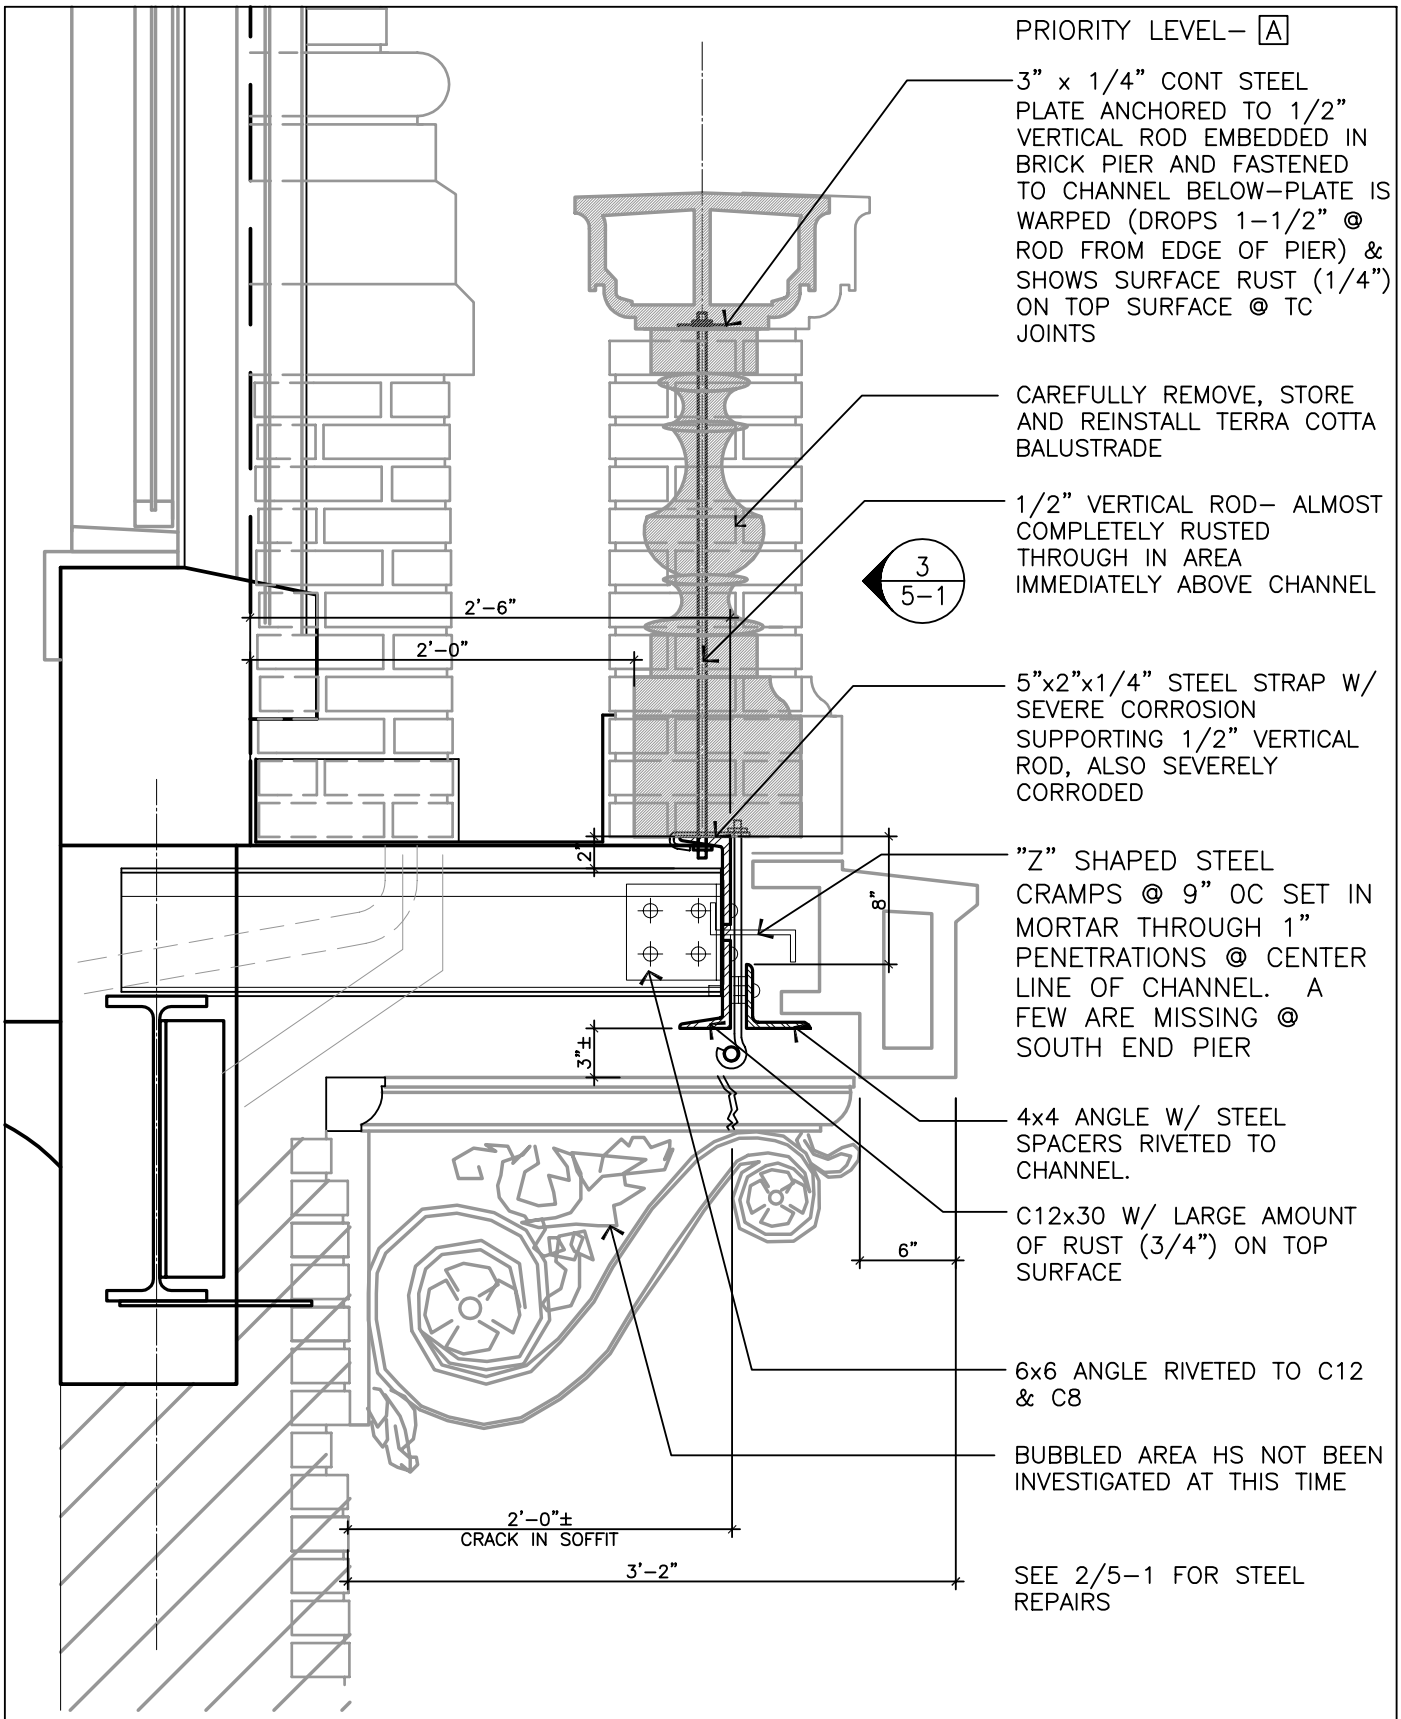
3" x 1/4" CONT STEEL PLATE ANCHORED TO 1/2" VERTICAL ROD EMBEDDED IN BRICK PIER AND FASTENED TO CHANNEL BELOW–PLATE IS WARPED (DROPS 1–1/2" @ ROD FROM EDGE OF PIER) & SHOWS SURFACE RUST (1/4") ON TOP SURFACE @ TC JOINTS

1/2" VERTICAL ROD– ALMOST COMPLETELY RUSTED THROUGH IN AREA IMMEDIATELY ABOVE CHANNEL

5"x2"x1/4" STEEL STRAP W/ SEVERE CORROSION SUPPORTING 1/2" VERTICAL ROD, ALSO SEVERELY CORRODED

"Z" SHAPED STEEL CRAMPS @ 9" OC SET IN MORTAR THROUGH 1" PENETRATIONS @ CENTER LINE OF CHANNEL. A FEW ARE MISSING @ SOUTH END PIER

4x4 ANGLE W/ STEEL SPACERS RIVETED TO CHANNEL.

C12x30 W/ LARGE AMOUNT OF RUST (3/4") ON TOP SURFACE

6x6 ANGLE RIVETED TO C12 & C8

BUBBLED AREA HS NOT BEEN INVESTIGATED AT THIS TIME

CAREFULLY REMOVE, STORE AND REINSTALL TERRA COTTA BALUSTRADE

SEE 2/5–1 FOR STEEL REPAIRS
