3112 3rd Ave South Heritage Preservation Site Plan

Prepared by Jennifer Tschida
Minneapolis Department of Health
On behalf of
Reina S Benavides Guaman

December 12, 2013

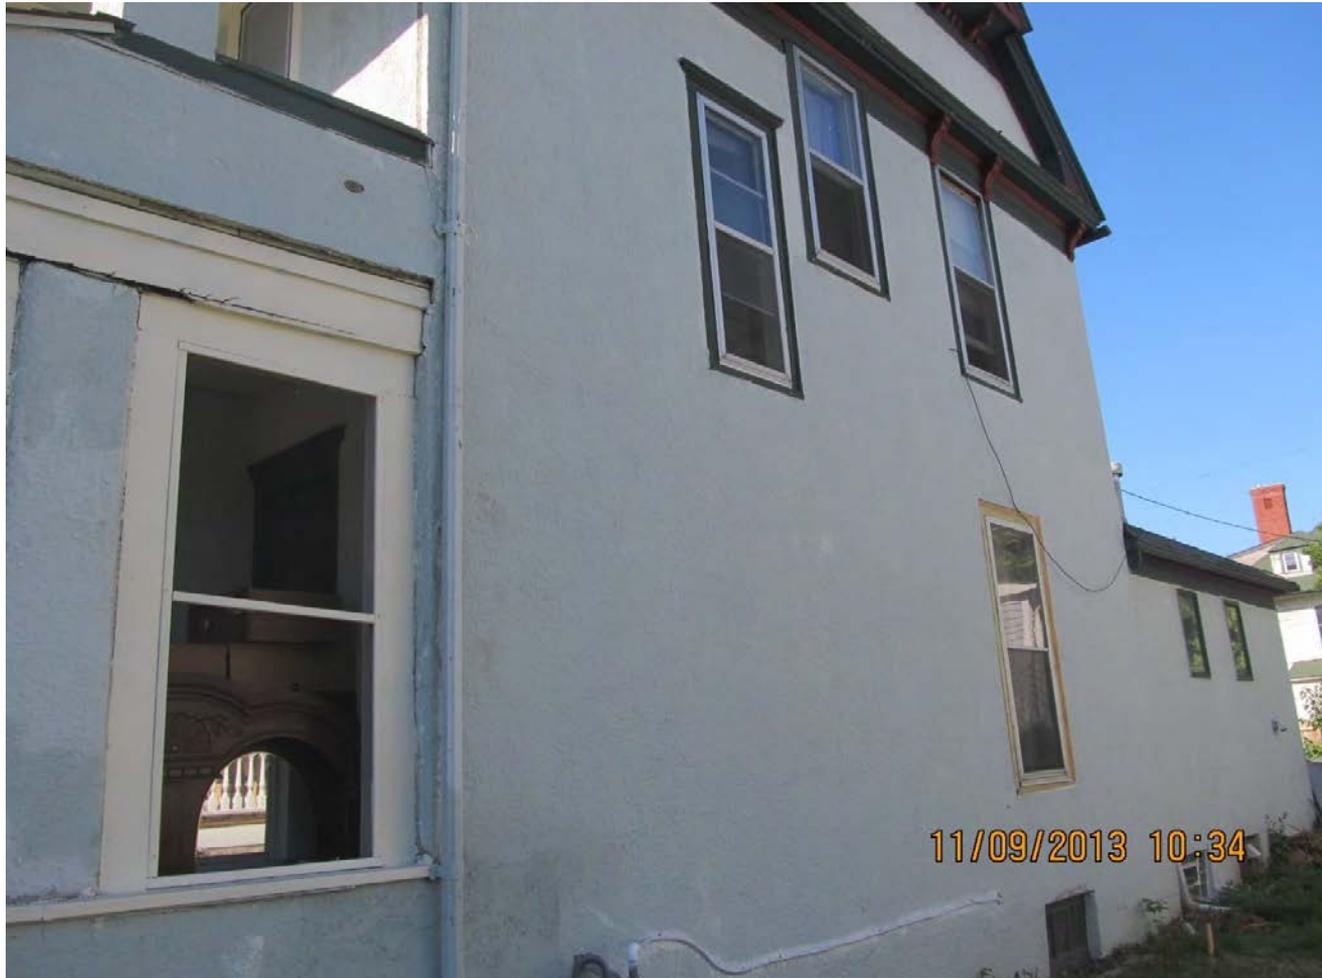
North Side Cellar Windows

These are the cellar windows on the north side. Note that there is no consistency in “historic-ness” of these windows.

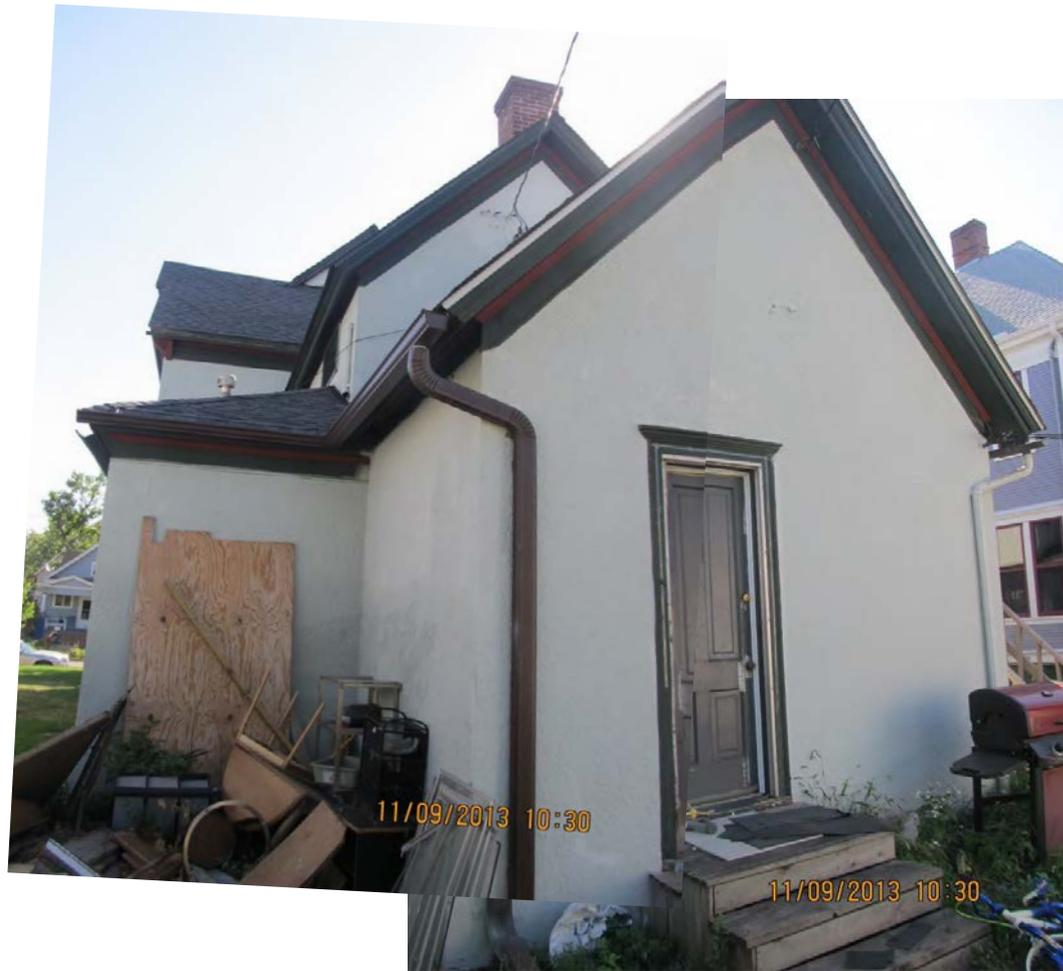
Alley Side

Non historic windows
