Framework for the Treatment of Character Defining Features
for the Reactivation of the Hollywood Theater

Proposed by CPED-Planning, Preservation & Design
March 10, 2009

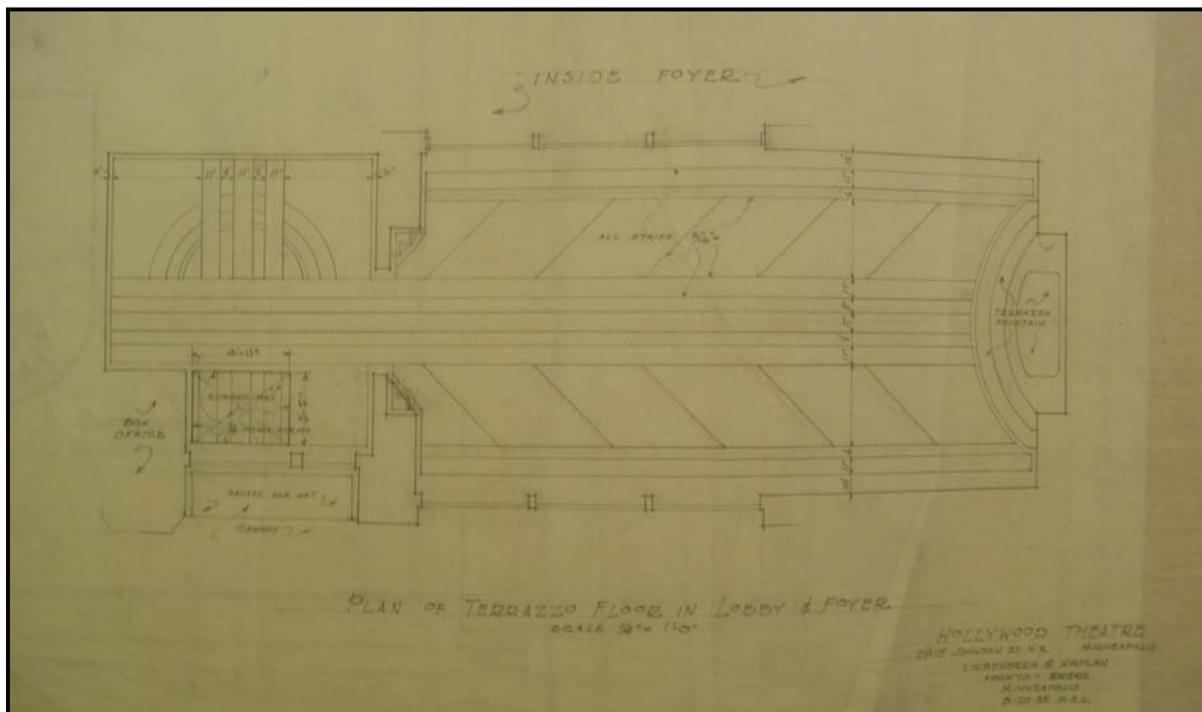
Terrazzo Floor

The multicolored terrazzo floor inlaid in grey, yellow, black and pink is covered in dust and dirt.

The floor of the entrance vestibule is flat, while the main lobby floor has a slight rake that slopes away from the main auditorium toward the exit doors. The terrazzo floor is one of the few original interior finishes that is intact and exemplifies the original design aesthetic. All efforts shall be made to rehabilitate the floor and showcase it in proposed reuses of the Hollywood.

All efforts shall be made to rehabilitate the floor. It may be covered up if proven necessary, that it is reversible, and that it won't damage the floor. See below for further guidance.

If a proposed rehabilitation requires the leveling of the outer lobby floor to activate the space, a sensitive and reversible leveling of the floor may be considered if the following criteria can be demonstrated. First, the proposed leveling will not result in the damage or destruction of the floor and adjacent original features and can be reversed without causing damage to the floor. Second, financial information, such as a pro forma, demonstrate that this space must be utilized to make the rehabilitation and activation of the theater viable. Furthermore, it is demonstrated that utilization of this space must require the floor to be leveled.

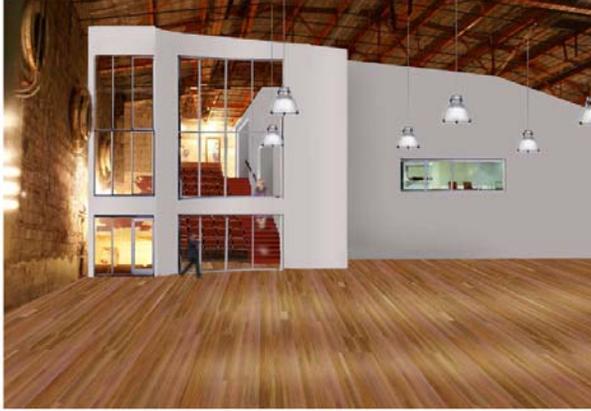
The volume of the auditorium is intact. The plaster of the roof was removed during remediation and roof replacement- this slightly changes the feeling of the volume of the space.

The subdivision of the space can be done, however, the sense of space associated with the volume of the space and theater activity shall be conveyed in the subdivision. See below for details.

The vastness of the auditorium space is an important feature of the theater and is historically significant. For an adaptive reuse of the theater it is likely that the auditorium space will need to be subdivided to accommodate tenants. The subdivision of the space can be done, however, the sense of space and feeling associated with the volume of the space and theater activity shall be conveyed in the subdivision. This can be done by subdividing the space at a natural division point between the balcony and the main floor. The rendering of the interior on the next page shows one design option that conveys the sense of space, while still allowing for the subdivision of the auditorium.
