Report  
for the  
2009 Structural Review

1001 West Broadway  
Avenue Building

BCG Project Number R739-09-1

## 2009 Structural Review of the 1001 West Broadway Avenue Building

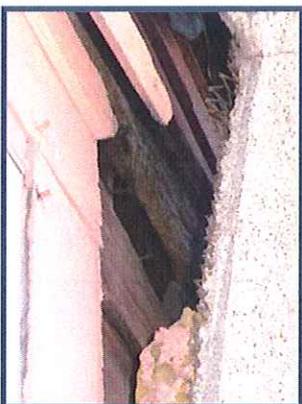
*Image 9, thumbnail.*

The stucco veneer at the west and south elevations had been installed over wood clapboard siding, and was generally dislocated away from the wall. Where the siding was accessible it was observed to be significantly distressed. (See image 9.) One layer of building paper was observed behind the stucco, and one layer of building paper was observed behind the clapboard. No obvious anchorage of the metal lath was observed.

The condition of the stucco veneer combined with the significant deterioration of the underlying clapboard siding may allow significant rainwater intrusion, resulting in further deterioration of the structurally supporting wood components.

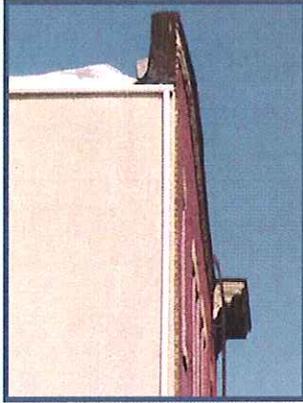
Image 10, thumbnail.

The east wall parapet appeared to bow outward several inches and displayed a slight outward rotation at the top. Additionally, there was brick and mortar cracking in the brick parapet. (See image 10.)

- A. The brick parapet along the east wall (see image 10) appeared to be dislocated, and bowed outwards.
- B. Isolated large areas of distressed brick veneer were also observed below the parapet.
