HERITAGE PRESERVATION APPLICATION SUMMARY

Property Location: 121-125 Washington Avenue North
Project Name: The Washington
Prepared By: John Smoley, Ph.D., (612) 673-2830
Applicant: Preservation Design Works
Project Contact: Meghan Elliott
Ward: 3
Neighborhood: Downtown West
Request: To rehabilitate the buildings
Required Applications:

APPENDIX B: THE WASHINGTON – WINDOW RECOMMENDATIONS

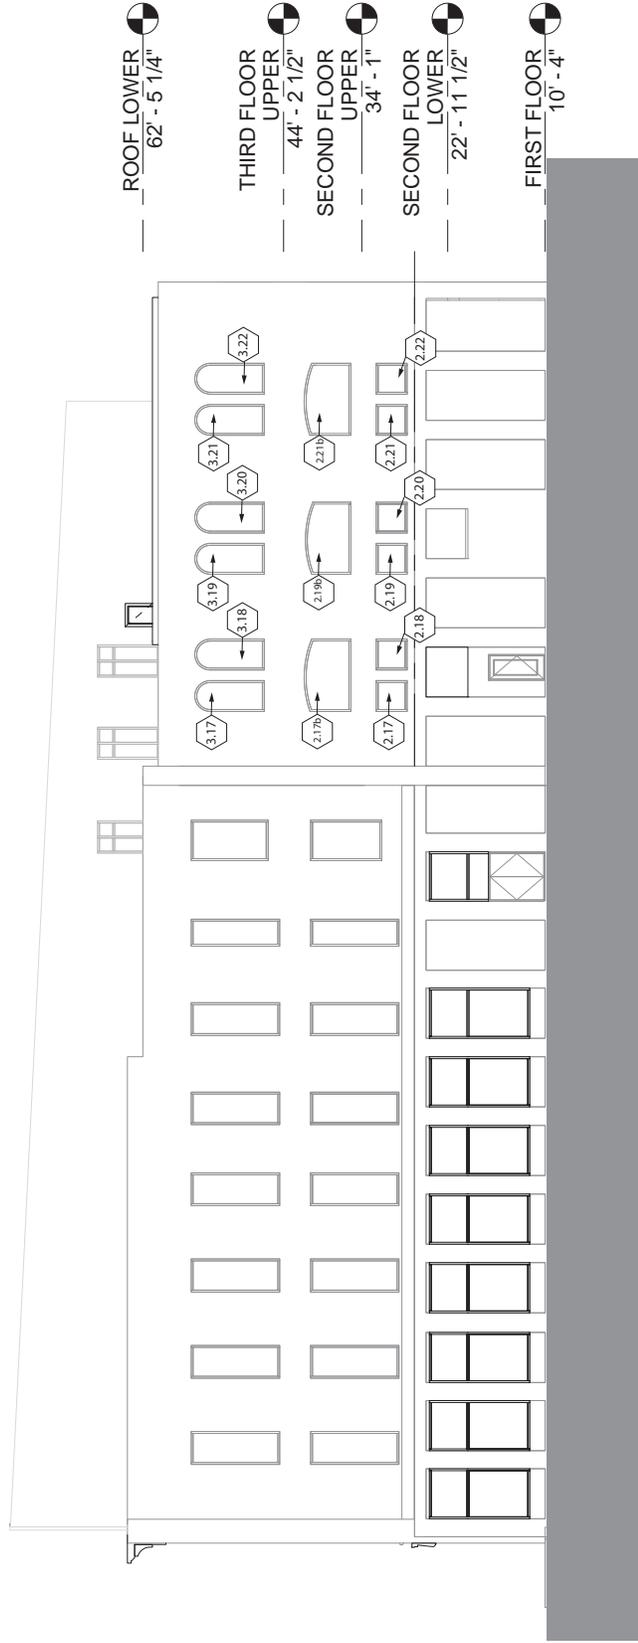
4 Elevation West
 A301 1/16" = 1'-0"

Drawing Title:
WINDOW SURVEY: ELEVATIONS
JULY 31, 2015

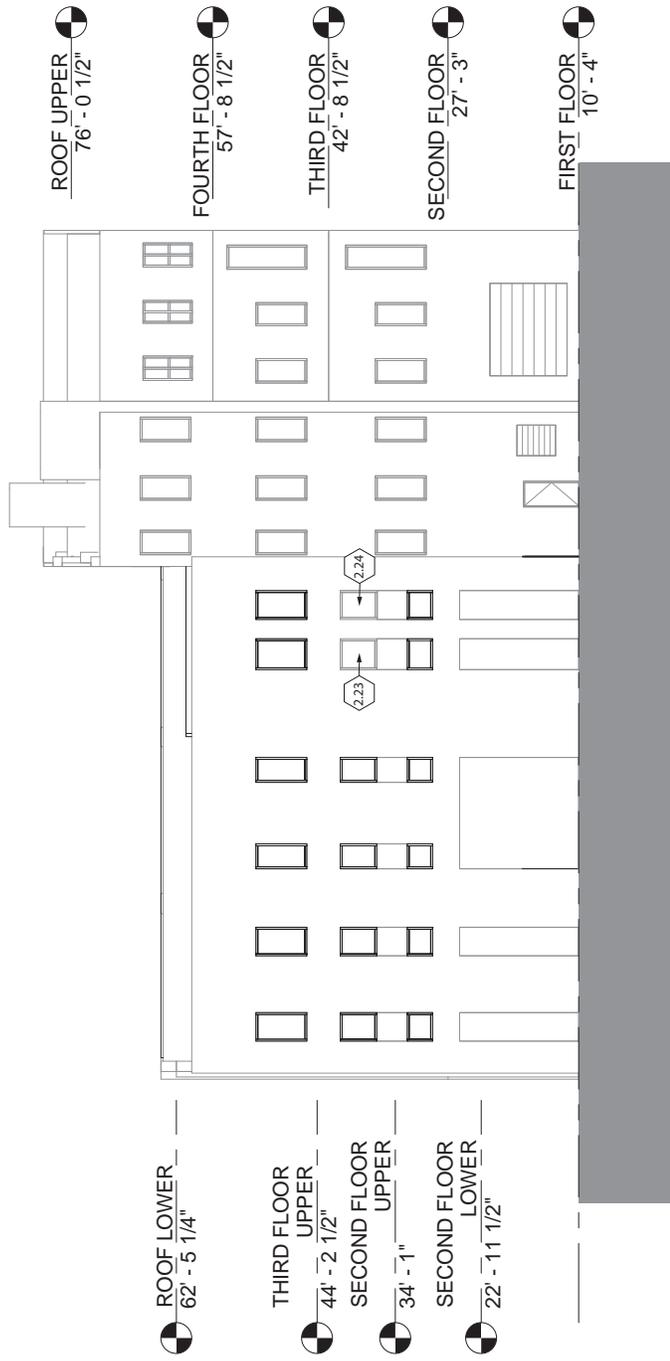
3 Elevation South
A301 1/16" = 1'-0"

Drawing Title:
WINDOW SURVEY: ELEVATIONS
 JULY 31, 2015

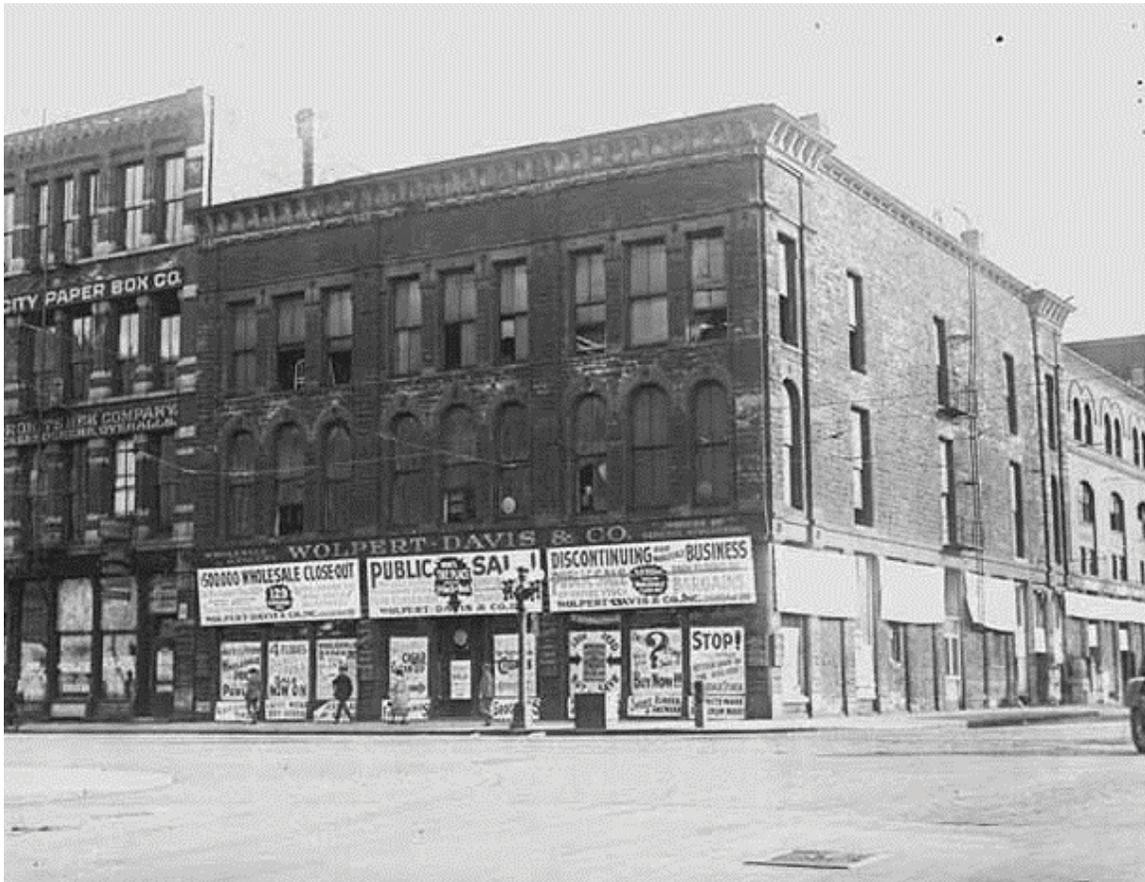
Figure 1: Wolpert-Davis Wholesale Grocers, Second Avenue North and Washington, Minneapolis. C. 1925. Photograph. Minnesota Historical Society, St. Paul, MN. ID Number: MH5.9 MP3.1W r5.

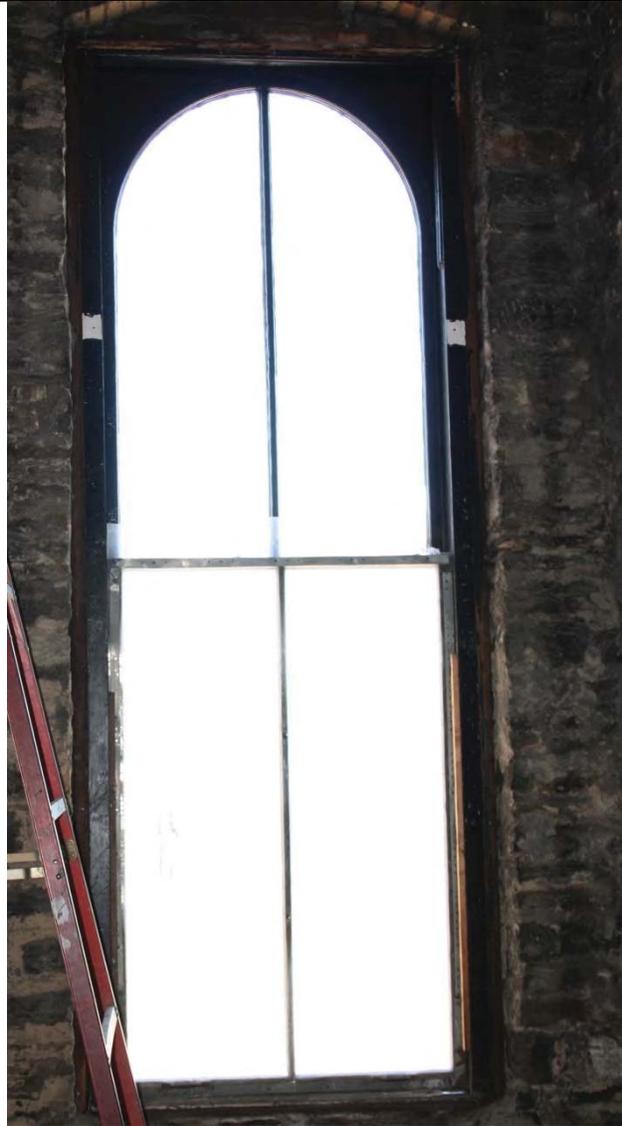
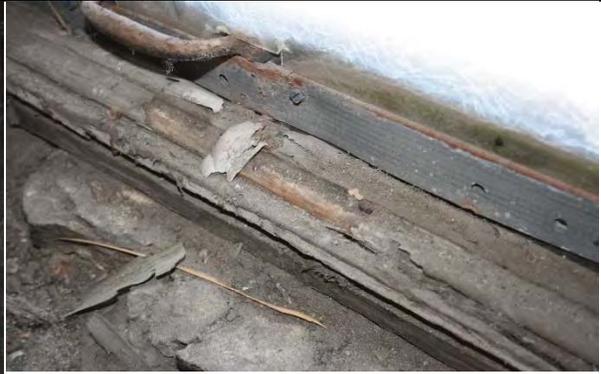
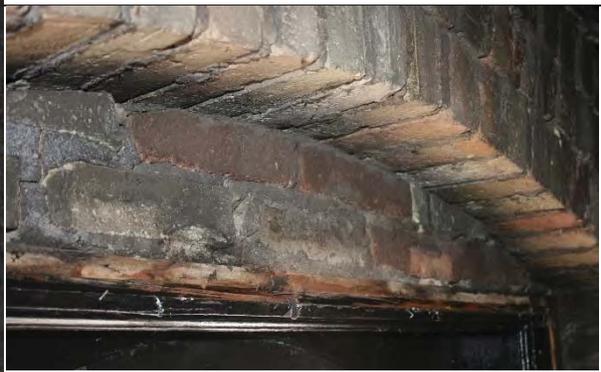
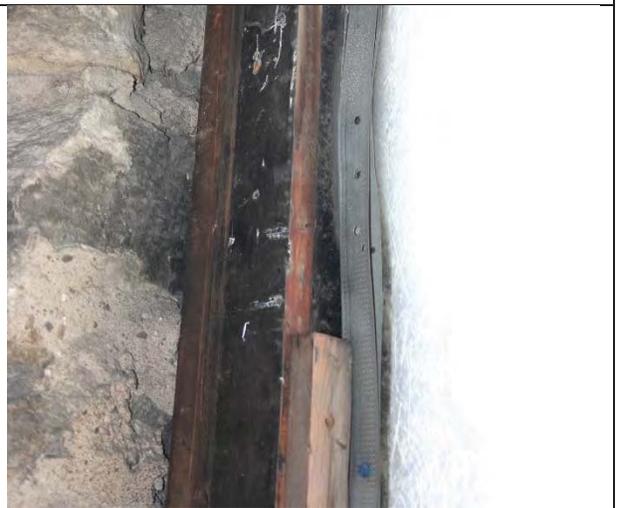
Photographic Documentation: 2.00

Assessment: Fair (rehabilitate)					
	Excellent	Good	Fair	Poor	Missing
Glazing Compound				X	
Frame		X			
Sash			X		
Exterior Trim			X		
Exterior Stop			X		
Exterior Wood Sill			X (Assumed)		
Interior Trim					NA
Interior Stop					X (partial)
Interior Stool				X	
Interior Header			X		
Hardware				X	
Muntins		X			
Finish			X

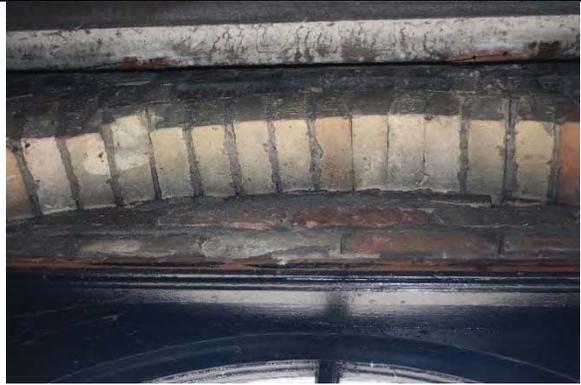
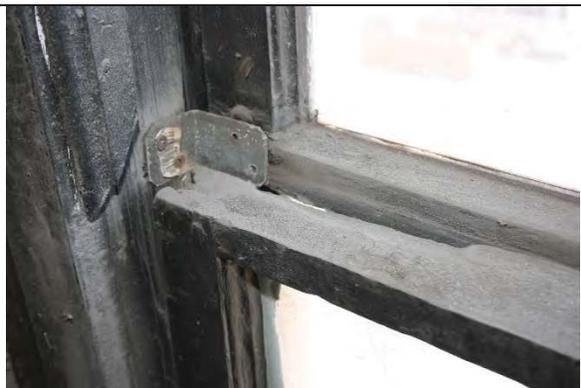
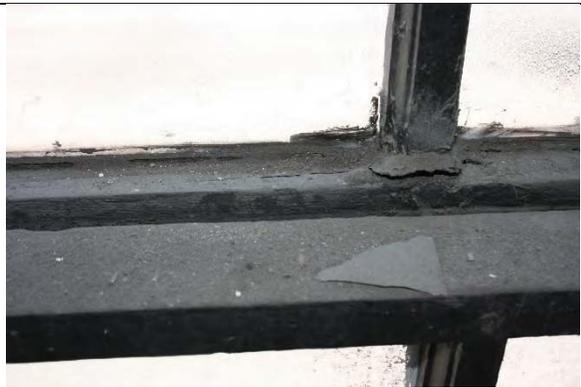
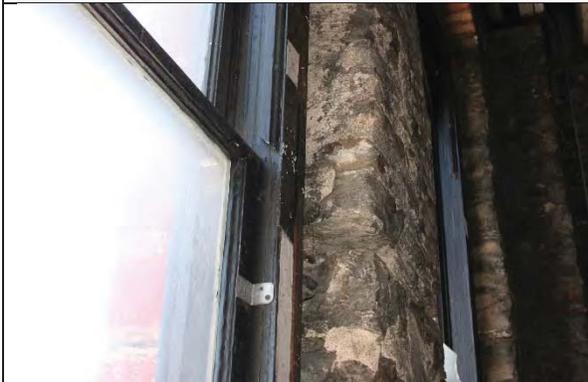
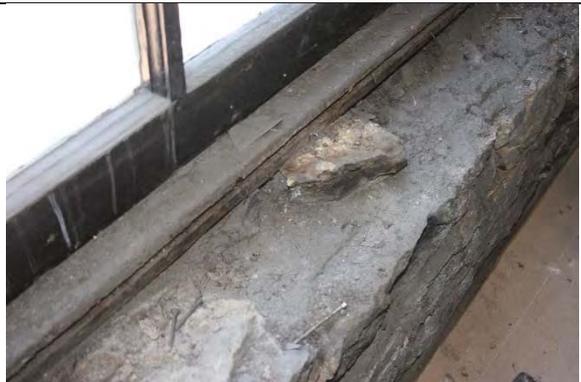
Photographic Documentation: 2.01

Assessment: Fair (rehabilitate)					
	Excellent	Good	Fair	Poor	Missing
Glazing Compound				X	
Frame			X		
Sash			X		
Exterior Trim			X		
Exterior Stop			X		
Exterior Wood Sill			X		
Interior Trim					NA
Interior Stop			X		
Interior Stool				X	
Interior Header			X		
Hardware				X	
Muntins		X			
Finish			X

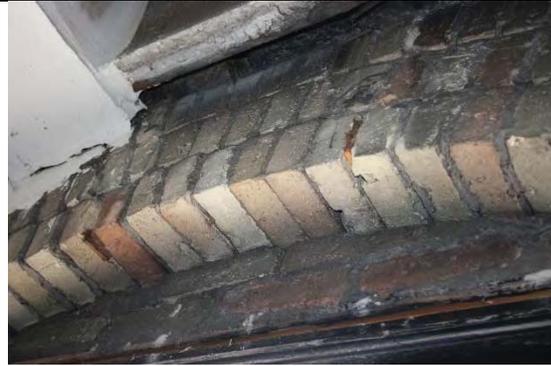
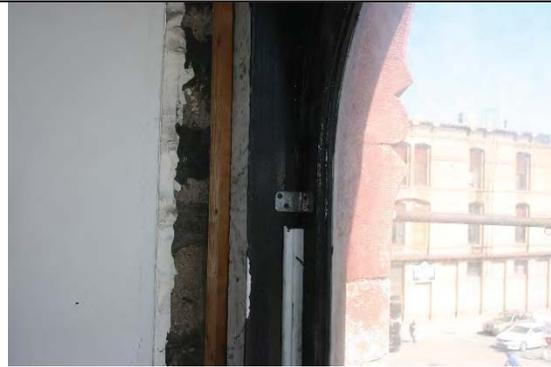
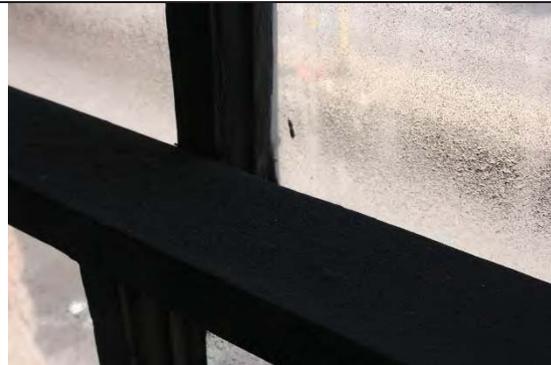
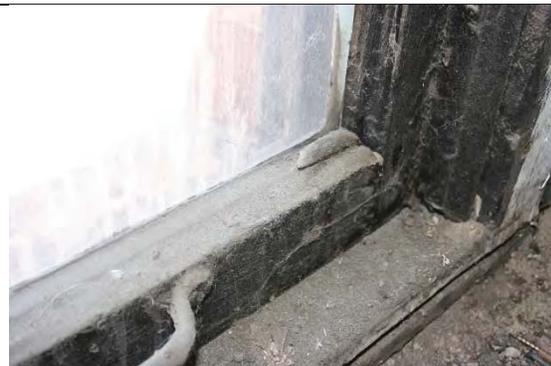
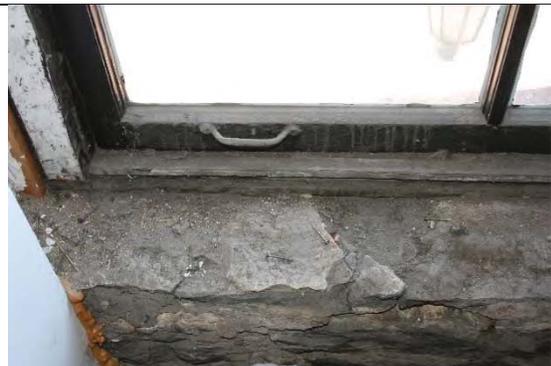
Photographic Documentation: 2.02

Window Number: 2.02	Reference Drawings: A1
<p>Description: Historic wood, painted, double-hung semi-circular arch-top window with vertical center muntin at both sashes. The window opening is arched at the exterior with a stone arch with a voussiour and stone sill. The opening is square at the interior; the frame has a flat top with an arch to accommodate the upper sash. The stool and jambs are stone; the interior header is a combination of a shallow brick arch and running bond brick. There is a double-ogee profiled stop at the interior sides and top, square stop at the exterior sides and top, round trim at the sides and top at the exterior and no finish trim at the interior. The window operated on sash cords and pulleys originally, but contains no other evidence of hardware.</p>	
<p>Conditions: The upper sash is slightly dropped. There are steel angles installed at the exterior, supporting the upper sash, as well as the interior to secure the lower sash. The stool is stone and is generally in fair to poor condition, with spalled or loose stone and loose, missing or deteriorated mortar joints. There is a piece of the right-hand corner of the bottom rail of the lower sash that is loose and raised. The top rail of the lower sash is deteriorated at both exterior corners. There is typically wood loss in these areas. The center of the bottom rail of the upper sash is deteriorated; it is soft and weathered. The left side interior stop is missing completely. The exterior square stop is broken and partially missing at the right-hand side of the window. A replacement (double-ogee style) stop has been temporarily installed. The exterior trim is typically weathered and deteriorated at the right side (generally toward the bottom). The wood is checked and the grain is raised. Mortar joints are deteriorated and missing in some areas at the arch at the header. There are two pulls at the bottom rail of the lower sash. The sash cord pulleys remain, but the cords are missing. The glazing compound is missing or deteriorated at both the upper and lower sash. The paint finish is peeling and flaking in a few areas and missing completely in other areas. There are three broken panes.</p>

Assessment: Fair (rehabilitate)					
	Excellent	Good	Fair	Poor	Missing
Glazing Compound				X	
Frame			X		
Sash			X		
Exterior Trim			X		
Exterior Stop			X		
Exterior Wood Sill			X		
Interior Trim					NA
Interior Stop				X	
Interior Stool			X		
Interior Header			X		
Hardware				X	
Muntins		X			
Finish

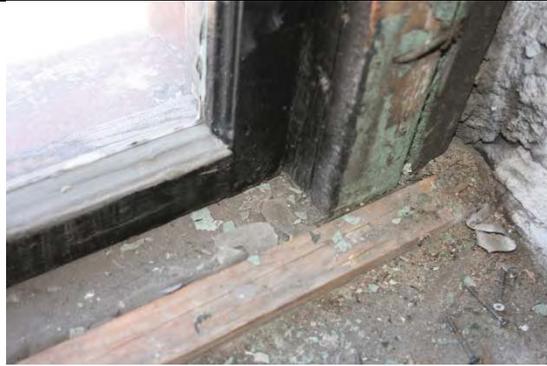
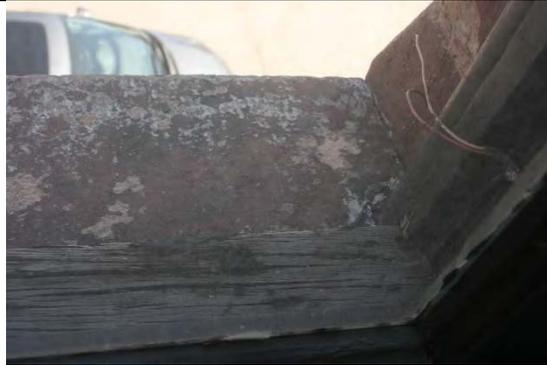
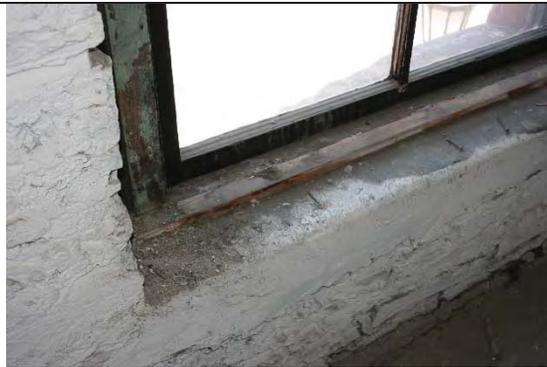
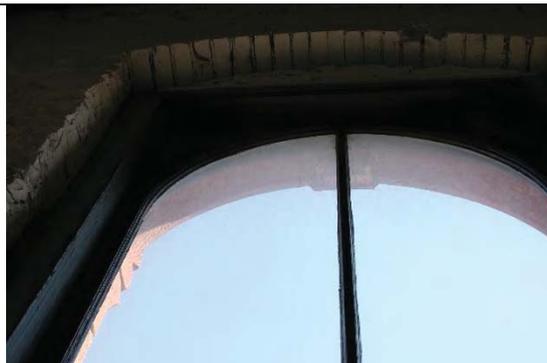
Photographic Documentation: 2.03

Window Number: 2.03	Reference Drawings: A1
<p>Description: Historic wood, painted, double-hung semi-circular arch-top window with vertical center muntin at both sashes. The window opening is arched at the exterior with a stone arch with a voussiour and stone sill. The opening is square at the interior; the frame has a flat top with an arch to accommodate the upper sash. The stool and jambs are stone; the interior header is a combination of a shallow brick arch and running bond brick. There is a double-ogee profiled stop at the interior sides and top, square stop at the exterior sides and top, round trim at the sides and top at the exterior and no finish trim at the interior. The window operated on sash cords and pulleys originally, but contains no other evidence of hardware.</p>	
<p>Conditions: There are steel angles installed at the exterior, supporting the upper sash, as well as the interior to secure the lower sash. The stool is stone and is covered with concrete. There is a wire coming through the right-hand corner of the bottom rail of the lower sash. The top rail of the lower sash is deteriorated at both exterior corners. There is typically wood loss in these areas. The bottom rail of the upper sash is deteriorated; it is checked along the entire length and the grain is raised. The interior stop is partially missing at the right side of the window towards the bottom. The exterior trim is typically weathered and deteriorated at the right side (generally toward the bottom). The wood is checked and the grain is raised. The exterior wood sill is heavily deteriorated with numerous checks and raised grain. The sash cord pulleys remain, but the cords are missing. The glazing compound is typically missing or deteriorated at both the upper and lower sash. The paint finish is peeling and flaking in a few areas and missing completely in other areas. There is one broken pane.</p>

Assessment: Fair (rehabilitate)					
	Excellent	Good	Fair	Poor	Missing
Glazing Compound				X	
Frame			X		
Sash			X		
Exterior Trim			X		
Exterior Stop			X		
Exterior Wood Sill				X	
Interior Trim					NA
Interior Stop				X	
Interior Stool				X	
Interior Header			X		
Hardware				X	
Muntins		X			
Finish			X

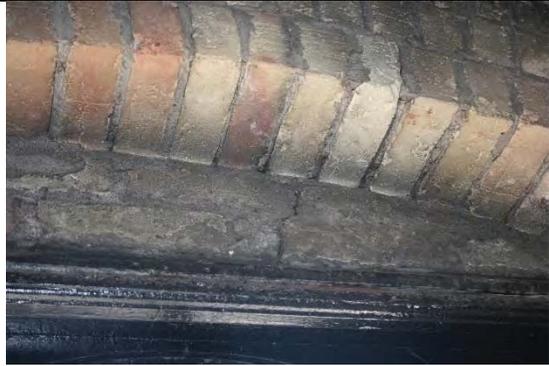
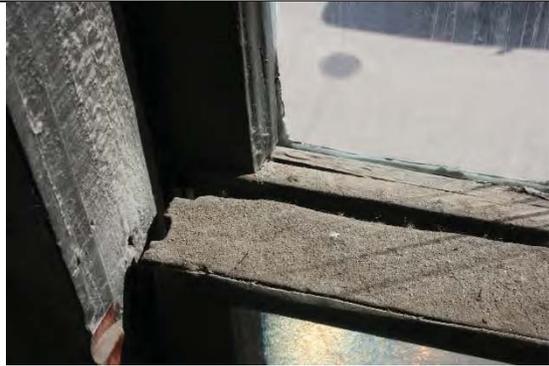
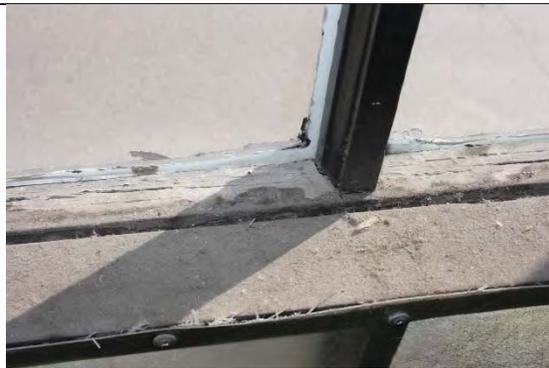
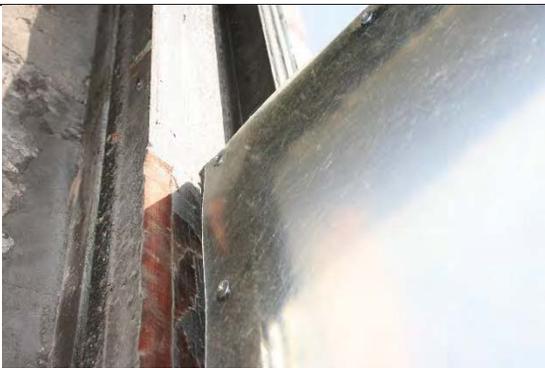
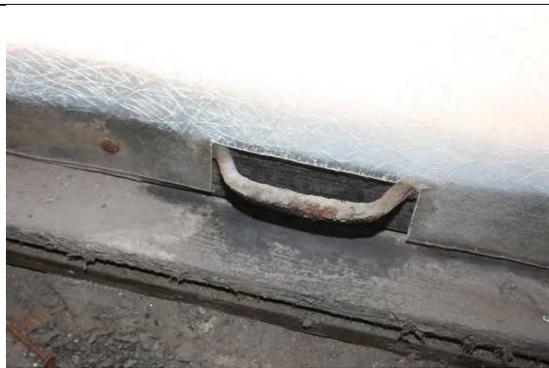
Photographic Documentation: 2.05

Assessment: Fair (rehabilitate)					
	Excellent	Good	Fair	Poor	Missing
Glazing Compound				X	
Frame			X		
Sash			X		
Exterior Trim			X		
Exterior Stop			X		
Exterior Wood Sill				X	
Interior Trim					NA
Interior Stop				X	
Interior Stool				X	
Interior Header			X		
Hardware				X	
Muntins		X			
Finish			X

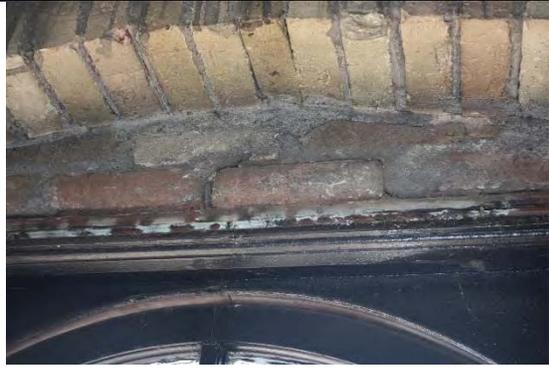
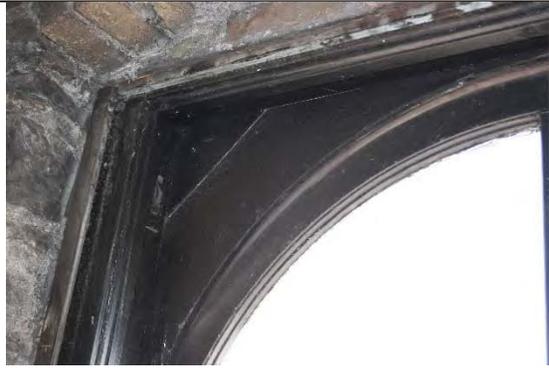
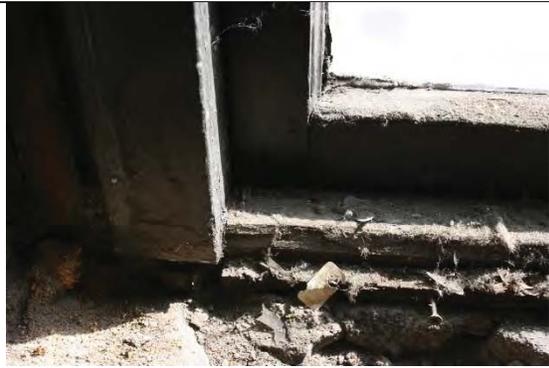
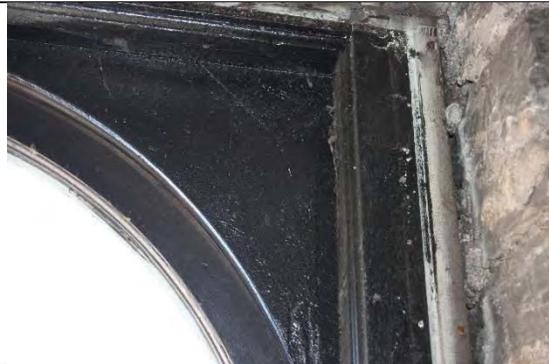
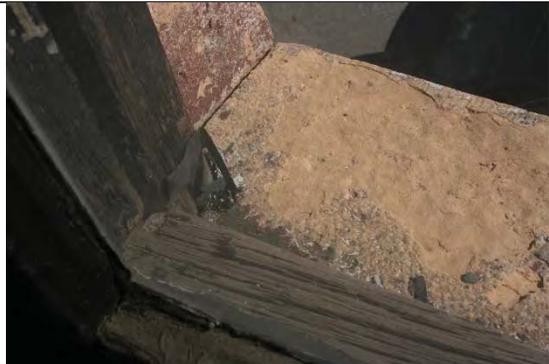
Photographic Documentation: 2.06

Window Number: 2.06	Reference Drawings: A1
<p>Description: Historic wood, painted, double-hung semi-circular arch-top window with vertical center muntin at both sashes. The window opening is arched at the exterior with a stone arch with a voussour and stone sill. The opening is square at the interior; the frame has a flat top with an arch to accommodate the upper sash. The stool and jambs are stone; the interior header is a combination of a shallow brick arch and running bond brick. There is a double-ogee profiled stop at the interior sides and top, square stop at the exterior sides and top, round trim at the sides and top at the exterior and no finish trim at the interior. The window operated on sash cords and pulleys originally, but contains no other evidence of hardware.</p>	
<p>Conditions: The upper sash is slightly dropped. There are steel angles installed at the exterior to support the upper sash and at the interior to secure the lower sash. The stool is stone and is generally in fair to poor condition, with spalled and missing stones and loose or deteriorated mortar joints. A portion of the wood frame near the top right corner appears to be carved or chipped away. The top rail of the lower sash is deteriorated at both exterior corners. Typically there is wood loss in these areas. The bottom rail of the upper sash is checking and soft, weathered wood was observed at the left side. The profile at the bottom rail of the lower sash appears to be deteriorated and weathered. A portion of the center muntin is missing towards the bottom rail of the lower sash. Also, a portion of the wood frame at the bottom of the window has been chipped off. The bottom rail of the lower sash is deteriorated; soft wood was observed in a few locations. The interior stop is missing completely at both sides. The exterior square stop is missing from the spring line of the arch down to the sill at both sides. The exterior trim is typically weathered and deteriorated at the left side (generally toward the bottom). The wood is checked and the grain is raised. The exterior wood sill is deteriorated with numerous checks and raised grain. The sash cord pulleys remain, but the cords are missing. The glazing compound is cracking and falling off and is in poor condition. There is a crack in the flat portion of the brick header above. The paint finish is peeling and flaking in a few areas and missing completely in other areas.</p>

Assessment: Fair (rehabilitate)					
	Excellent	Good	Fair	Poor	Missing
Glazing Compound				X	
Frame			X		
Sash			X		
Exterior Trim			X		
Exterior Stop			X		
Exterior Wood Sill				X	
Interior Trim					NA
Interior Stop				X	
Interior Stool				X	
Interior Header			X		
Hardware				X	
Muntins			X		
Finish			X

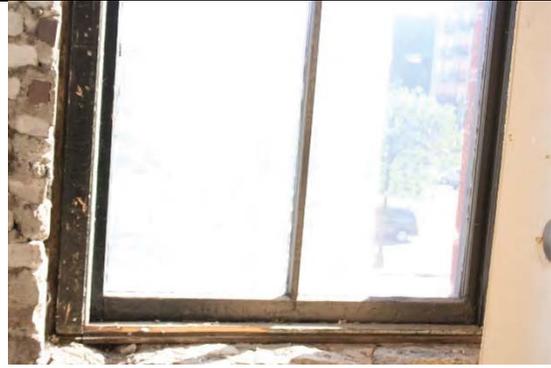
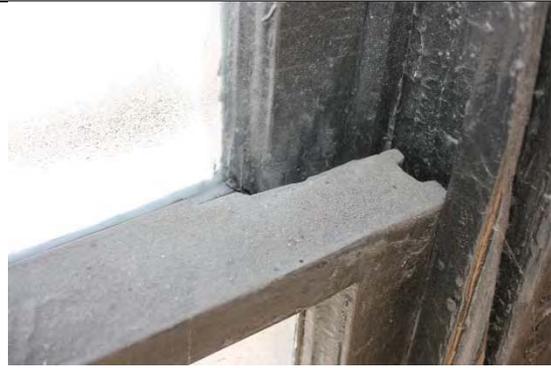
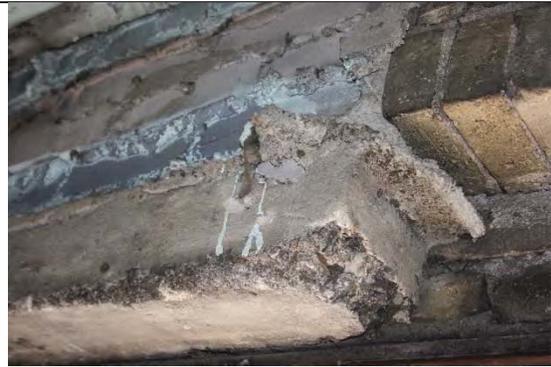
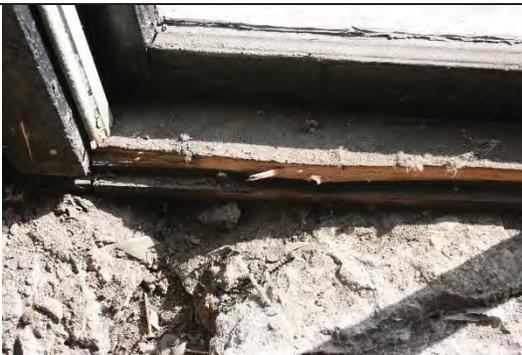
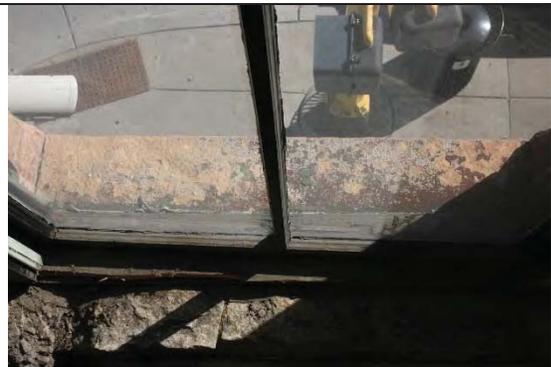
Photographic Documentation: 2.08

Assessment: Fair (rehabilitate)					
	Excellent	Good	Fair	Poor	Missing
Glazing Compound				X	
Frame			X		
Sash			X		
Exterior Trim			X		
Exterior Stop					X (Partial)
Exterior Sill				X	
Interior Trim					NA
Interior Stop			X		
Interior Stool				X	
Interior Header				X	
Hardware				X	
Muntins		X			
Finish			X

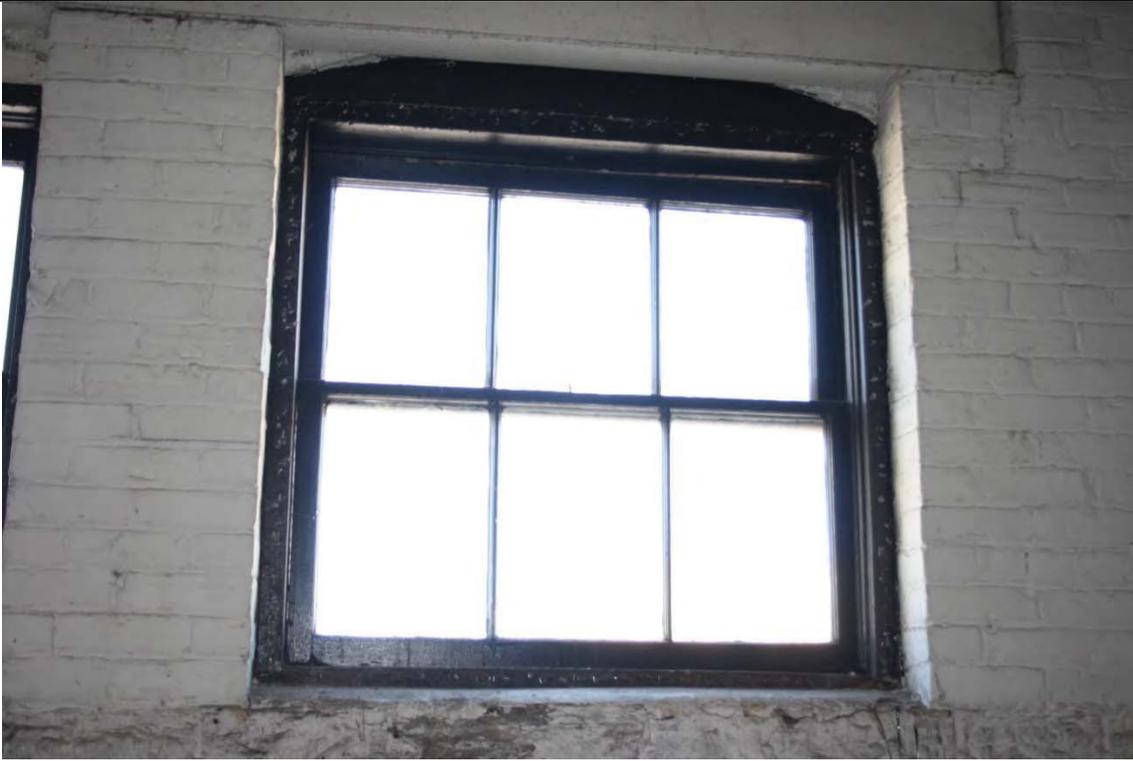
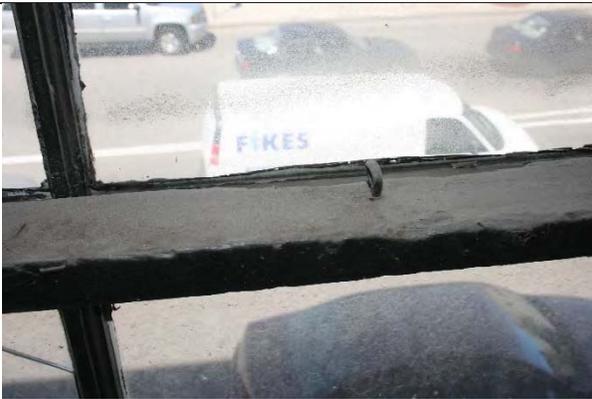
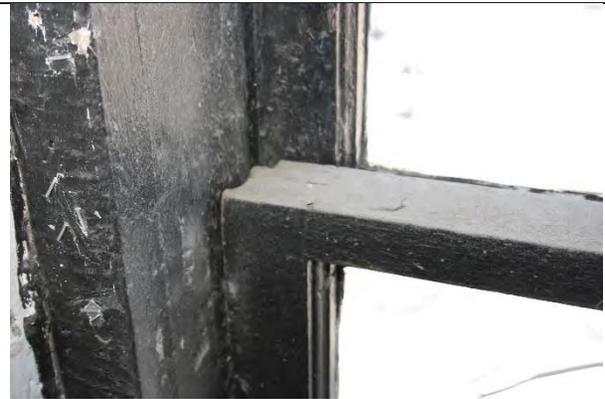
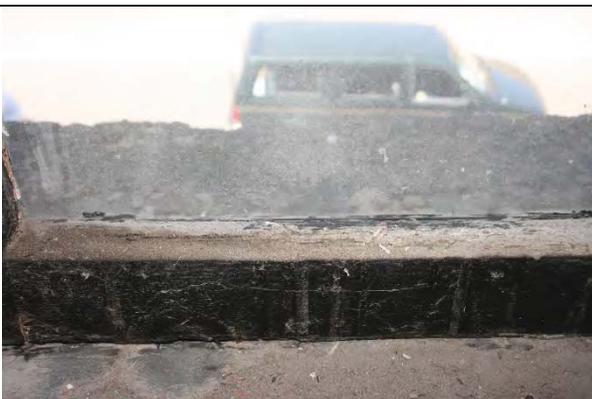
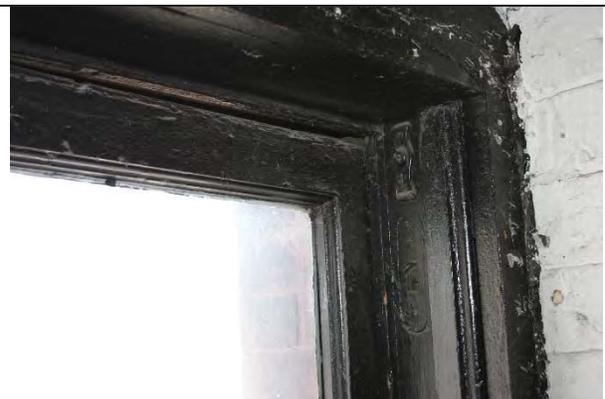
Photographic Documentation: 2.17

<p>Conditions: The painted steel lintel is in good condition, as it was added later. The condition of the brick arch lintel behind was not observed. The interior stool is cracked. The exterior stone sill has spalled. The upper sash is not square within the frame; there is a gap at the right-hand corner of the upper sash. Nails support the upper sash within the frame. The top rail of the lower sash is deteriorated at the center. The bottom rail of the lower sash is checked and deteriorated. The interior stop is missing at the right and top sides. The round wood trim at the exterior of the window is heavily checked, as is the wood sill. A large chunk of the wood sill at the exterior is missing at the left-hand side. The sash cord system is present. There are four broken panes. The glazing compound is typically in poor condition; it is cracked, loose, or missing. The paint finish is generally in fair condition; it has peeled and flaked.</p>

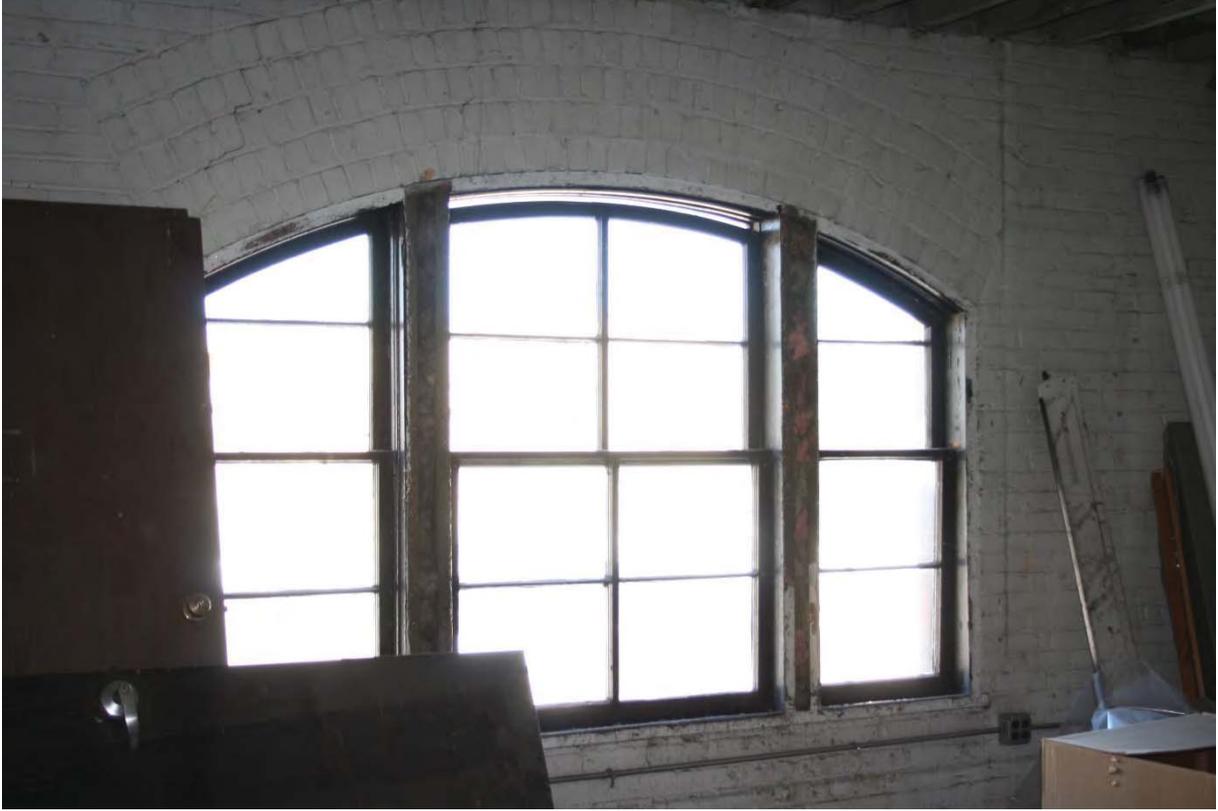
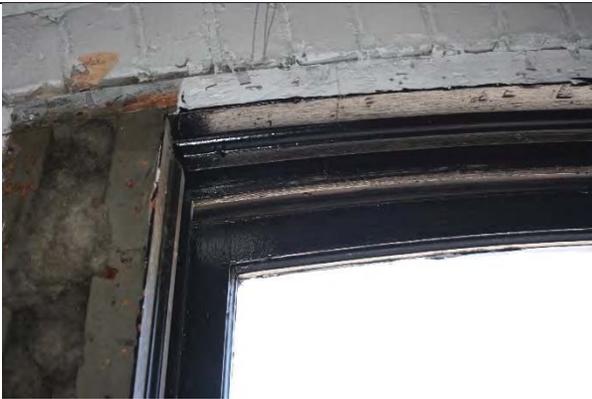
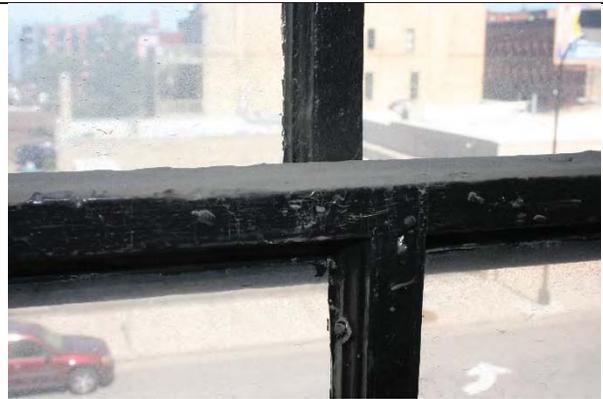
Photographic Documentation: 2.17b

<p>Conditions: Approximately 50% of the exterior brick at the arch header has spalled. The brick header at the interior is in good condition. There are mortar joints missing at the exterior stone sill. The exterior wood sill is in poor condition with typical deterioration, heavily checked and raised grain. The top sash of the center window is loose and slightly dropped; there are nails holding the upper sash in place. Wood at the junction of the vertical muntin and lower rail of the top sash has deteriorated. The bottom rail of the lower sash is deteriorated. The lower rail may have been replaced at some point as glazing compound is used as the interior stop for the glass panes. The glazing compound is now cracked. The interior and exterior stops are missing at the right side of the center window. A portion of the left interior stop is missing near the bottom. There is a small chunk of the exterior square stop missing at the upper sash of the left window. The interior stop is missing at the left side and broken at the bottom of the right side. Half of a muntin is missing at the lower sash. The upper sash is secured with nails. The bottom rail of the top sash is lightly checked. The bottom rail of the top sash exhibits typical deterioration at both exterior corners. There is wood loss evident in this location. The exterior trim and frame of the left and right windows are checked, most severely at the right-hand side. The bottom rail of the upper sash of the right-hand window is deteriorated and checked at the exterior. The top rail of the lower sash is also typically deteriorated at both exterior corners. The interior stop is missing at the right side, and the exterior stop is missing at both sides of the right-hand window. The paint finish is typically peeling and flaking. The glazing compound is generally in poor condition, showing deterioration in the form of cracks, being loose, or missing. The sash cord system is in place, but inoperable.</p>

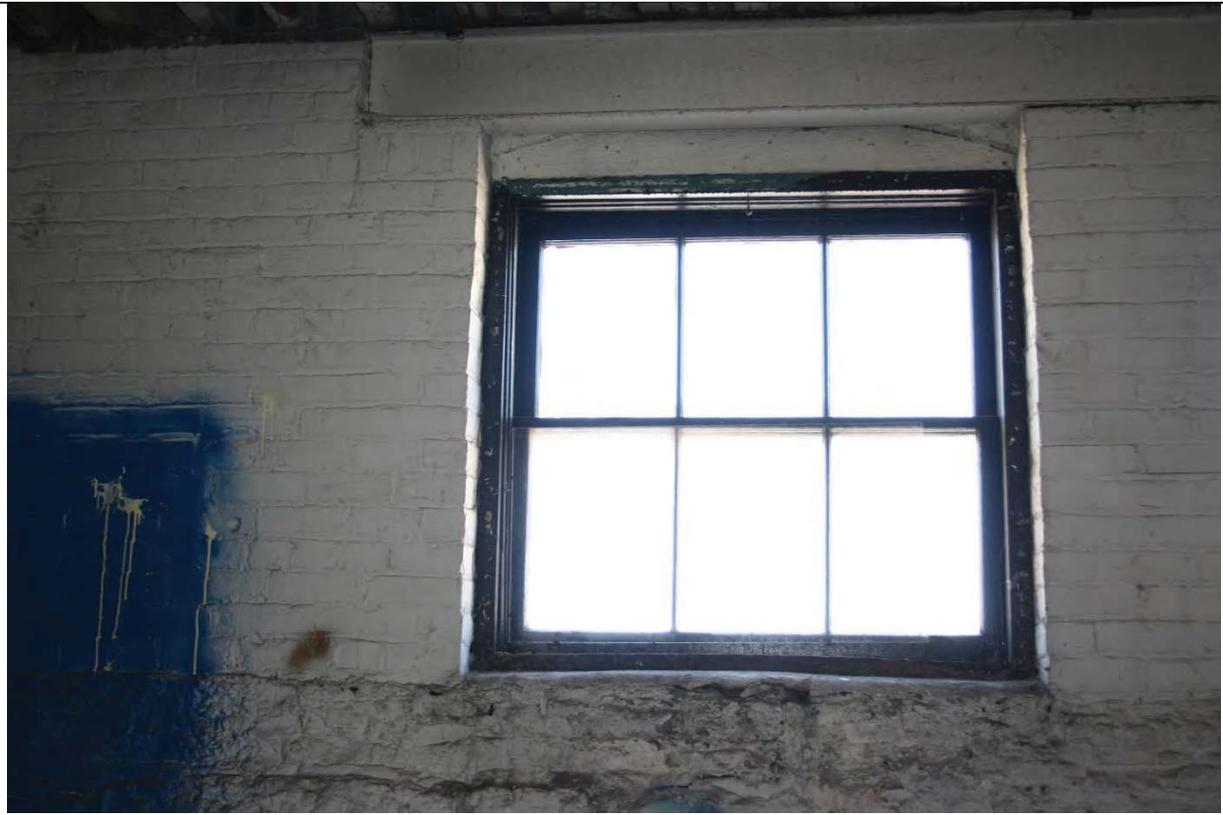
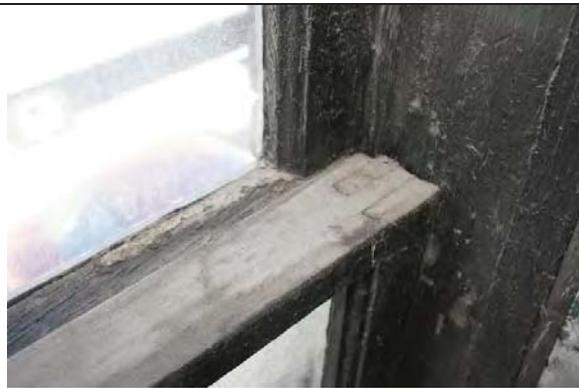
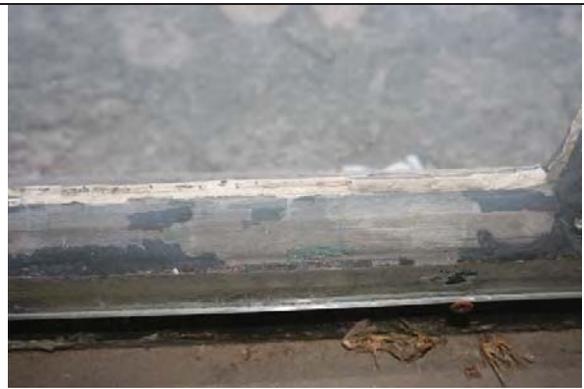
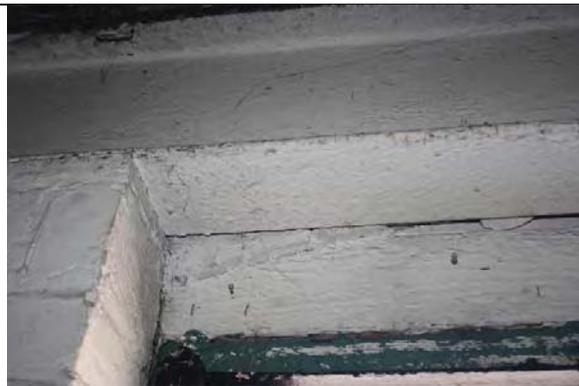
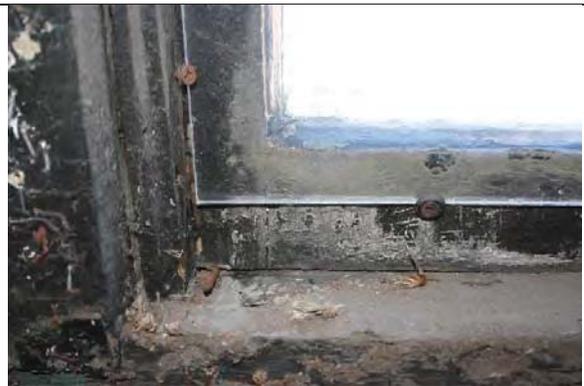
Photographic Documentation: 2.18

<p>Conditions: The painted steel lintel is in good condition, as it was added later. The condition of the brick arch lintel behind was not observed. The interior stool is cracked. The exterior stone sill is spalled. The upper sash is not square within the frame; there is a gap at the left-hand corner of the upper sash. Nails support the upper sash within the frame. The top rail of the lower sash is deteriorated, with a chunk of wood missing near the center. The bottom rail of the lower sash is deteriorated at both corners. The bottom rail of the upper sash is checked. The interior stop is missing at the right side. The exterior stop is partially missing at the right side (approximately 75% missing). The round wood trim at the exterior of the window is heavily checked, as is the wood sill. A large chunk of the wood sill at the exterior is missing at the left-hand side. The sash cord system is present. There are two broken panes and a plexi-glass cover over them (lower sash). The glazing compound is typically in poor condition; it is cracked, loose, and missing in several locations. The paint finish is generally in fair condition; it is peeling and flaking.</p>

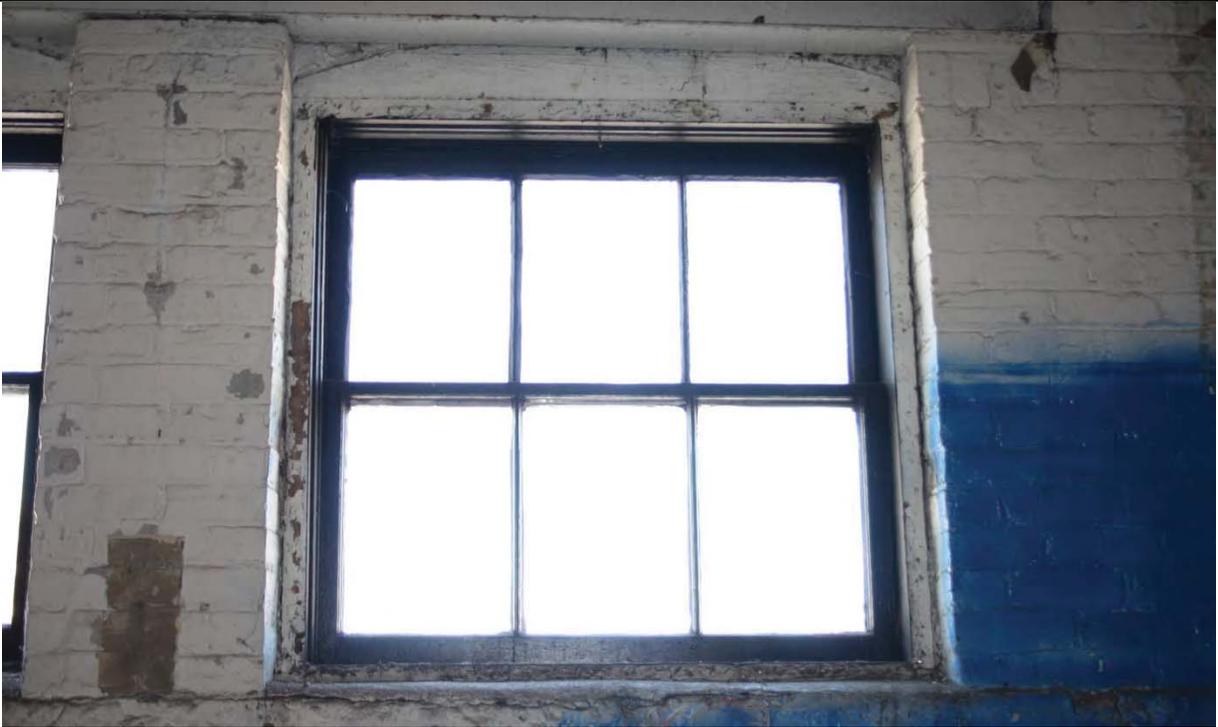
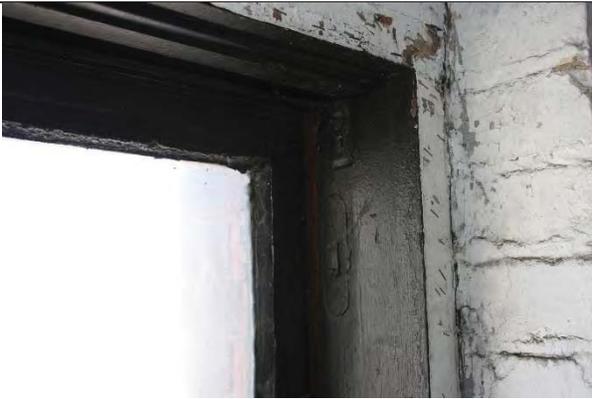
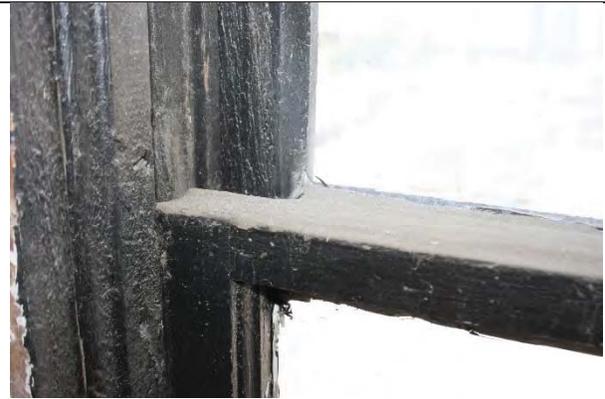
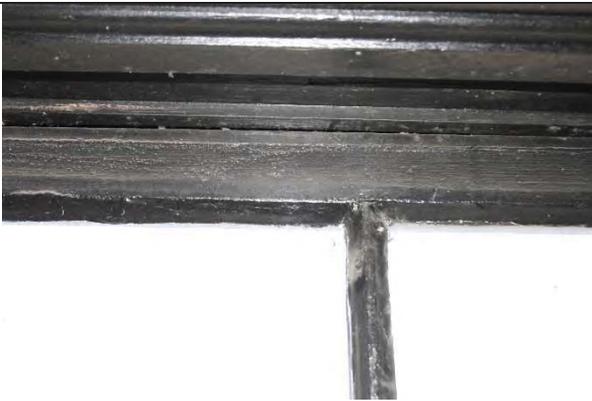
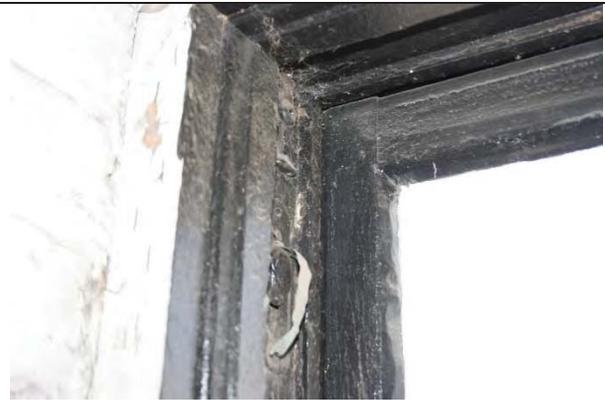
Photographic Documentation: 2.19

<p>Conditions: The painted steel lintel is in good condition, as it was added later. The condition of the brick arch lintel behind was not observed. The interior stool is in good condition. The exterior stone sill is spalled. The top rail of the lower sash is deteriorated, with a chunk of wood missing near the center and at the left side. The bottom rail of the upper sash is lightly checked. The interior and exterior stops are missing at the right side. The frame and round wood trim at the exterior of the window is moderately checked, as is the wood sill. The sash cord system is present, but broken. Glazing compound has been installed at the interior of the upper sash. The majority of the glazing compound at the exterior is missing. The paint finish is generally in fair condition; it is peeling and flaking.</p>
