HERITAGE PRESERVATION APPLICATION SUMMARY

Property Location: 121-125 Washington Avenue North
Project Name: The Washington
Prepared By: John Smoley, Ph.D., (612) 673-2830
Applicant: Preservation Design Works
Project Contact: Meghan Elliott
Ward: 3
Neighborhood: Downtown West
Request: To rehabilitate the buildings
Required Applications:

APPENDIX B: THE WASHINGTON – WINDOW RECOMMENDATIONS

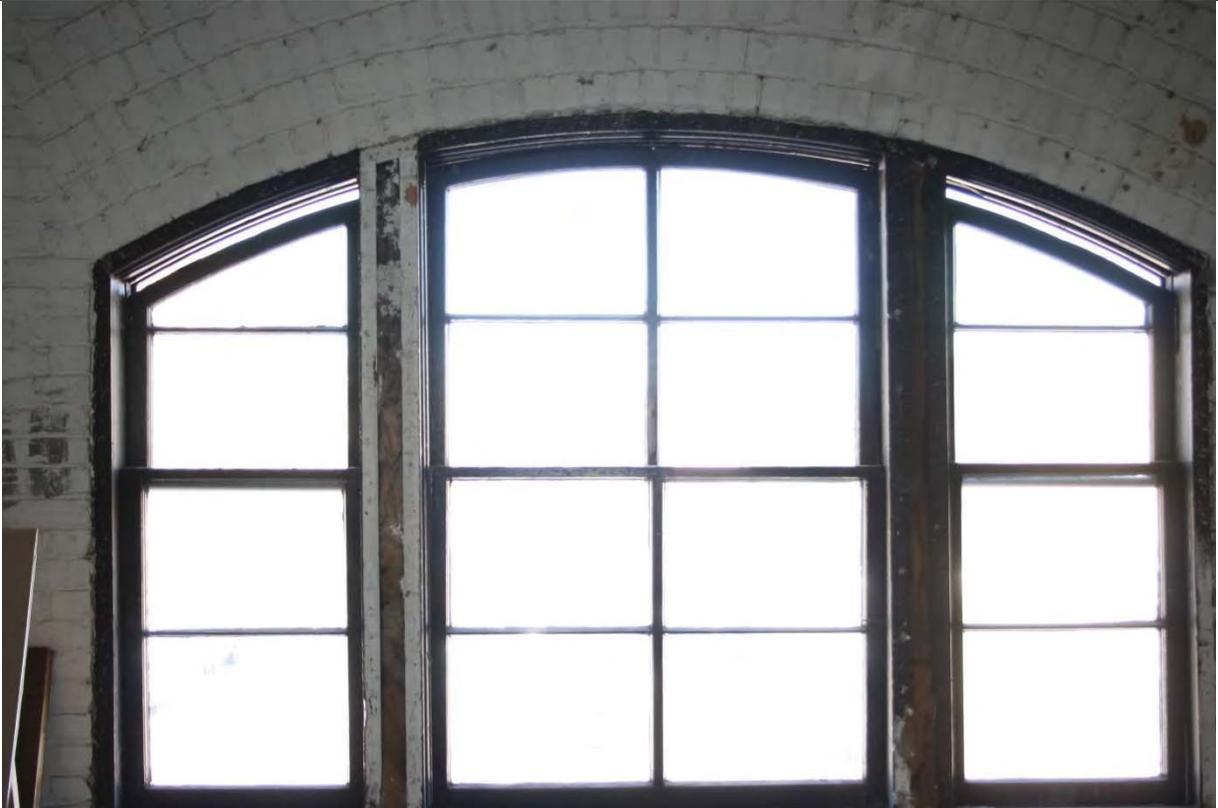
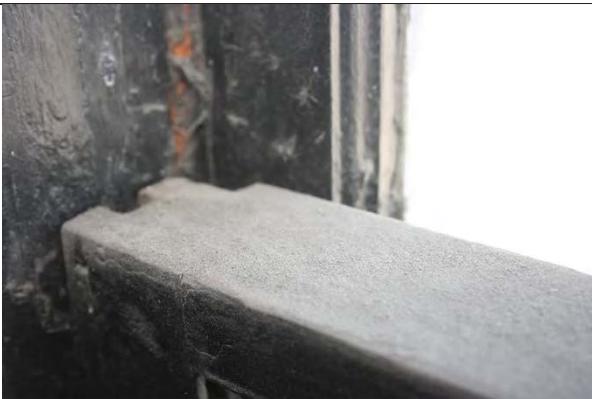
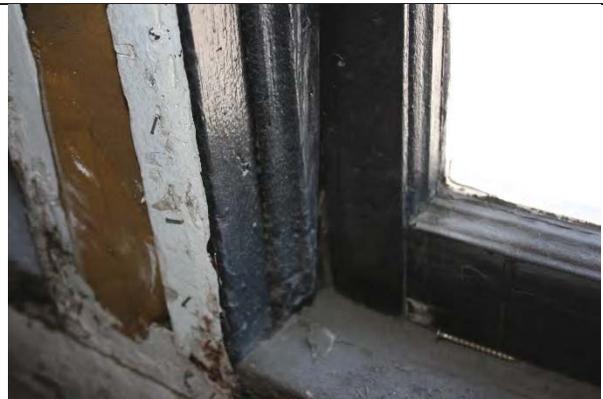
Photographic Documentation: 2.19b

<p>Conditions: Brick at the exterior arch header is spalled. The brick header at the interior is in good condition. There are mortar joints missing at the exterior stone sill. There appears to be movement in the stone sill as the wood window components are pulled out of plane. The exterior wood sill is in poor condition with typical deterioration, heavily checked and raised grain. Wood at the junction of the vertical muntin and lower rail of the top sash is deteriorated. The top rail of the lower sash is deteriorated at the exterior corners, similar to the majority of the wood windows. The bottom rail of the lower sash is deteriorated and checked; the wood is soft at the lower right-hand corner. The interior stop is missing entirely at the right side of the center window and partially near the bottom at the left side. The exterior square stop is partially missing at the right side of the upper sash of the center window. The lower right-hand pane is loose in its opening.</p> <p>The bottom rail of the upper sash at the left window exhibits is lightly checked and dropped slightly, supported only by nails and screws. The top rail of the lower sash exhibits typical deterioration at the left exterior corners. There is wood loss evident in this location. The muntin at the lower sash is checked. The bottom rail of the lower sash is lightly checked. The exterior wood sill is in poor condition with typical deterioration, heavily checked and raised grain. The exterior trim and frame of the left and right windows are checked, most severely at the right-hand side. Both the interior and exterior stops are missing at both sides of the window at the left.</p> <p>The upper sash is dropped slightly at the right window. The top rail of the lower sash is deteriorated at the right-hand exterior corner. There is a small chunk missing at the lower rail of the top sash. The interior stop is missing at the right side, and the exterior stop is missing at the right side and broken at the top of the right-hand window. The muntin at the lower sash is heavily checked and deteriorated. The sash is pulled from the frame slightly. The exterior wood sill is in poor condition with typical deterioration, heavily checked and raised grain.</p> <p>The paint finish is typically peeling and flaking. The glazing compound is generally in poor condition, showing deterioration in the form of cracks, being loose, or missing. The metal sash cord system is in place, but inoperable, except for it is missing at the right window.</p>

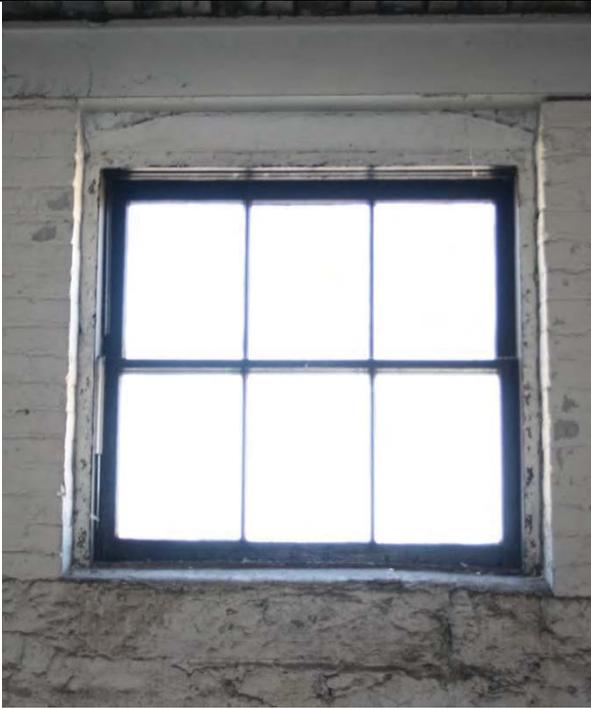
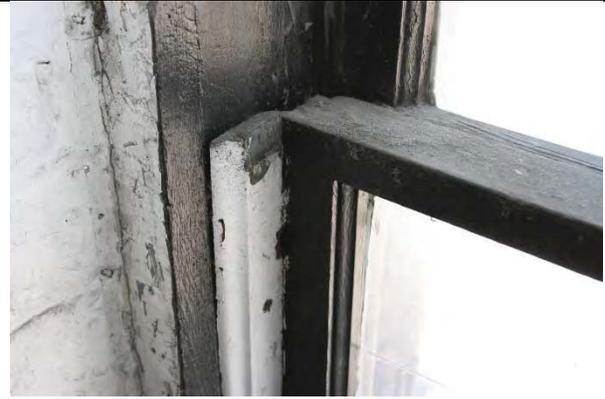
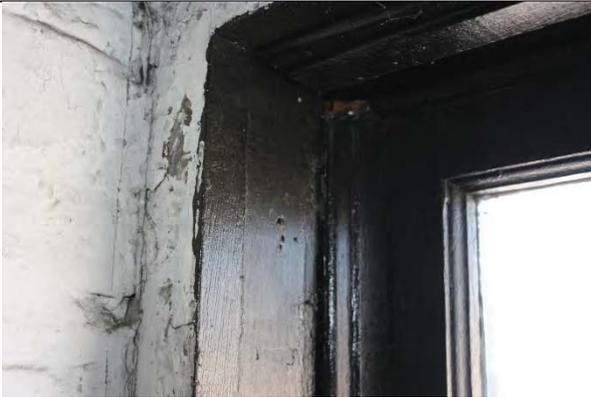
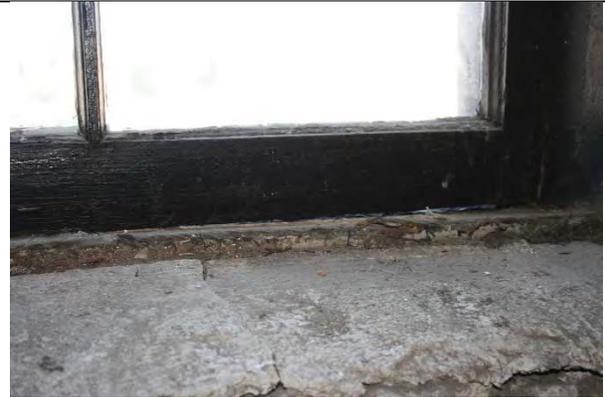
Photographic Documentation: 2.20

<p>Conditions: The painted steel lintel is in good condition, as it was added later. The condition of the brick arch lintel behind was not observed. The interior stool has bowed up. The exterior stone sill is spalled. Steel angles have been added at the exterior to support the upper sash. The top rail of the lower sash is deteriorated, with a chunk of wood missing near the center. An eye hook has been installed at the top rail of the lower sash. The bottom rail of the upper sash is checked and the grain is raised. The bottom rail of the lower sash is stained and lightly checked. The interior stop is missing at the right and left sides. The exterior stop is also missing at the left-hand side. There is an unfinished stop installed partially at the interior. The frame and round wood trim at the exterior of the window is checked and deteriorated. The wood sill is heavily checked and deteriorated. The sash cord system is present. Glazing compound is typically in poor condition, with cracked, loose, or missing areas. The paint finish is generally in fair condition; it is peeling and flaking. There is one broken pane.</p>

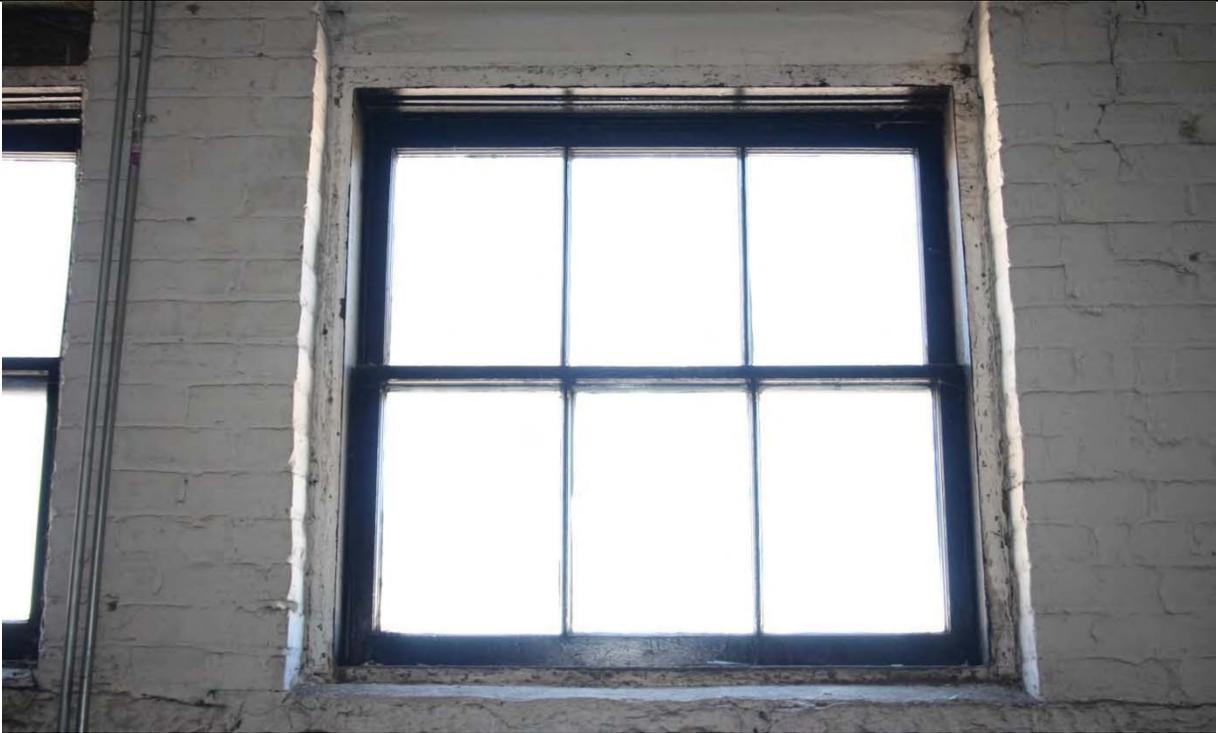
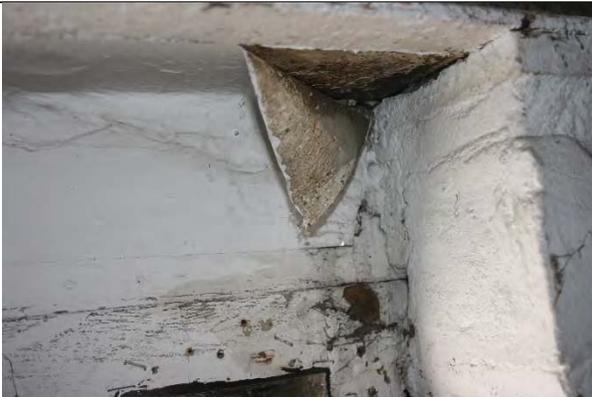
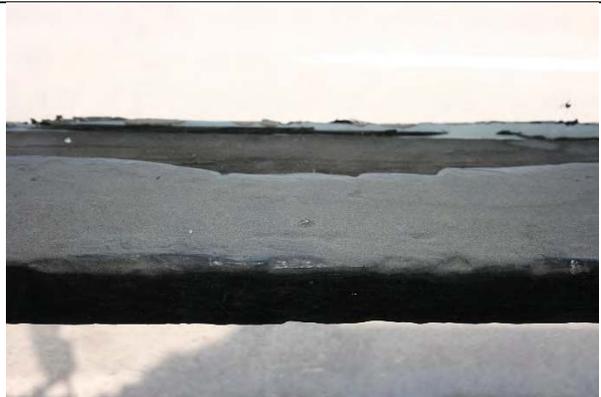
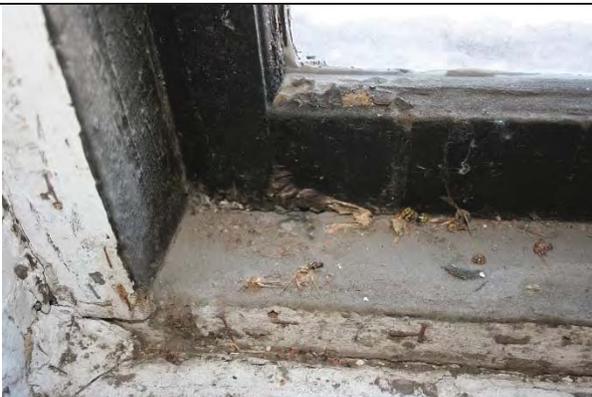
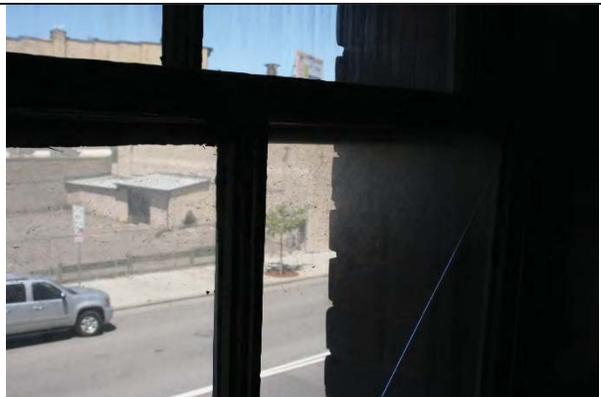
Photographic Documentation: 2.21

<p>Conditions: The painted steel lintel is in good condition, as it was added later. The condition of the brick arch lintel behind was not observed. There appears to be foil flashing installed at the header. The exterior stone sill is spalled. The top rail of the lower sash is lightly checked and deteriorated, with a chunk of wood missing near the center. The bottom rail of the lower sash is stained and lightly checked. The interior stop is missing at the right and left sides. The exterior stop is also missing at the right-hand side. An additional piece of wood has been added to the exterior to hold the frame in place. The frame and round wood trim at the exterior of the window are moderately checked and deteriorated, as is the wood sill. The sash cord system is present. Glazing compound is typically in poor condition, with cracked, loose, or missing areas. The paint finish is generally in fair condition; it is peeling and flaking. There are four broken panes.</p>

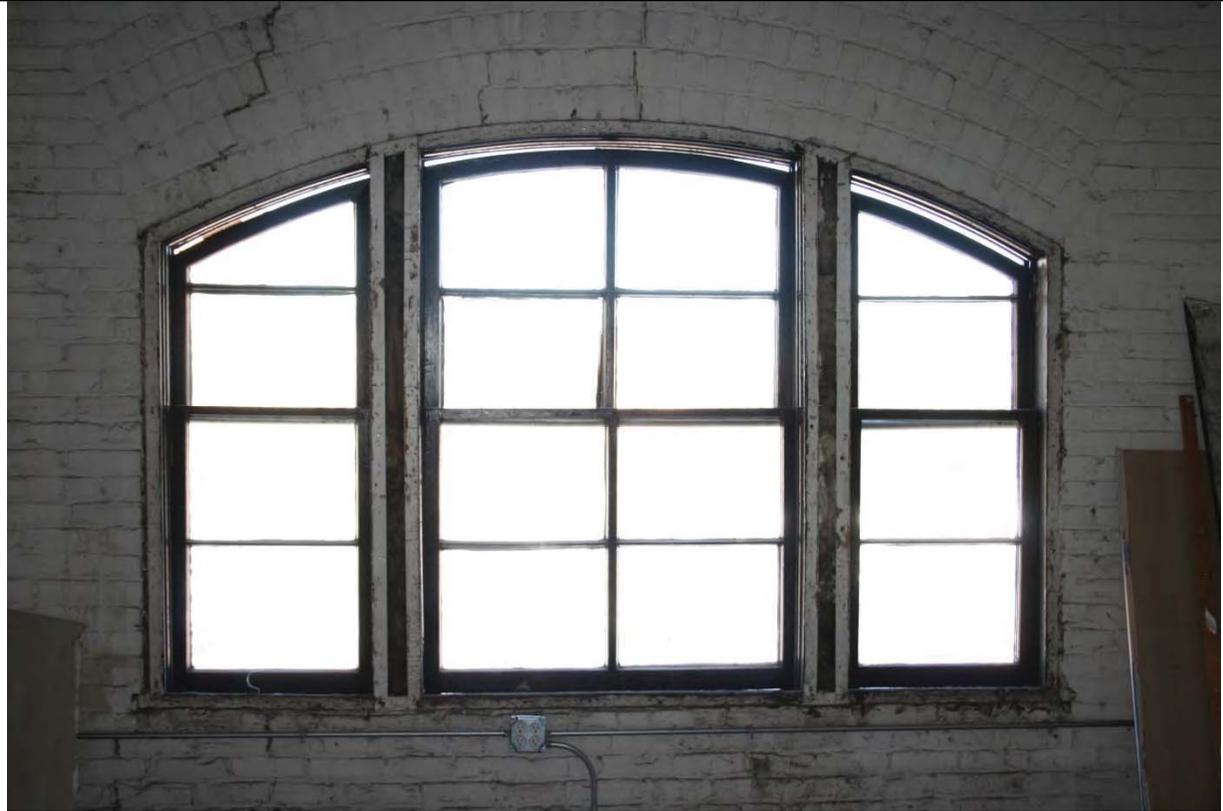
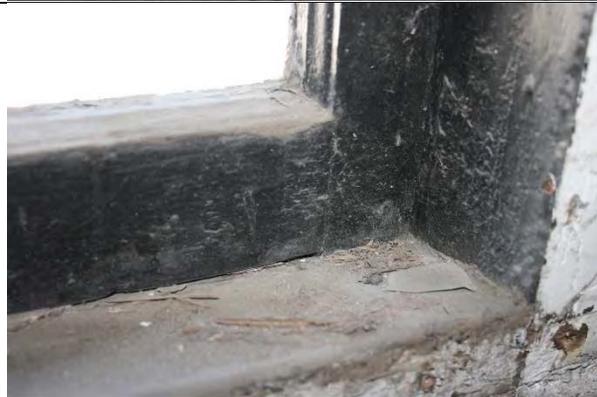
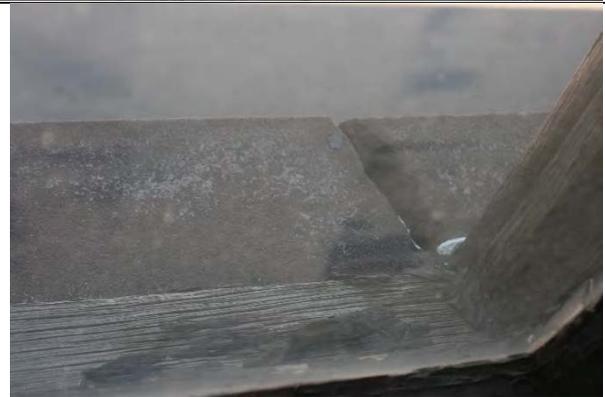
Photographic Documentation: 2.21b

Window Number: 2.21b	Reference Drawings: A2
<p>Description: Historic wood, painted, arch-top, set of three double-hung, true divided lite windows. Side double-hung windows consist of a two over two sash configuration with one horizontal muntin in each sash. The upper sash of the side windows has an arch top which leads to the arch at the center window. The larger center window is four over four with central vertical and horizontal muntins. The windows are separated by a built-up 2X mullion that lacks interior finish trim. The interior surround is brick, the interior stool is stone with a concrete parge coat and the header consists of a series of stacked radiating header bricks in an arch form. The exterior surround is brick, the sill is stone and the header is similar to the interior. There is a double-ogee profiled stop at the interior sides and top, square stop at the exterior sides and top, and round trim at the sides and top at the exterior. The window operated on a metal tape sash cord system (which is no longer operable), and contains no other evidence of hardware.</p> <p>Conditions: Brick at the exterior arch header is spalled and there are two loose bricks that pose a life safety hazard at the left side of the opening. The brick header at the interior is cracked through mortar joints in three locations. There are mortar joints missing at the exterior stone sill. The exterior trim is lightly checked, including the wood sill. The upper sash is dropped slightly. Wood at the junction of the vertical muntin and lower rail of the top sash of the center window is deteriorated. The right-hand side of the horizontal muntin of the upper sash is deteriorated; the wood is soft to the touch. There is a chunk of wood missing at the top plane of the top rail of the lower sash. The bottom rail of the upper sash is checked and deteriorated. The bottom rail of the lower sash is deteriorated and checked; the wood is soft at the intersection of the vertical muntin and bottom rail and also at the right-hand side. There is also a chunk of wood missing from the lower frame of the center window. The lower sash is not square in the opening. The interior and exterior stops are missing entirely at the left side of the center window. The two lower panes in the lower sash are plexi-glass. There is a gap between the wood and glass at the upper panes of the upper sash. Replacement caulking was done inappropriately and poorly.</p> <p>There is a large crack in the stone sill at the exterior, near the left side of the opening. The bottom rail of the upper sash at the left window is lightly checked with loss of wood section and is dropped slightly. The bottom rail of the lower sash is lightly checked and soft. The exterior wood sill is in poor condition with typical deterioration, heavily checked and raised grain. The exterior trim and frame of the left and right windows are checked. Both the interior and exterior stops are missing entirely at the right side of the left window. There is one broken pane at the left window.</p> <p>The upper sash is dropped slightly at the right window and is secured by nails. The top rail of the lower sash is deteriorated at both exterior corners, similarly to the majority of the wood windows. The interior stop is missing at both sides of the right window, and the exterior stop is missing at the left side. The exterior wood sill is in fair condition with typical deterioration, heavy checked and raised grain. There are two broken panes at the right-hand window.</p> <p>The paint finish is typically peeling and flaking. The glazing compound is generally in poor condition, showing deterioration in the form of cracked, being loose, or missing. The metal sash cord system is partially missing and inoperable at all three windows.</p>

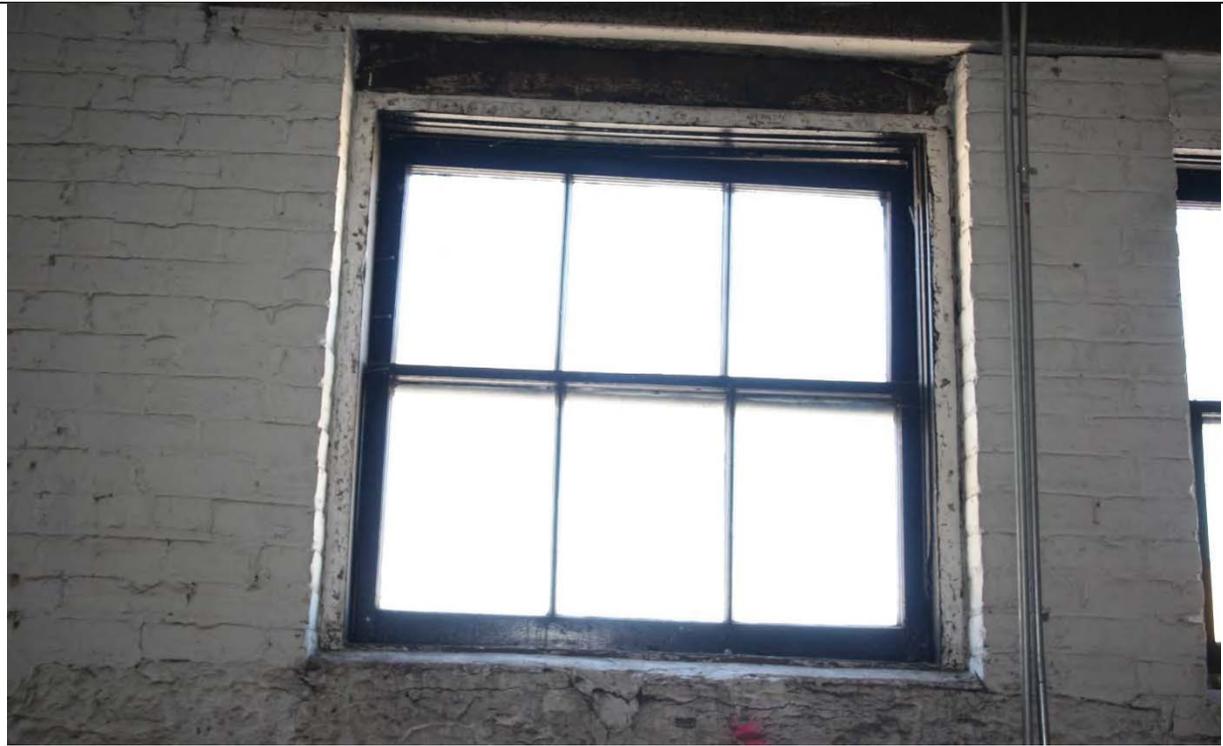
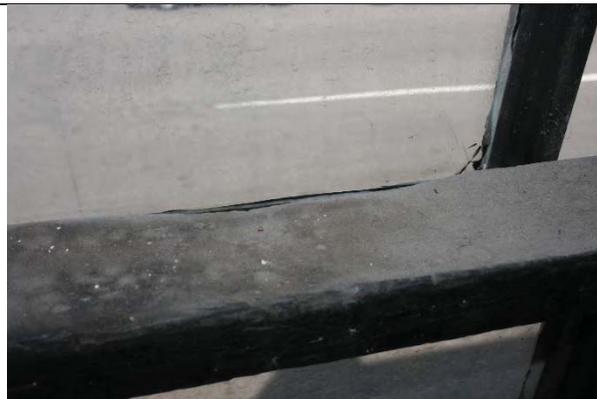
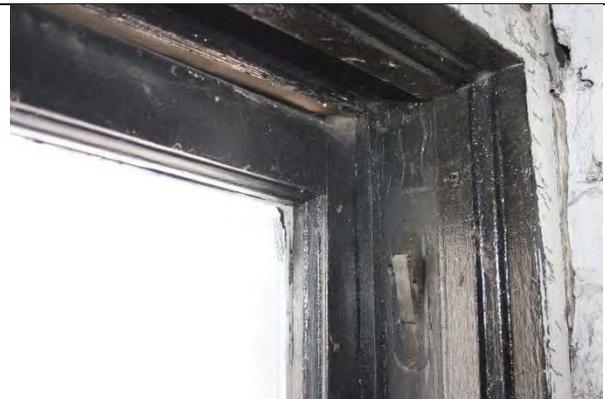
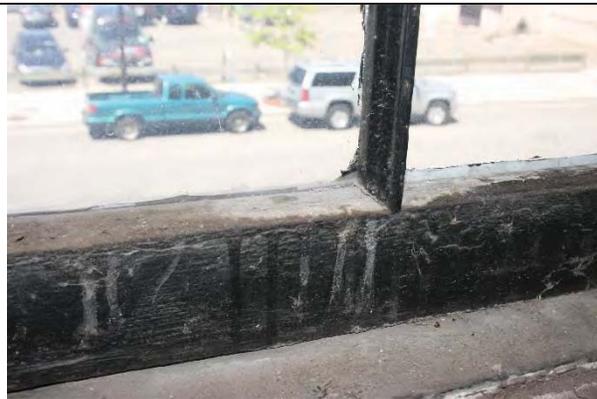
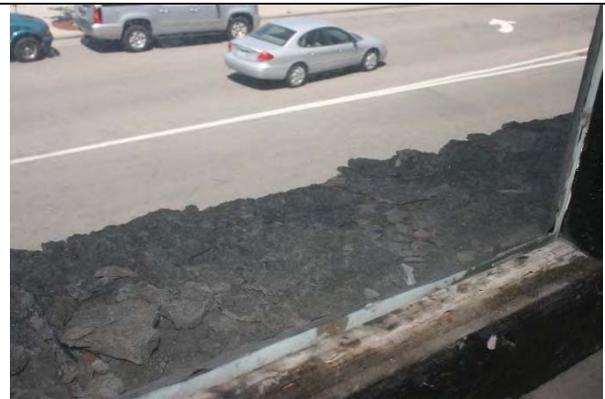
Photographic Documentation: 2.22

Window Number: 2.22	Reference Drawings: A2
<p>Description: Historic wood, painted, double-hung, 3 over 3, true divided lite window with a flat header at the exterior constructed of radiating bricks. The window opening and frame have a shallow arch at the interior. A steel wide flange beam has been placed above each pair of flat topped windows. Evidence of the original radiating brick arch remains behind the wide flange beam. The interior window surround is painted brick, the interior stool is stone with a sloped concrete parge coat. There is a double-ogee profiled stop at the interior sides and top, square stop at the exterior sides and top, and round trim at the sides and top at the exterior. The window operated on a metal tape sash cord system (which is no longer operable), and contains no other evidence of hardware. There is a small metal clip toward the top of the window which is assumed to be for previously installed blinds. The exterior surround is brick with a stone sill.</p>

<p>Conditions: The painted steel lintel is in good condition, as it was added later. The condition of the brick arch lintel behind was not observed. The exterior stone sill is spalled. Several bricks at the exterior window surround are deteriorated, typically near the bottom of the opening. The upper sash is slightly dropped. The top rail of the lower sash is lightly checked and deteriorated, with a chunk of wood missing near the center. The bottom rail of the lower sash is lightly checked. The interior stop is missing entirely at the left side, and partially at the right side. The exterior stop is also missing at the left-hand side. There are additional pieces of wood to hold the lower sash in place. The frame and round wood trim at the exterior of the window are moderately checked and deteriorated, as is the wood sill. The sash cord system is present. Glazing compound is typically in poor condition, with cracked, loose, or missing areas. The paint finish is generally in fair condition; it is peeling and flaking. There are two broken panes.</p>

Assessment: Fair (rehabilitate)					
	Excellent	Good	Fair	Poor	Missing
Glazing Compound				X	
Frame			X		
Sash			X		
Exterior Trim			X		
Exterior Stop					X (partial)
Exterior Wood Sill			X		
Interior Trim					NA
Interior Stop					X (partial)
Interior Stool			X		
Interior Header			X (Assumed)		
Hardware			X		
Muntins			X		
Finish			X

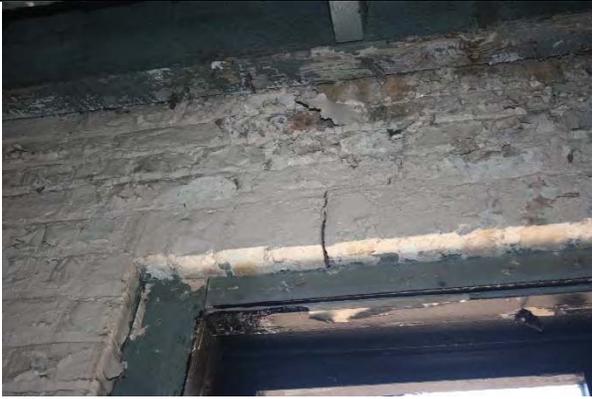
Photographic Documentation: 2.23

Window Number: 2.23	Reference Drawings: A3
<p>Description: Non-historic, wood, painted, double-hung, true divided lite window. This is a two over two window with a center vertical mullion. The top of the window is flat with a rowlock course of brick at the interior header. No other lintel was observed. All components of the window are simple, flat pieces of wood lacking a decorative profile, typical to the original wood windows in the building. No hardware or evidence of hardware was observed other than the pulleys for the sash cord system. The interior surround is brick and the interior stool is brick with a sloped parge coat. The exterior surround is also brick with a brick rowlock sill and header course for the header. The exterior wood frame acts as an additional sill, similar to the original wood windows.</p>	
<p>Conditions: The stool is generally in good condition; there is one crack. There are two square wood stops at the interior and exterior of the lower sash. The exterior wood sill is in good to fair condition; it is lightly checked and lacks a finish. Wood at the exterior is checked. The exterior brick sill is in poor condition. There are four bricks that have significantly spalled. There is a crack in a mortar joint in the rowlock lintel. The sash cord hardware remains, but is no longer operable. There is no other hardware on the window. The exterior square stop is missing at the left side and top. The glazing compound is generally in poor condition, as it is falling off. The paint finish is peeling and flaking. There is one broken pane.</p>

Assessment: Fair (rehabilitate)					
	Excellent	Good	Fair	Poor	Missing
Glazing Compound				X	
Frame			X		
Sash		X			
Exterior Trim			X		
Exterior Stop					X (partial)
Exterior Wood Sill		X			
Interior Trim					NA
Interior Stop					X (partial)
Interior Stool		X			
Interior Header			X		
Hardware			X		
Muntins		X			
Finish			X

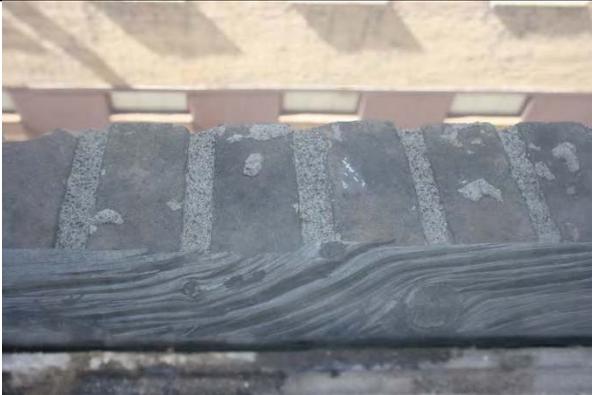
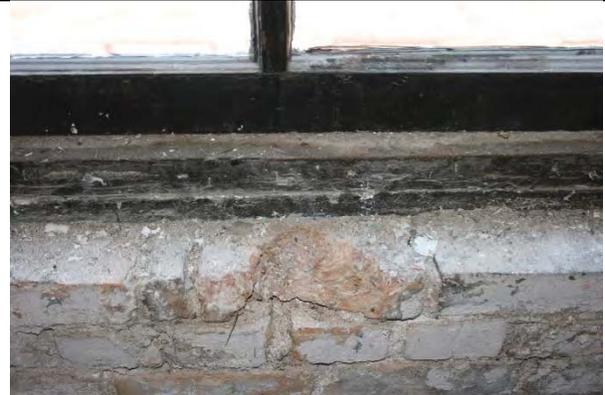
Photographic Documentation: 2.24

Window Number: 2.24	Reference Drawings: A3
<p>Description: Historic wood, painted, double-hung, two over two, true divided lite window with a radiating arched header at the exterior. The exterior surround is brick with a brick rowlock sill. The wood frame is flat at the top of the sash and rounded to fit into the brick arch header at both the interior and exterior. The interior window surround is painted brick, the interior stool is brick, and the header is also a radiating brick arch. There is a double-ogee profiled stop at the interior sides and top, square stop at the exterior sides and top, and round trim at the sides and top at the exterior. The window operated on a metal tape sash cord system (which is no longer operable), and contains no other evidence of hardware.</p>	
<p>Conditions: There are steel angles installed at the interior to support the upper sash. In addition an angle is installed at the lower sash corner at the left-hand side. Daylight was also observed in this location. The brick stool is generally in fair condition, with two chipped bricks. There are two square wood stops at the interior of the lower sash and one temporary wood stop at the exterior supporting the upper sash. The profiled interior wood stop is missing at both sides. The top rail of the lower sash is deteriorated at the left-hand side corner. There is typical wood loss in this location. In addition, the entire top rail is deteriorated; the wood is soft, it is checked, and the grain is raised. The bottom rail of the upper sash is deteriorated and has dropped slightly from the glass. The exterior wood sill is in poor condition; it is heavily checked and deteriorated. There are mortar droppings on the exterior brick sill. The sash cord hardware remains, but is no longer operable. There is no other hardware on the window. The glazing compound is generally in poor condition, as it is falling off. The paint finish is peeling and flaking. There is one broken pane.</p>

Assessment: Fair (rehabilitate)					
	Excellent	Good	Fair	Poor	Missing
Glazing Compound				X	
Frame			X		
Sash			X		
Exterior Trim			X		
Exterior Stop			X		
Exterior Wood Sill				X	
Interior Trim					NA
Interior Stop					X (partial)
Interior Stool			X		
Interior Header			X		
Hardware			X		
Muntins			X		
Finish			X

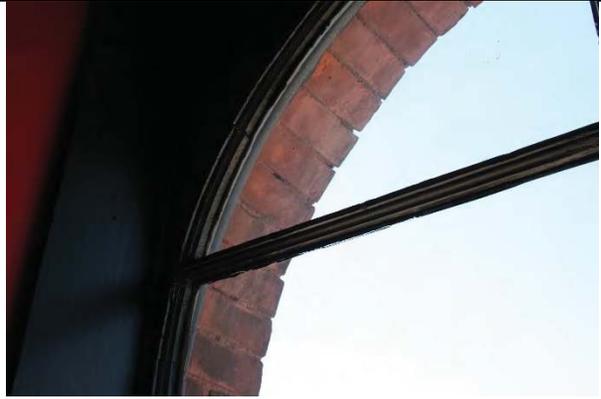
Photographic Documentation: 3.17

Window Number: 3.17	Reference Drawings: A2
<p>Description: Modified historic wood, painted, double-hung, four over four window with an arch top. The sashes are original, but have been set in new frame and casing trim and fixed shut. The top of the upper sash is flat to fit the square opening at the interior. All sides of the opening have been cased with flat, painted wood trim. The dropped ceiling is slightly below the level of the top of the window opening. The exterior surround is brick with a stone sill and radiating brick arch header with a projecting brick hood.</p>	
<p>Conditions: There are steel angles installed at the exterior to support the upper sash. The stool is covered with flat, painted, wood trim. The stone sill is in good condition. There is a wood stop installed at the exterior of the bottom frame. The bottom rail of the lower sash is deteriorated (the wood is soft). The horizontal muntins, at both the upper and lower sash, are checked and deteriorated. The horizontal muntin at the upper sash is missing a chunk of wood at the right-hand side. The upper sash is cracked and broken at both sides at the spring line of the arch, at the horizontal muntin intersection and slightly above the muntin. There are no historic interior or exterior stops visible. The upper and lower sash are caulked together and the window is fixed shut. No sash cord hardware remains, as the frame has been replaced with flat casing trim. The exterior trim and sill are checked, most significantly at the right-hand side. The glazing compound is typically in poor condition; it is cracked, loose or missing. The paint finish at the interior is in good to fair condition with small areas flaking or missing. The exterior paint finish is in fair condition due to typical weathering.</p>

Assessment: Fair (rehabilitate)					
	Excellent	Good	Fair	Poor	Missing
Glazing Compound				X	
Frame			X		
Sash			X		
Exterior Trim			X		
Exterior Stop					X
Exterior Wood Sill			X		
Interior Trim		X			
Interior Stop					X
Interior Stool				X	
Interior Header			X (Assumed)		
Hardware					X
Muntins			X		
Finish			X

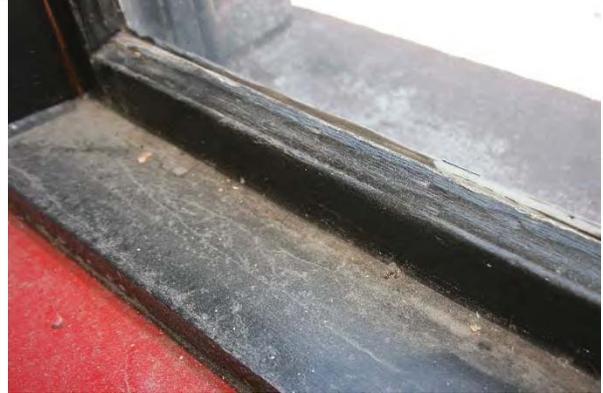
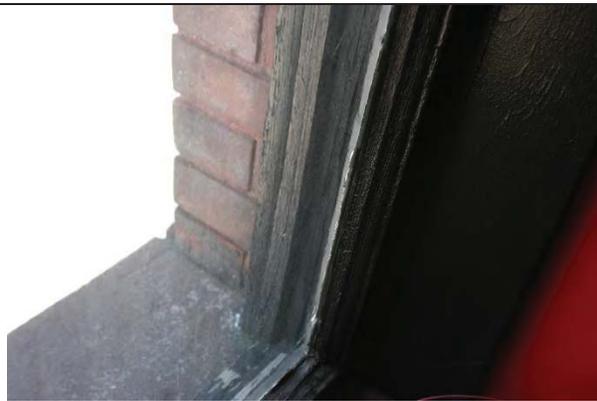
Photographic Documentation: 3.19

Assessment: Fair (rehabilitate)					
	Excellent	Good	Fair	Poor	Missing
Glazing Compound				X	
Frame			X		
Sash			X		
Exterior Trim			X		
Exterior Stop					X
Exterior Wood Sill			X		
Interior Trim		X			
Interior Stop					X
Interior Stool				X	
Interior Header			X (Assumed)		
Hardware					X
Muntins			X		
Finish			X

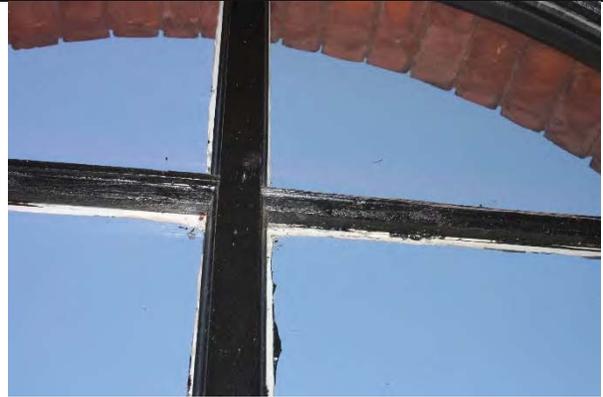
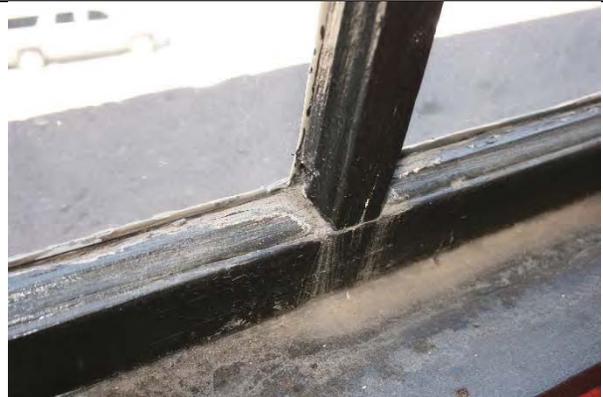
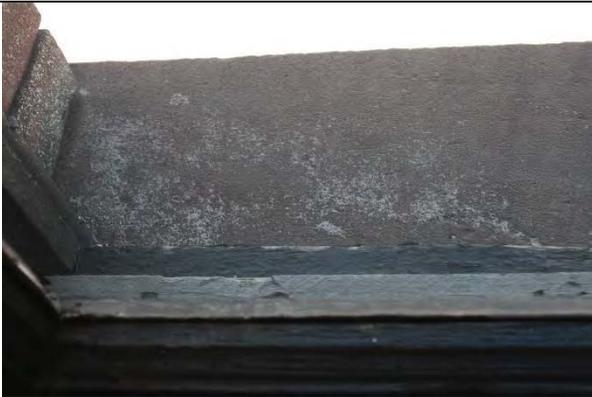
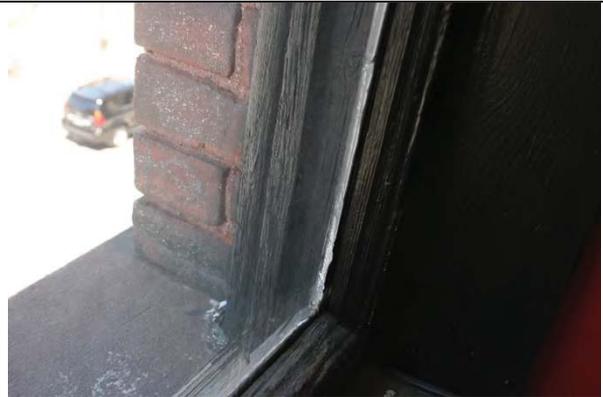
Photographic Documentation: 3.20

Window Number: 3.20	Reference Drawings: A2
<p>Description: Modified historic wood, painted, double-hung, four over four window with an arch top. The sashes are original, but have been set in new frame and casing trim and fixed shut. The top of the upper sash is flat to fit the square opening at the interior. All sides of the opening have been cased with flat, painted wood trim. The dropped ceiling is slightly below the level of the top of the window opening. The interior stool and header are not visible. The exterior surround is brick with a stone sill and radiating brick arch header with a projecting brick hood.</p>	
<p>Conditions: There are steel angles installed at the exterior to support the upper sash. The stool is covered with flat, painted, wood trim. The stone sill is in good condition. There is a wood stop installed at the exterior to secure the lower sash in place. The bottom rail of the lower sash is lightly checked and deteriorated (the wood is soft), especially at the intersection of the rail and vertical muntin. A piece of wood has been added to the top rail of the lower sash. The horizontal muntins at the upper sash is checked and deteriorated. The upper sash is cracked and broken at both sides at the spring line of the arch, at the horizontal muntin intersection and slightly above the muntin. There are no historic interior or exterior stops visible. The upper and lower sash are caulked together and the window is fixed shut. No sash cord hardware remains, as the frame has been replaced with flat casing trim. The exterior trim and sill are checked, most significantly at the right-hand side. The glazing compound is typically in poor condition; it is cracked, loose or missing. The paint finish at the interior is in good to fair condition with small areas flaking or missing. The exterior paint finish is in fair condition due to typical weathering.</p>

Assessment: Fair (rehabilitate)					
	Excellent	Good	Fair	Poor	Missing
Glazing Compound				X	
Frame			X		
Sash			X		
Exterior Trim			X		
Exterior Stop					X
Exterior Wood Sill			X		
Interior Trim		X			
Interior Stop					X
Interior Stool				X	
Interior Header			X (Assumed)		
Hardware					X
Muntins			X		
Finish			X

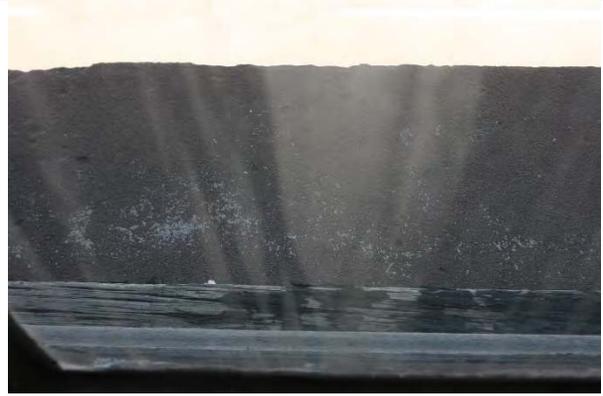
Photographic Documentation: 3.21

Window Number: 3.21	Reference Drawings: A2
<p>Description: Modified historic wood, painted, double-hung, four over four window with an arch top. The sashes are original, but have been set in new frame and casing trim and fixed shut. The top of the upper sash is flat to fit the square opening at the interior. All sides of the opening have been cased with flat, painted wood trim. The dropped ceiling is slightly below the level of the top of the window opening. The interior stool and header are not visible. The exterior surround is brick with a stone sill and radiating brick arch header with a projecting brick hood.</p>	
<p>Conditions: There are steel angles installed at the interior and exterior to support the upper sash. The stool is covered with flat, painted, wood trim. The stone sill is in good condition. There is a wood stop installed at the exterior of the bottom rail to secure the lower sash in place. The bottom rail of the lower sash is lightly checked and deteriorated. The horizontal muntins, at both the upper and lower sash are checked and deteriorated. The upper sash is cracked and broken at both sides at the spring line of the arch, at the horizontal muntin intersection and slightly above the muntin. There are no historic interior or exterior stops visible. The upper and lower sash are caulked together and the window is fixed shut. No sash cord hardware remains, as the frame has been replaced with flat casing trim. The exterior trim and sill are heavily checked, most significantly at the right-hand side. The glazing compound is typically in poor condition; it is cracked, loose or missing. The paint finish at the interior is in good to fair condition with small areas flaking or missing. The exterior paint finish is in fair condition due to typical weathering. There is one broken pane.</p>

Assessment: Fair (rehabilitate)					
	Excellent	Good	Fair	Poor	Missing
Glazing Compound				X	
Frame			X		
Sash			X		
Exterior Trim			X		
Exterior Stop					X
Exterior Wood Sill			X		
Interior Trim		X			
Interior Stop					X
Interior Stool				X	
Interior Header			X (Assumed)		
Hardware					X
Muntins			X		
Finish			X

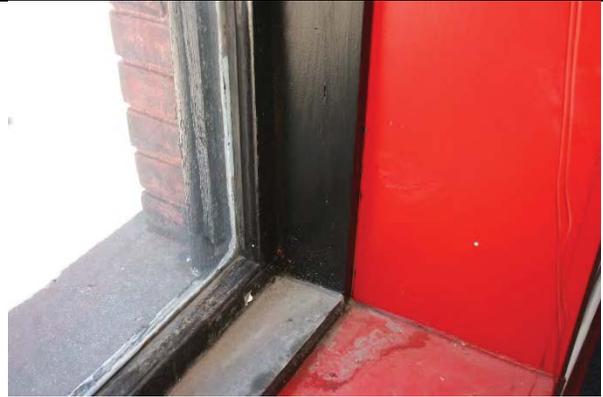
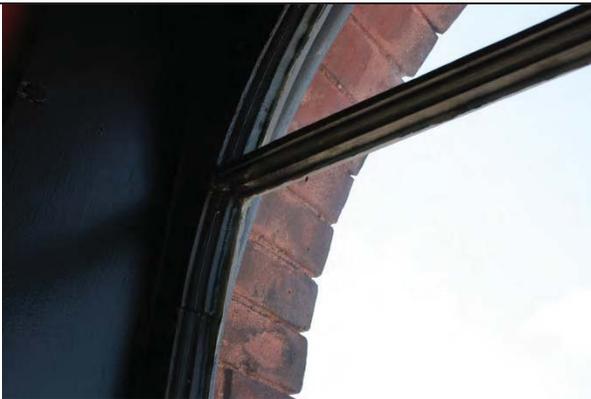
Photographic Documentation: 3.22

Window Number: 3.22	Reference Drawings: A2
<p>Description: Modified historic wood, painted, double-hung, four over four window with an arch top. The sashes are original, but have been set in new frame and casing trim and fixed shut. The top of the upper sash is flat to fit the square opening at the interior. All sides of the opening have been cased with flat, painted wood trim. The dropped ceiling is slightly below the level of the top of the window opening. The interior stool and header are not visible. The exterior surround is brick with a stone sill and radiating brick arch header with a projecting brick hood.</p>	
<p>Conditions: There are steel angles installed at the exterior to support the upper sash. The stool is covered with flat, painted, wood trim. The stone sill is in good condition. There is a block of wood installed at the exterior of the lower sash to secure in place. The bottom rail of the lower sash is lightly checked and deteriorated (the wood is soft). The horizontal muntin at the lower sash is checked and deteriorated. The upper sash is cracked and broken at both sides at the spring line of the arch, at the horizontal muntin intersection and slightly above the muntin. There are no historic interior or exterior stops visible. The upper and lower sash are caulked together and the window is fixed shut. No sash cord hardware remains, as the frame has been replaced with flat casing trim. The exterior trim and sill are heavily checked and cracked, most significantly at the right-hand side. The glazing compound is typically in poor condition; it is cracked, loose or missing. The paint finish at the interior is in good to fair condition with small areas flaking or missing. The exterior paint finish is in fair condition due to typical weathering. There is one broken pane.</p>

Assessment: Fair (rehabilitate)					
	Excellent	Good	Fair	Poor	Missing
Glazing Compound				X	
Frame			X		
Sash			X		
Exterior Trim			X		
Exterior Stop					X
Exterior Wood Sill			X		
Interior Trim		X			
Interior Stop					X
Interior Stool				X	
Interior Header			X (Assumed)		
Hardware					X
Muntins			X		
Finish			X
