HERITAGE PRESERVATION APPLICATION SUMMARY

Property Location: 515 Washington Avenue North
Project Name: The Maytag Building
Prepared By: Lisa Steiner, Senior City Planner, (612) 673-3950
Applicant: AWH Architects
Project Contact: Alex Haecker
Ward: 3
Neighborhood: North Loop
Request: To construct a stairway addition and rehabilitate the existing building for use as offices and a retail/restaurant at the ground level.

Certificate of Appropriateness	To allow exterior modifications and the construction of a stairway addition.
---------------------------------------	--

MAYTAG BUILDING - 515 N WASHINGTON AVE, MINNEAPOLIS, MN 55401

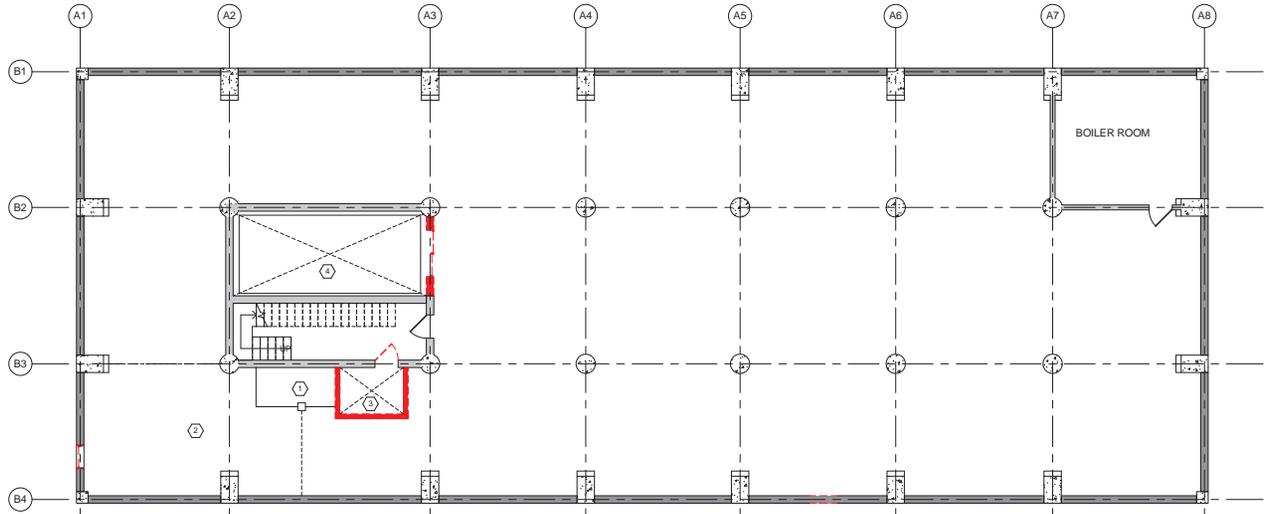
1 BASEMENT DEMOLITION PLAN
SCALE: 1/8" = 1'-0"

DEMOLISH WALLS AS INDICATED; PROTECT WALLS/COLUMNS TO REMAIN. REPAIR AS REQUIRED. CONSULT ARCHITECT.

As a part of the phase one core and shell redevelopment the renovations to the interior will be minimal. One non-historic shaft is proposed to be demolished and the historic site-cast concrete shaft is to remain. The modern freight elevator in the historic shaft will be replaced with a mechanical shaft to service the building, and a new passenger size elevator with the remaining

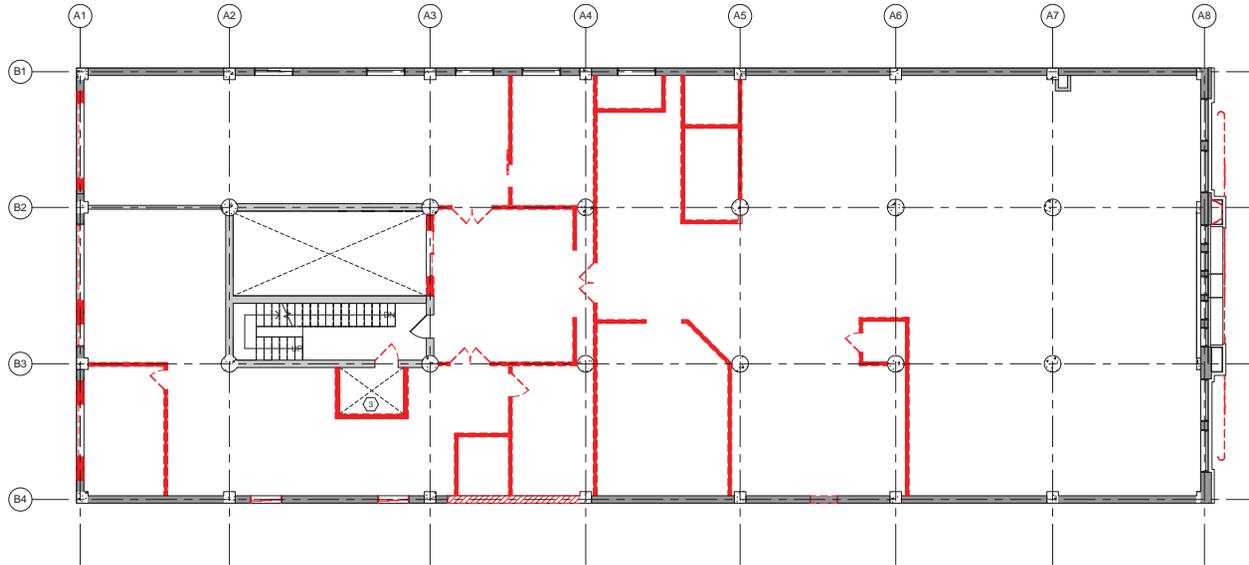
1 SECOND FLOOR DEMOLITION PLAN
SCALE: 1/8" = 1'-0"

DEMOLISH WALLS AS INDICATED; PROTECT WALLS/COLUMNS TO REMAIN. REPAIR AS REQUIRED. CONSULT ARCHITECT.

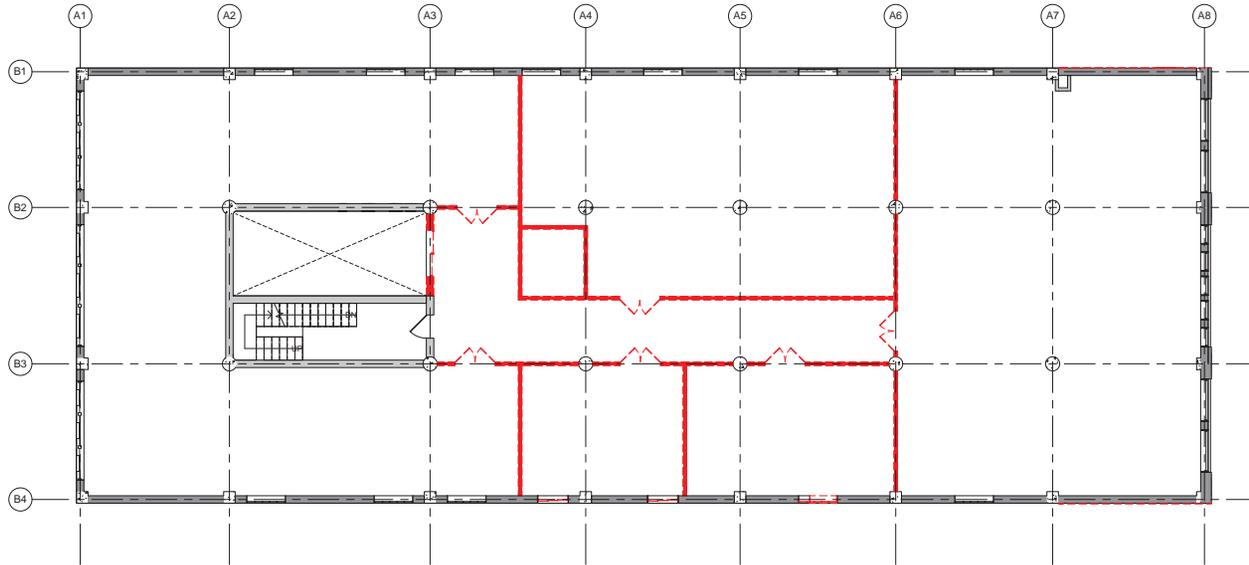
1 FOURTH DEMOLITION PLAN
SCALE: 1/8" = 1'-0"

DEMOLISH WALLS AS INDICATED; PROTECT WALLS/COLUMNS TO REMAIN. REPAIR AS REQUIRED. CONSULT ARCHITECT.

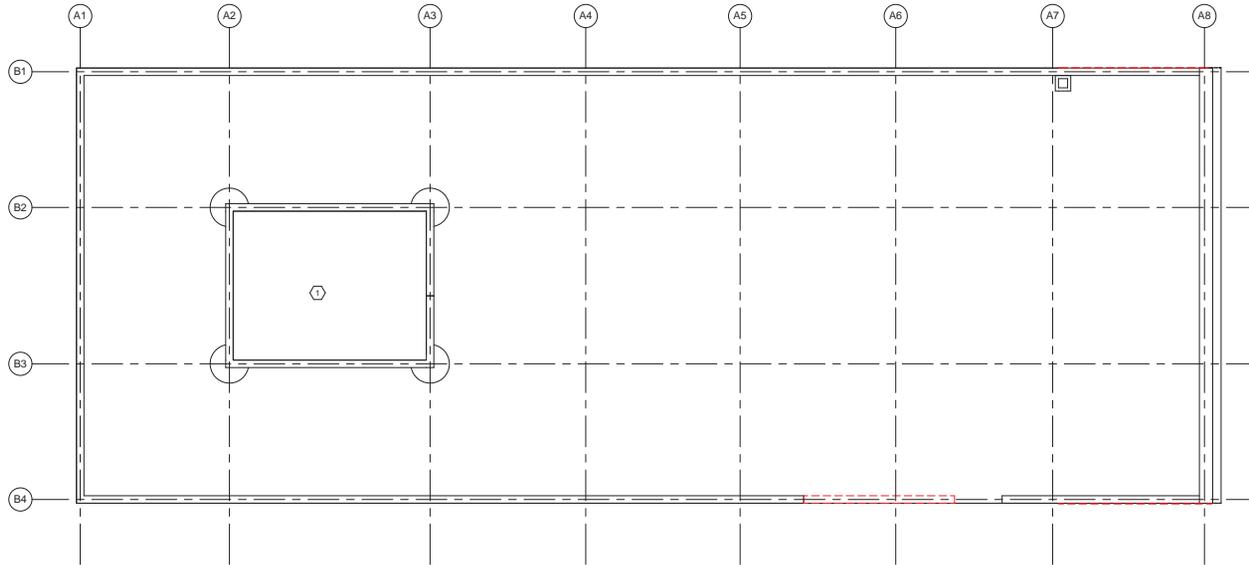
1 PENTHOUSE PLAN
SCALE: 1/8" = 1'-0"

DEMOLISH WALLS AS INDICATED; PROTECT WALLS/COLUMNS TO REMAIN. REPAIR AS REQUIRED. CONSULT ARCHITECT.

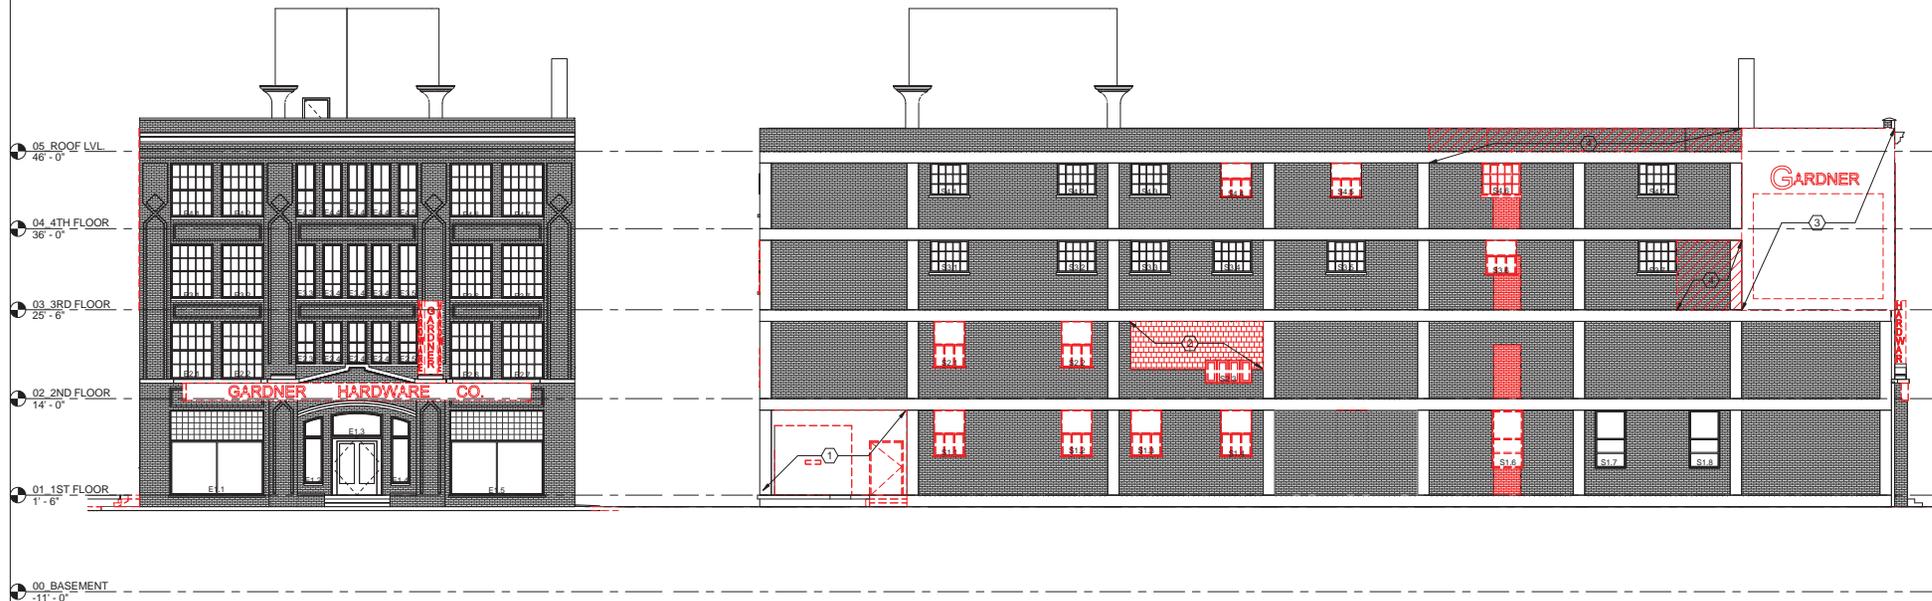
DEMOLITION ELEVATION

1 EAST ELEVATION
 SCALE: 1/8" = 1'-0"

2 SOUTH ELEVATION
 SCALE: 1/8" = 1'-0"

- Enlarge and install new openings on the ground level South façade for ADA and service entry.
- Removal of non-historic masonry infill, restoration of opening to original dimensions, and installation of appropriate replacement windows.

One modified opening is proposed on the south façade. The bay between A1-A2 has been modified outside the period of significance to accommodate a small, angled loading dock, with masonry infill removed and featuring a wood stud wall, overhead door, and man-sized door. Here the infill is proposed to be removed and replaced with an aluminum storefront window system with a double-door entrance. The loading dock will remain, and a new main entrance for building tenants on floors 2-4 will be built in this bay. The entrance will include an ADA ramp, stairs, and glass railings. On the alley side the three ground-level bays are original concrete frame with non-historic infill. All infill is proposed to be removed and replaced with overhead glass garage doors.

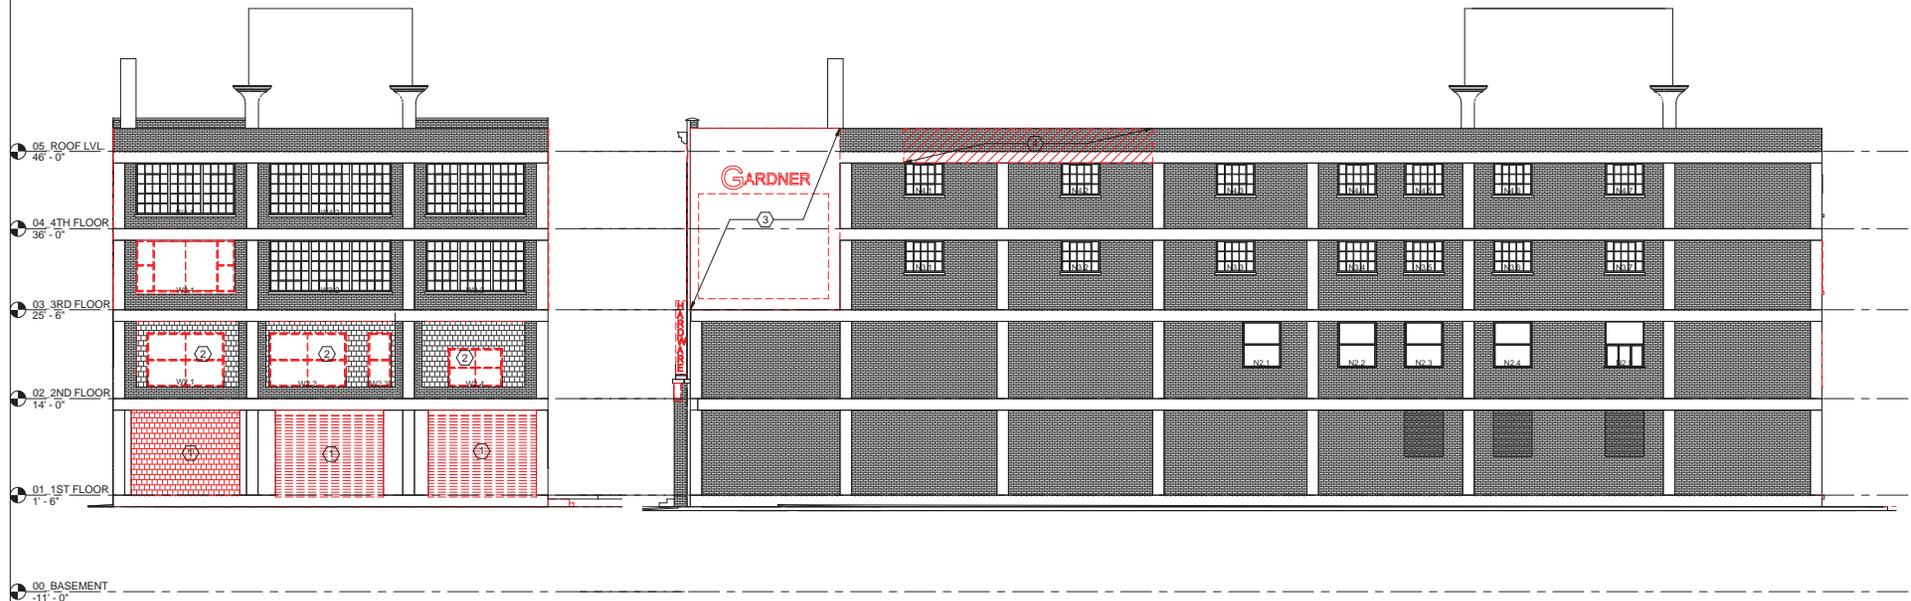
1 WEST ELEVATION
 SCALE: 1/8" = 1'-0"

2 NORTH ELEVATION
 SCALE: 1/8" = 1'-0"

On the north and south walls there exists large faded "ghost" painted signs, likely from the period of significance. **Ghost signs from the period of significance will be preserved to the greatest extent possible. Tuck pointing and replacement of bricks will only be performed where there is evidence of a moisture problem or when a substantial amount of the mortar is missing.** A large, recently painted sign that obscures the last few letters of the ghost signs is proposed to be reused for building and tenant identification.

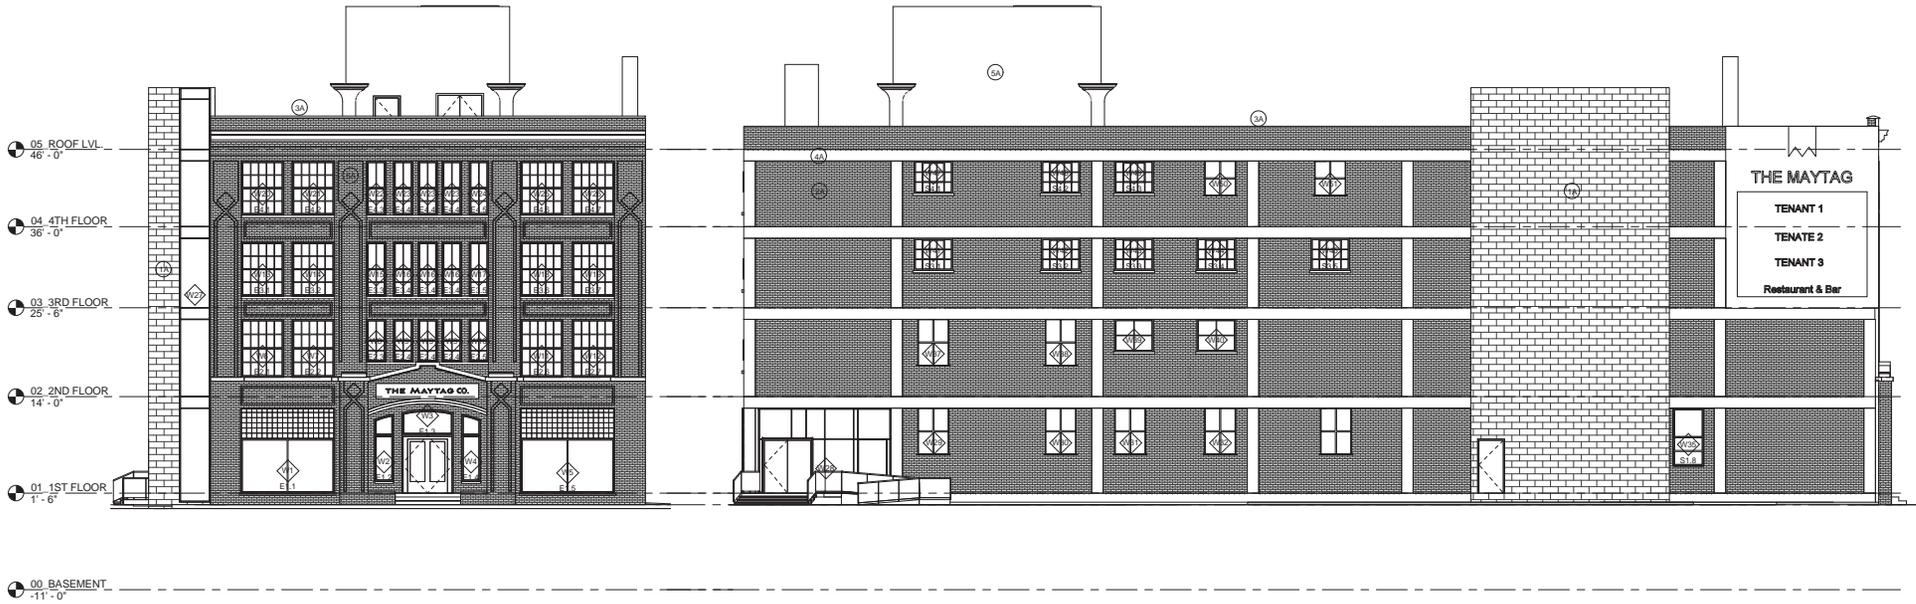
1 EAST ELEVATION
SCALE: 1/8" = 1'-0"

2 SOUTH ELEVATION
SCALE: 1/8" = 1'-0"

- Repair and restoration of the exposed concrete frame on the secondary facades.
- Addition of a second means of egress stair and an ADA entrance and service entrance to the South façade.

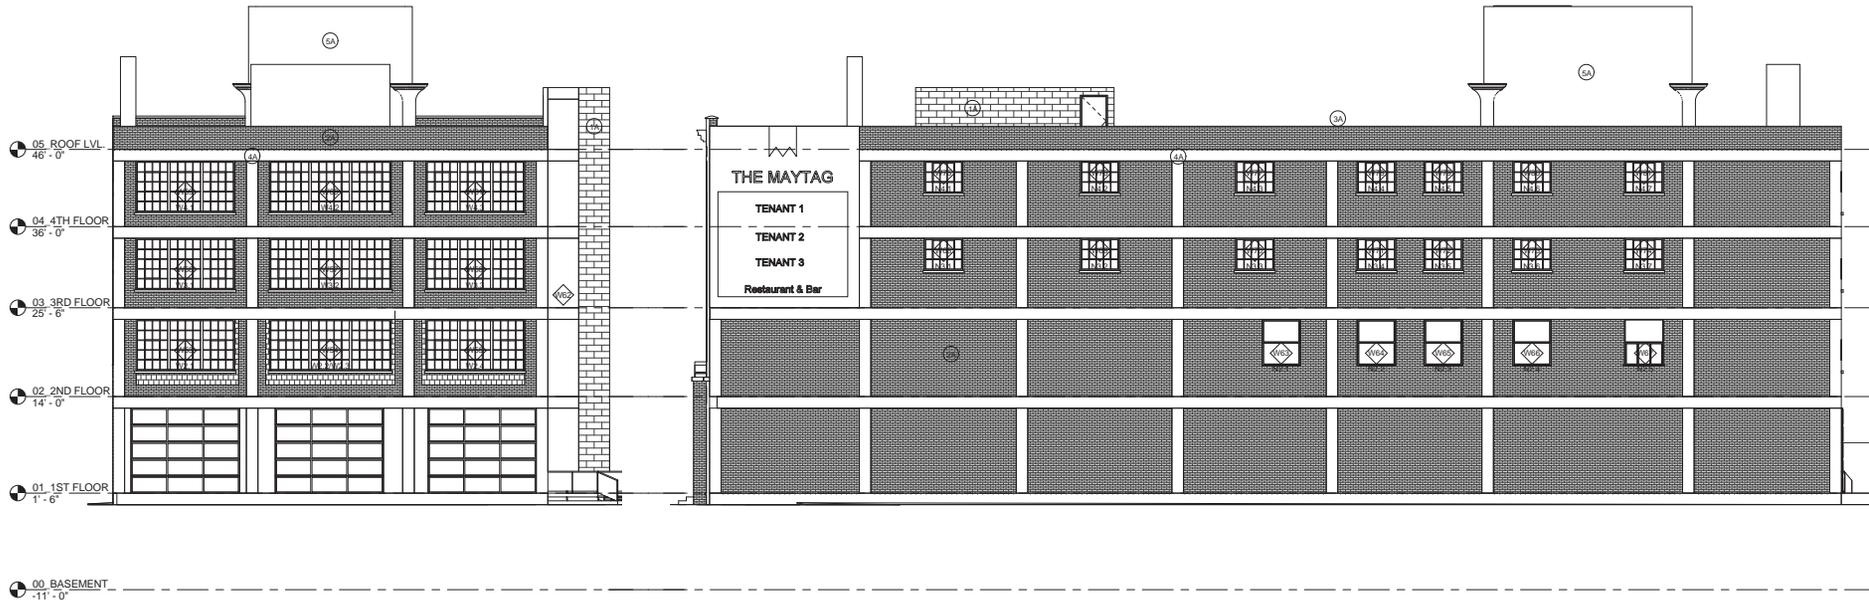
ELEVATION
SHEET TITLE
A201
SHEET NO.

1 WEST ELEVATION
SCALE: 1/8" = 1'-0"

2 NORTH ELEVATION
SCALE: 1/8" = 1'-0"

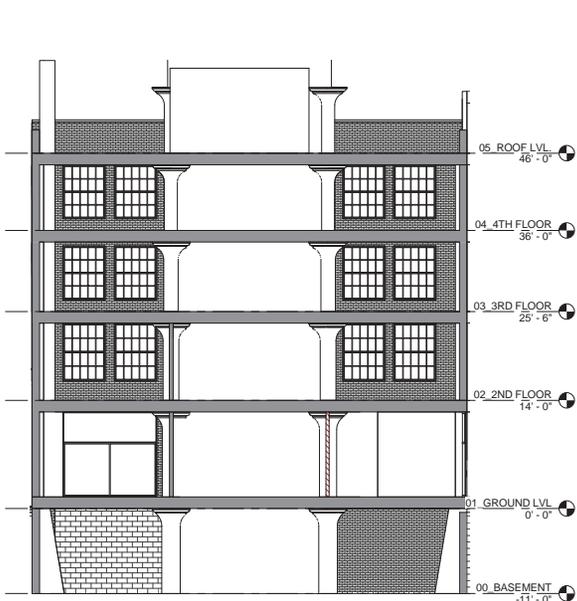
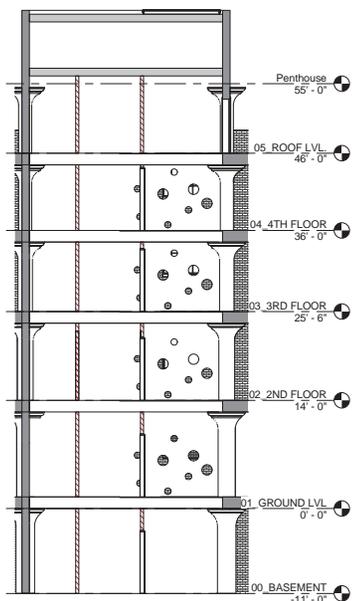
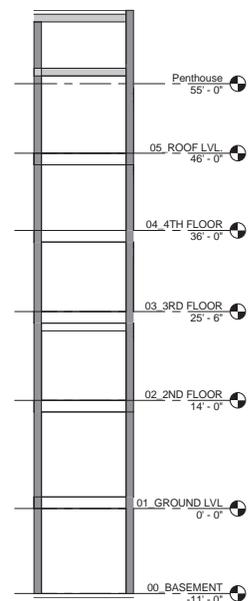
1 SECTION
SCALE: 1/8" = 1'-0"

2 SECTION
SCALE: 1/8" = 1'-0"

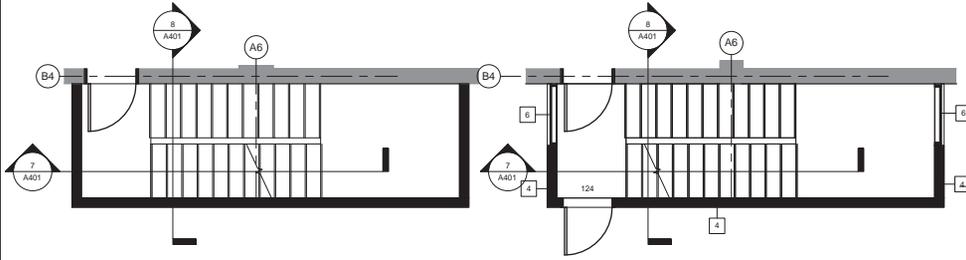
1 EGRESS STAIR ENLARGED-BAS FL
SCALE: 1/4" = 1'-0"

2 EGRESS STAIR ENLARGED-1ST FL
SCALE: 1/4" = 1'-0"

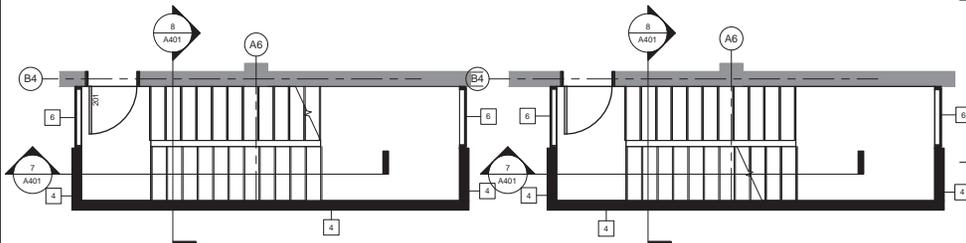
3 EGRESS STAIR ENLARGED-2ND FL
SCALE: 1/4" = 1'-0"

4 EGRESS STAIR ENLARGED-3RD FL
SCALE: 1/4" = 1'-0"

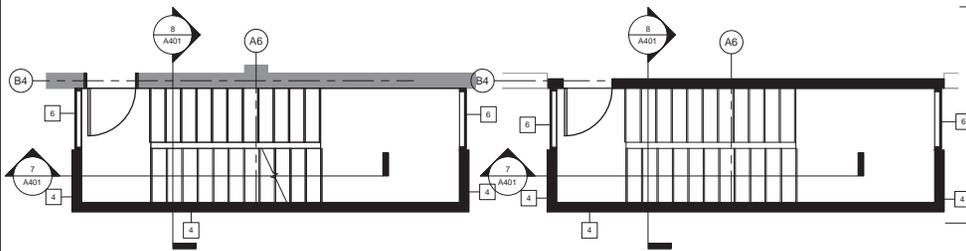
5 EGRESS STAIR ENLARGED-4TH FL
SCALE: 1/4" = 1'-0"

6 EGRESS STAIR ENLARGED-ROOF
SCALE: 1/4" = 1'-0"

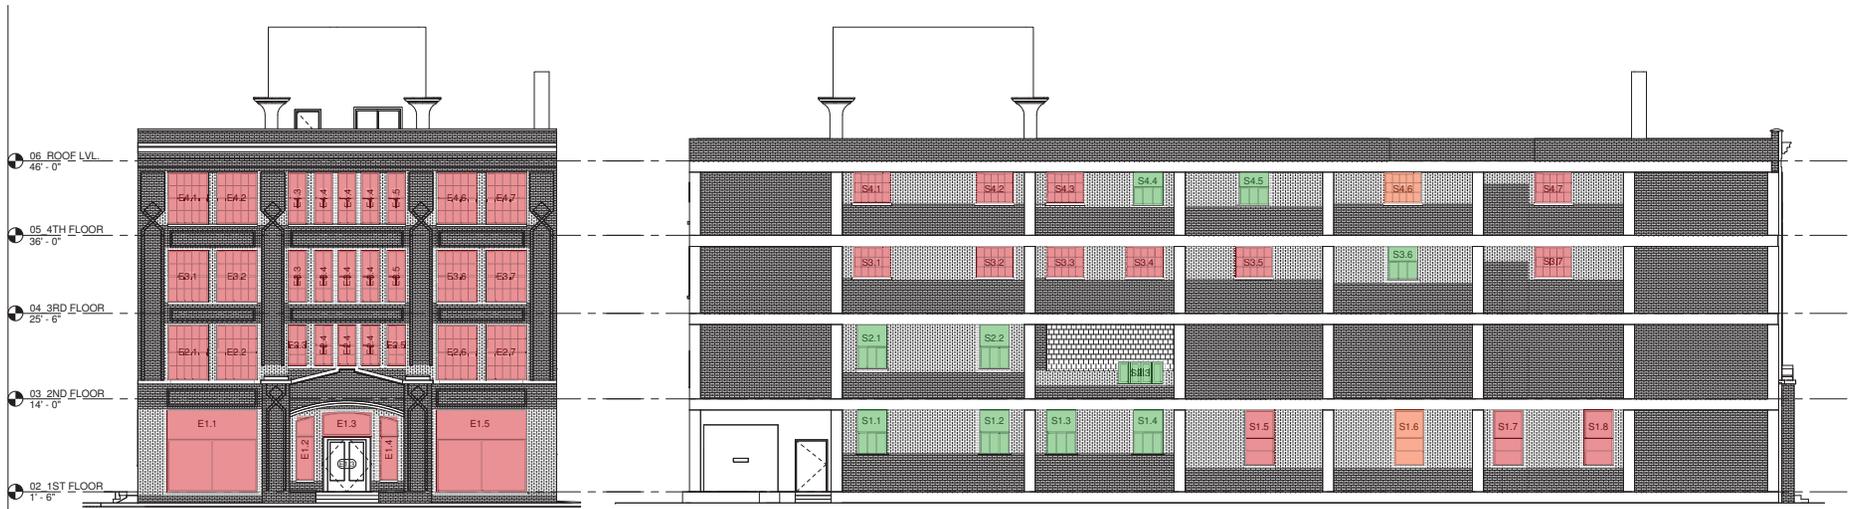
1 EAST ELEVATION
RA200 SCALE: 1/8" = 1'-0"

2 SOUTH ELEVATION
RA200 SCALE: 1/8" = 1'-0"

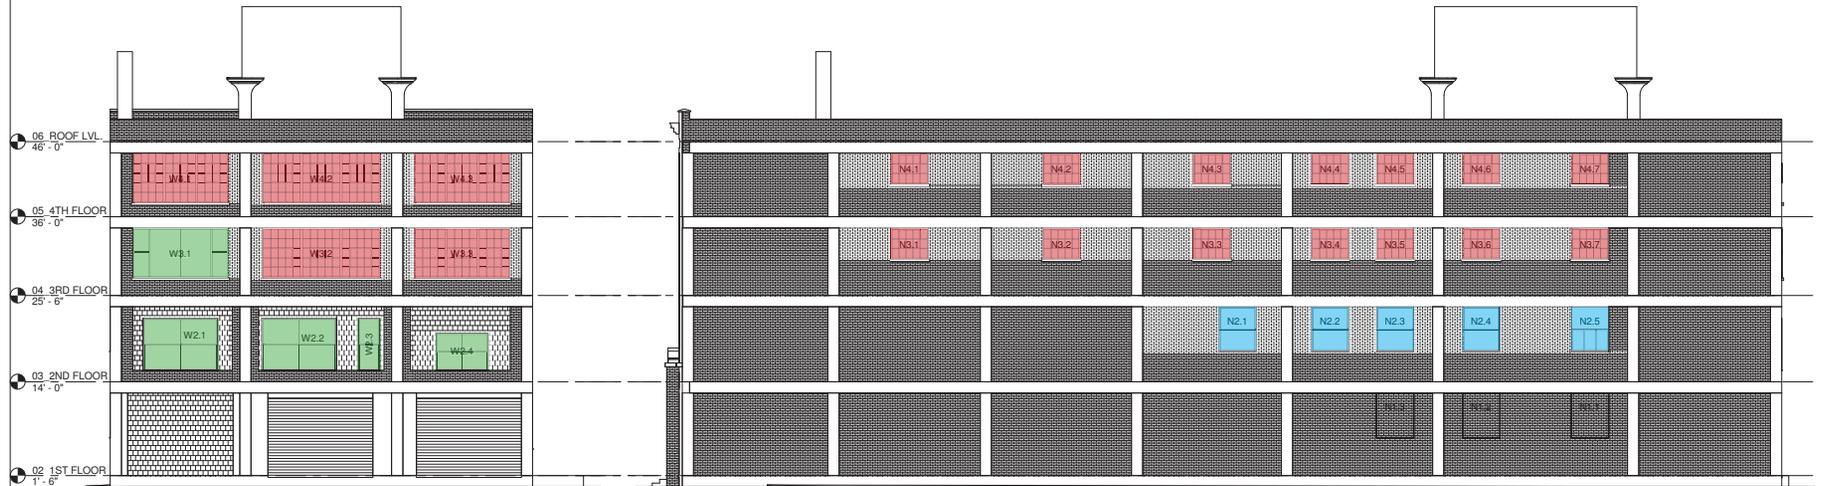
1 WEST ELEVATION
RA201 SCALE: 1/8" = 1'-0"

2 NORTH ELEVATION
RA201 SCALE: 1/8" = 1'-0"

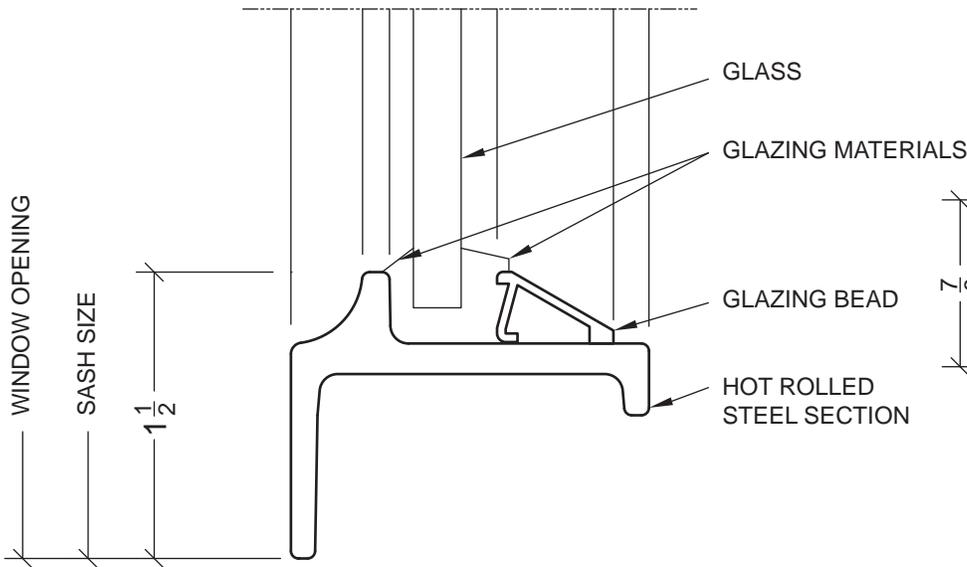
FIXED DETAIL
INTERIOR GLAZED WITH 1/4" GLASS

Details are full scale.

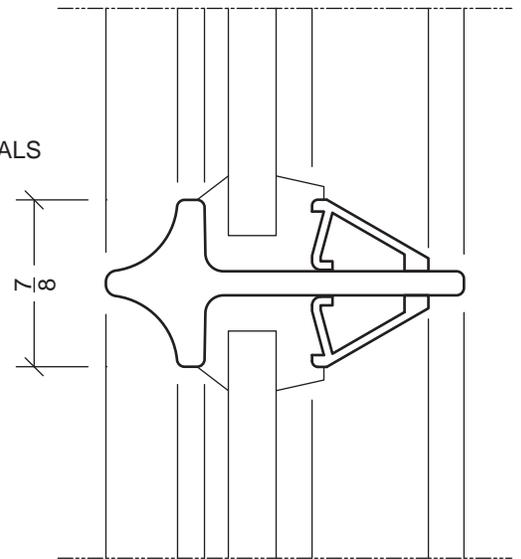
#449 TRUE MUNTIN DETAIL
INTERIOR GLAZED WITH 1/4" GLASS

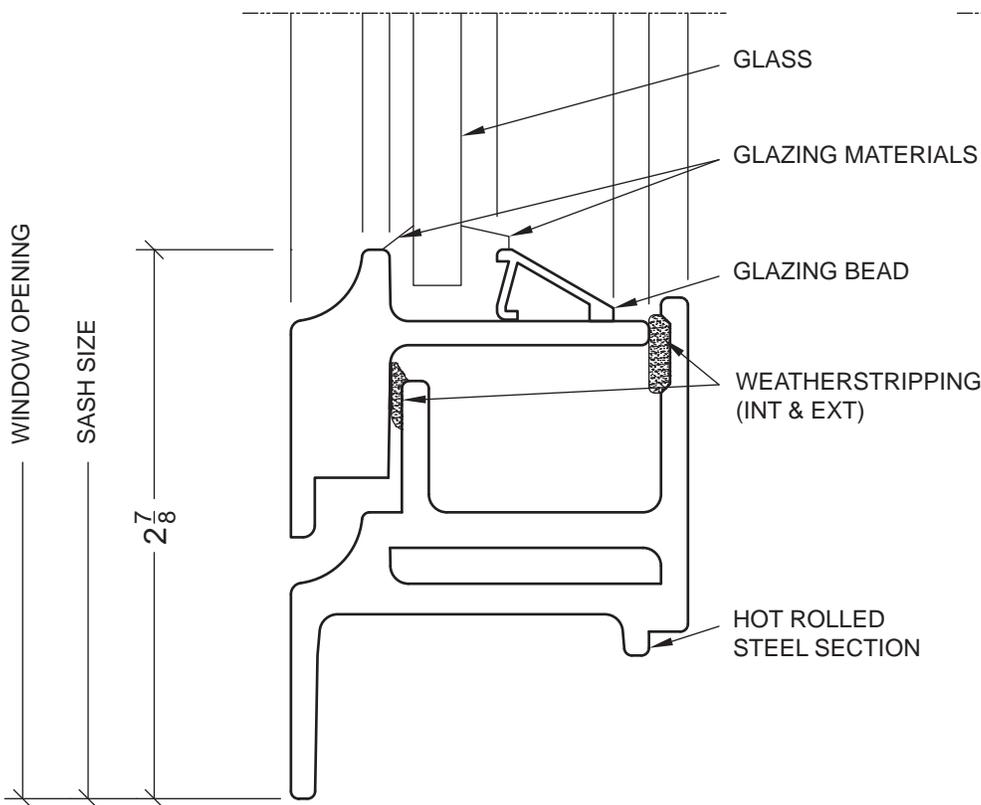
SWING-OUT DETAIL
INTERIOR GLAZED WITH 1/4" GLASS

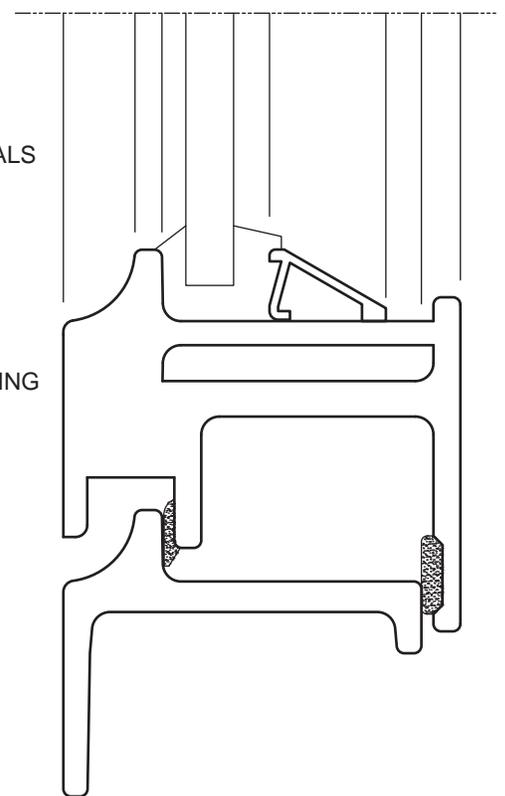
SWING-IN DETAIL
INTERIOR GLAZED WITH 1/4" GLASS
