MINNEAPOLIS COMBINED SEWER OVERFLOW PROGRAM 2009 ANNUAL REPORT

APRIL 23, 2010

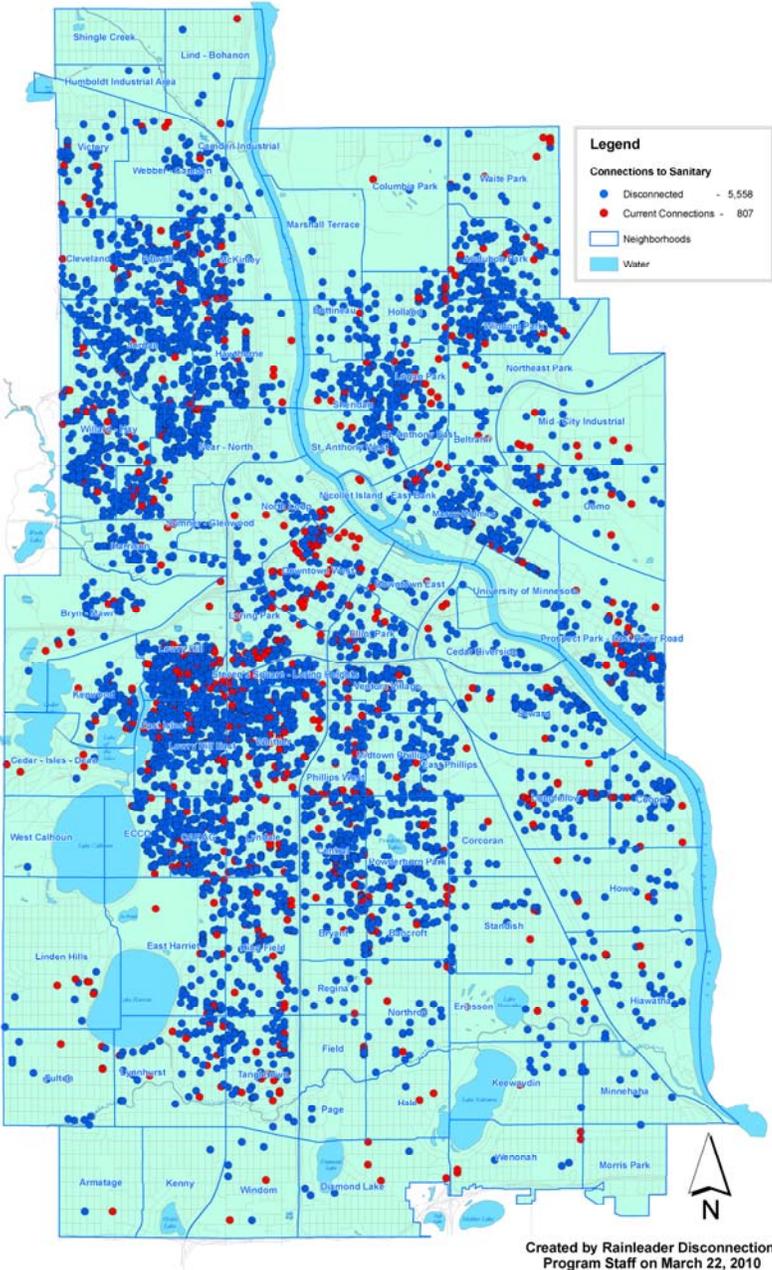
Figure 2

**City of Minneapolis - Rainleader Disconnect Program
Status as of March 22, 2010**

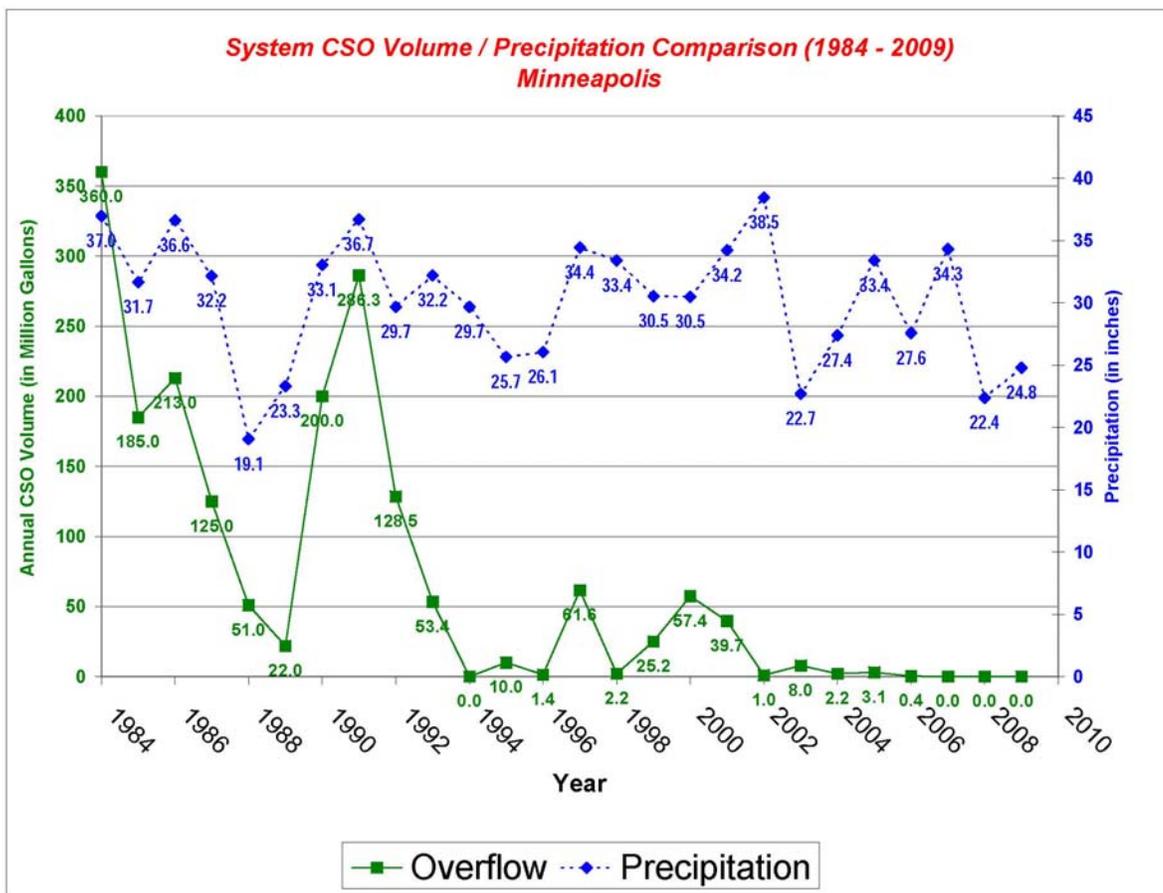
Progress has been dramatic throughout Phase I and Phase II as upgrades to the system have been carried out (see Figure 3). Figure 3 indicates a very high percent capture since 1984. Frequency and volume of untreated sewage overflowing into the stormwater system during intense rainstorms and discharging into the Mississippi River have steadily diminished. In 2007, 2008, and 2009 there were zero CSO events within the City of Minneapolis. The year 2007 was the first since the City of Minneapolis had combined sewers that untreated sewage did not pollute the Mississippi River in Minneapolis. Nevertheless, overflows could still occur and the separations that remain are generally the most difficult and complex to locate and resolve.

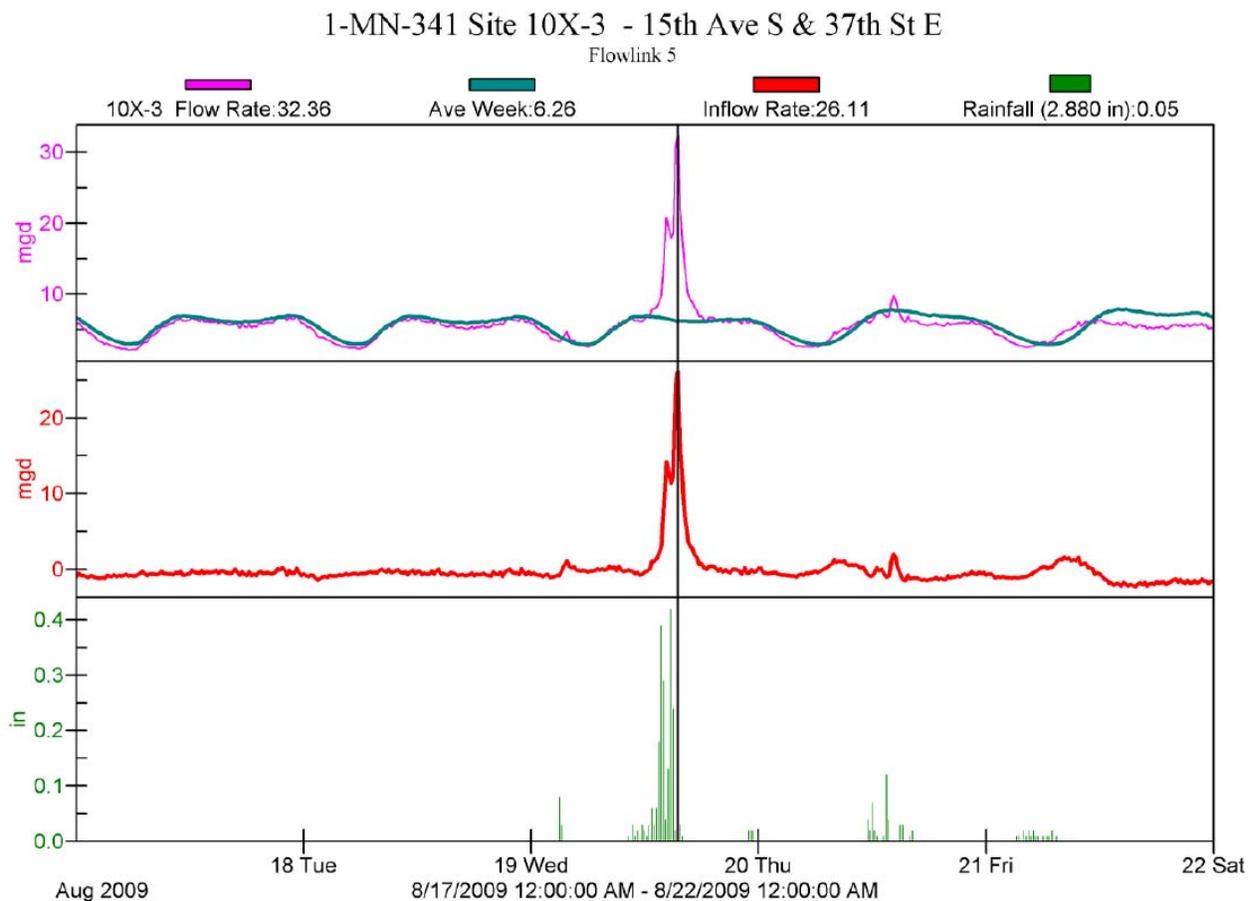
Figure 4: Meter Data

The unknown sources of inflow have an effect on the system demonstrated by the following meter data in Figure 4. These metering data reveal an immediate reaction of increased flow in the sanitary system after a rainfall event. This meter is located on the City's system in south Minneapolis and is representative of current metering data within this sewer shed.
