Warehouse District Heritage Street Plan

Existing Conditions

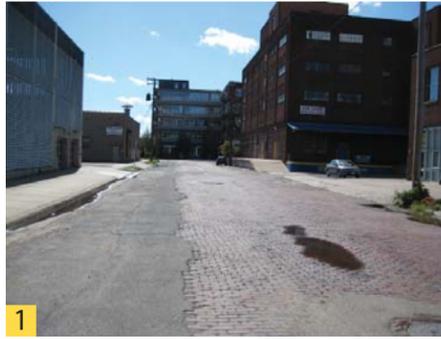
1 Significant paver patching exists adjacent to new sidewalk areas.

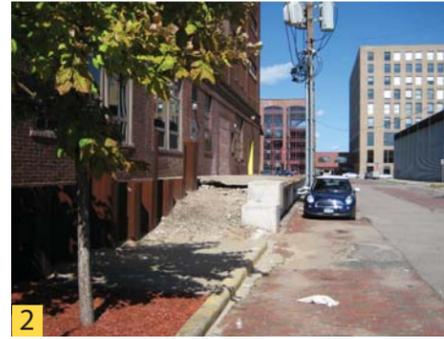
2 Sidewalk area and loading dock not fully constructed. Parallel parking blocks pedestrian circulation.

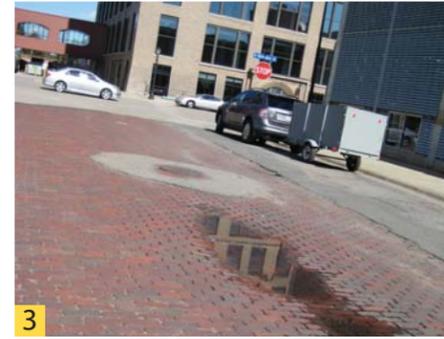
3 Standing water in areas of paver settlement. Concrete overlay at manhole.

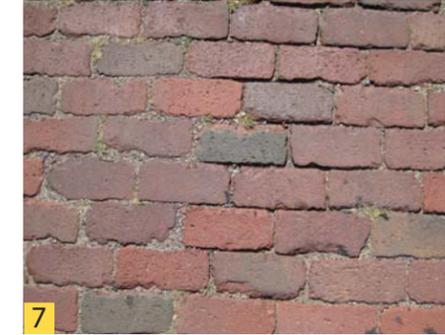
7 Photo of typical paver condition in roadway.

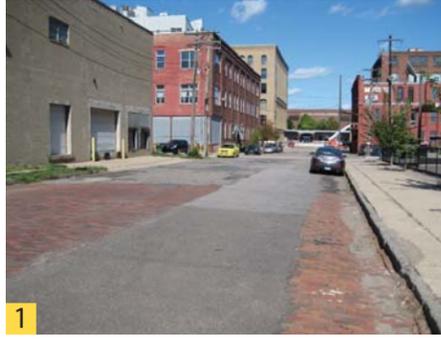
1 Extensive areas of bituminous paving over historic pavers

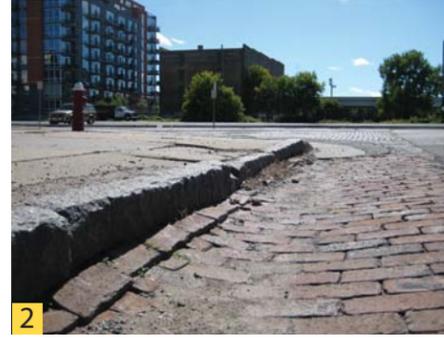
2 Areas of settling along existing granite curb

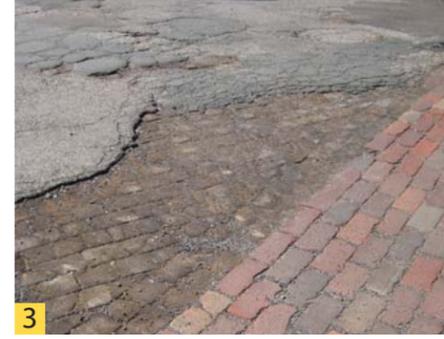
3 Transition of brick pavers to wood block pavers

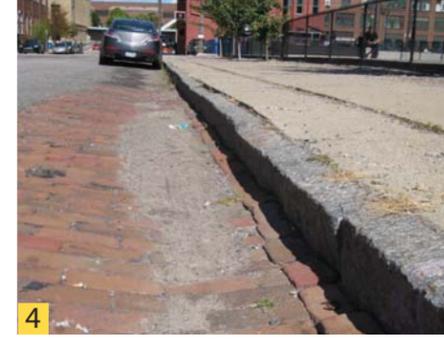
4 Areas of settling along existing granite curb

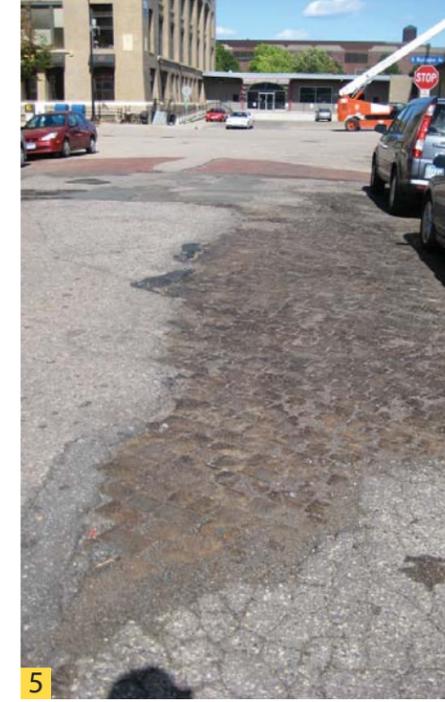
5 Existing areas of wood block pavers

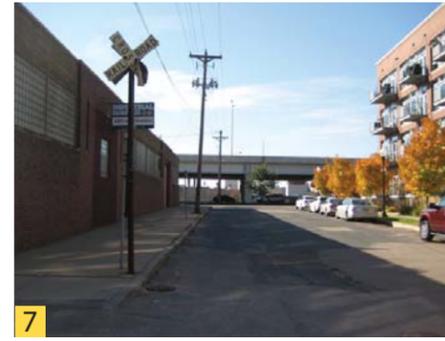
Existing R.R. crossing sign and exposed tracks

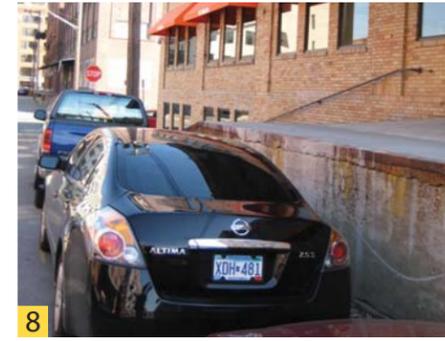
Parallel parking adjacent to loading docks requires some pedestrians to walk in streets

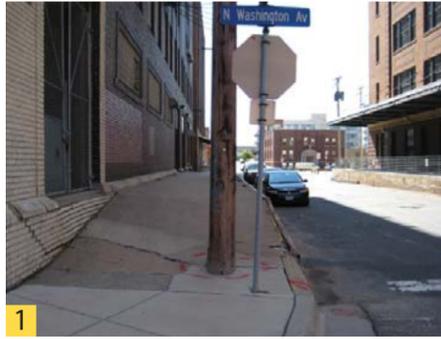
1 Existing ramp in poor condition and not ADA accessible

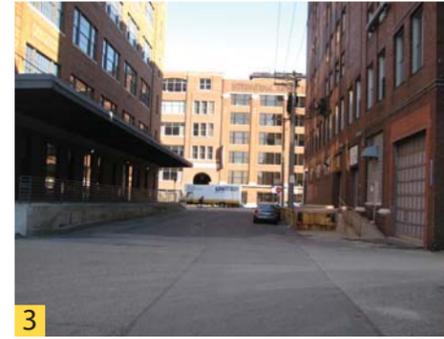
3 Narrow R.O.W. with loading docks on both sides of streets creates circulation issues

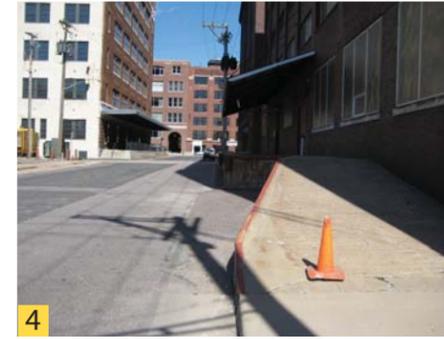
4 Steep ramp access to loading dock. Current dock is inactive with truck deliveries.

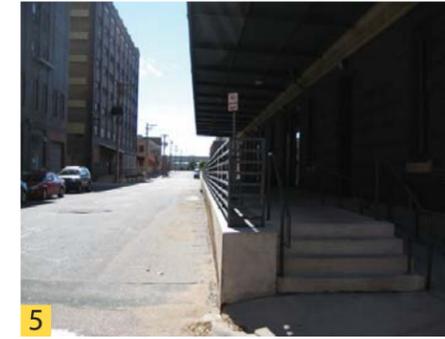
5 Stairs at HGA loading dock

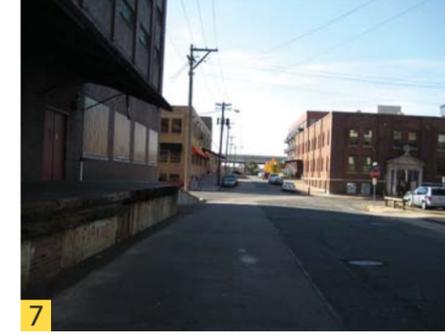
7 Limited pedestrian circulation

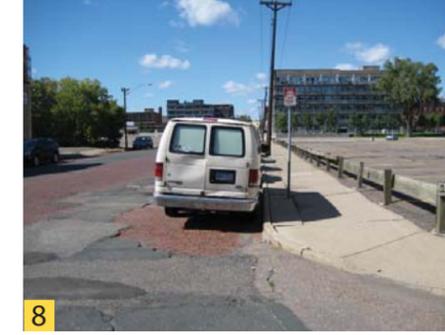
8 Narrow sidewalks and poor street conditions along 3rd St.

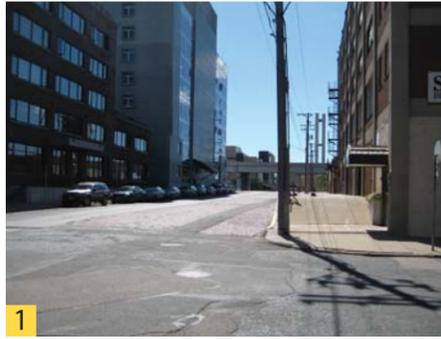
1 View north east along 6th Ave.

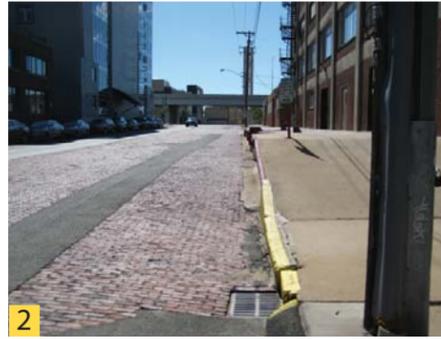
2 Edge of loading dock in poor condition
Loading dock not ADA compliant

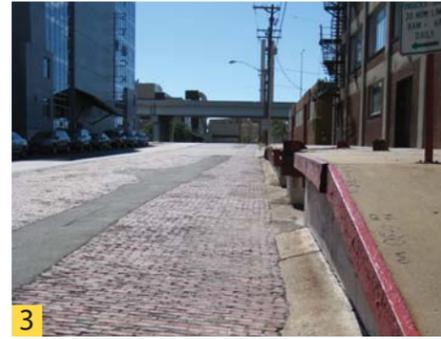
3 Pavers appear to be in good condition along street. Some extensive areas of patching exist along the street

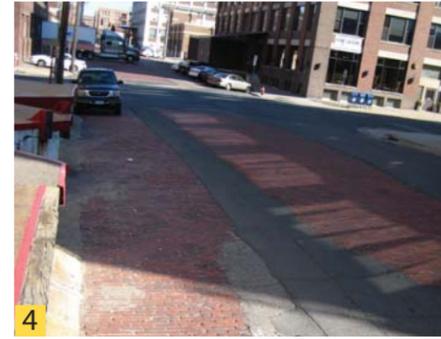
4 Some utility work and bituminous patching has occurred along the street

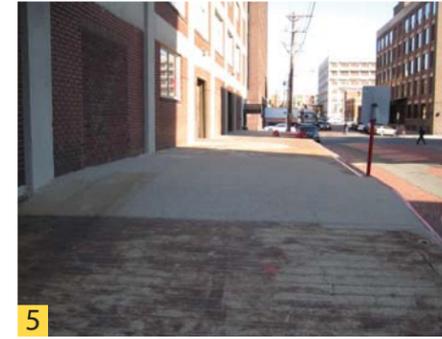
5 Surface of loading dock in good condition

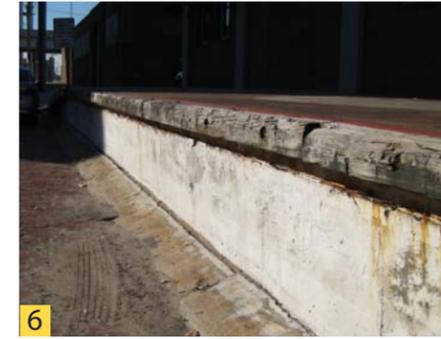
6 Edge of loading dock in fair condition

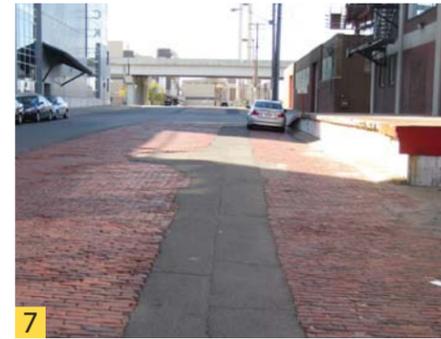
7 Parallel parking along loading dock forces pedestrian to walk in street

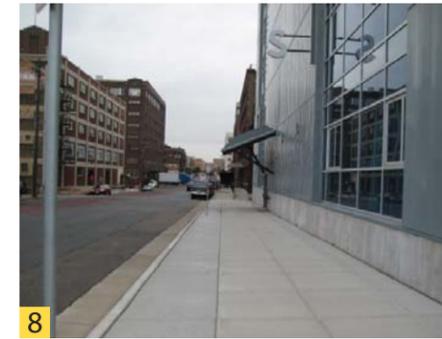
8 Sidewalk in front of Bookman Stacks is wide and offers opportunity for street trees

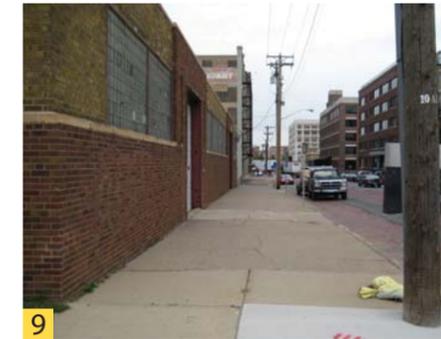
9 Sidewalk sidewalk in northwest side of street in fair condition and is wide enough to accommodate trees

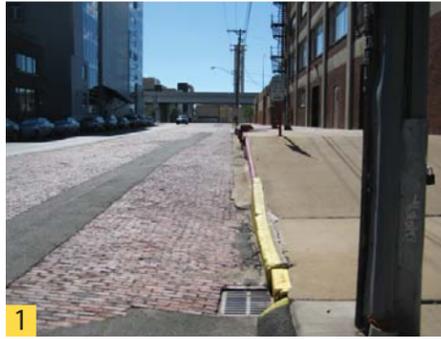
1 Current loading dock not ADA compliant

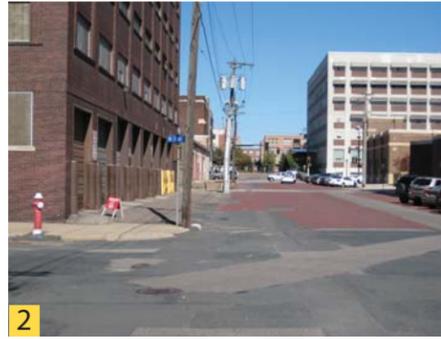
2 No clearly defined pedestrian access on north side of street

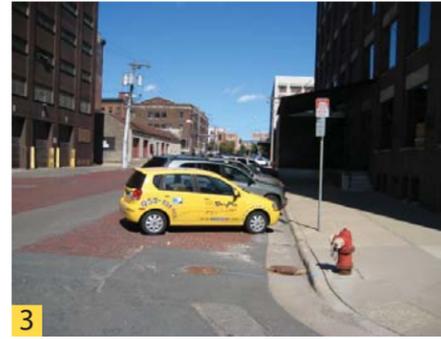
3 Parallel parking blocks pedestrian access past building. The existing ROW is narrow and limits potential improvements

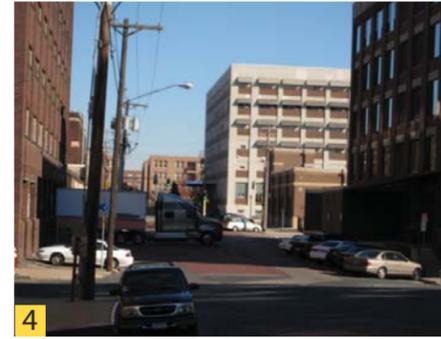
4 Truck deliveries block street and limit pedestrian and vehicular circulation

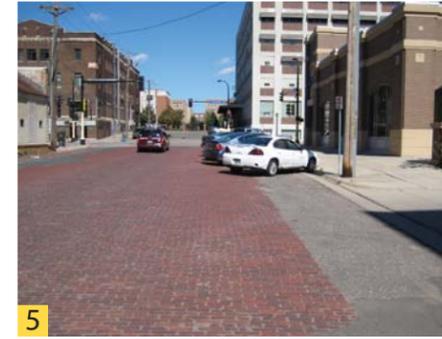
5 Angled parking limits vehicular circulation

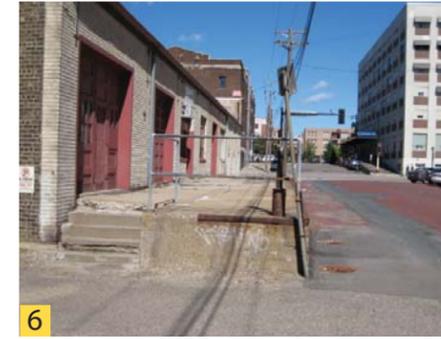
6 Existing stairs at loading dock in poor condition

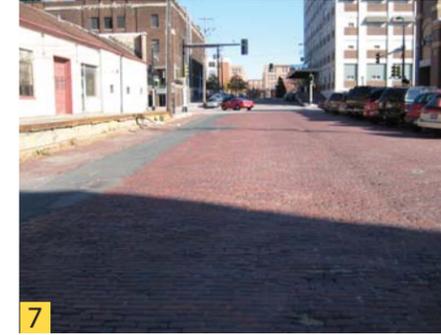
7 Majority of street remains exposed pavers. Some patching and paver settling exists based on visual inspection, pavers appear to be in good condition

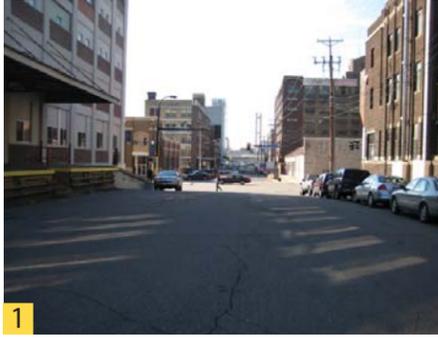
1 View towards Washington Avenue along 6th Avenue N. Existing loading dock and on-street parking create pedestrian conflicts

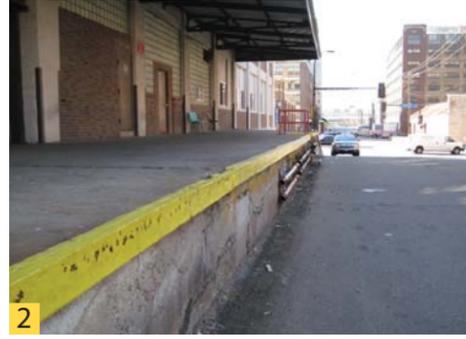
2 View along existing loading dock.

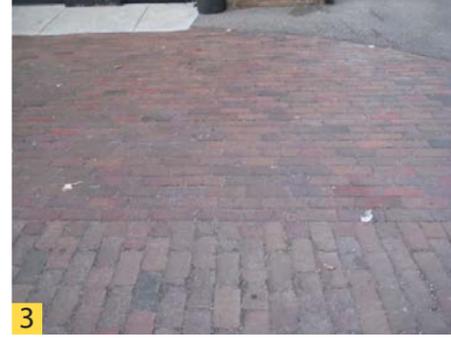
3 Historic street paving adjacent to infill paving within the street

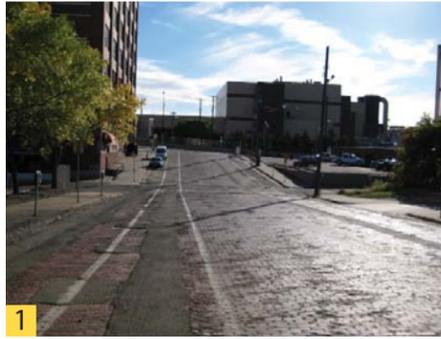
1 Multiple areas of patching along street
 • pavers in good condition in center park of street

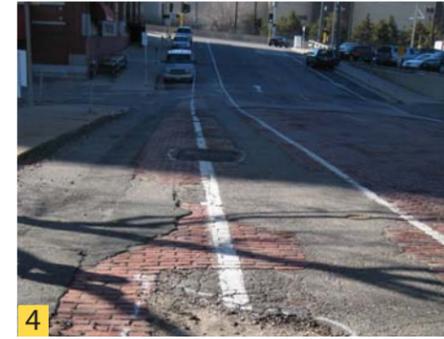
4 Bike lane in poor condition

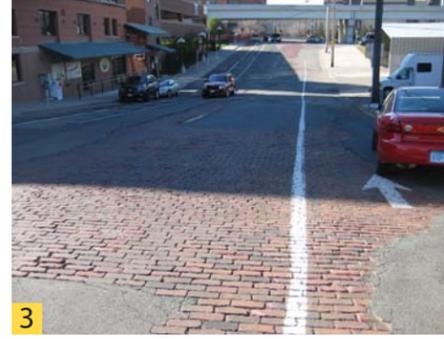
3 Pavers in streets in good condition. Shared bike lane and on-street parking conflicts

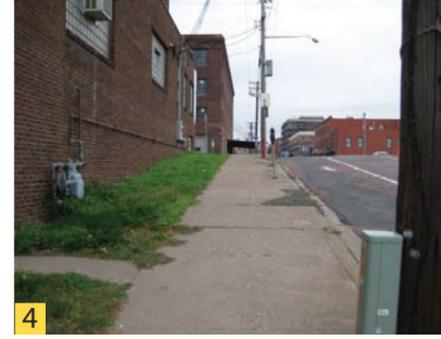
4 Sidewalks on the block appearing in good condition but have steep grades.

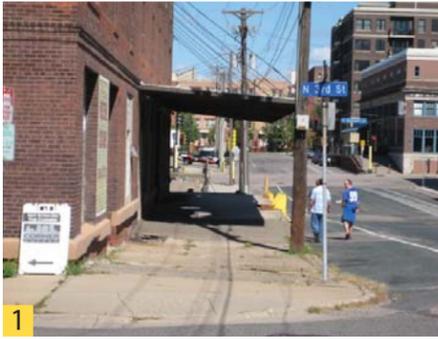
1 Sidewalk in poor condition. Pedestrians prefer to walk on streets vs. loading dock

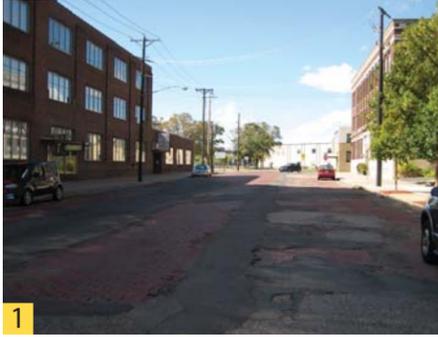
1 Excessive areas of road patching between 9th and 10th Avenue

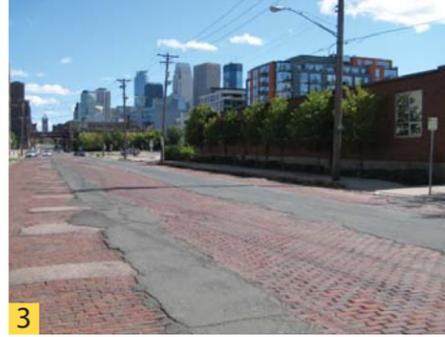
3 Extensive areas of exposed pavers
 • pavers in fair condition
 • extensive areas of settling
 • large areas of utility cuts with bituminous overlay

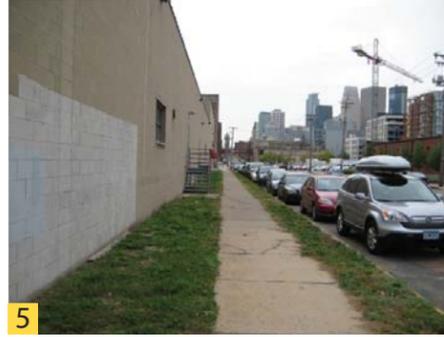
5 Existing sidewalk in fair to poor condition

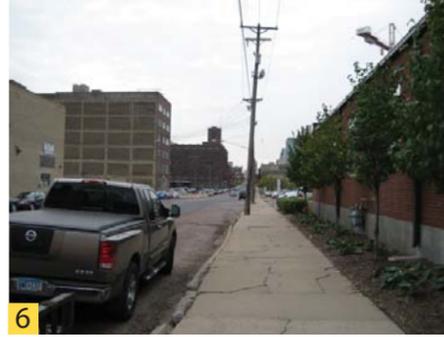
6 Existing curb and sidewalk in fair to poor condition
 • areas of standing water

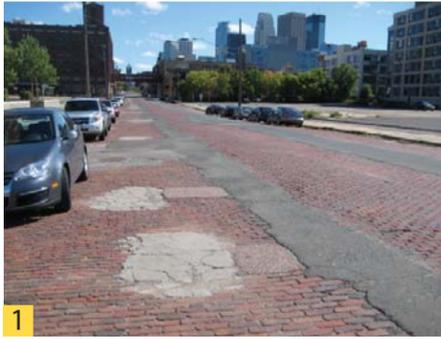
1 Excessive areas of road patching. Pavers settling causes water to collect in certain areas. Variety of different materials has been used in patching

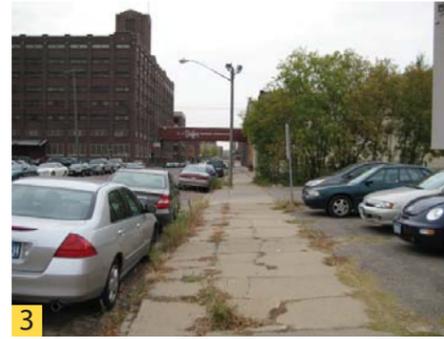
3 Most sidewalks in poor condition throughout this section of 3rd Street N

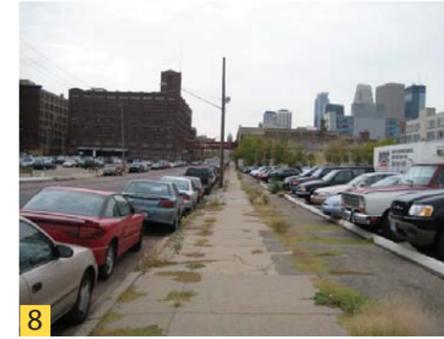
8 Sidewalks in poor condition and not accessible

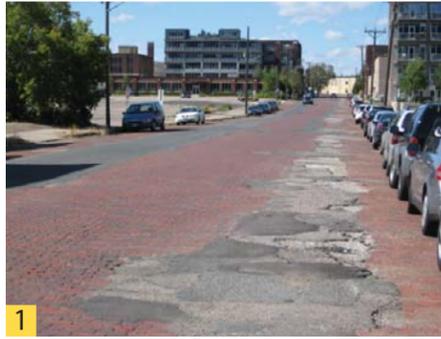
1 Excessive areas of pavement patching

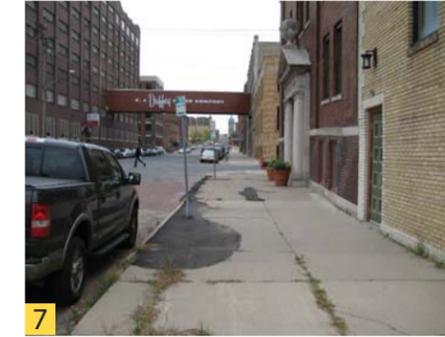
7 Sidewalk in fair to poor condition
• opportunity to add street trees

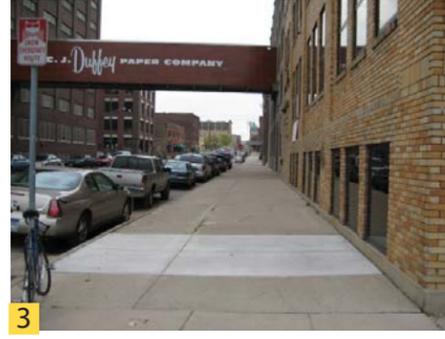
3 Wide sidewalks exist along both sides of 3rd Street N.

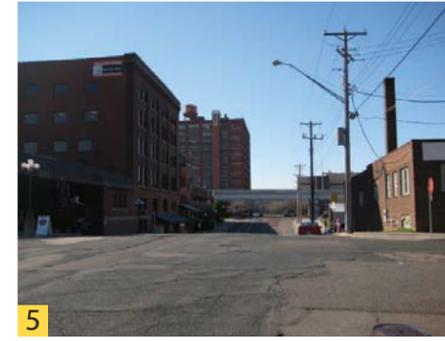
5 View at 3rd Street/5th Avenue Intersection. Good views towards Ford Center

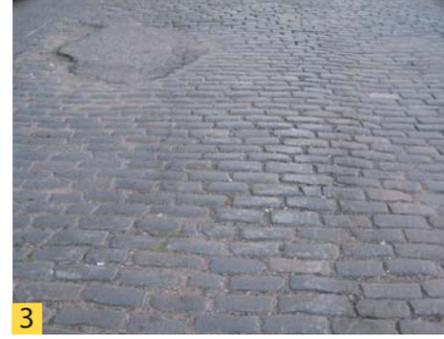
3 Road paving in fair to good condition

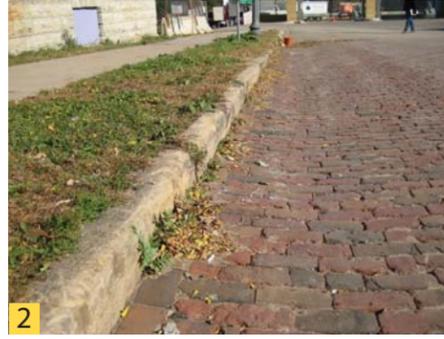
2 View of historic paved street, sidewalk area and sandstone curb along 2nd Avenue N

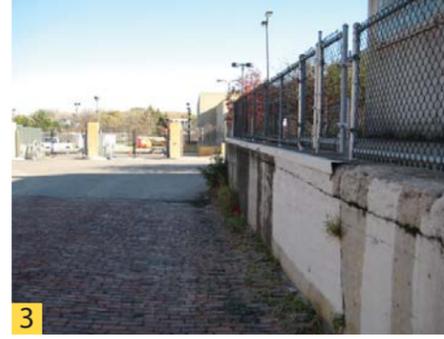
3 View along loading dock on northwest edge of 2nd Avenue N

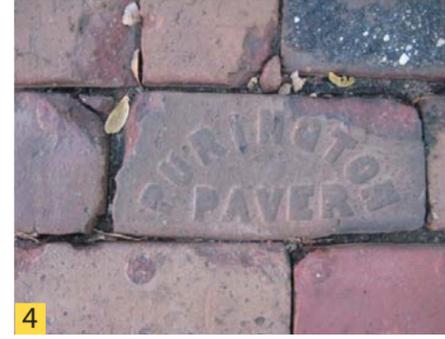
4 Closeup view of historic Purington pavers placed in 2nd Avenue roadway

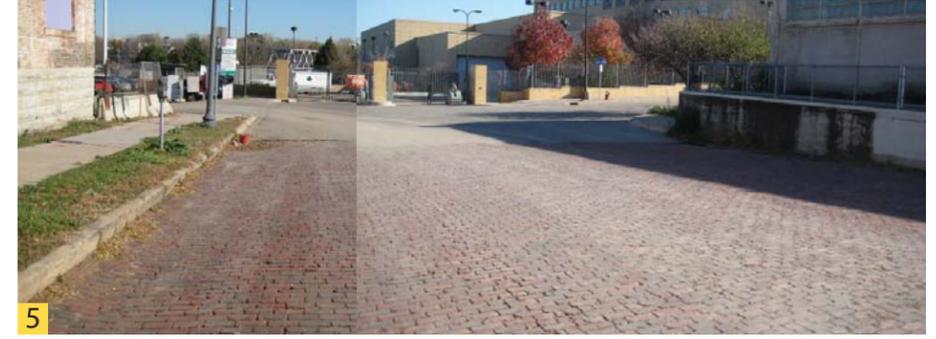
5 Wide view of 2nd Avenue N. Paving is generally in good condition and remains very level throughout the entire roadway

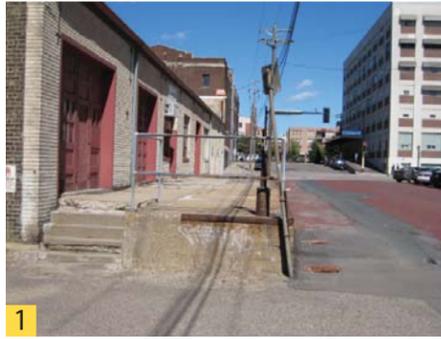
1 Existing stairs at loading dock in poor condition

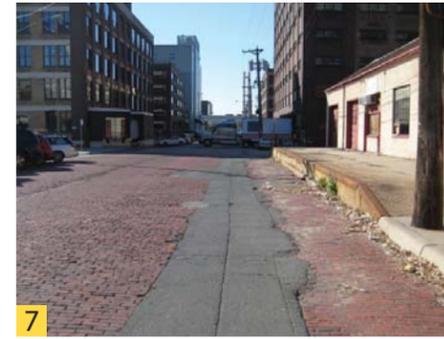
7 No clearly defined pedestrian access around existing loading dock.

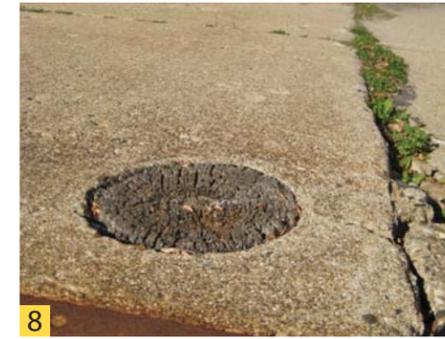
8 Remnant utility pole

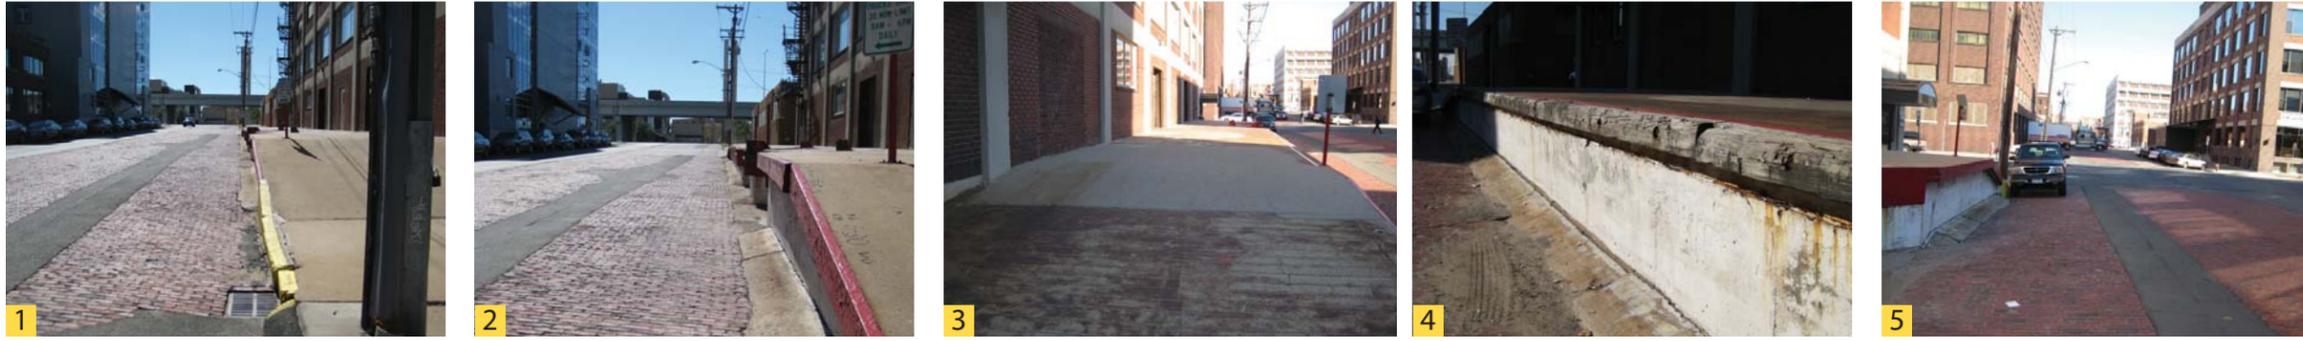
Surface of loading dock in good shape. Concrete and wood edge of loading dock also in good condition

Loading dock ramp not ADA accessible and has no stair access.

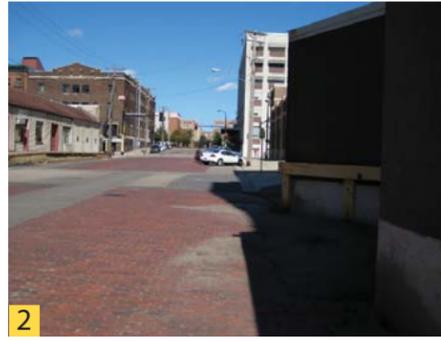
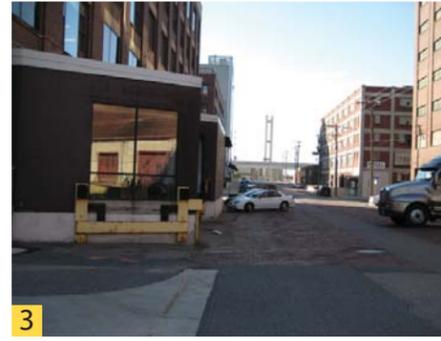
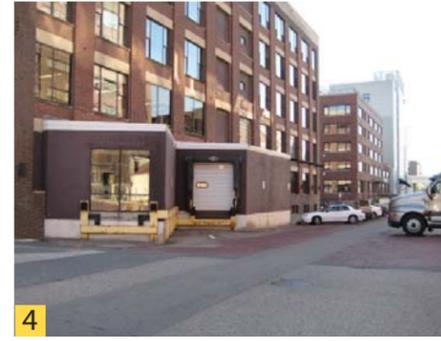
Loading dock extends into ROW and limits pedestrian access along the southeast side of 6th Avenue N
